Greetings Mirror Lake Residents,

Please find the latest bioassessment report for your lake below. Our next scheduled survey will be **October 20th**, weather permitting. Key highlights of this update include:

### **Bioassessment**

On **August 19th, 2014**, SCLMP personnel, Thomas Calhoun, Gloria Eby, and Marianne Pluchino, surveyed the aquatic plants in **Mirror Lake** and conducted a Lake Vegetation Index (LVI) assessment.

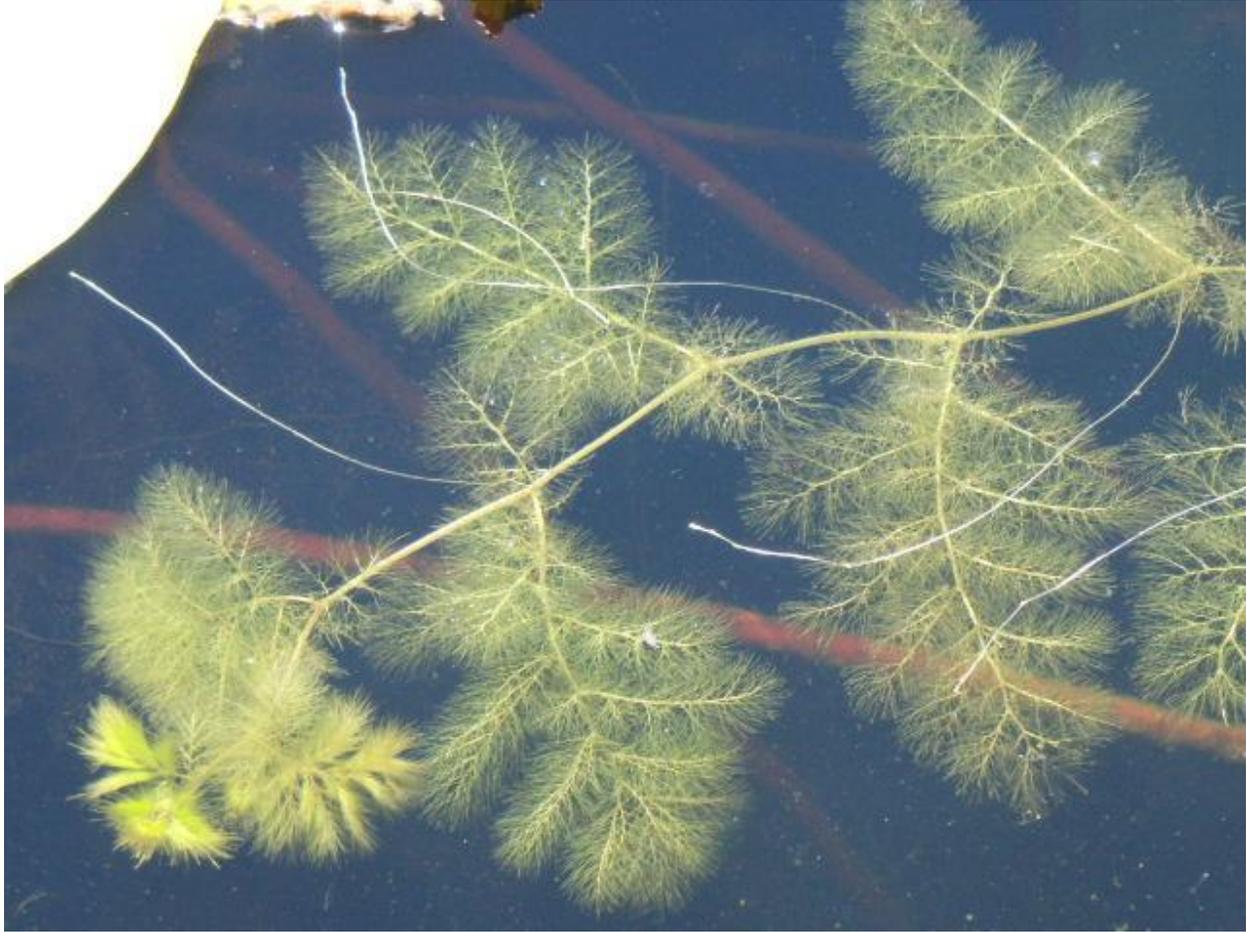
Six species of submersed aquatic vegetation (SAV) were found during the inspection, five of which were native species. These native species included: lemon bacopa to 2 feet, road grass to 2 feet, 2 types of bladderwort to 10 feet, and eelgrass to 4 feet. Eelgrass was also found topping out (reaching the surface) at a depth of 3 feet. Bladderwort was the dominant species of SAV found in Mirror Lake. Native SAV plays an important part within Mirror Lake by providing wildlife habitat, reducing nutrients in the water, and by competing with hydrilla for space.

**Photo: Close up of bladderwort.**

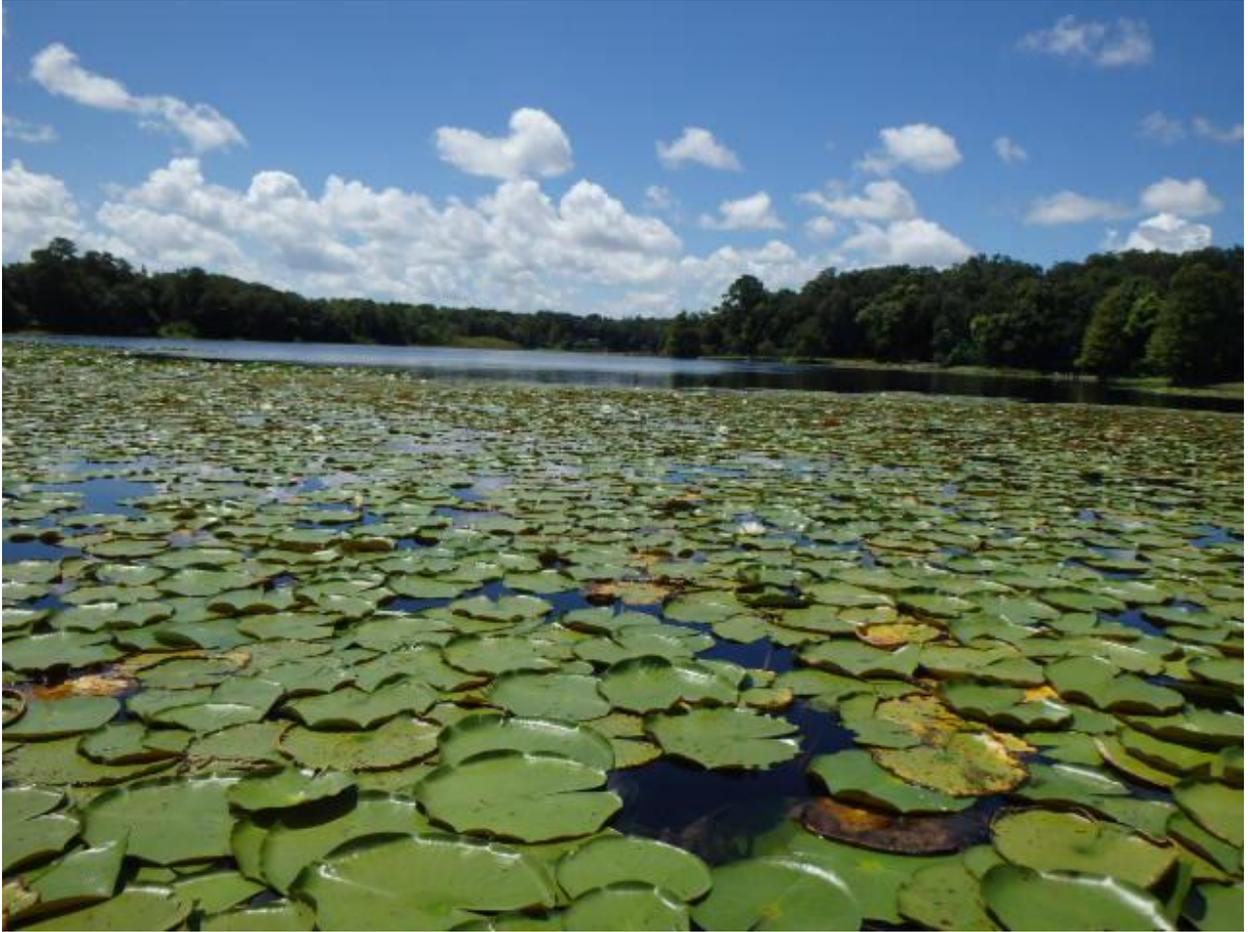
The access corridors in the southern end of Mirror Lake were still open; however, the native lily pads (spatterdock and the fragrant water lily) have expanded lake-wide. American lotus has also significantly expanded along the northwestern shore of the lake. Both of these species will be targeted during the next treatment.

**Photo: Fragrant water lily.**

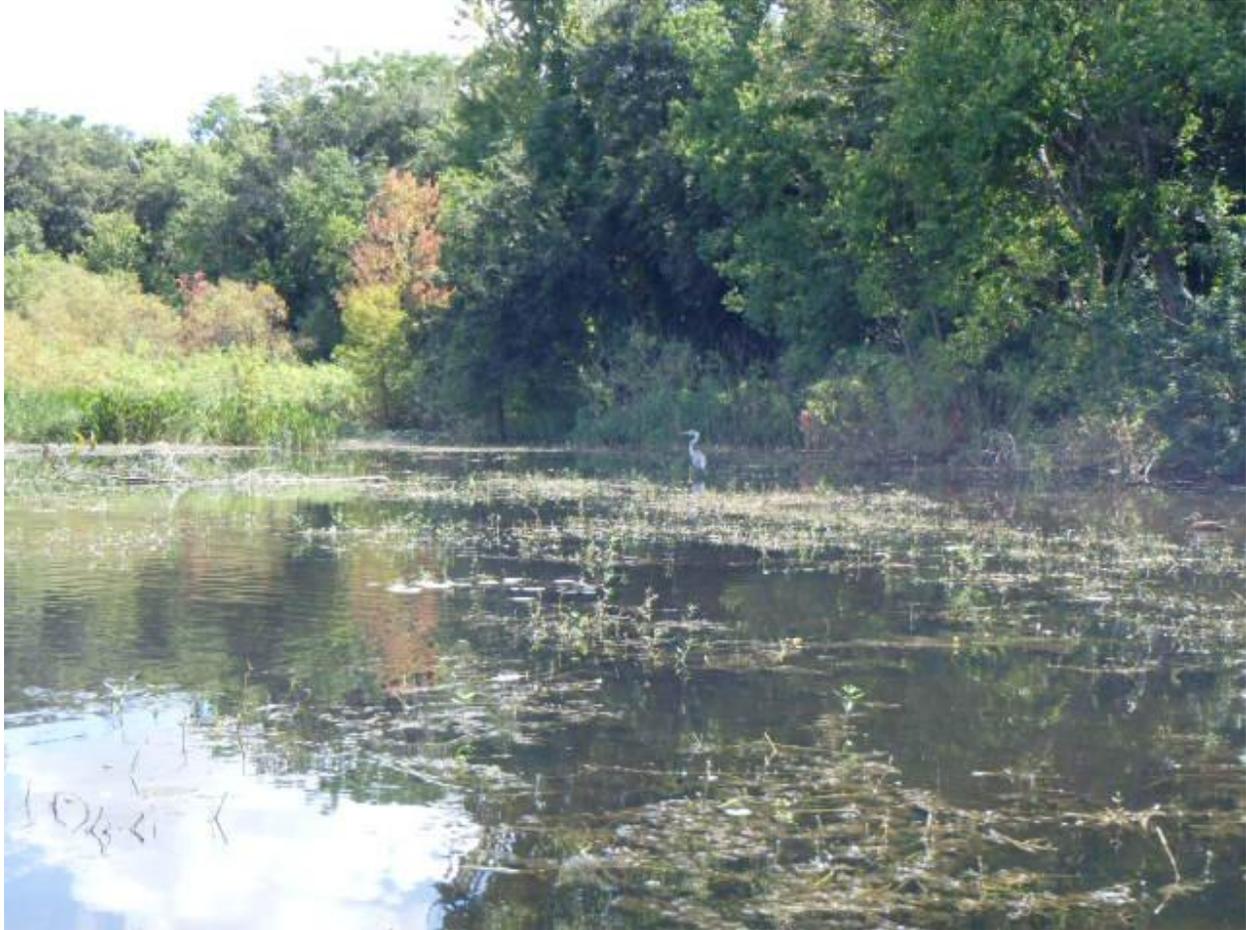
**Photo: Alligator weed found at the southern end of Mirror Lake.**

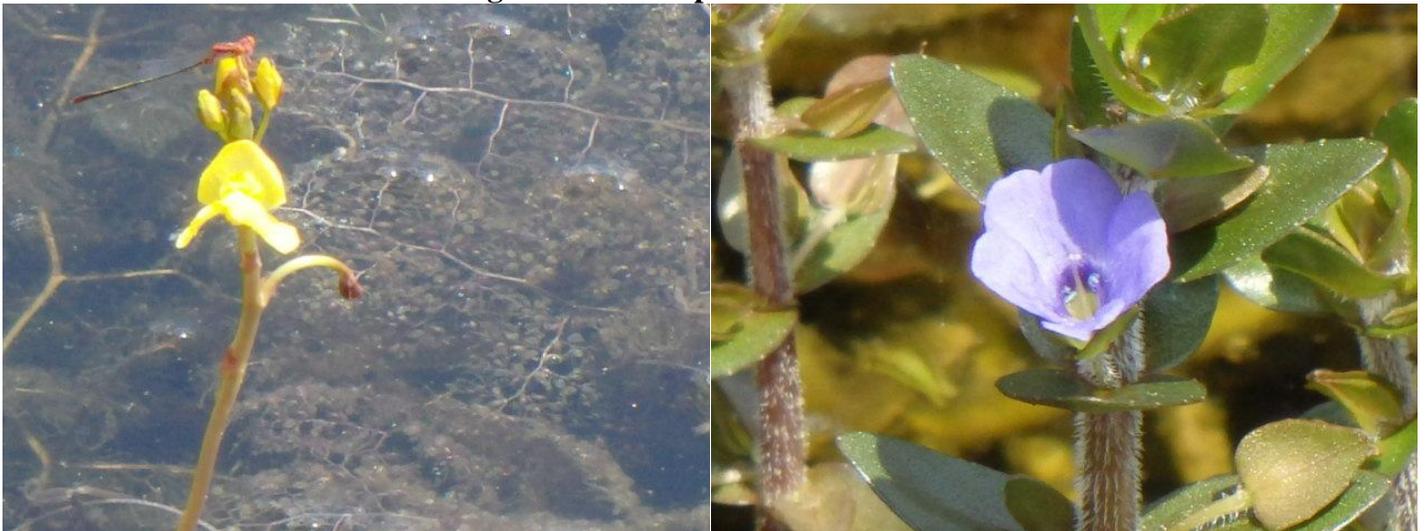
Six species of submersed aquatic vegetation (SAV) were found during the inspection; five of which were native species. These native species included: lemon bacopa to 3 feet, road grass to 2 feet, 2 types of bladderwort to 5 feet, and eelgrass to 3.5 feet. Eelgrass was also found topping out at a depth of 2 feet. Native SAV plays an important part within Mirror Lake by providing wildlife habitat, reducing nutrients and competing for space with hydrilla.

**Photo: Left bladderwort bloom. Right lemon bacopa bloom.**

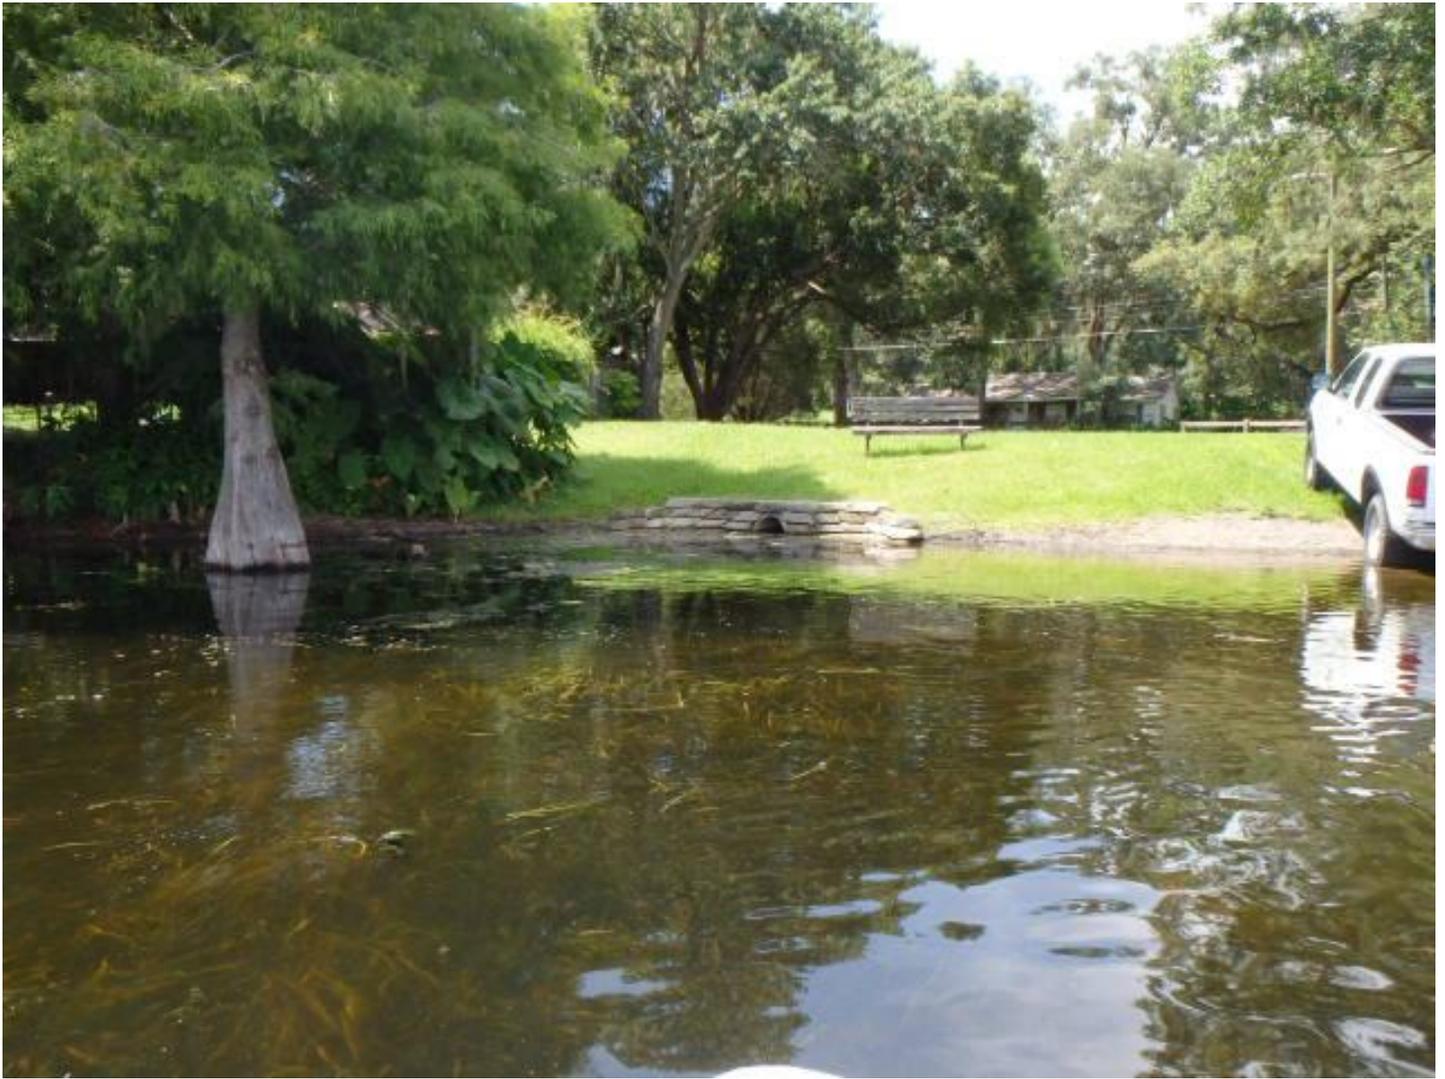
**Photo: Eelgrass reaching surface at the boat ramp.**

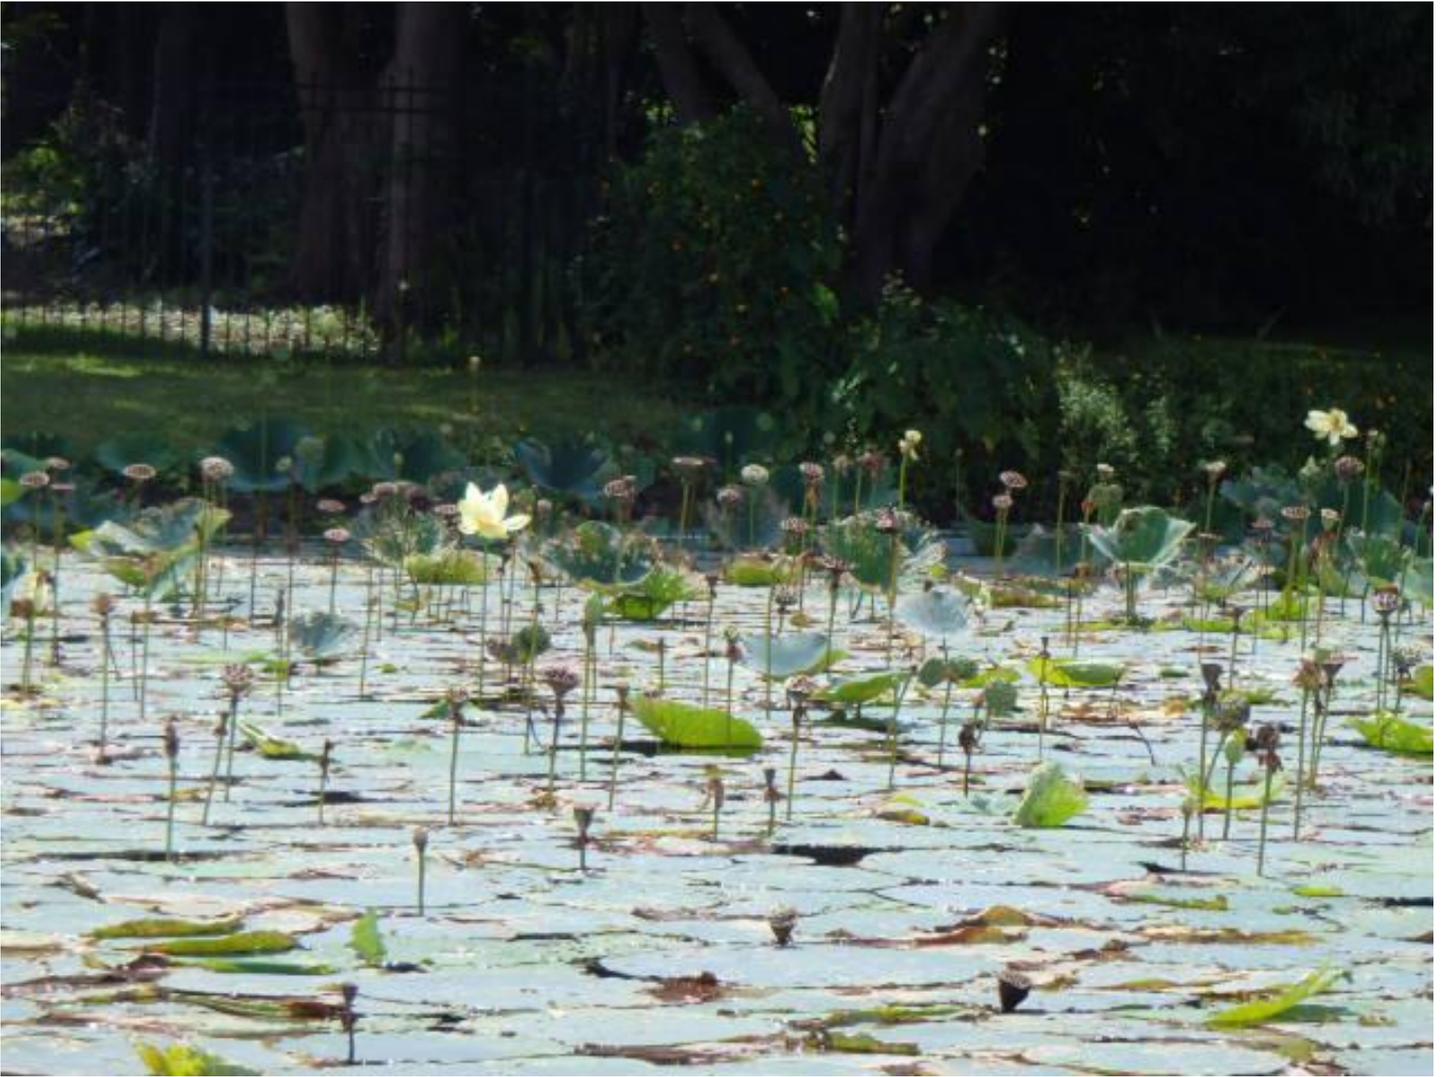
The access corridors in the southern end of Mirror Lake were still open; however the native lily pads (spatterdock and the fragrant water lily) have expanded lake wide. American lotus has also significantly expanded along the northwestern shore of the lake. Both of these species will be targeted during the next treatment.

**Photo: American lotus.**

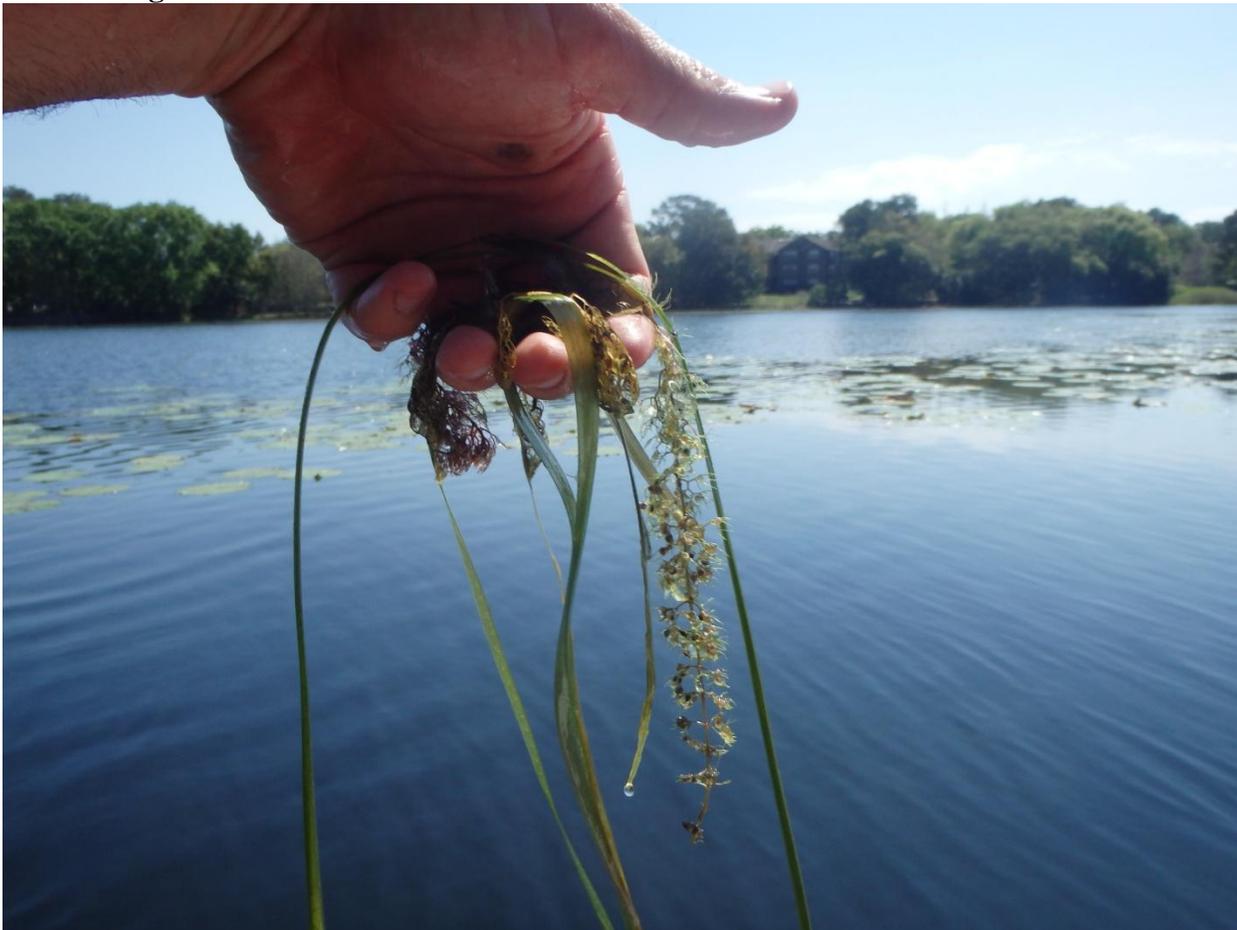
Seven SAV were found during the inspection; six of which were native species. These native species included: lemon bacopa to 2 feet, smooth water hyssop to 2 feet, road grass to 6 feet, 2 types of bladderwort to 5 feet, and eelgrass to 5 feet. Bladderwort and eelgrass were found “topped out” reaching the surface at a depth of 3 feet. Native SAV plays an important part within Mirror Lake by providing wildlife habitat, reducing nutrients, and competing for space with hydrilla.

**Photo: Eelgrass and bladderwort.**

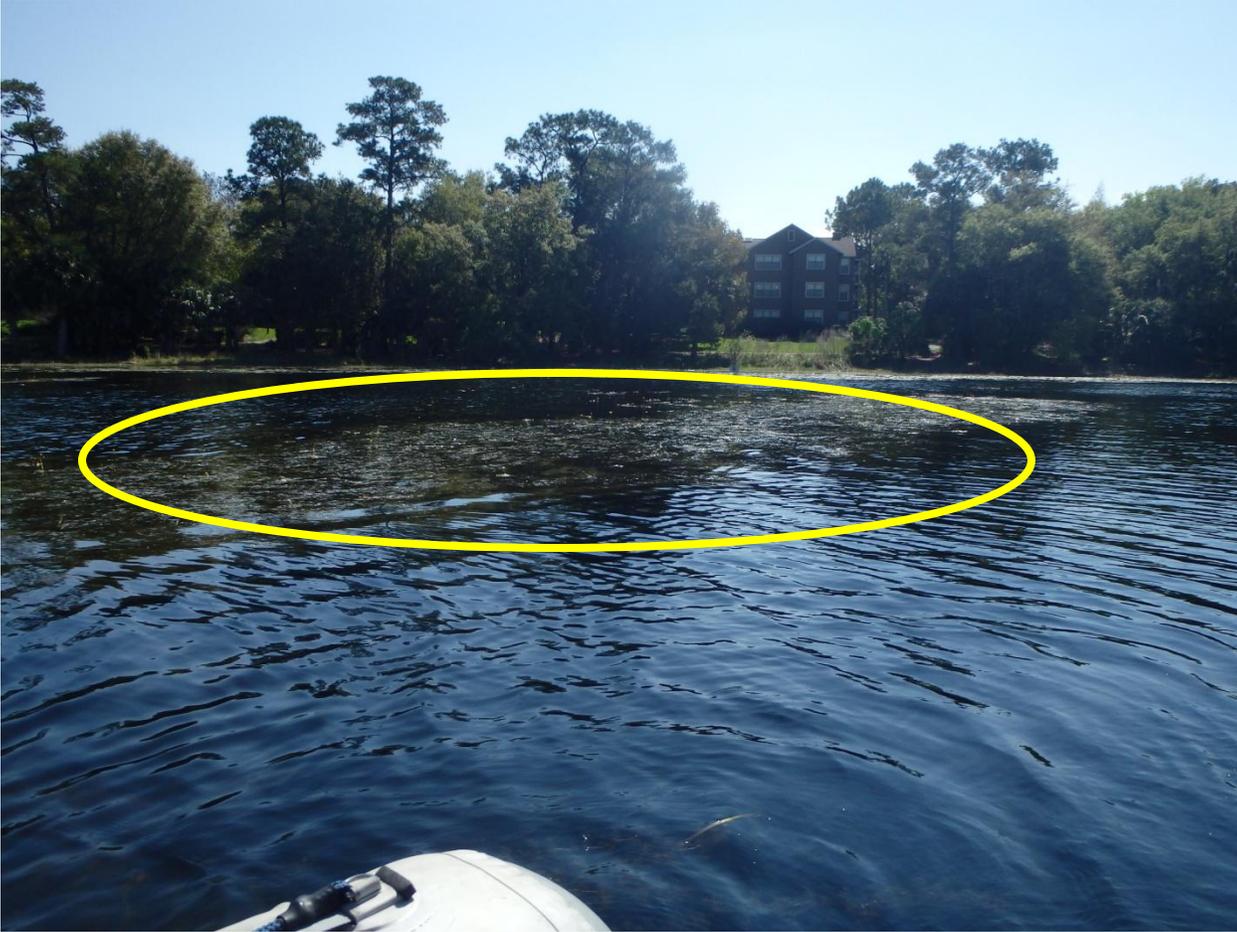
**Photo: Bladderwort topped out at a depth of 3 feet.**

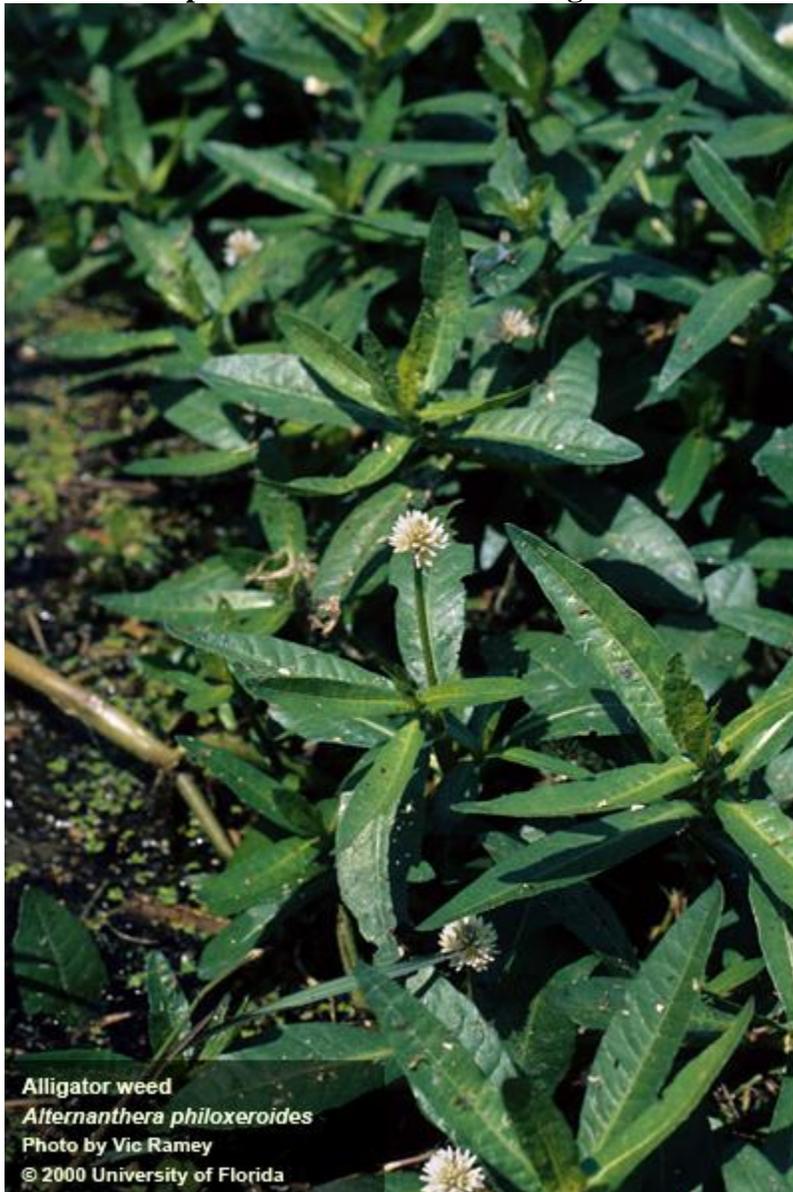
Alligatorweed and torpedo grass was found in more locations along the shoreline since the previous inspection. As result, both species will be targeted during the next herbicide treatment. The access corridors in the southern end of Mirror Lake were observed open and free of vegetation. Other invasive emergent vegetation found included: alligatorweed, dwarf papyrus, dog fennel, elephant ear, and bur-head sedge.

**Photo: Example of the invasive exotic alligatorweed.**

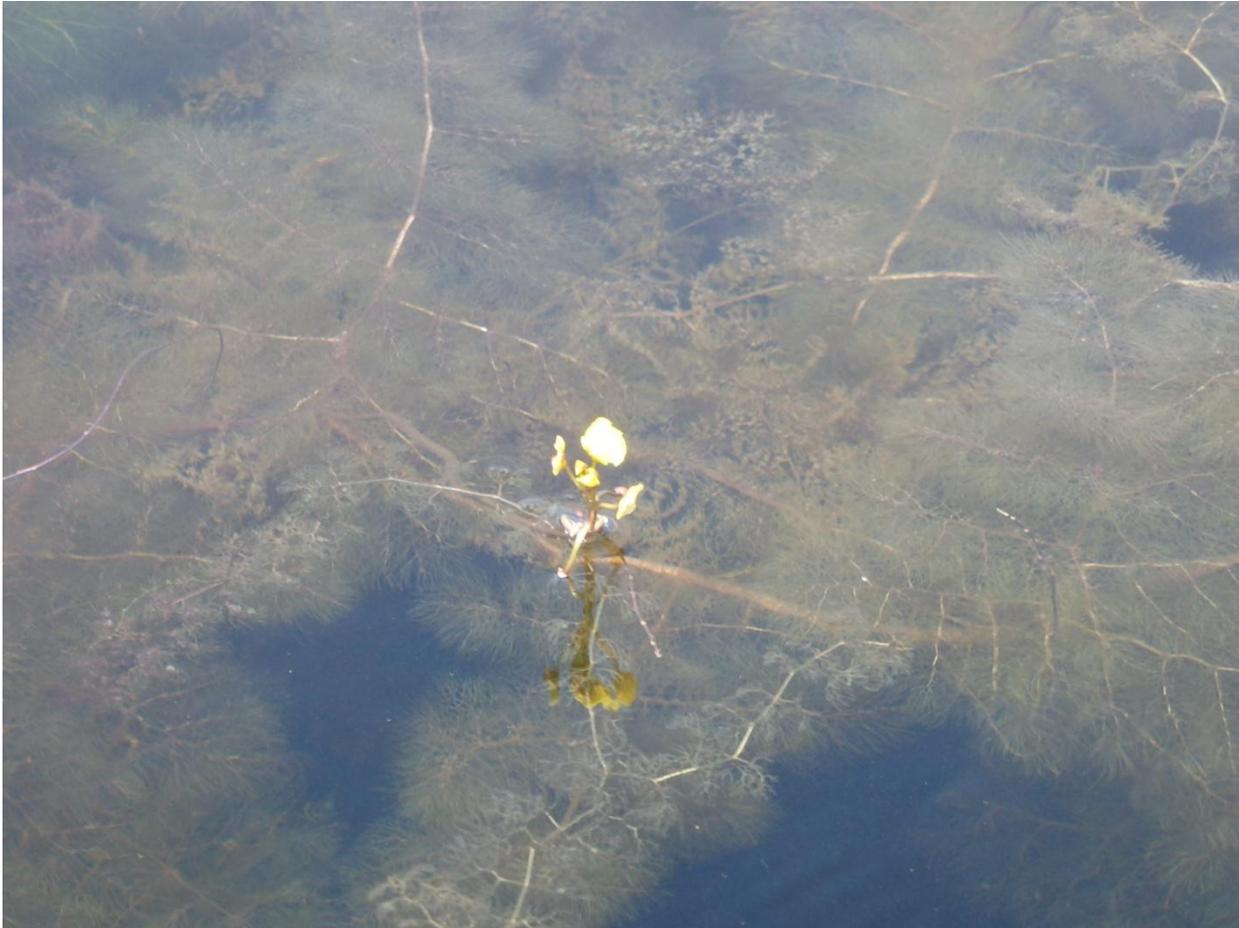
Eight species of SAV were found during the inspection; seven of which were native species. These native species included: lemon bacopa to 2 feet, smooth water hyssop to 2 feet, road grass to feet, southern naiad to 4 feet, 2 types of bladderwort to 5 feet, and eelgrass to 5 feet. Eelgrass has expanded along the eastern shoreline of the lake.

**Photo: Bladderwort with bloom.**

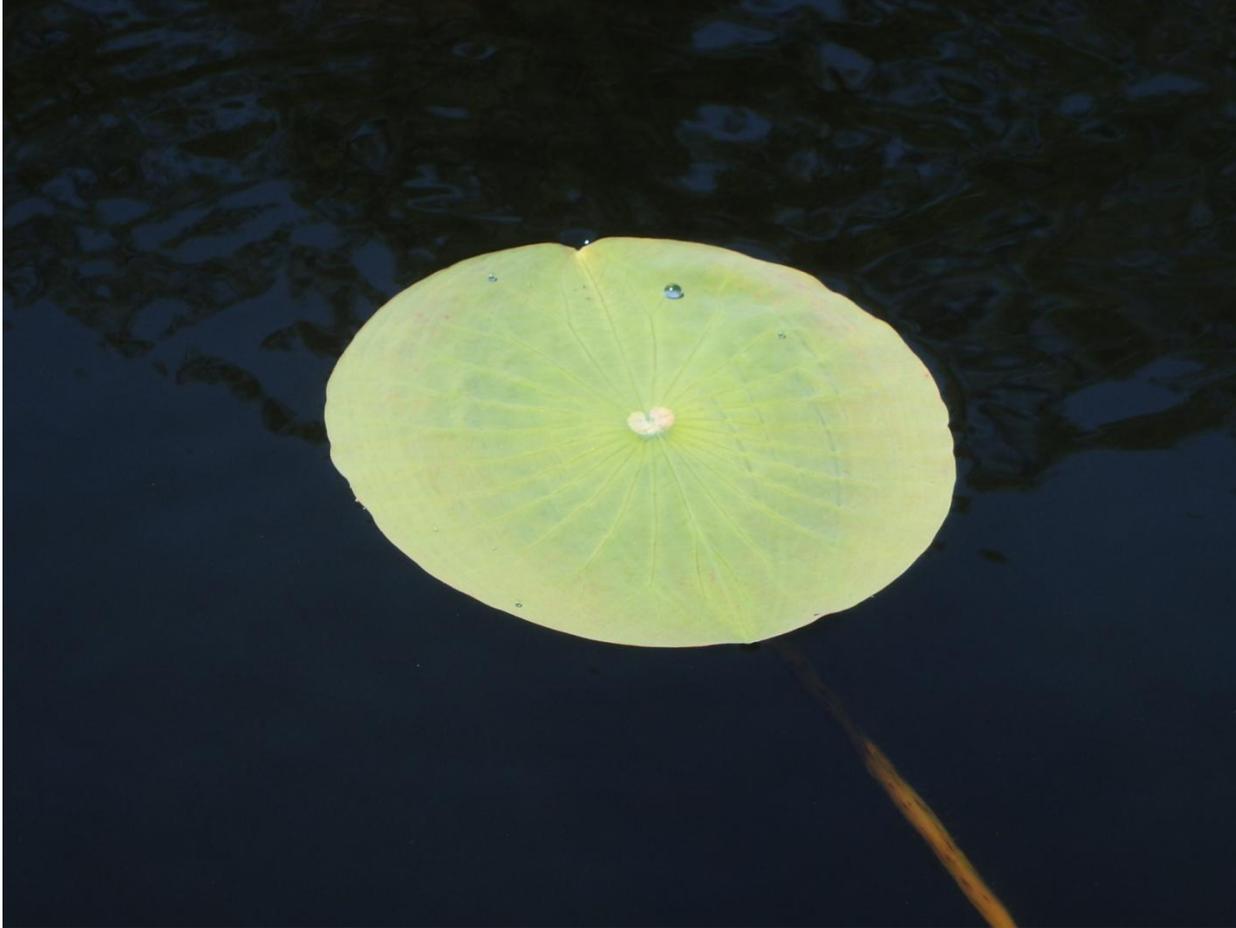
Four types of lily pads were found to be expanding from the previous inspection. These species included: yellow cow lily, fragrant water lily, banana lily, and American lotus. The access corridors in the southern end of Mirror Lake continue to remain free of vegetation.

**Photo: American lotus found along the north western shore of the Mirror Lake.**

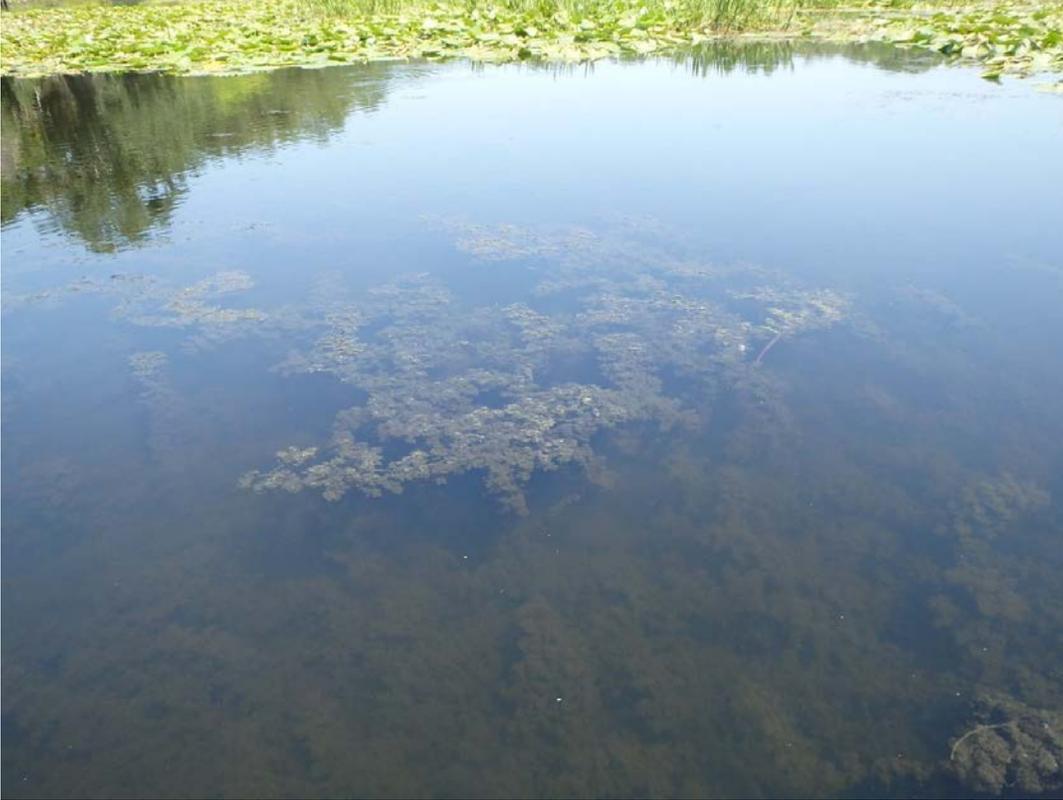
Seven species of submersed aquatic vegetation (SAV) were found during the inspection; six of which were native species. These native species included: lemon bacopa to 3 feet, smooth water hyssop to 1 foot, southern naiad to 1 foot, 2 types of bladderwort to 7 feet, and eelgrass to 4.5 feet. Bladderwort was the dominant SAV species topping out (reaching the surface) in a depth of 4 feet. Eelgrass was also found topping out at a depth of 3 feet. Native SAV plays an important part within Mirror Lake by providing wildlife habitat, reducing nutrients and competing for space with hydrilla.

**Photo: Bladderwort found to a depth of 7 feet.**

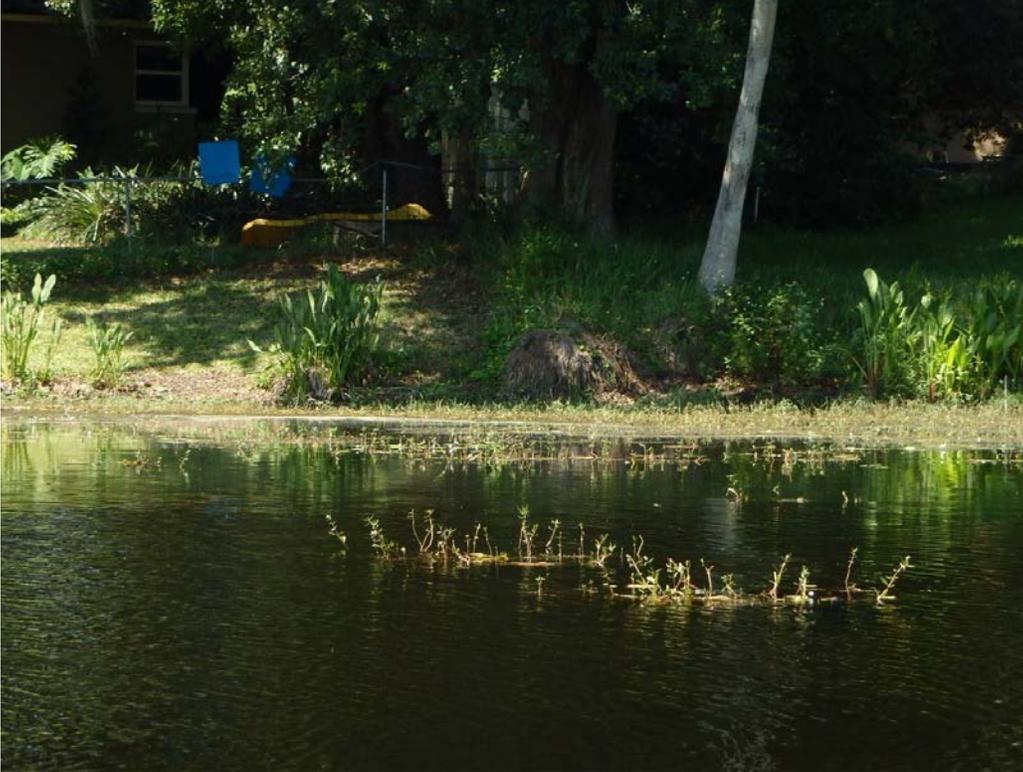
The access corridors in the southern end of Mirror Lake were still open. Patches of alligatorweed and torpedo grass are growing in the southern end of Mirror Lake these patches will be targeted the next herbicide treatment.

**Photo: Alligatorweed found in the southern portion of Mirror Lake.**

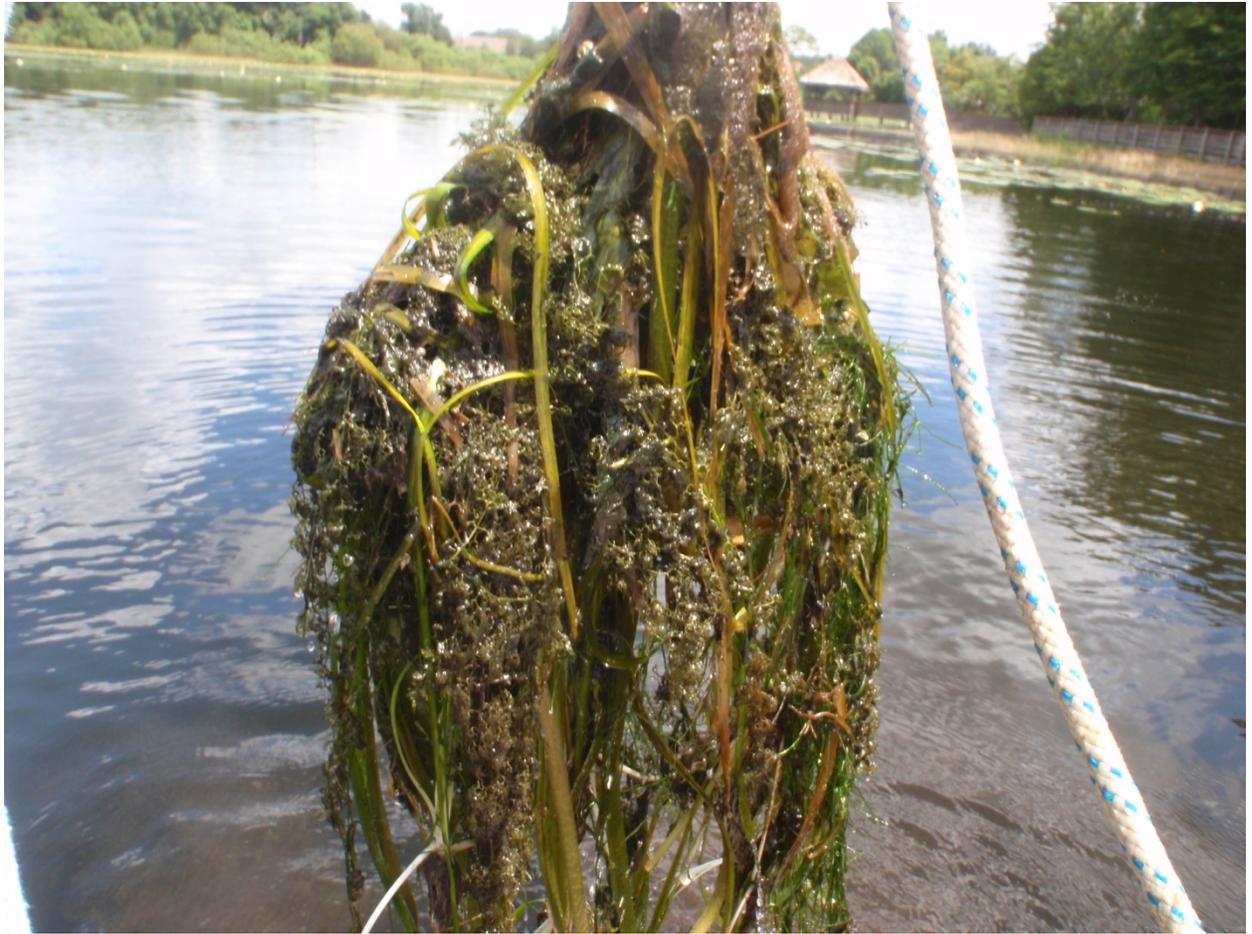
Nine species of submersed aquatic vegetation (SAV) were found during the inspection; eight of which were native species. These native species included: lemon bacopa to 3 feet, smooth water hyssop to 3 feet, road grass to 8 feet, southern naiad to 9 feet, stonewort to 9 feet, 3 types of bladderwort to 9 feet, and eelgrass to 9 feet. Both lemon bacopa and bladderwort have expanded in the inshore areas of the lake. Native SAV plays an important role within Mirror Lake by providing wildlife habitat, reducing nutrients, and competing for space with hydrilla.

**Photo: Typical sample in Mirror Lake consisting of eelgrass, stonewort, and bladderwort.**

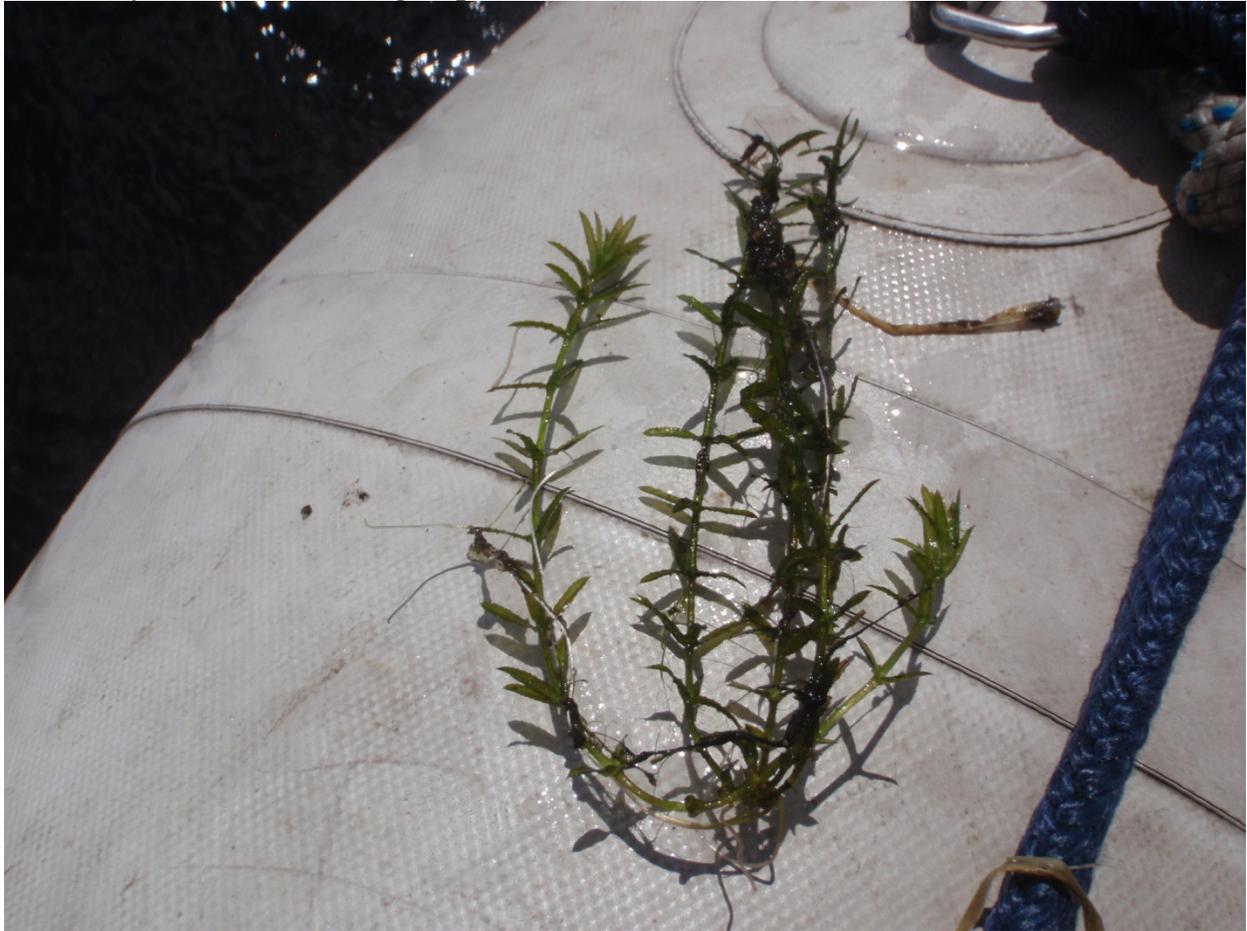
Hydrilla was the only invasive exotic species found and in less quantities than the previous inspection. It is suspected that with the increase in water elevation, the grass carp fish will be able to consume and reduce the population of hydrilla establishing in shallow water.

**Photo: Hydrilla found during inspection.**

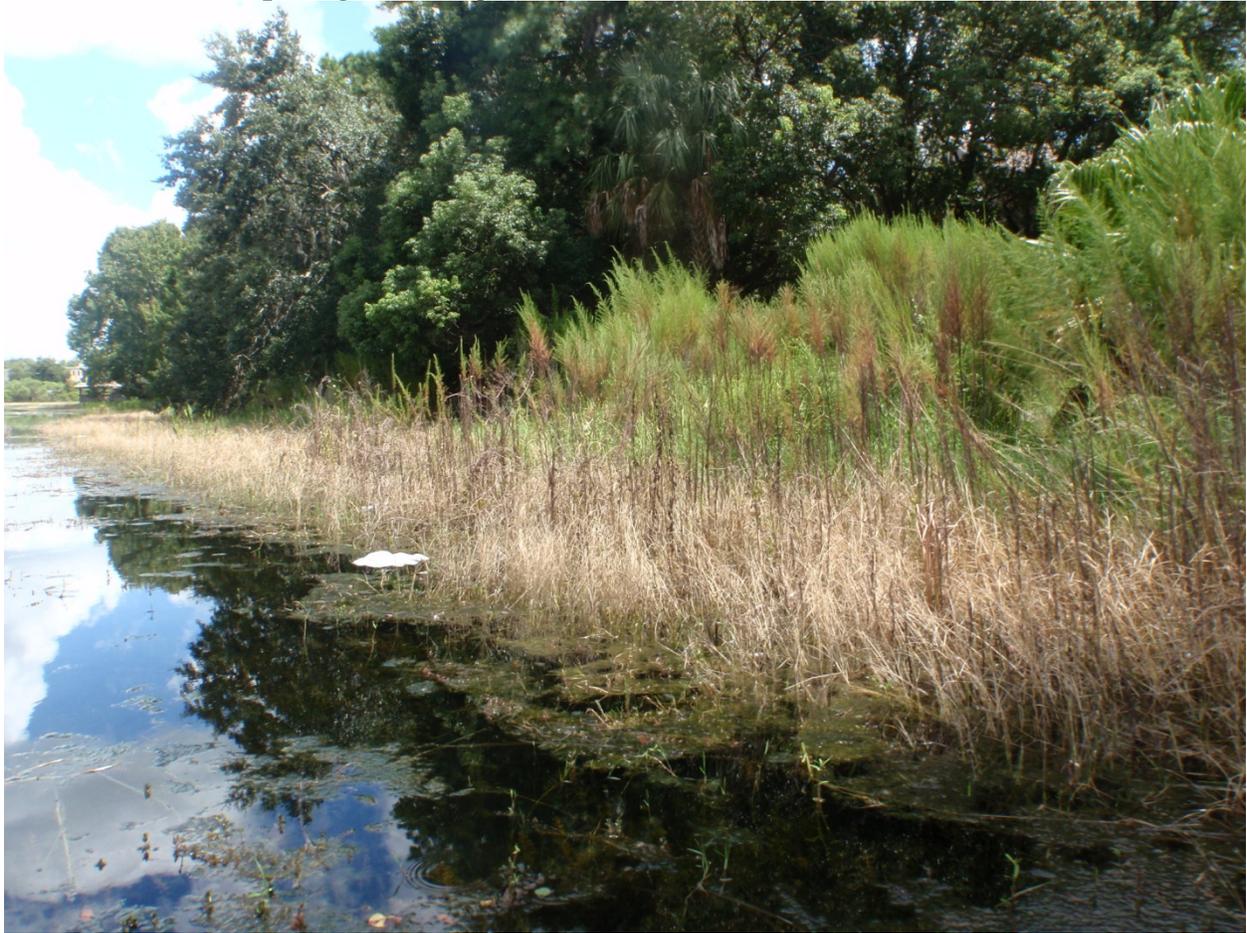
Torpedo grass was showing signs of impact from last month's treatment. The access corridors in the southern end of Mirror Lake were still open. Other invasive emergent vegetation found included: alligator weed, dwarf papyrus, dog fennel, elephant ear, and bur-head sedge. Bur-head sedge was found growing within pickerelweed in the southern portion of the lake. This species will be targeted during the next herbicide treatments.

**Photo: Treated torpedo grass along the eastern shoreline.**

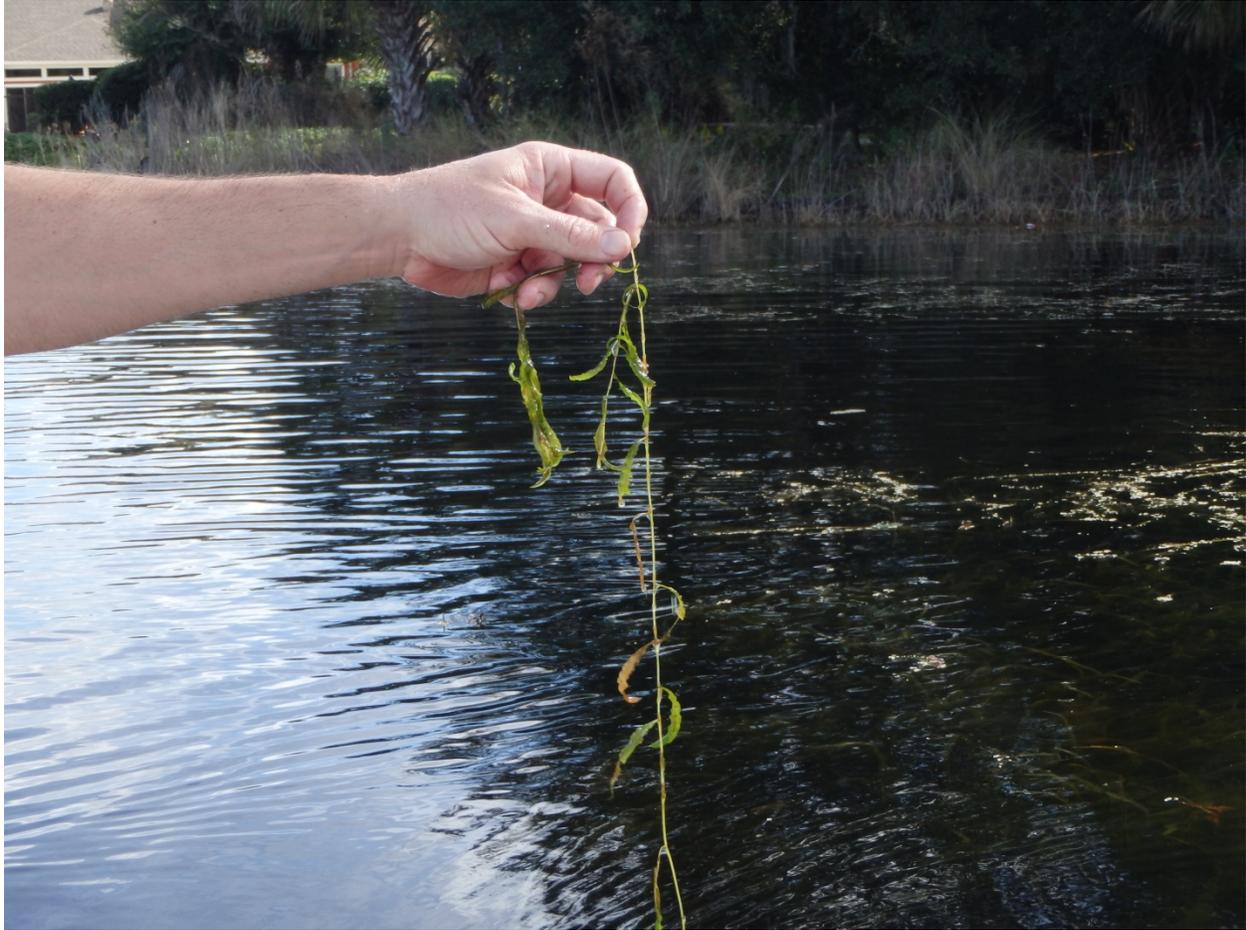
Ten species of submersed aquatic vegetation (SAV) were found during the inspection; nine of which were native species. These native species included: lemon bacopa to 4 feet, baby's tears to 2 feet, pond weed to 3 feet, southern naiad to 2 feet, stonewort to 3 feet, 2 types of bladderwort to 7 feet, and eelgrass to 6 feet. Stonewort has expanded in the northeast corner of the lake. Native SAV plays an important role within Mirror Lake by providing wildlife habitat, reducing nutrients, and competing for space with hydrilla.

**Photo: Pond weed found in Mirror Lake.**

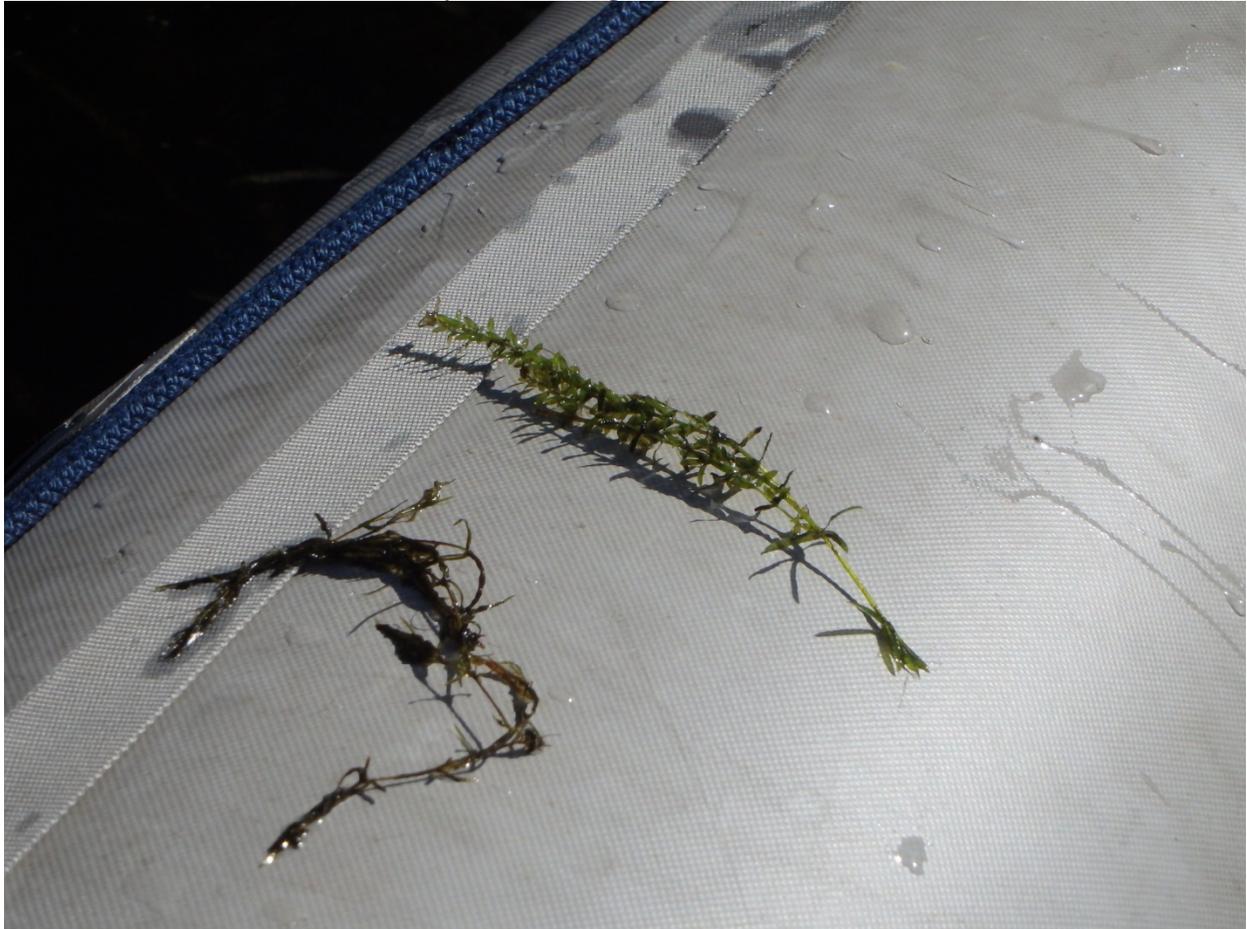
Hydrilla was the only invasive exotic species found in sparse patches. It is suspected that the grass carp are consuming population of hydrilla establishing in shallow water. No hydrilla was found in depths greater than 3 feet.

**Photo: Southern naiad on left, hydrilla on right.**
