Greetings Mirror Lake Residents,

Please find the latest bioassessment report for your lake below. Our next scheduled survey will be **October 20th**, weather permitting. Key highlights of this update include:

### **Bioassessment**

On **August 19th, 2014**, SCLMP personnel, Thomas Calhoun, Gloria Eby, and Marianne Pluchino, surveyed the aquatic plants in **Mirror Lake** and conducted a Lake Vegetation Index (LVI) assessment.

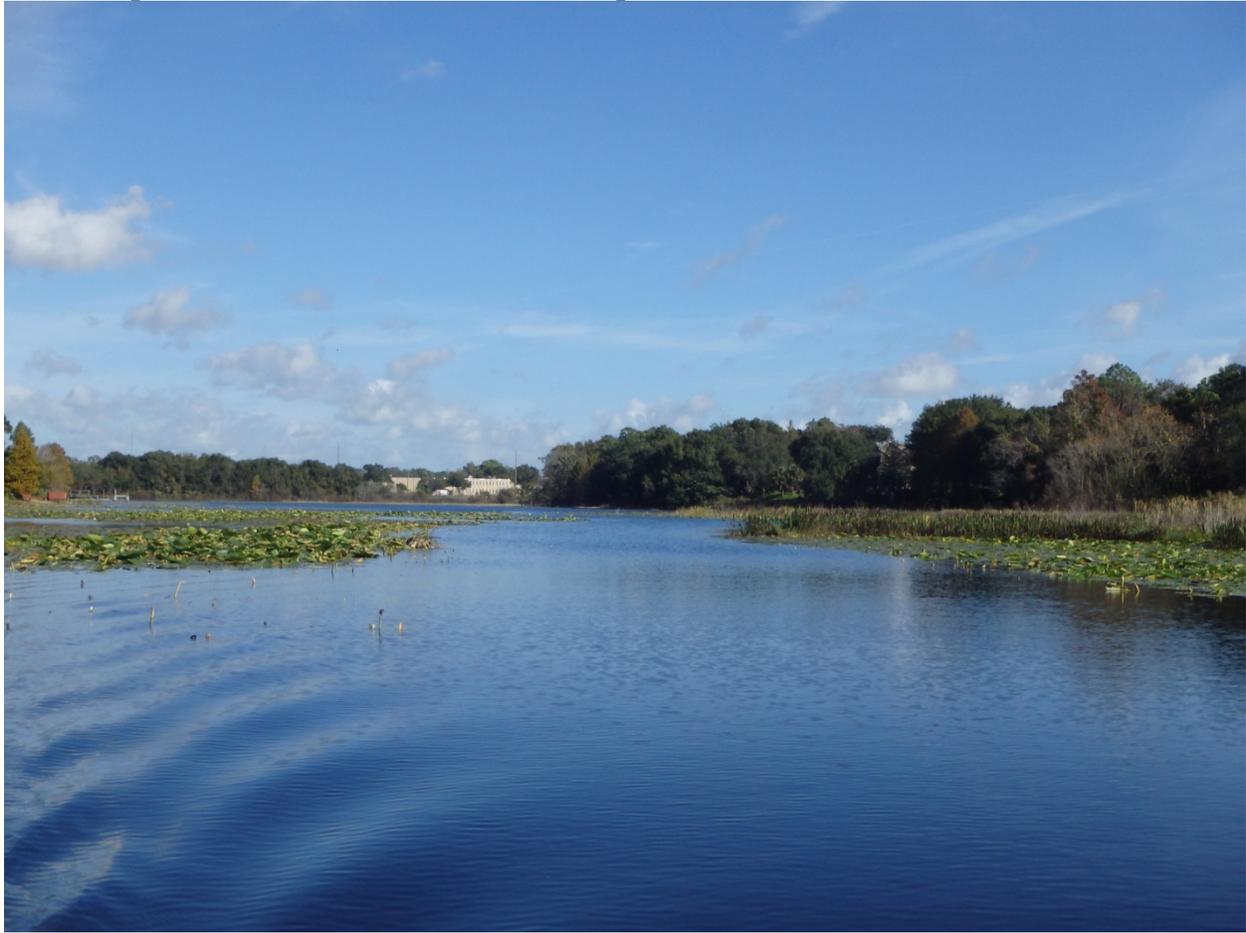
All invasive emergent vegetation were showing signs of impact from the previous month's treatment. The access corridors in the southern end of Mirror Lake were still open. Yellow water lily was treated in the southern portion of the lake. Invasive emergent vegetation found included: alligator weed, dwarf papyrus, dog fennel, elephant ear, and bur-head sedge. Alligator weed will be targeted in the southern portion of the lake during the next scheduled herbicide treatment.

**Photo: Open access corridor in the southern portion of Mirror Lake.**
