On **July 3rd, 2012**, Thomas Calhoun (Seminole County Lake Management Program) and Stan McCreary (Seminole County Intern) surveyed the aquatic plants of **Howell Creek and Lake Waumpi**.

On **March 19th, 2012**, Thomas Calhoun (Seminole County Lake Management Program) and Shannon Wetzel (Seminole County Environmental Scientist) surveyed the aquatic plants of **Howell Creek**.

On **December 15th, 2011**, Gloria Eby (Seminole County Lake Management Program) and Thomas Calhoun (Seminole County [SC] Contracted Scientist) surveyed the aquatic plants of **Howell Creek** via canoe. The purpose of assessment is to observe the aquatic plant community within the creek and to provide feedback or recommendations based upon these observations related to the aquatic weed control MSBU resolution.

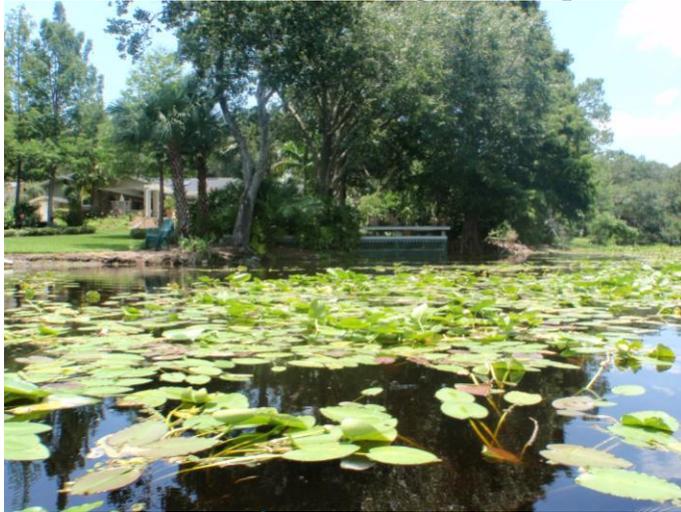
Howell Creek was treated the week of May 21st, and is scheduled to be treated the week of August 20th as part of the routine quarterly treatments funded by the MSBU. Treatment will target the yellow cow lily (spatterdock) and salvinia that is blocking access in many areas along the creek as well as torpedo grass, primrose, and alligator weed. With the treatment and rising water elevation, the creek should become more navigable.

Photo: Yellow cow lily blocking access in parts of Howell Creek.

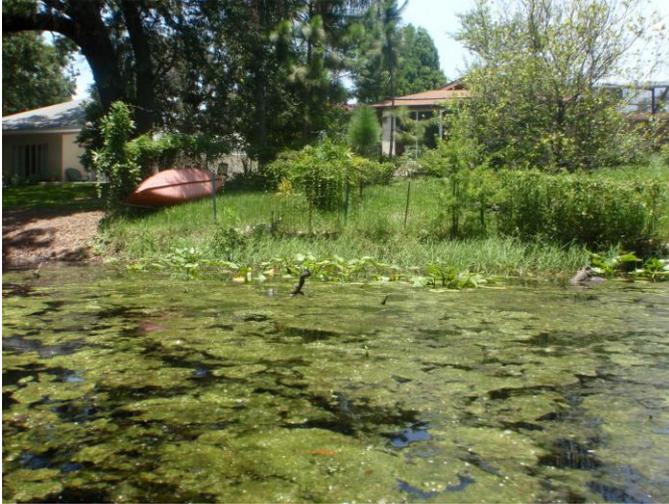
Submersed aquatic vegetation (SAV) found during the inspection included; roadgrass, filamentous algae (in large presence), eelgrass, southern naiad, stonewort, coontail and widgeon-grass. Coontail is the most abundant species found in the creek system. Hydrilla was the only invasive exotic found during the inspection and was observed in isolated locations throughout the creek.

Photo: Algae bloom present in creek as result of submersed vegetation surfacing.

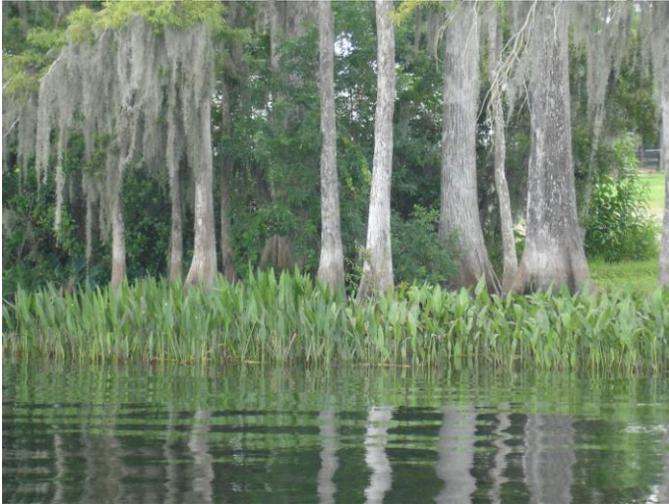
Photo: Example of pickerelweed planted along shoreline.

Some shorelines along the north bank of the creek have erosion issues. It is recommended that native shoreline vegetation be planted to help reduce and stabilize further shoreline erosion. The types of plants recommended include (but are not limited to), pickerelweed, duck potato, canna, thalia, and cord grass.

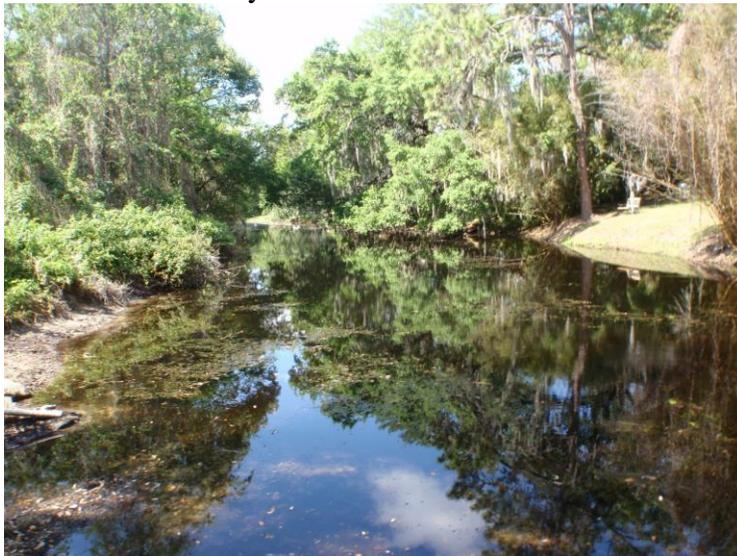
The Seminole County MSBU funded herbicide contractor treated the creek on February 22nd where 85% of the creek was covered with salvinia then subsequently treated on March 8th for the salvinia at the weir and upstream ~200 feet. Additionally, Seminole County Stormwater crews treated in association to the weir (as functional maintenance) on March 5th. Since these treatments, the salvinia has died but is still within the creek. We anticipate that the salvinia will remain within the creek until water begins to flow over the weir again or it decomposes off the surface of the creek. For the next scheduled MSBU funded treatment (conducted quarterly), alligator weed, torpedo grass, wild taro, primrose, and water lilies will be targeted.

Photo: Area recently treated for salvinia.

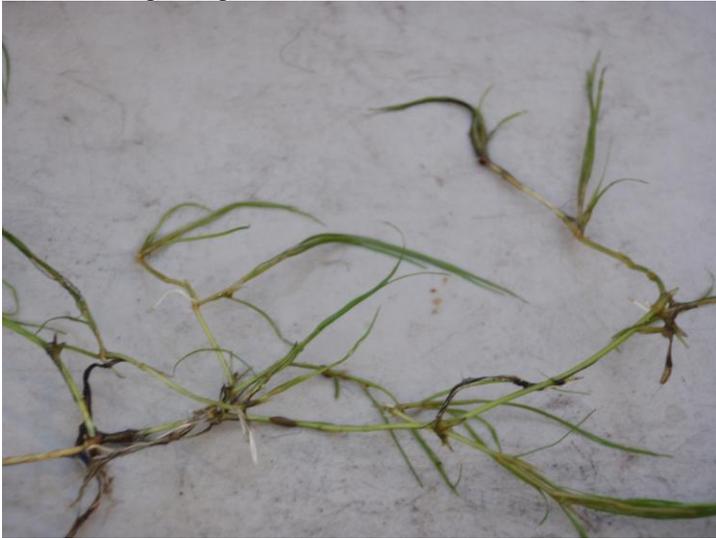
Native submersed aquatic vegetation (SAV) found during this inspection included; roadgrass, filamentous algae, eelgrass and widgeon-grass. Hydrilla was the only invasive exotic found during the inspection and was only observed in one location in the creek.

Photo: Widgeon-grass.

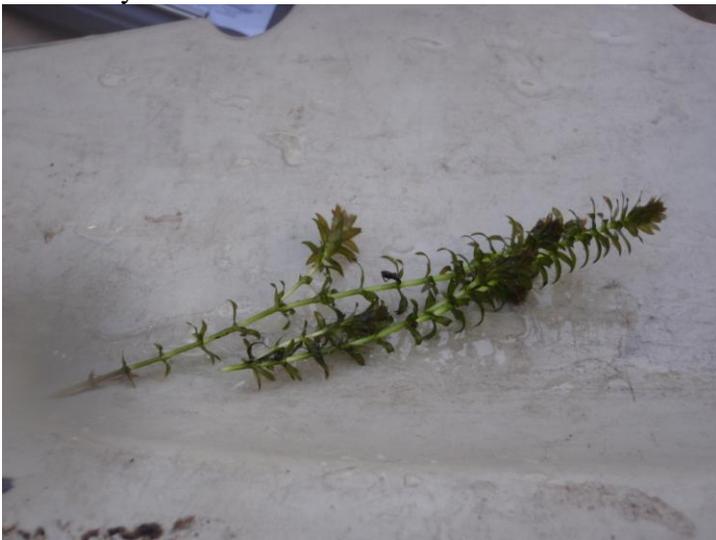
Photo: Hydrilla

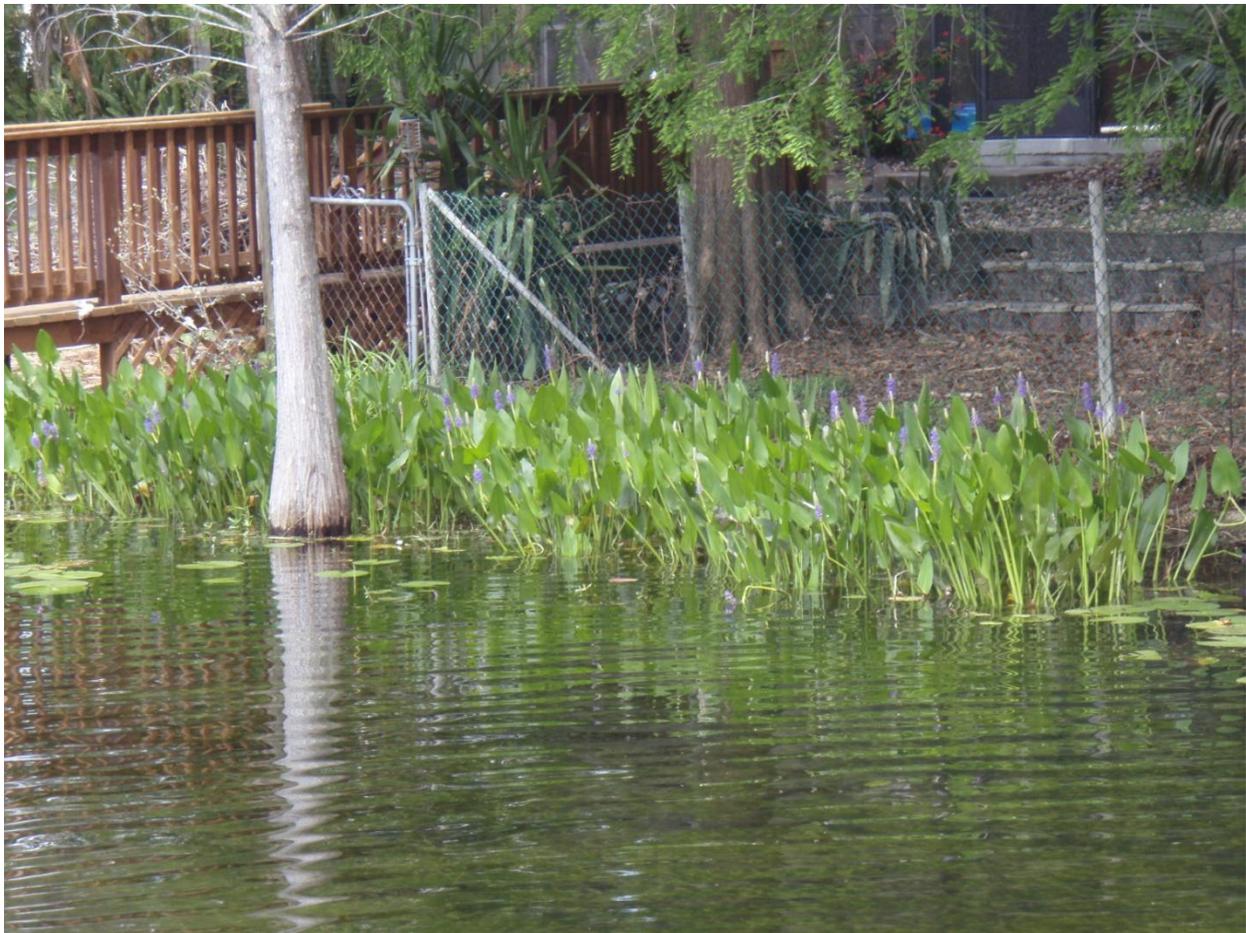
Photo: Example of planted pickerelweed.

Some shorelines along the north bank of the creek have noticeable erosion issues. It is recommended that native shoreline vegetation be planted to help reduce and stabilize shoreline erosion. The types of plants that are recommended (but are not limited to) are pickerelweed, duck potato, canna, thalia, and cord grass.

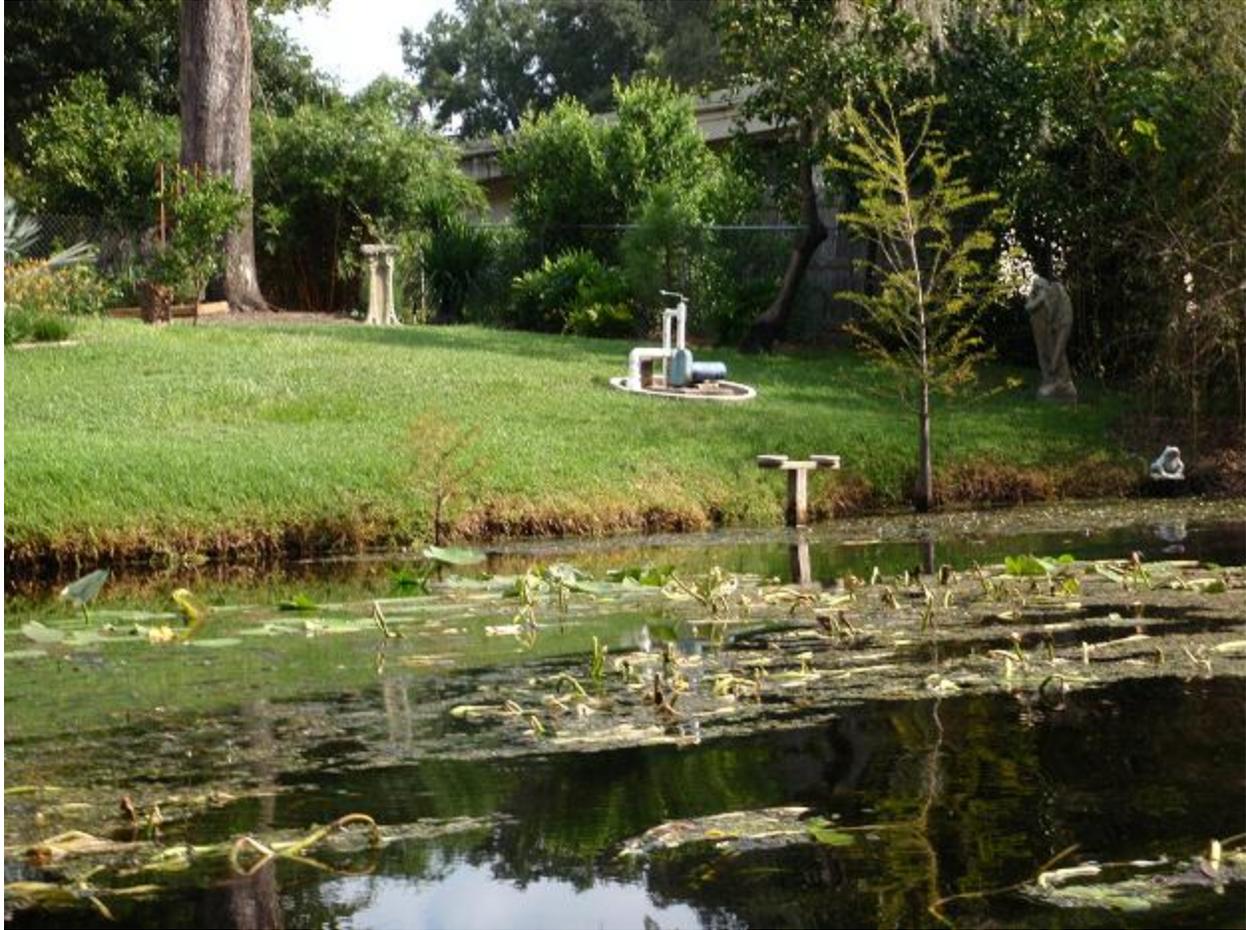
The Seminole County MSBU herbicide contractor last treated the creek on November 29th. The next quarterly treatment is scheduled for mid-march. The water lilies (spatterdock) was well treated and is showing some signs of new growth. Alligator weed and torpedo grass (both exotic/invasive plants) also appeared to be impacted from the recent herbicide treatment. Other exotic/invasive shoreline vegetation observed included: wild taro, water primrose, and water sprite.

Photo: Treated lily pads.

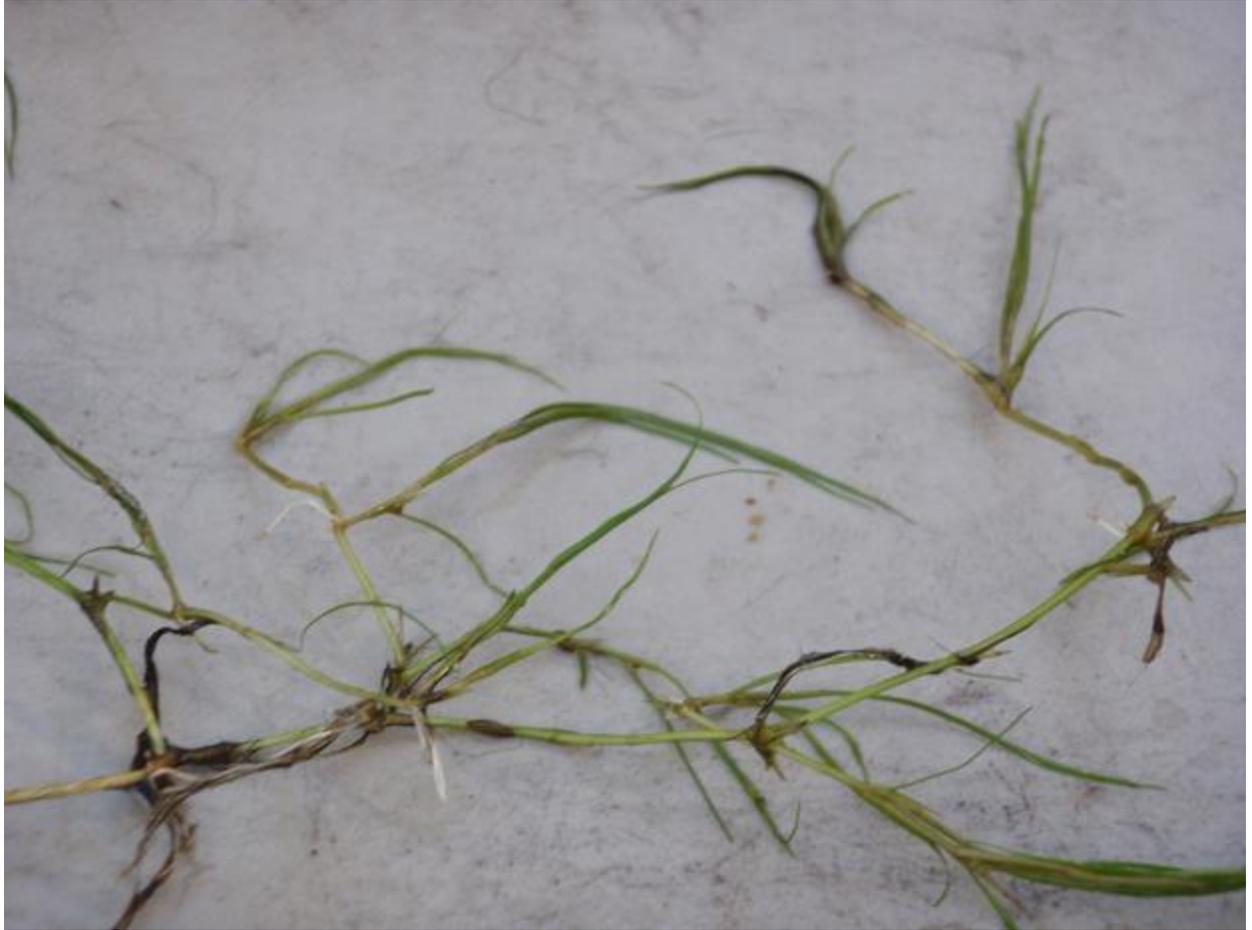
Submersed aquatic vegetation (SAV) found during the inspection included: coontail, roadgrass, filamentous algae, southern naiad, bladderwort, eelgrass, and widgeon-grass. These species are all natives providing good diversity for the creek. Hydrilla was the only exotic/invasive SAV found during the inspection and was observed in one location located mid-way by an inflow pipe.

Photo: Widgeon-grass.

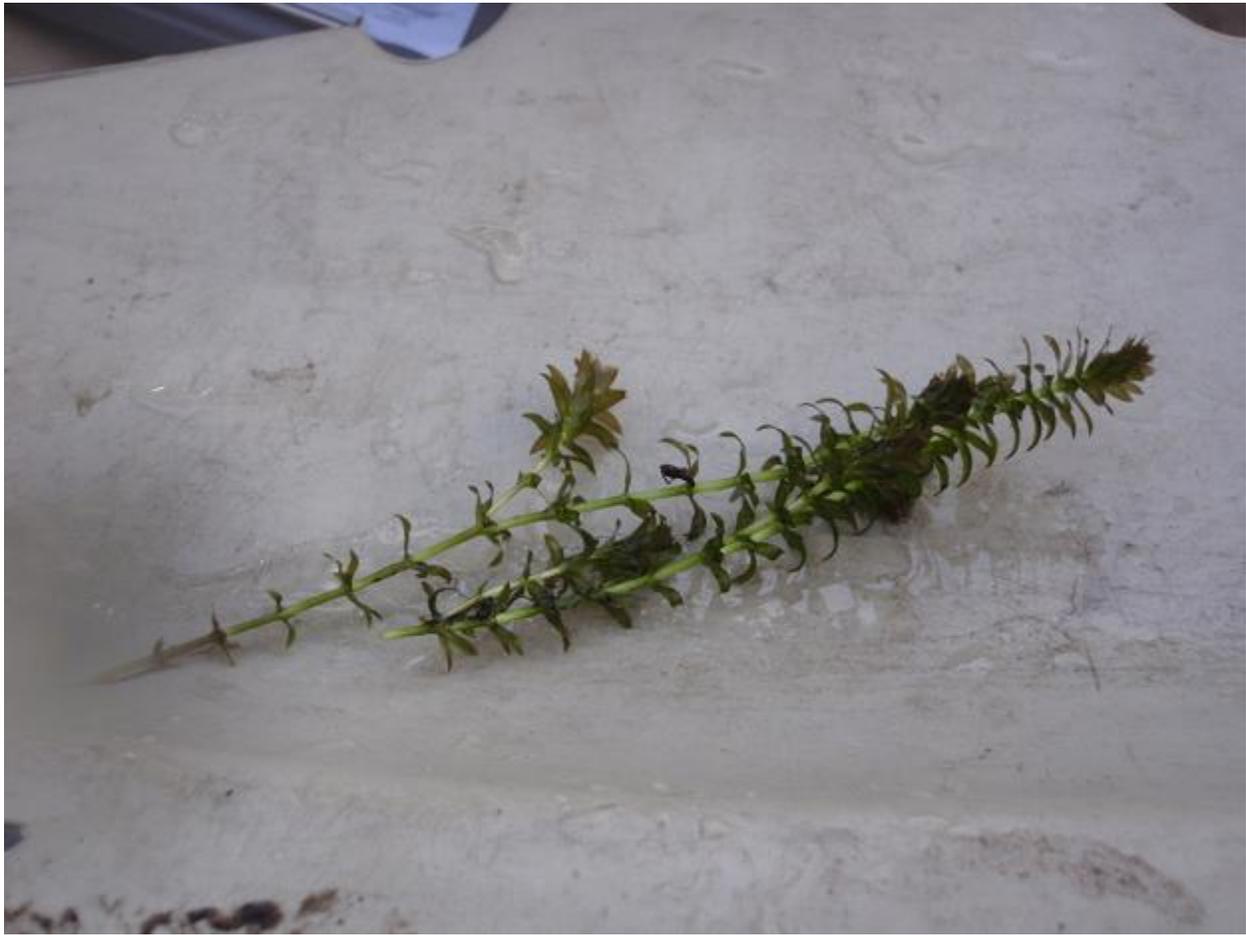
Photo: Hydrilla

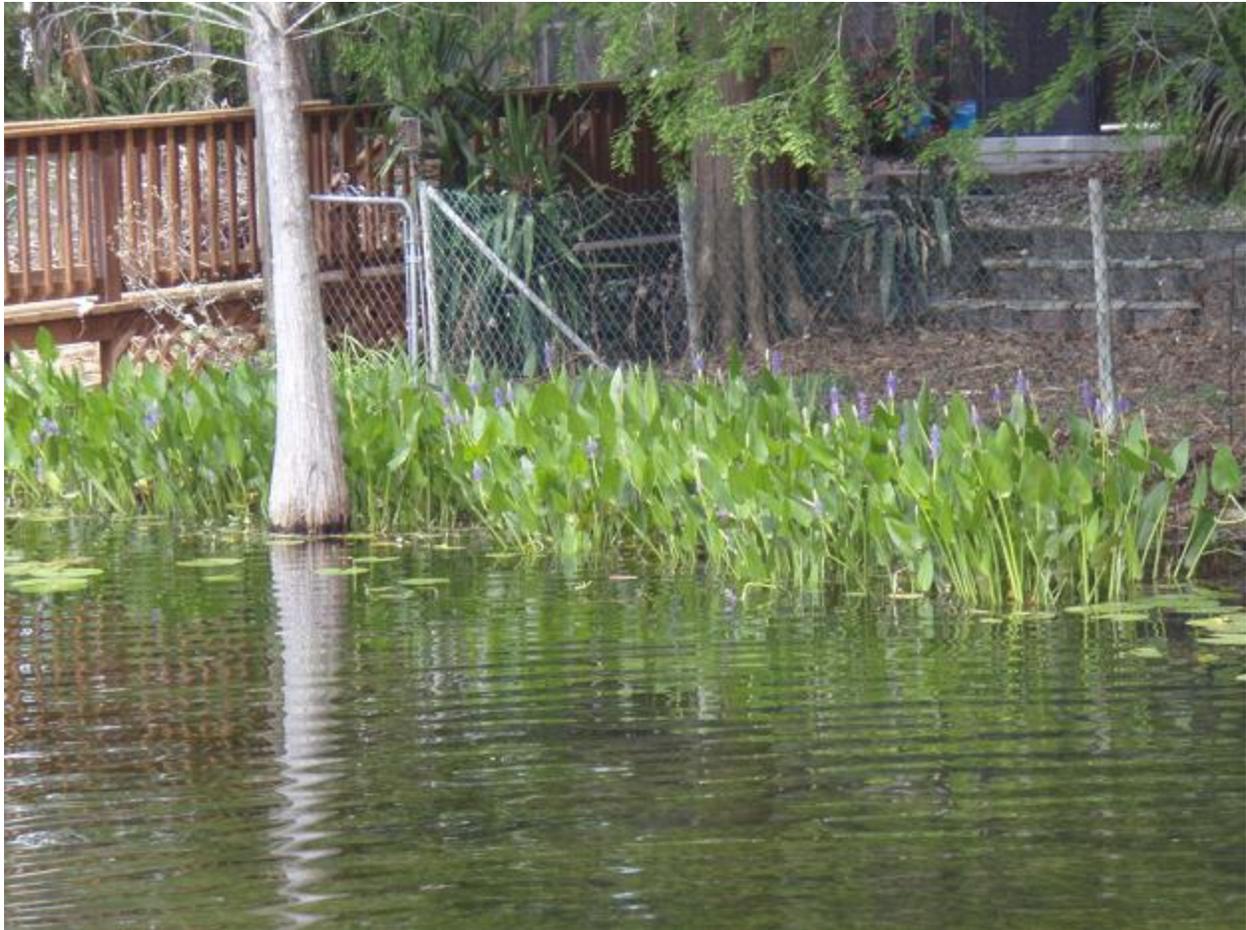
Photo: Example of planted pickerelweed.

Some shorelines along the north bank of the creek have erosion issues. It is recommended that native aquatic vegetation be planted to help reduce and stabilize the shoreline erosion occurring. The some plant examples that would be suitable for this area are: pickerelweed, duck potato, canna, thalia, and cord grass.
