Greetings Lakes Burkett and Martha

Please find the latest assessment report for your lake below. Our next scheduled assessment will be October 23rd; weather permitting. Key highlights of this update will include:

On **September 18th, 2012**, Seminole County Lake Management Staff Thomas Calhoun and Devin Whitney (joined by OC staff- Ryan Patrick and John Pierce) inspected the aquatic plants within Lakes Martha and Burkett. Minimal hydrilla was noted within both the lakes.

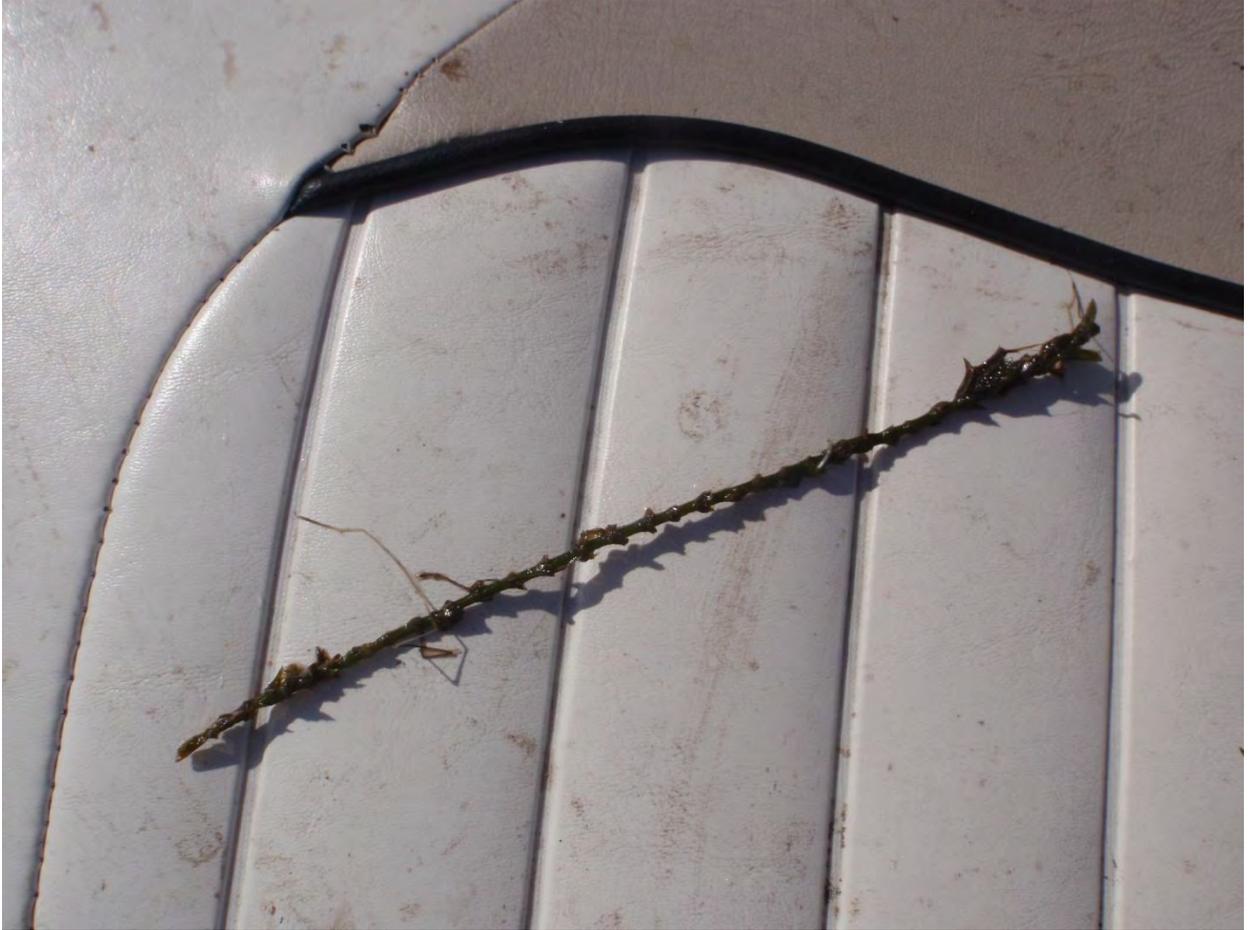
For **Lake Burkett**, hydrilla biomass was found sparse and non-viable as compared to prior inspections and almost no surface algae. Portions of the shoreline are experiencing some floating eelgrass blades as result of wind/wave action. Much of the lake was observed to be free and clear of hydrilla!

Photos: Sprig of hydrilla found during inspection.

We will continue to monitor the inshore areas of the lake to enable rapid response to new hydrilla growth as result of tubers (via chemical spot treatments). Tubers are potato-like bulbs that are deposited by the plant into the sediment which can remain viable for up to four years. Tubers are produced in each growing season and are used to perennialize the plant as a means of propagation (re-growth). Since the lakes were previously infested with hydrilla, an abundant amount of tubers (which can sprout new growth at any time) were deposited in the lake bed; one square meter of hydrilla can produce 5,000 tubers.

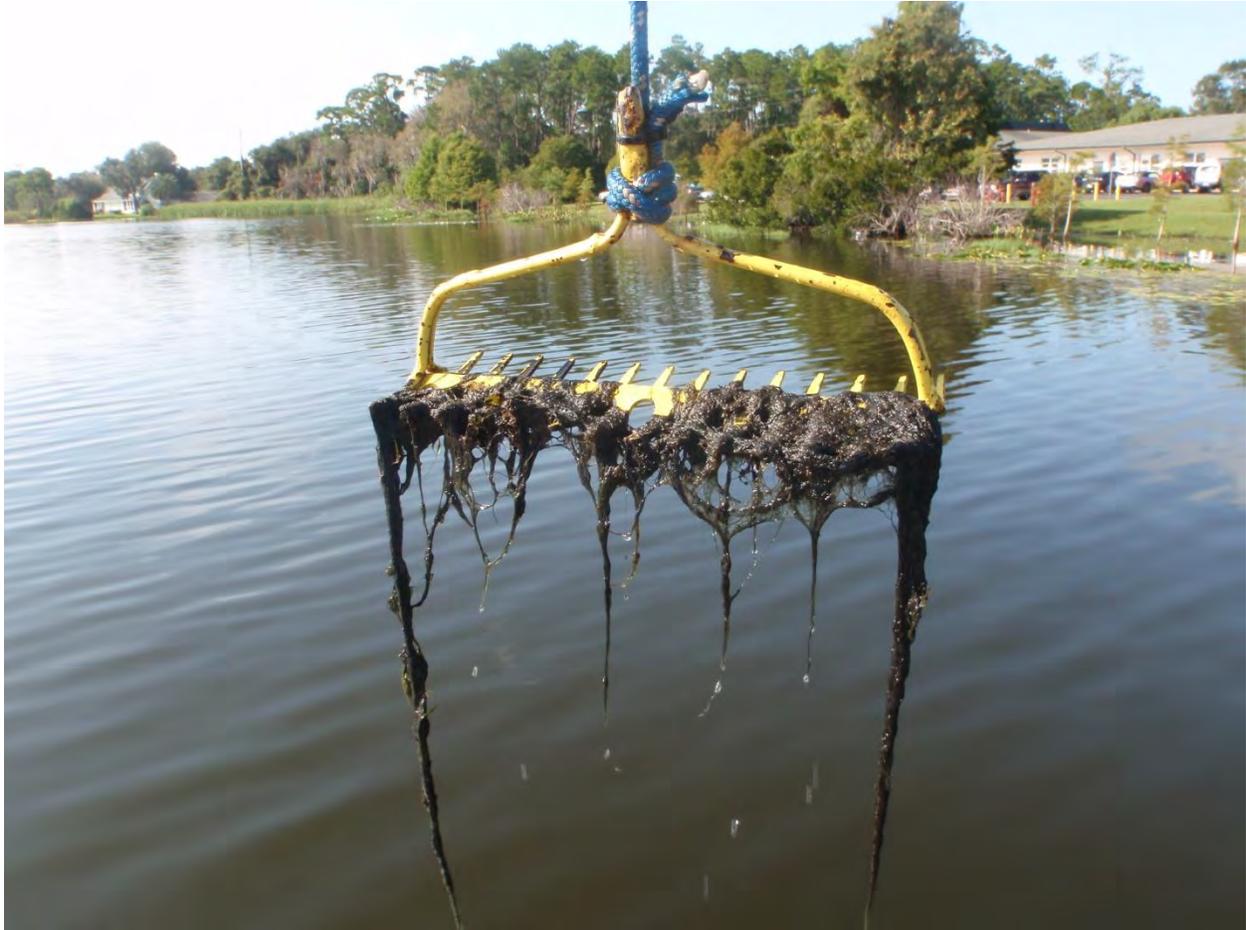
Photo: Filamentous algae found along the bottom of the lake.

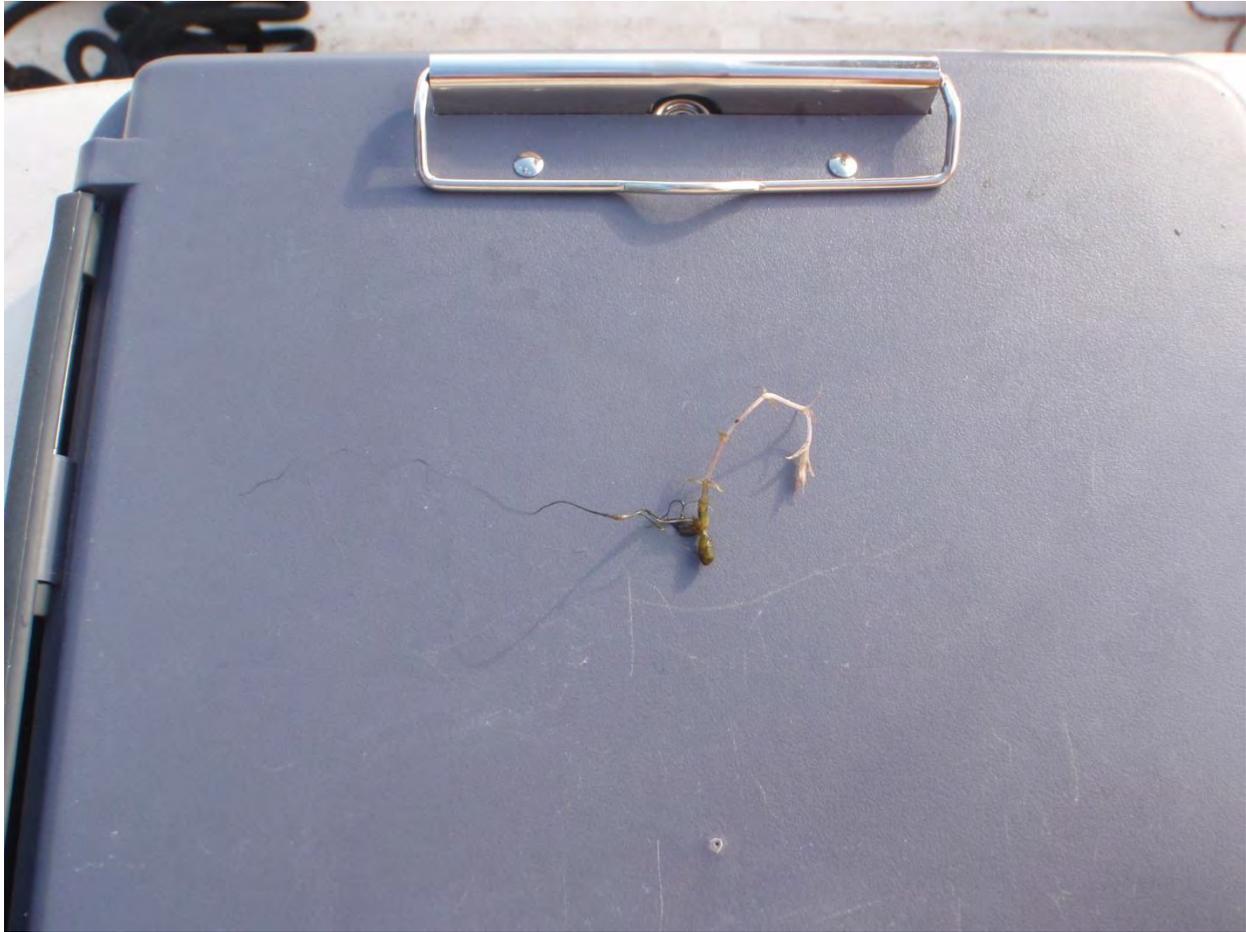
Photos: Example of hydrilla tubers.

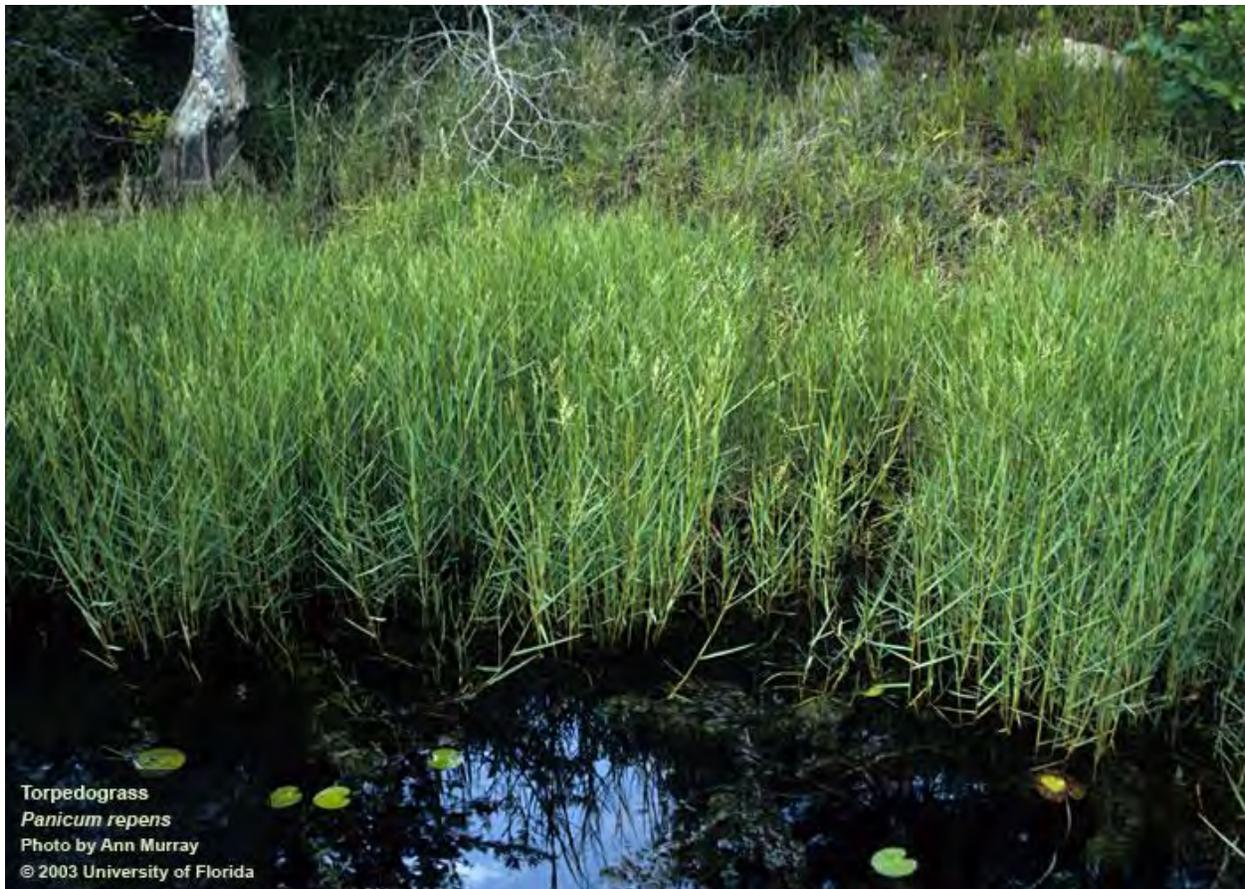
Photo: Torpedo grass.

Beginning in October 2012 Seminole County's herbicide contractor will begin treating shorelines on the Seminole County side of the lake only. The target species of these treatments will be torpedo grass and cattails. If you would like your cattails treated please respond to this email.

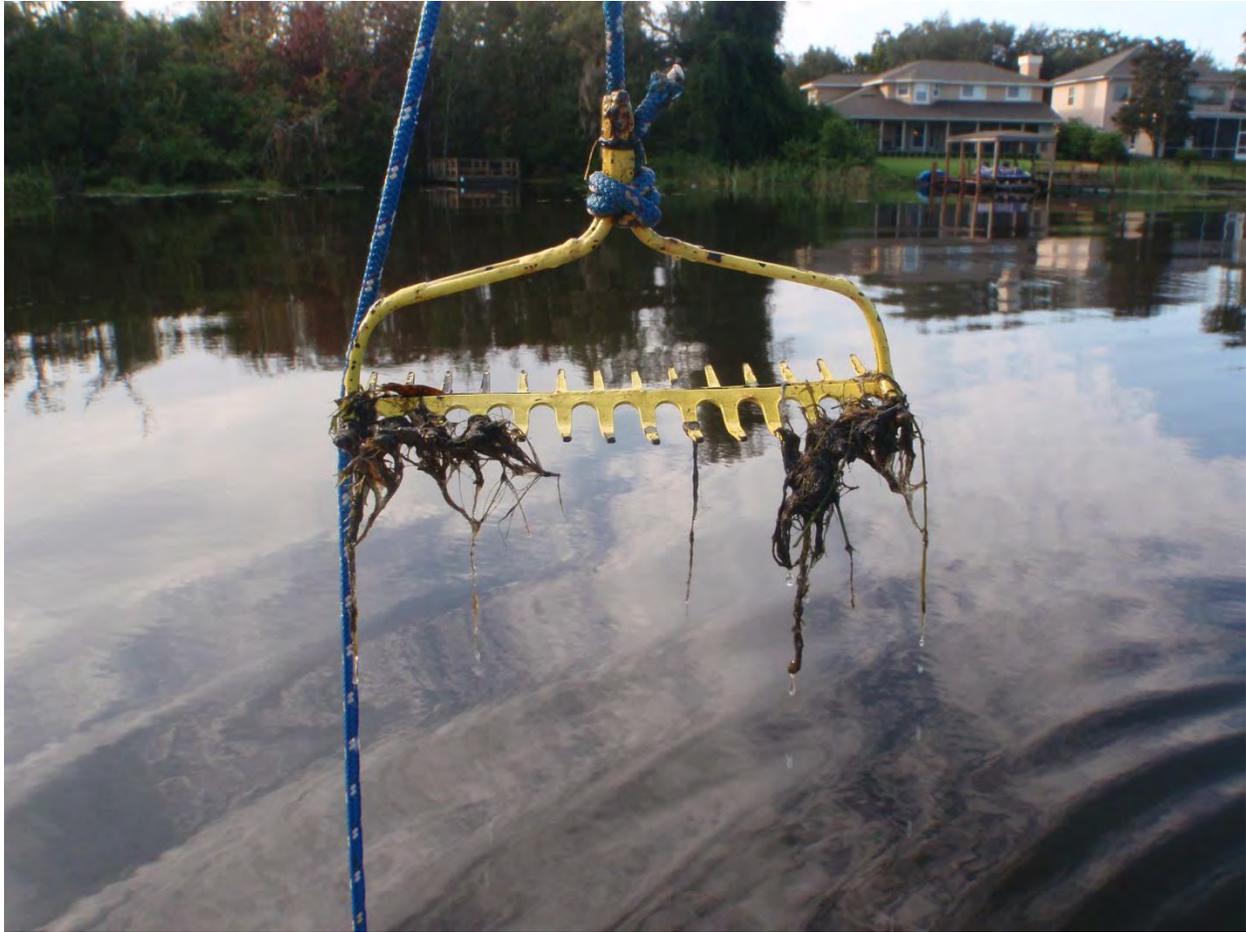
For **Lake Martha**, much of the lake was observed to be free and clear of hydrilla with only small fragments of non-viable hydrilla remaining. Eelgrass was observed reestablishing in many areas within Lake Martha. With the absence of hydrilla, it is anticipated for eelgrass to continue to migrate into further areas of the lake.

Photo: Expanding eelgrass in Lake Martha.

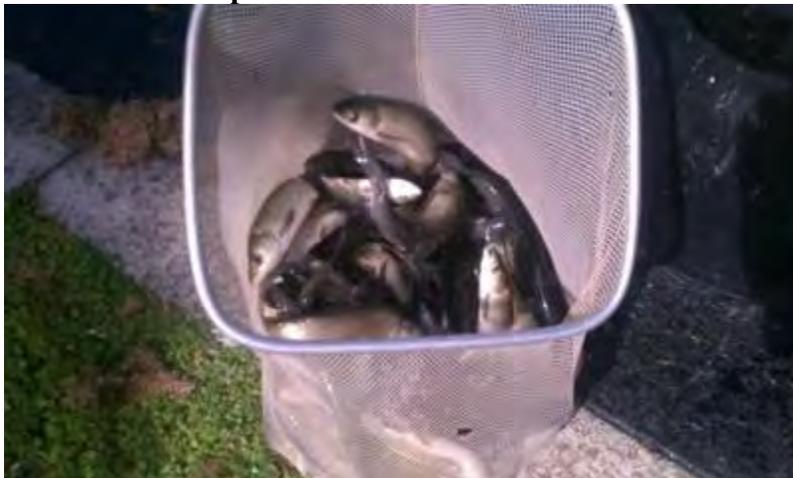
Lakes Martha and Burkett were stocked with 360 sterilized grass carp fish on July 26th, 2012. The use of grass carp fish are continued efforts for the hydrilla management plan that utilizes integration of chemical and biological control methods. Thanks to OC for being on hand to capture photos of the fish for the lake community!

Photo: Grass carp fish released into lakes Martha and Burkett.

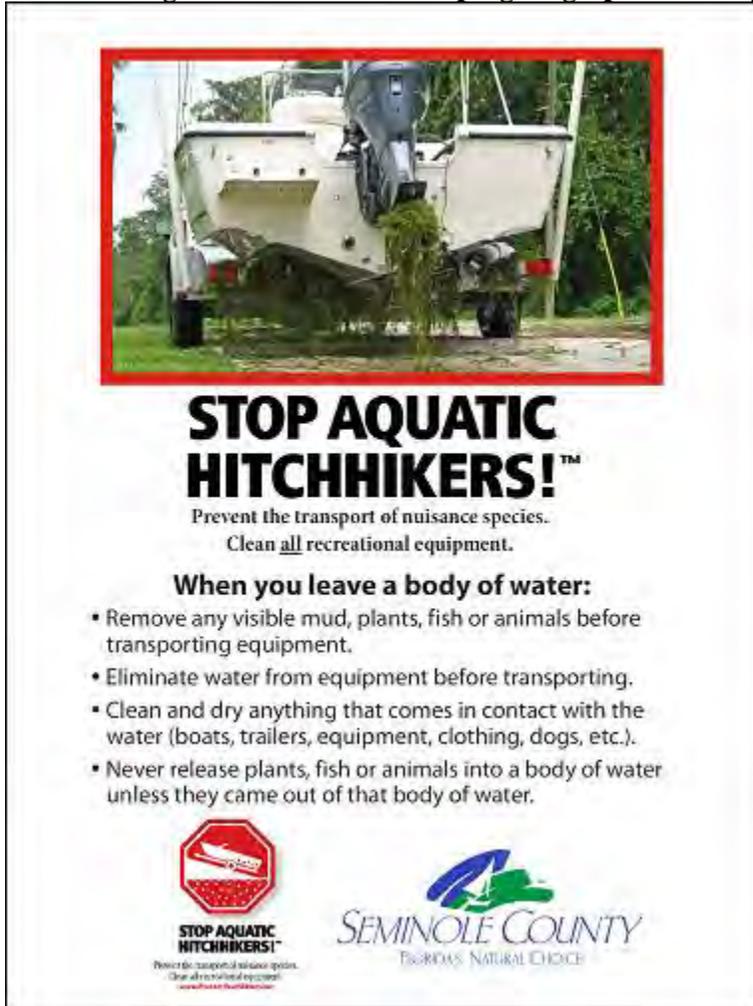
In efforts to reduce transportation of exotics in/out of your lake, SC-LMP will be installing educational campaign signs at the Trinity Bay and at Trinity Prep ramps. These signs are designed to educate boaters on the potential of transporting nuisance species that can be costly to manage. Image of sign is below.

Photo: Image of educational campaign sign provided by SCLMP.

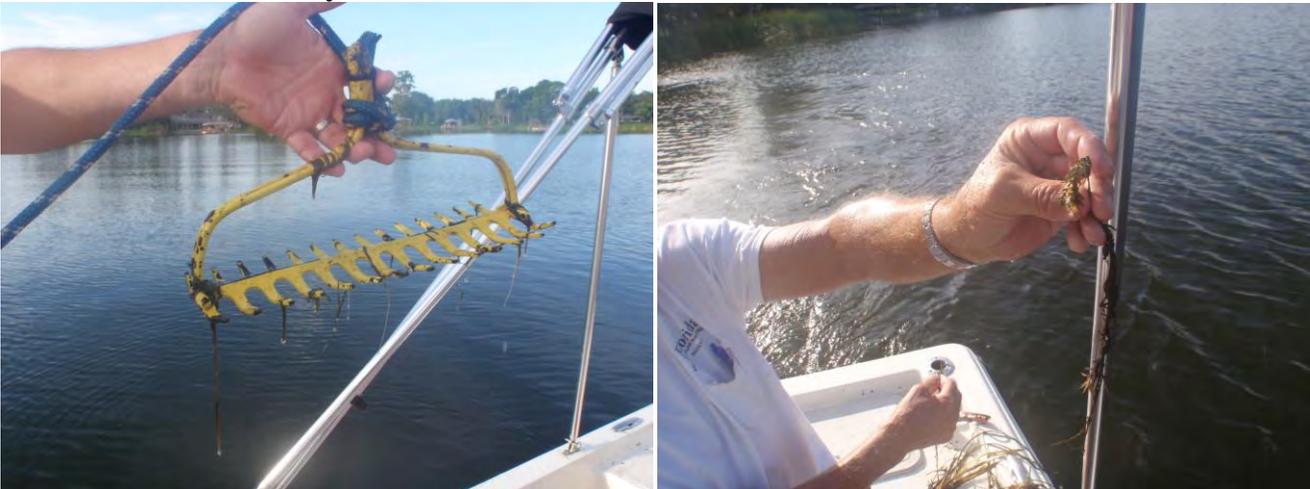
For **Lake Burkett**, hydrilla biomass was found sparse and non-viable as compared to prior inspections and surface algae was significantly reduced. Portions of the shoreline are experiencing some floating eelgrass blades as result of wind/wave action. Much of the lake was observed to be free and clear of hydrilla!

Photos: Minimal to no hydrilla found in Lake Burkett.

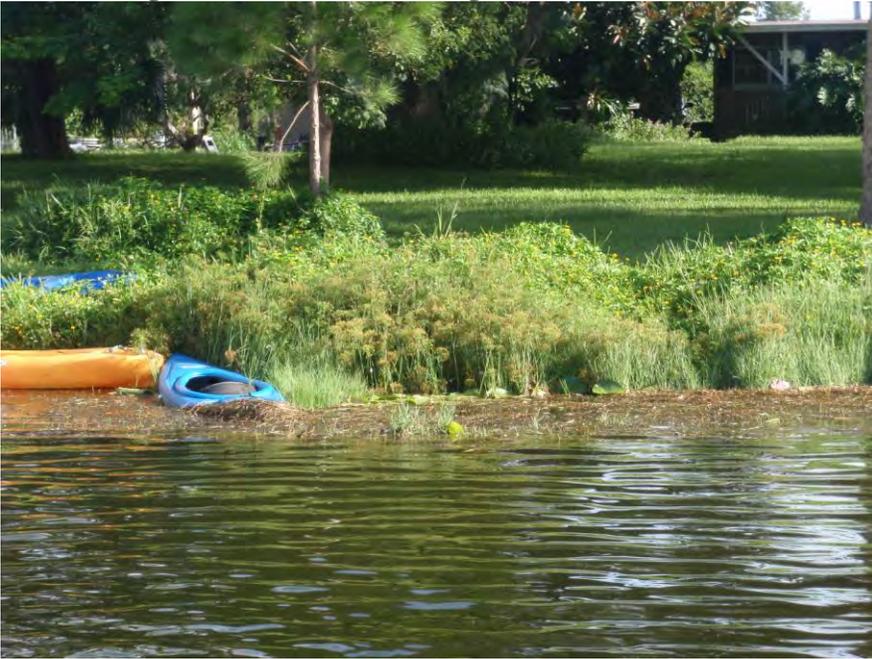
Photo: Eelgrass blades found along shoreline.

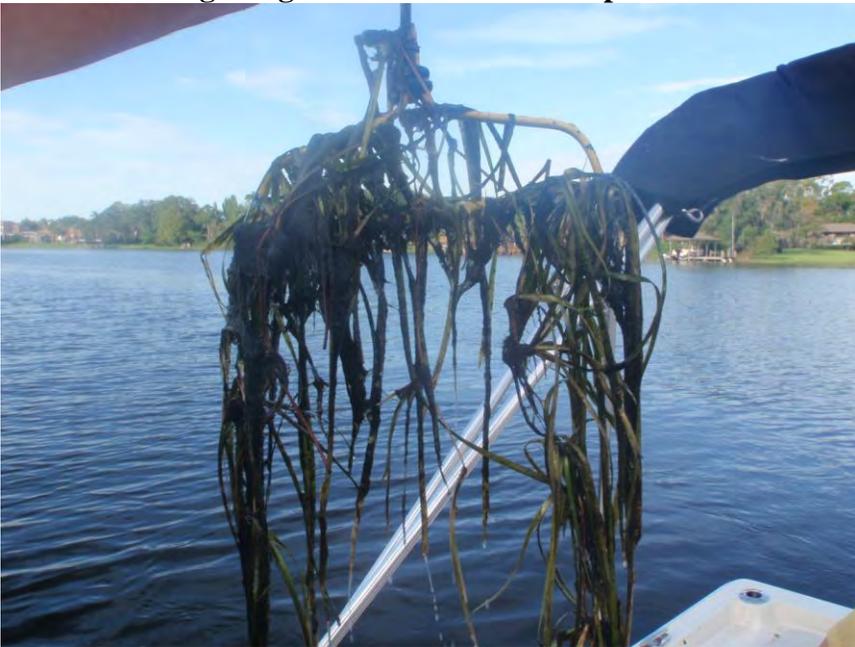
Prior to the whole lake hydrilla infestation, eelgrass (a beneficial native SAV) was present in greater biomass and water depths. Hydrilla likely shaded out the necessary sunlight for eelgrass to survive causing a reduction in plant biomass (current estimates are at 40-50% reduction in eelgrass). Despite the impacts from hydrilla, new growth was observed inshore to a depth of 5 feet. With the absence of hydrilla, it is anticipated for eelgrass to continue to migrate into further areas of the lake.

Photo: New eelgrass growth observed to a depth of 5 feet.

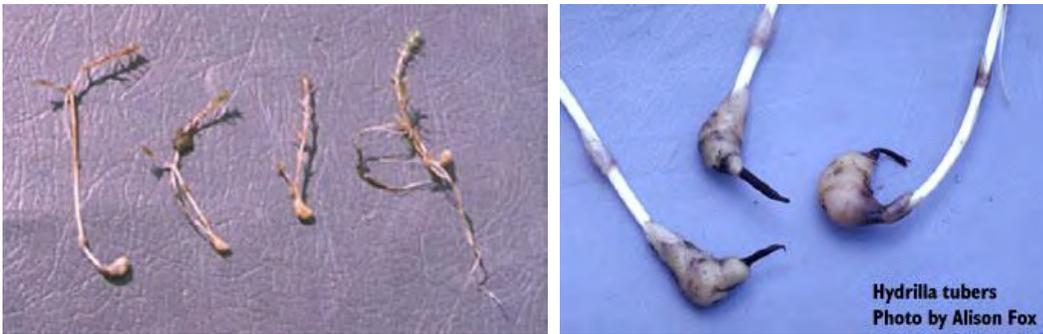
We will continue to monitor the inshore areas of the lake to enable rapid response to new hydrilla growth as result of tubers (via chemical spot treatments). Tubers are potato-like bulbs that are deposited by the plant into the sediment which can remain viable for up to four years. Tubers are produced in each growing season and are used to perennialize the plant as a means of propagation (re-growth). Since the lakes were previously infested with hydrilla, an abundant amount of tubers (which can sprout new growth at any time) were deposited in the lake bed; one square meter of hydrilla can produce 5,000 tubers.

Photos: Example of hydrilla tubers.

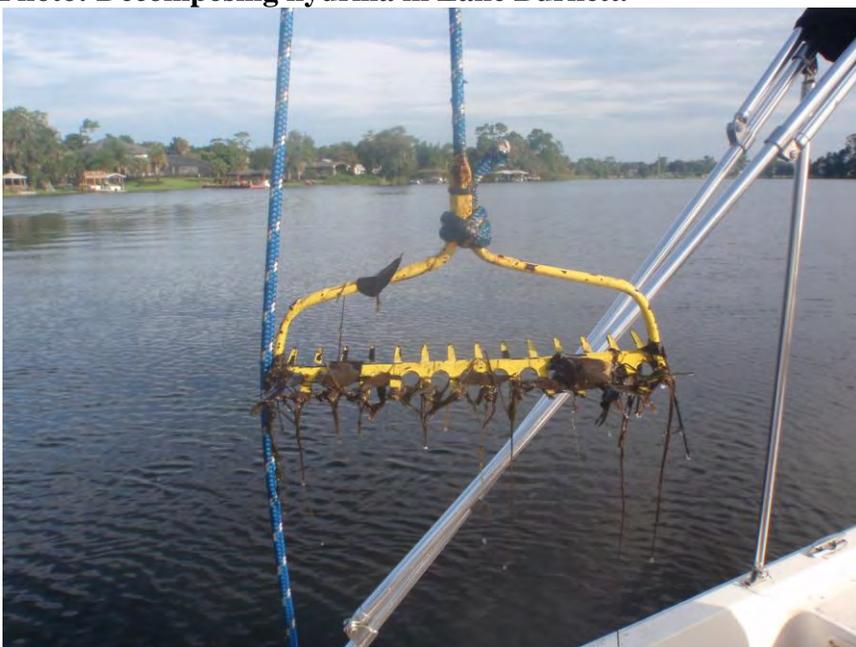
Photo: Decomposing hydrilla in Lake Burkett.

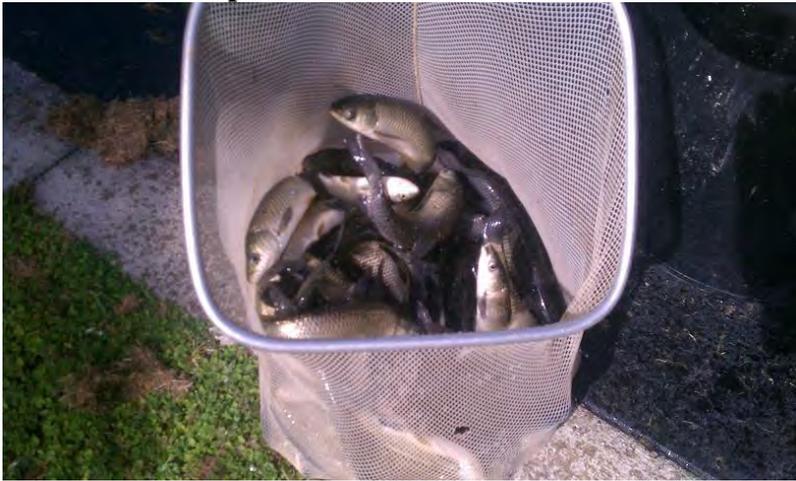
Lakes Martha and Burkett were stocked with 360 sterilized grass carp fish on July 26th, 2012. The use of grass carp fish are continued efforts for the hydrilla management plan that utilizes integration of chemical and biological control methods. Thanks to OC for being on hand to capture photos of the fish for the lake community!

Photo: Grass carp fish released into lakes Martha and Burkett.

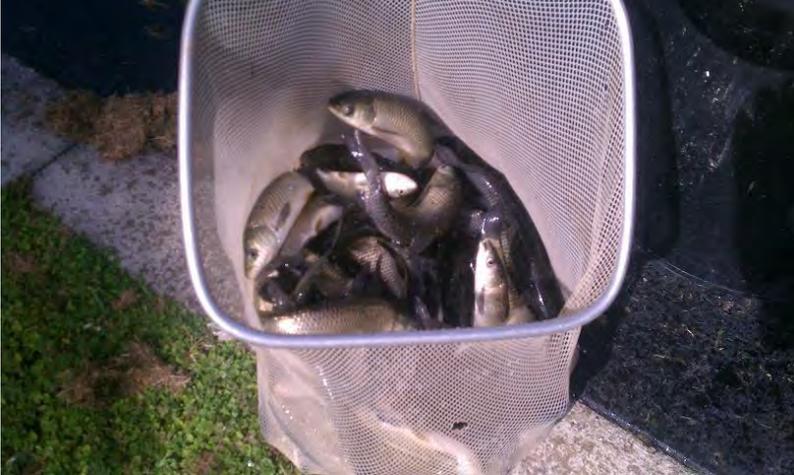
Lakes Martha and Burkett were stocked with 360 sterilized grass carp fish on July 26th, 2012. The use of grass carp fish are continued efforts for the hydrilla management plan that utilizes integration of chemical and biological control methods. Thanks to OC for being on hand to capture photos of the fish for the lake community!

Photo: Grass carp fish released into lakes Martha and Burkett.

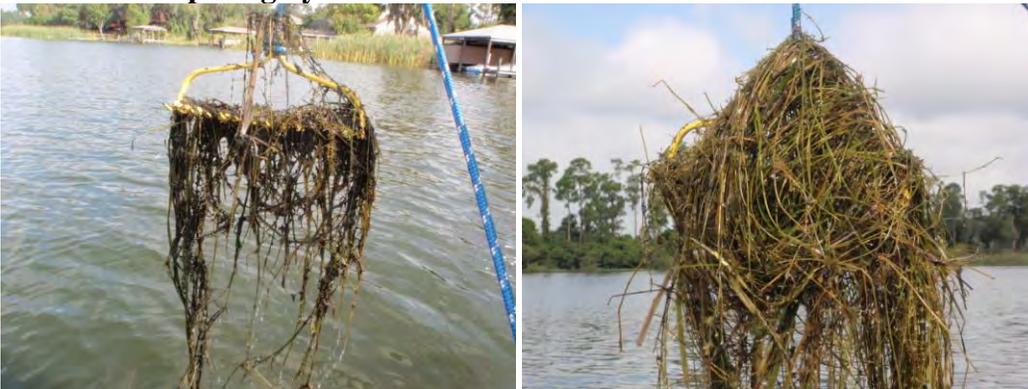
For **Lake Burkett**, decaying biomass remains within the lake however is anticipated to continue to decompose and disintegrate. Biomass was present in less quantity and surface algae was significantly reduced as compared to prior inspections. Portions of the shoreline are experiencing floating hydrilla as result of wind/wave action. As in prior reports, we continue to advise to **please refrain from raking out hydrilla from the lakes at this time**. Raking now only **increases** the chances for the raked hydrilla strands/fragments to survive when and if introduced back into the lake (i.e. reintroduced by rain or wind). Many portions of the lake were observed to be free and clear of hydrilla.

Photo: Decomposing hydrilla in Lake Burkett.

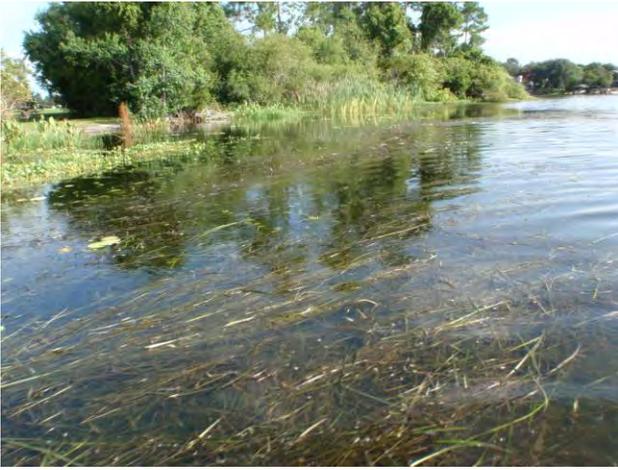
Photo: Floating hydrilla (decomposing) found along shoreline.

We will continue to monitor the decomposition stage and inshore areas of the lake to enable rapid response to new hydrilla growth as result of tubers. Tubers are potato-like bulbs that are deposited by the plant into the sediment which can remain viable for up to four years. Tubers are produced in each growing season and are used to perennialize the plant as a means of propagation (re-growth). Since the lakes were previously infested with hydrilla, an abundant amount of tubers (which can sprout new growth at any time) were deposited in the lake bed; one square meter of hydrilla can produce 5,000 tubers.

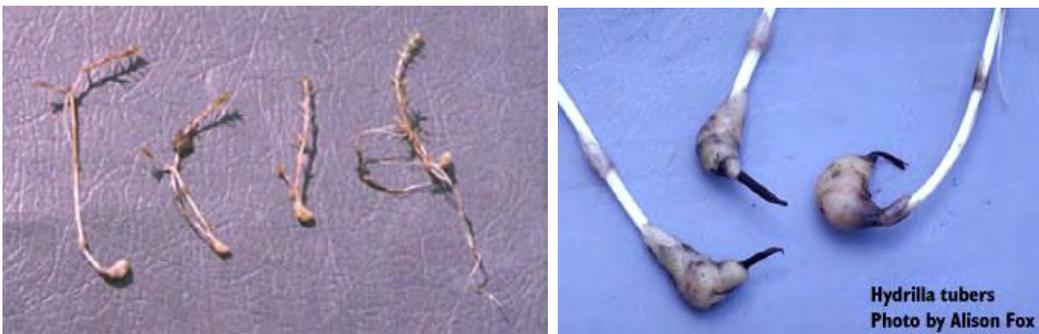
Photo: Example of hydrilla tubers:

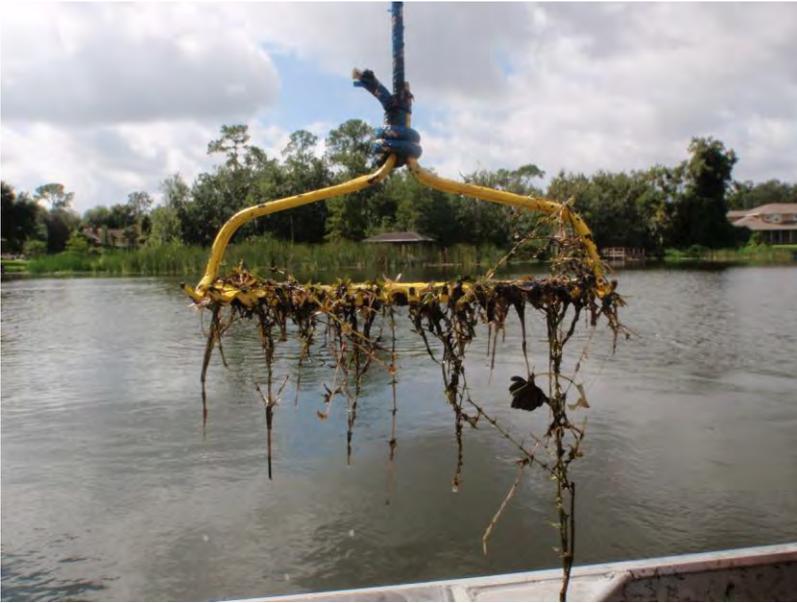
For **Lake Martha**, a significant amount of decomposing hydrilla has already disintegrated leaving much of the lake free and clear of hydrilla. Although decomposing biomass is still present, as in Burkett, we anticipate for the remaining biomass to fall out. Water lilies, specifically spatterdock, were impacted by the treatment leaving some of the root system (rhizomes) to surface. This was found in both lakes. Because of the density of this material, it is suggested to rake out these roots when encountered.

Photo: Decomposing hydrilla in Lake Burkett.

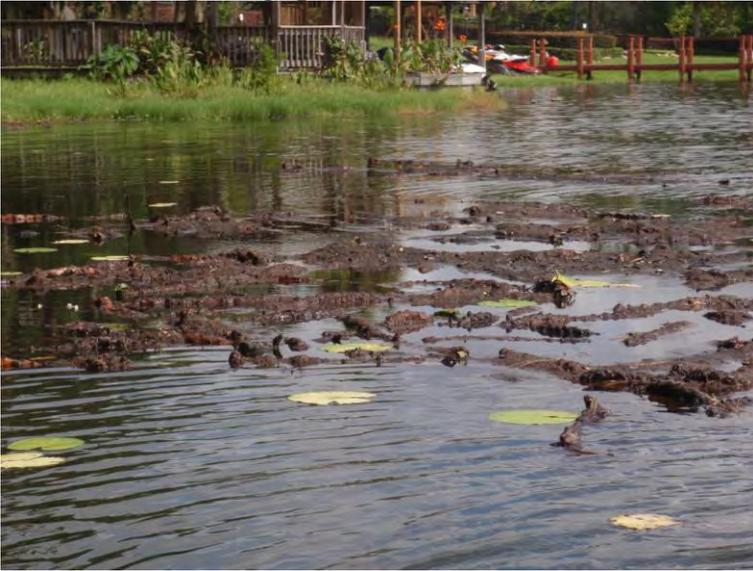
Photo: Decomposing spatterdock root system (rhizomes).

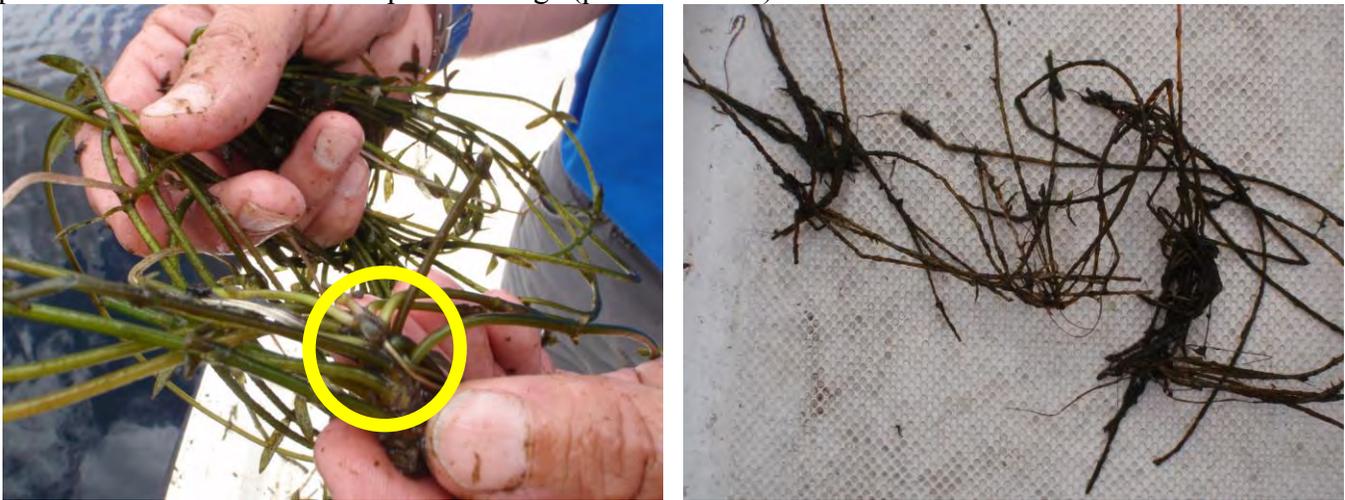
We continue to closely monitor the decomposition of hydrilla inspecting the lakes on May 17th and 23rd, June 13th and 21st. Based on these inspections, most of the plant material is impacted beyond recovery and is expected to continue to decompose and fall out. We continue to advise to **please refrain from raking out hydrilla and/or algae from the lakes at this time.**

Photos: Left-growth (in yellow) noted in May that had potential to survive if left untreated. Right- remains of plant that is now in full decomposition stage (post treatment).

Raking now only **increases** the chances for the raked hydrilla strands/fragments to survive when and if introduced back into the lake (i.e. reintroduced by rain or wind). This is because the removed plant material will no longer be in contact with the herbicide in the water column and could survive if reintroduced to the lake. As product concentrations still remain in the lake, continuing to expose the hydrilla is the best option for long term control and allow the natural process of decomposition to occur. Once the hydrilla fully decomposes, the associated algae will disappear.

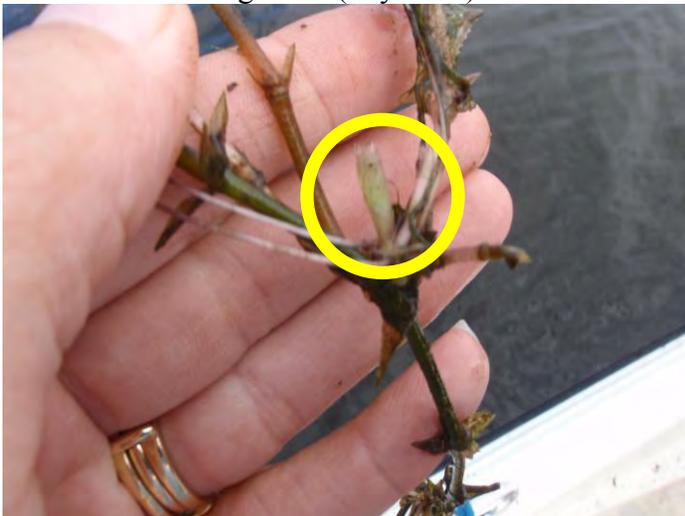
Photo: Continued growth (in yellow) that is not viable as product uptake is visible within plant.

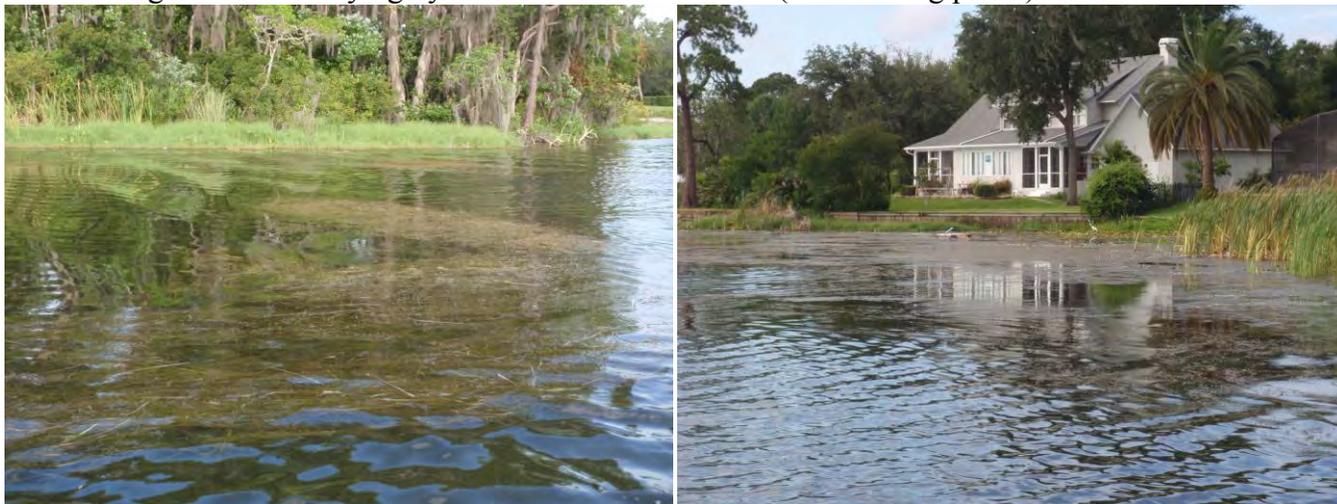
Upon each site visit, we are seeing surface algae increase in **Lake Burkett**. This is a normal, expected occurrence that results from the hydrilla decomposing. We anticipated much worse conditions, like last summer, however this has not taken place thus far. There is still a considerable amount of decaying hydrilla that has the potential to surface in Lake Burkett creating large algae mats. Wind/wave action will facilitate

Photos: Large mats of decaying hydrilla observed in Burkett (south facing photo).

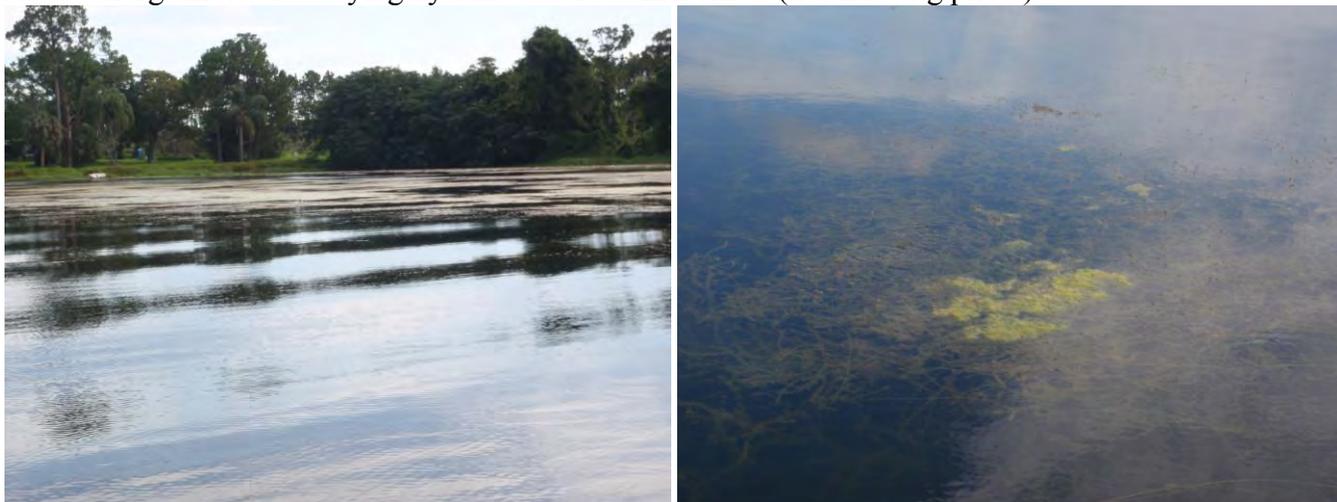
Photos: Large mats of decaying hydrilla observed in Burkett (north facing photo).

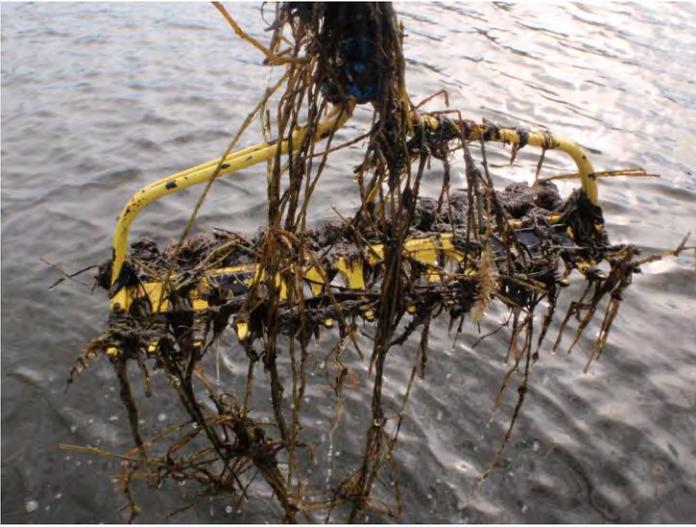
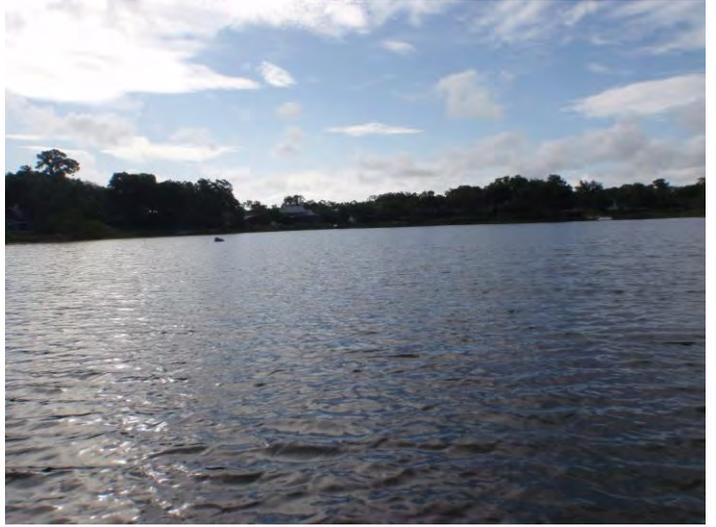
Lake Martha has seen dramatic improvements over the series of inspections. At the time of inspection, much of the lake was free and clear of hydrilla, however decomposing plant (none that appear viable) are still prevalent on the south lobe. Wind/rain storms has aided in reducing the plant material/algae off the surface of the lake. We anticipate to see much less decomposing hydrilla upon our next inspection.

Photos: Lake Martha's fully decomposed hydrilla (left) and lake surface free of algae/floating hydrilla strands (right).

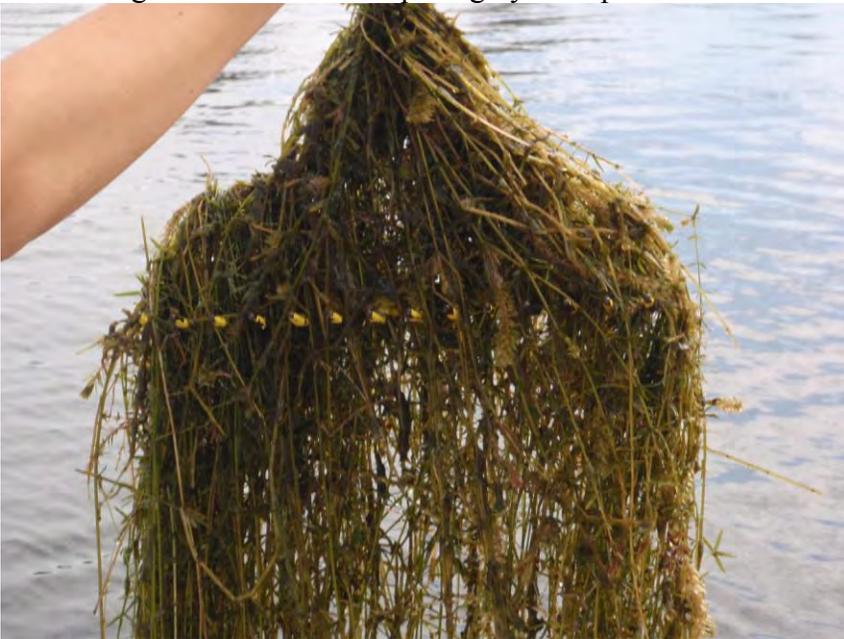
Photo: Large biomass of decomposing hydrilla present in Burkett at time inspection.

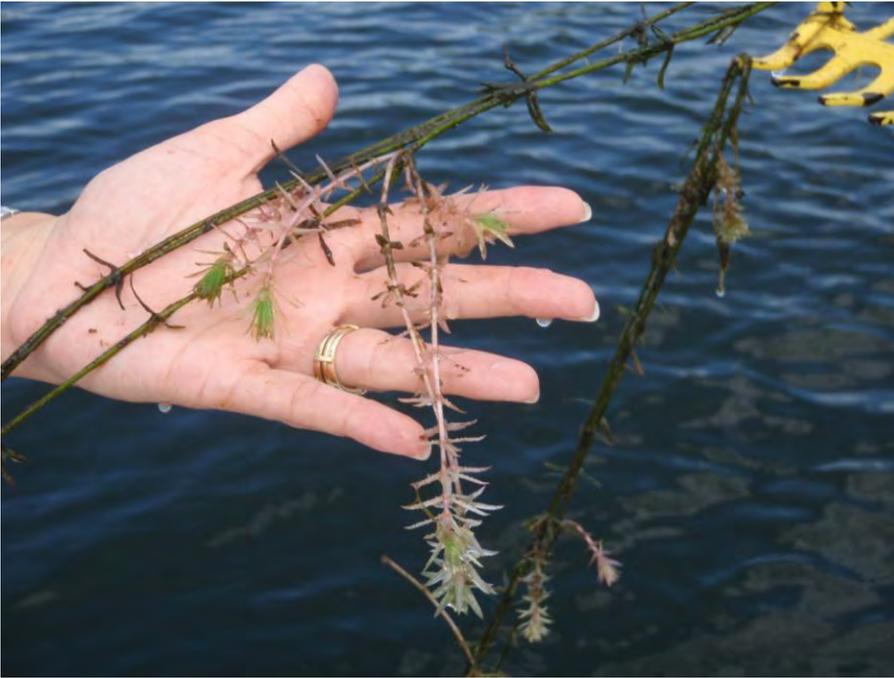
Photo: Example of plant using stored food supply in attempts to survive (five strands growing off one plant node!). None of these tips are viable and will not survive.

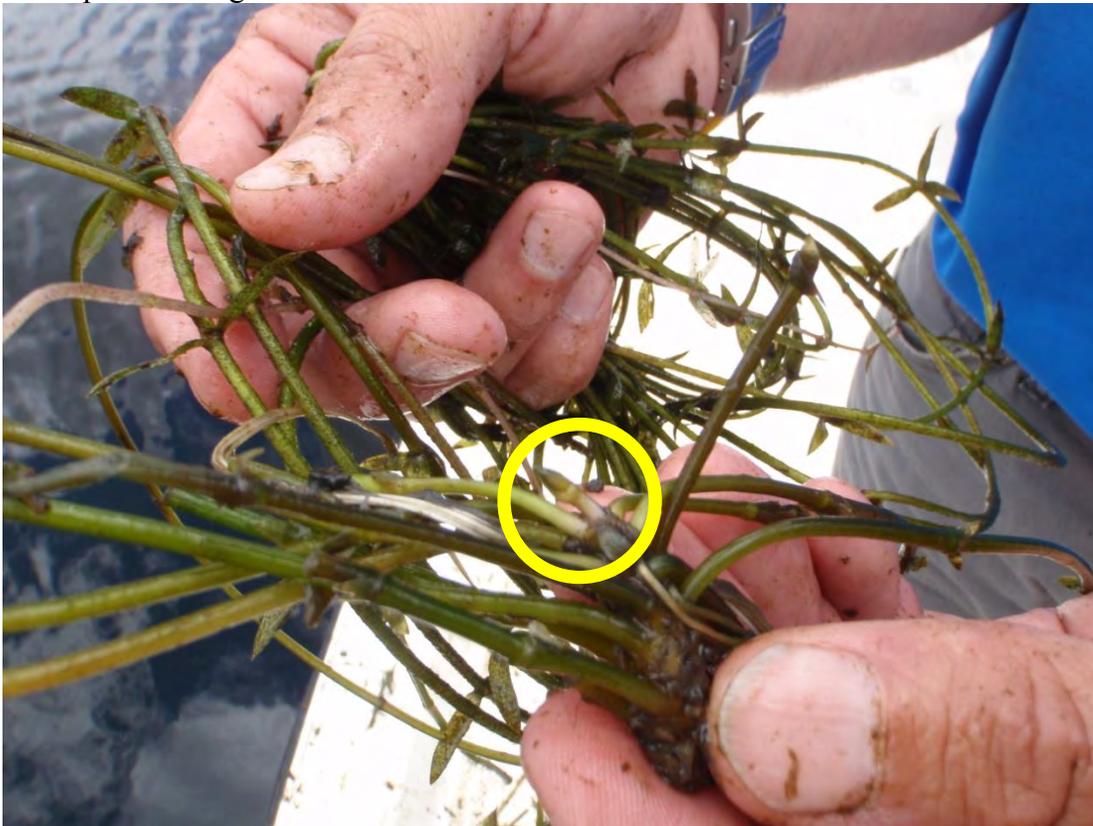
Attached is a photo of the minor growth observed. The rest of the plant material, although long and dense, is impacted beyond recovery and is expected to continue to decompose. Once the decomposition phase has completed, the surface algae feeding on the decaying plant material will disappear as well. The decomposition stage is prolonged by the sheer amount of hydrilla biomass that was present in the lake prior to treatment. Additionally, this amount of plant material contains a large food storage supply. This carbohydrate storage is what can supply new growth from the existing plant stem as seen in photo below. Keeping the concentration of product within the water column at the prescribed level will impact the growth observed. Continual close monitoring to observe these events is critical to having a successful hydrilla treatment outcome.

Photo: Growth (in yellow) that has potential to survive if left untreated. The remaining plant is in decomposition stage.

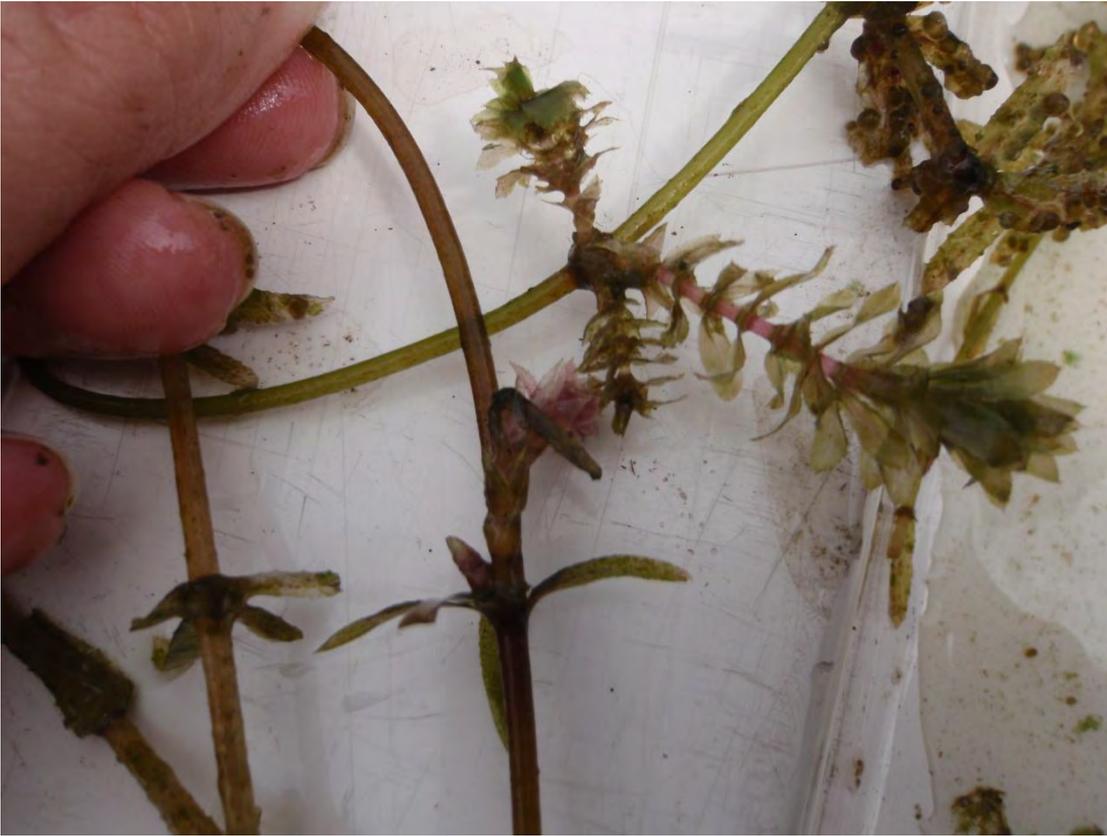
Photo: Example of plant using stored food supply in attempts to survive (three strands growing off one plant node!). None of these tips are viable and will not survive.

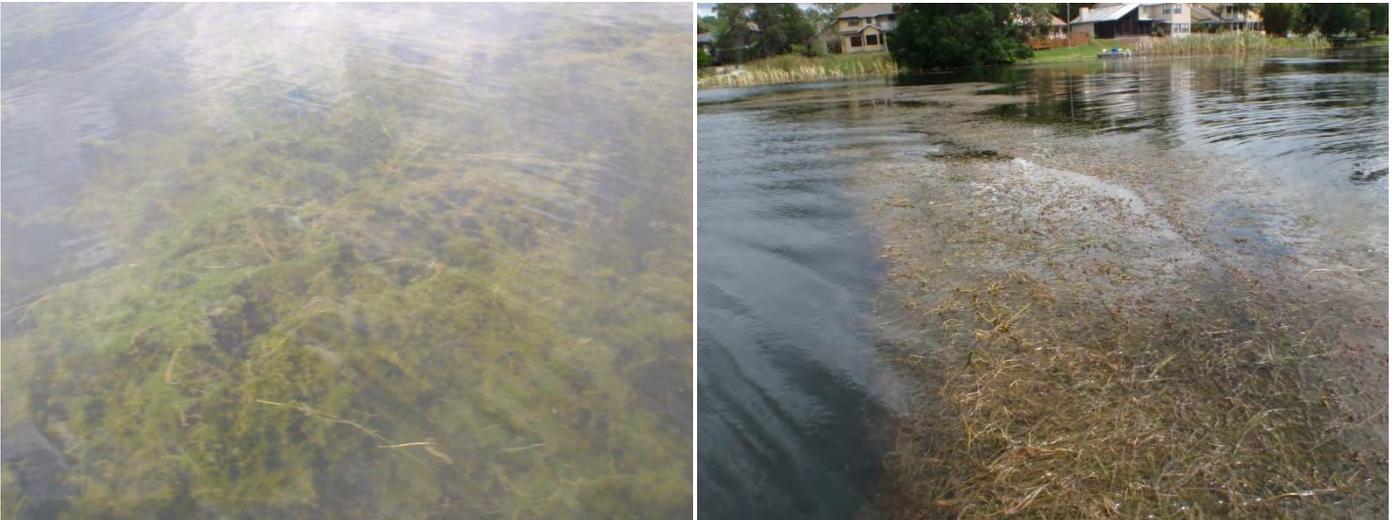
Upon each site visit, we are seeing an increase in the surface algae (more so in Burkett). This is a normal, expected occurrence that results from the hydrilla decomposing. We anticipated much worse conditions, like last summer, however this has not taken place thus far. There is still a considerable amount of decaying hydrilla that has the potential to surface, creating large algae mats. Wind/wave action will facilitate (speed up) the decomposition of the hydrilla, which is the final stage of the plant.

Photo: Large mats of decaying hydrilla observed.
