Greetings Lakes Burkett and Martha

Please find the latest assessment report for your lake below. Our next scheduled assessment will be October 23rd; weather permitting. Key highlights of this update will include:

On **September 18th, 2012**, Seminole County Lake Management Staff Thomas Calhoun and Devin Whitney (joined by OC staff- Ryan Patrick and John Pierce) inspected the aquatic plants within Lakes Martha and Burkett. Minimal hydrilla was noted within both the lakes.

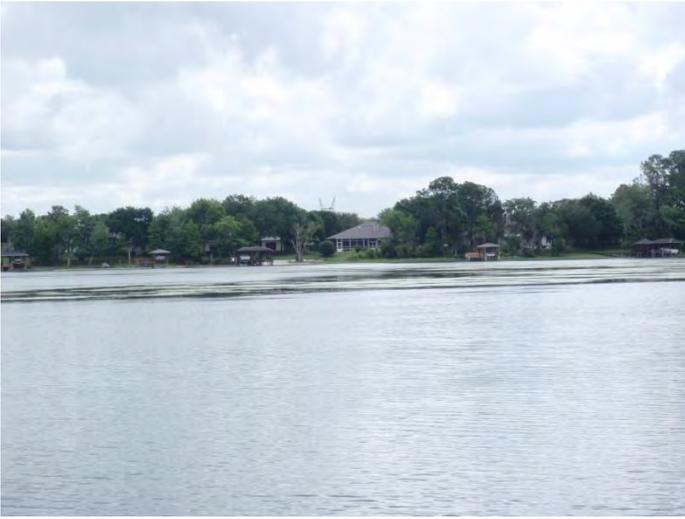
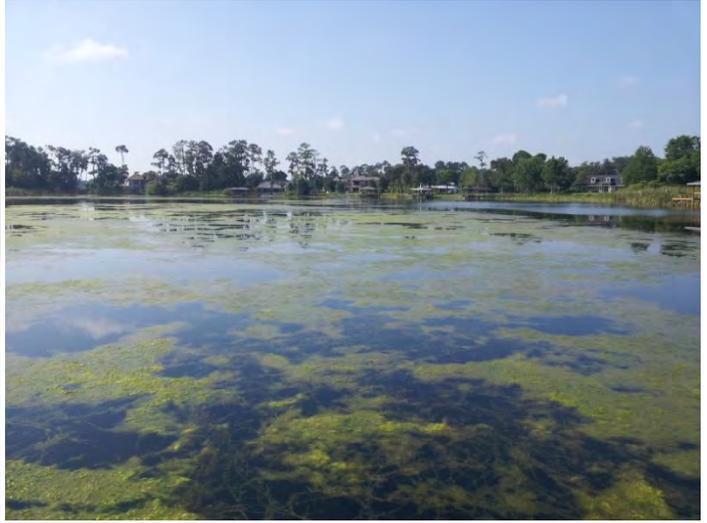
Photo: Lake Burkett on 5-17-12 with some surface algae present (left). Lake Burkett on 5-23-12 with greater surface bloom present (right).

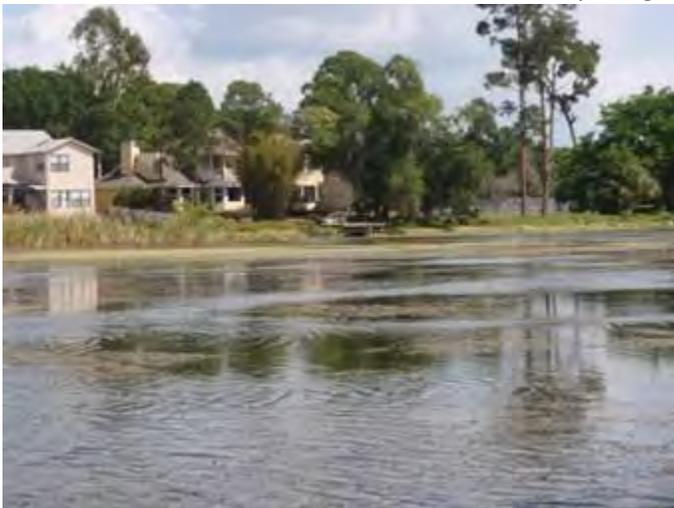
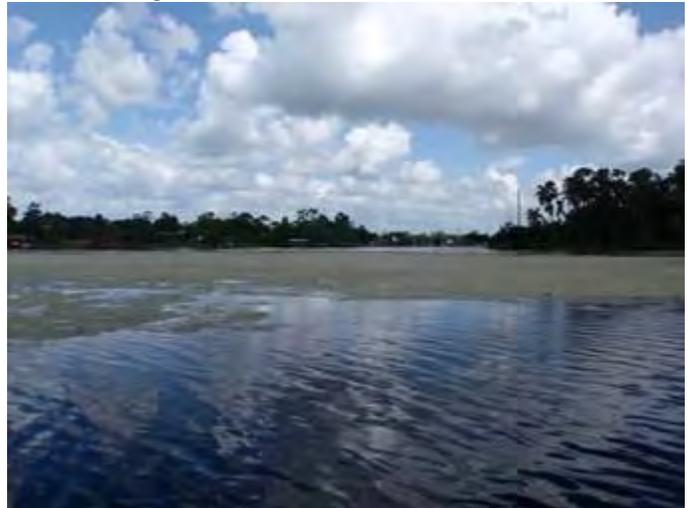
We had expected to see a much larger surface algae bloom for a longer period of time on the lakes, however we are happy to report that we have not seen this thus far. Although, we still expect to see more of the hydrilla surface as it decomposes. Hydrilla, with strands up to 20 feet in length, will either break off and surface in large mats or sink to the bottom of the lake; we are observing both of these changes.

Photos: North Burkett and South Martha; decomposing hydrilla creating a surface bloom.

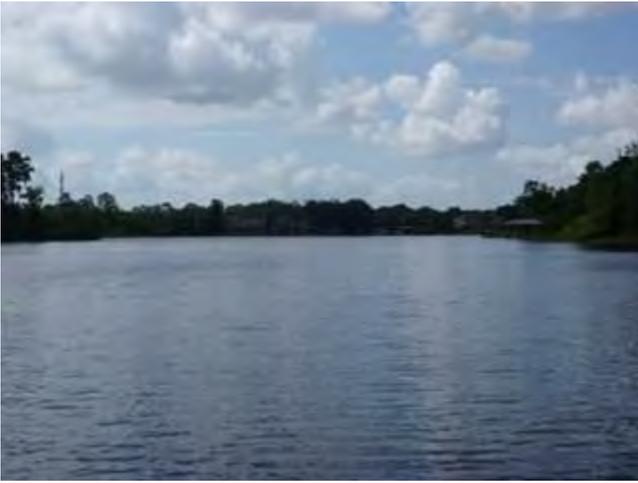
Photos: South facing view of Martha; open and navigable.

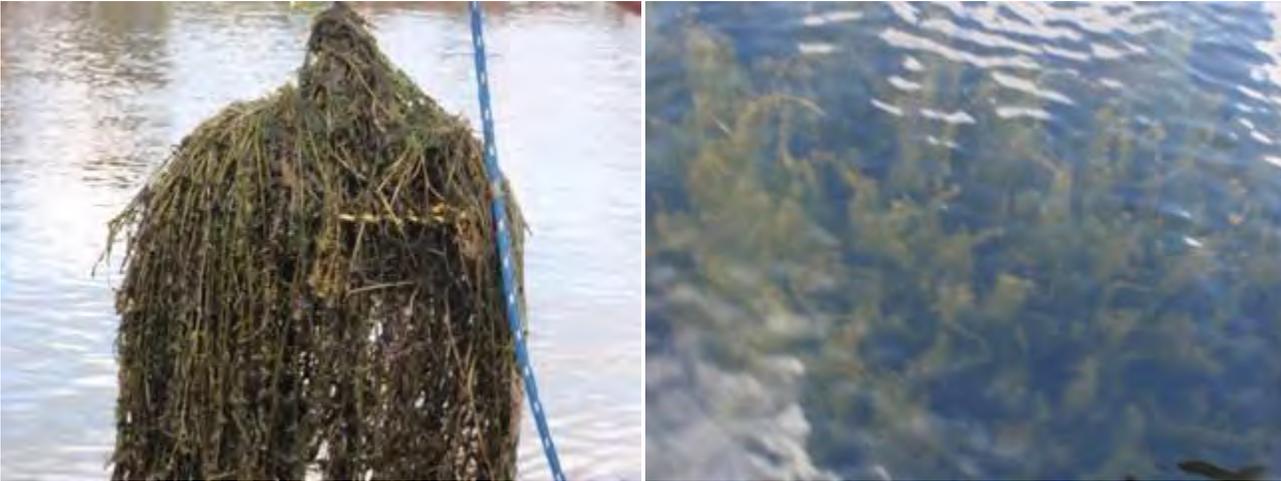
Photos: Hydrilla in early decomposition stage with algae present as result.

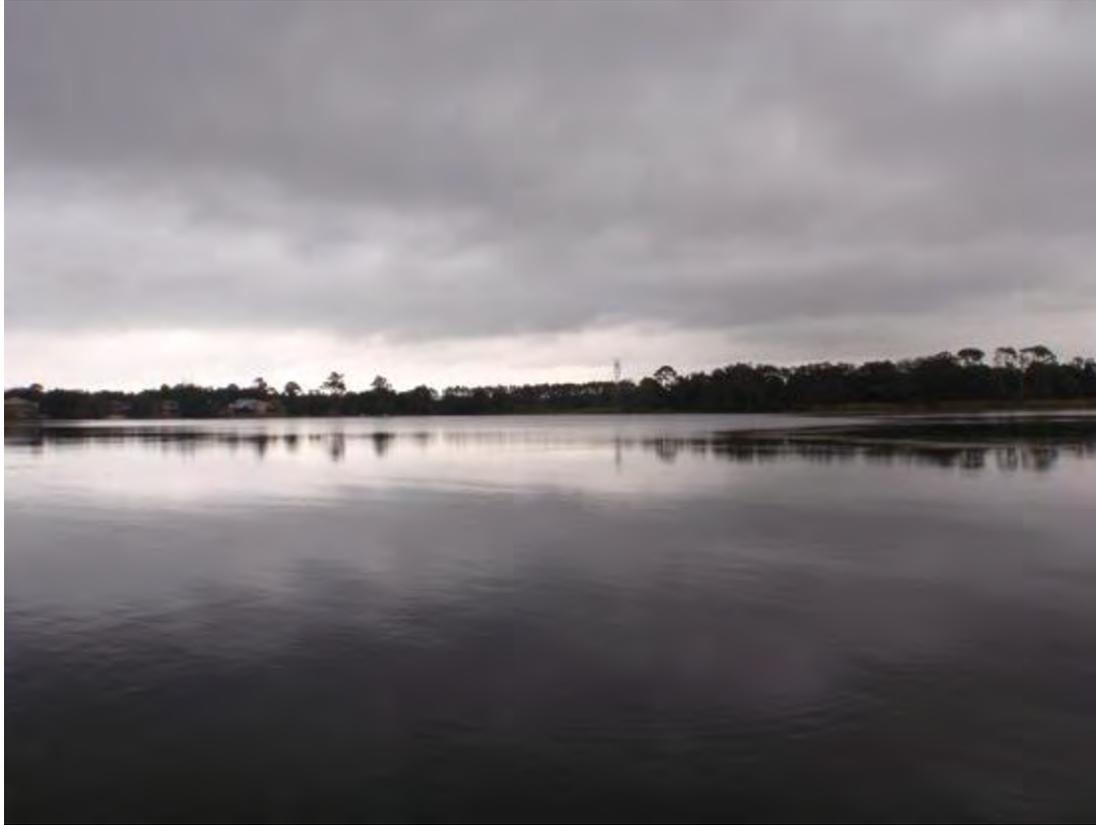
Hydrilla has significantly increased throughout **Lake Burkett** blocking access for a majority of the boat docks and is impeding navigation through the canal of which is now 100% choked with hydrilla. Hydrilla plant tips, previously topping out in 60% of the lake and growing laterally along the surface, have been reduced off the surface (by less than one foot) in a majority of places due to cold weather affecting the plants. Plants were found in depths of 10-12 feet, making the plants over 12 feet in length. During previous surveys, eelgrass and southern naiad were much more dominant than hydrilla, however hydrilla continues to be the dominant aquatic plant within the lakes.

Photo: Hydrilla topping out in less area of Lake Burkett; surface algae bloom no longer present.

- 2 ****In progress**** Treat the invasive hydrilla. This could be managed by Seminole/Orange County by establishing a Municipal Service Benefit Unit (MSBU); a funding format for aquatic weed control via non-ad valorem assessments assessment.

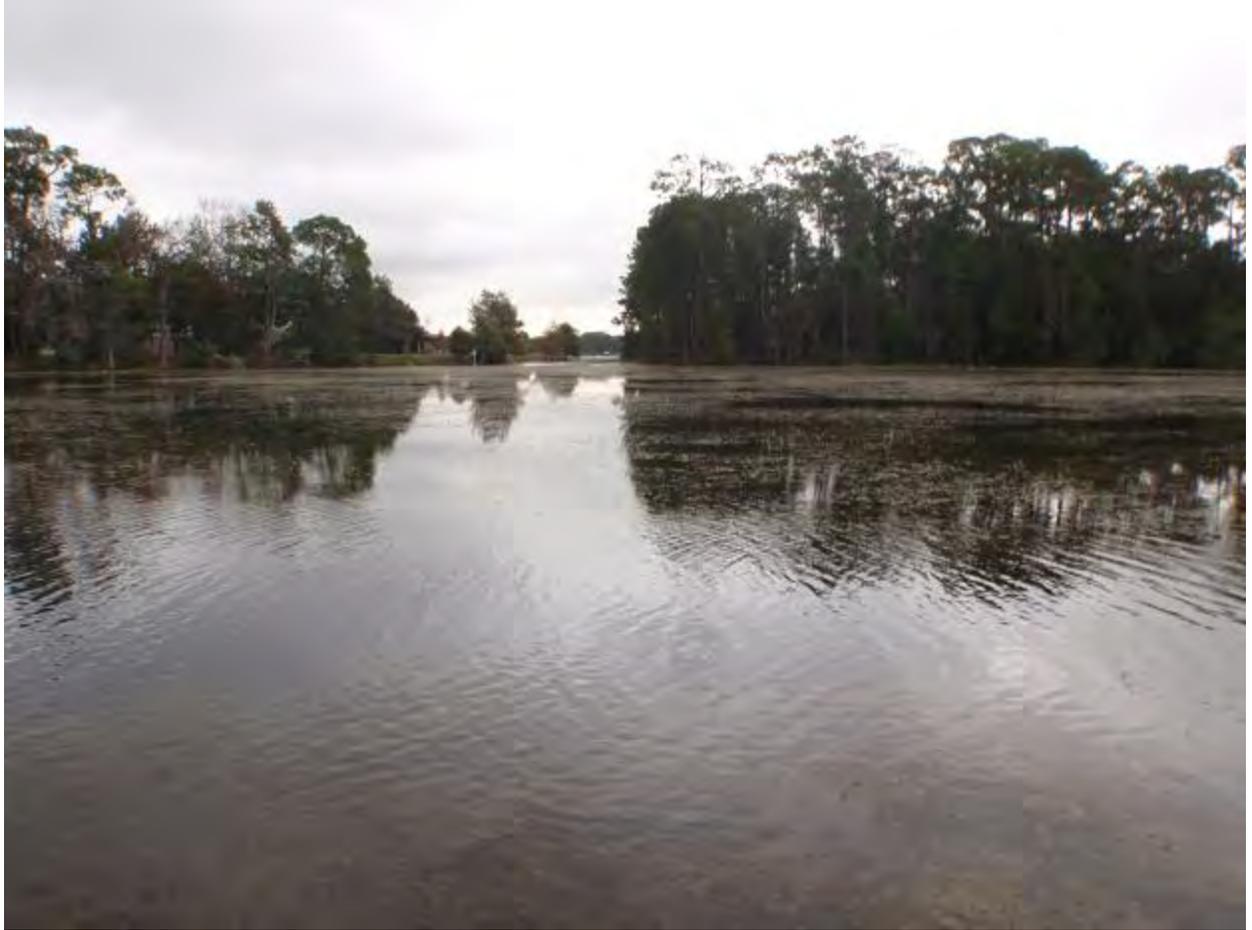
Hydrilla in **Lake Martha** was much more extensive than Lake Burkett in which 75% of the lake is topped out (a percent reduction as well due to cold weather). Once the plant surfaces, the plant tips decompose during high temperatures. Algae feeds upon the plant decay creating a surface algal bloom. With this amount of plant material (biomass), the lake is susceptible to large algal blooms and dissolved oxygen fish kills however with cooler temperatures the chances of this occurring are significantly reduced as the plants are reduced off the surface, less algae is present, and dissolved oxygen levels are increased during cooler temperatures.

Photo: Martha with hydrilla topped out at 75% due to recent cold weather reducing the plant off the surface.

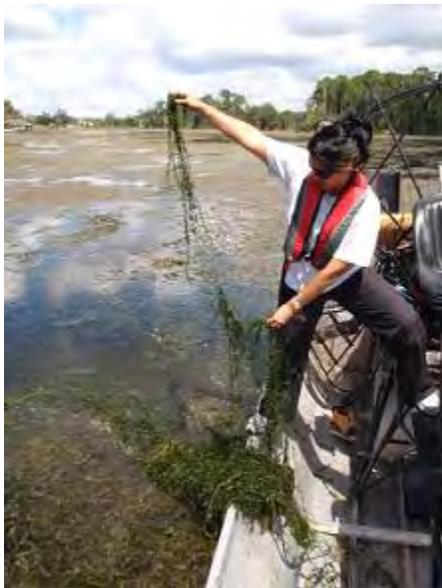
Photo: Martha with hydrilla strands up to 12 feet.
