Greetings Spring Wood Lake and Springwood Waterway!

Spring Wood Lake

On **May 7th, 2013**, Seminole County Lake Management Program (SCLMP) staff Gloria Eby and Marie Lackey surveyed the aquatic plants in **Spring Wood Lake**.

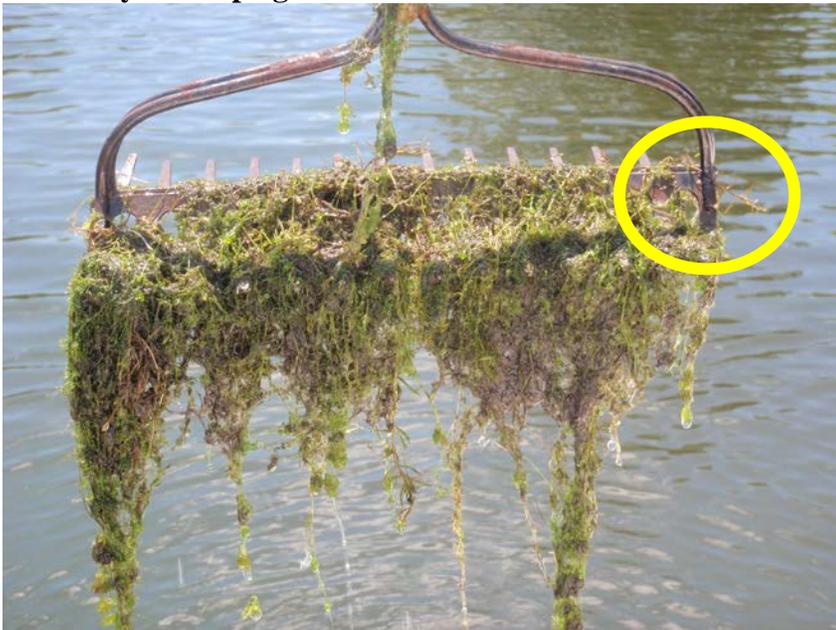
Hydrilla was found during the inspection to a depth of 9 feet intermixed with the native vegetation. There were no monocultures (single-crop) of hydrilla found within the lake as they were successfully treated in April. Although sprigs of hydrilla were found to a depth of 9 feet, it was noted that hydrilla was present in less biomass than in prior inspections. With the increase in water elevation (ultimately decreasing clarity and sunlight availability to the deep water hydrilla plants) and the combination of the grass carp stockings, we are hopeful hydrilla continues to struggle and diminish without the need of chemical intervention. We will continue to closely monitor hydrilla to determine if further management action is required.

Photo: Hydrilla sprig found intermixed with stonewort and southern naiad.

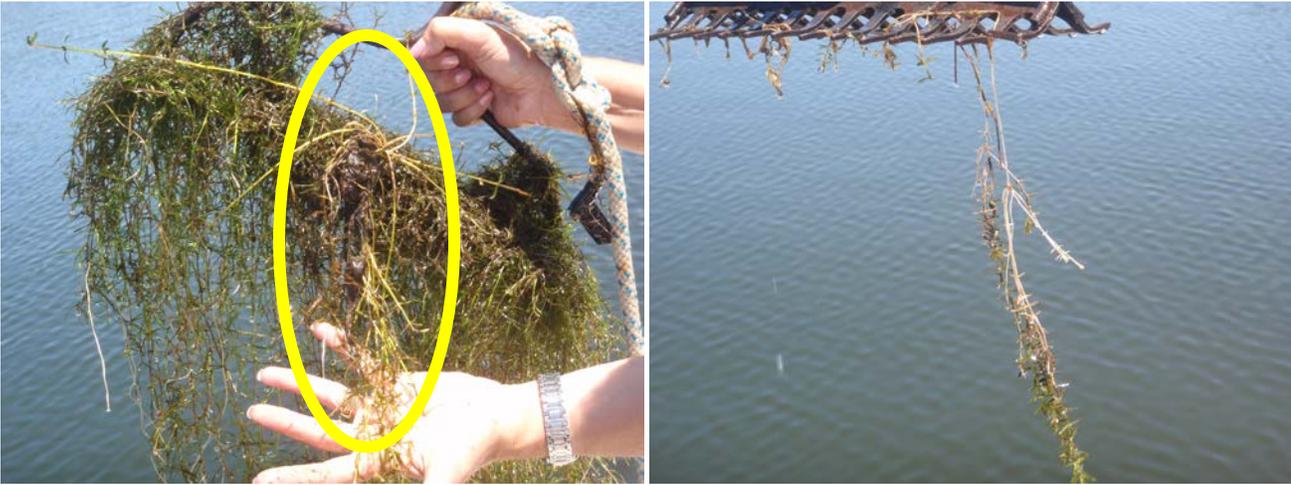
Beneficial native SAV found during inspection included; southern naiad to 9 feet, chara to 8 feet, nitella to 6 feet, and lemon bacopa to 6 feet. Southern naiad is considered the dominant SAV.

Photo: Hydrilla found intermixed with southern naiad (on left) and collected from water depths of 9 feet (on right).

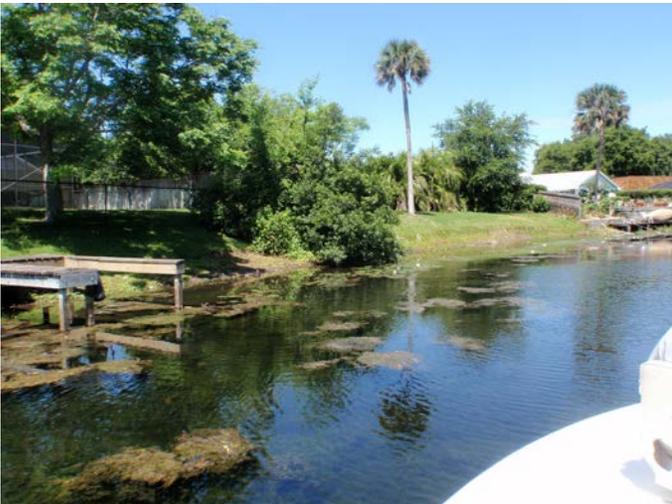
Native submersed aquatic vegetation (SAV) observed included; lemon bacopa to a depth of 2 feet, road grass to 2 feet, stonewort to 2 feet, and purple bladderwort to 3 feet. Stonewort and bladderwort are found in 1 to 3 foot mats along the bottom at the entrance of the waterway. The entrance to canal is navigable and does not require mechanical harvesting for access at this time.

Photo: Bladderwort found at the entrance to the waterway topping out.

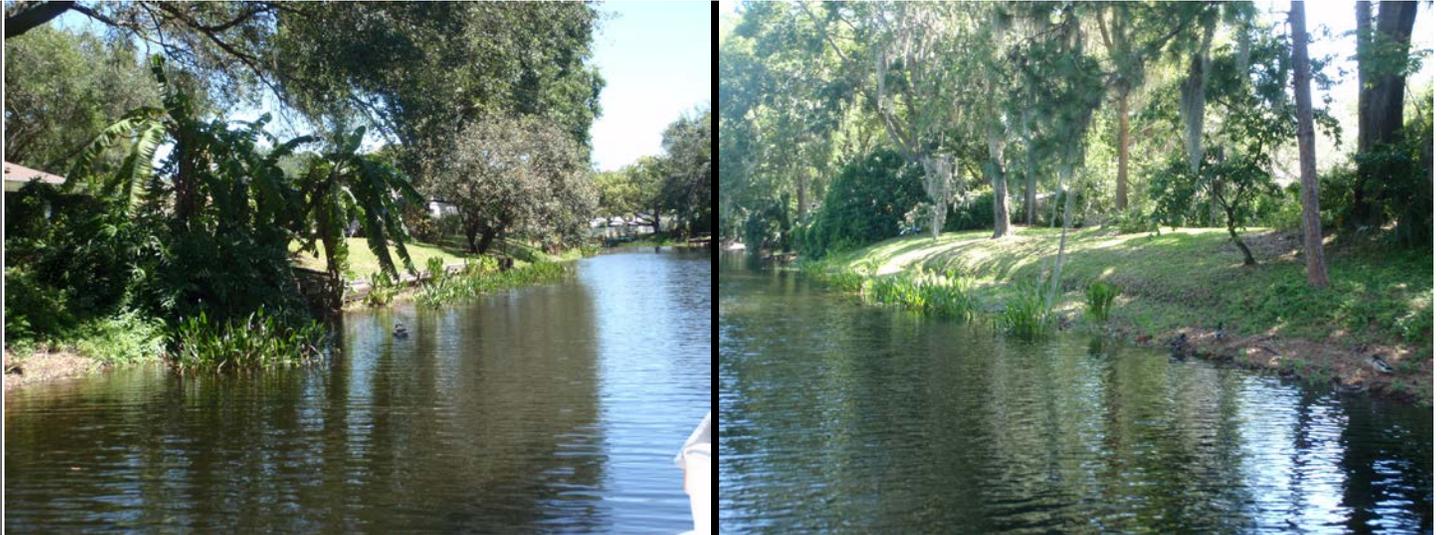
As result of the multiple restoration events and the routine MSBU funded maintenance, native plants are expanding well especially in the last 2/3 of the canal. To encourage more locations, **the next volunteer planting event is scheduled for June 29th, 2013 starting at 9am.** We are looking forward to seeing everyone and having another successful event. If you have any event questions or would like to sign up as a location please contact our SERV Program at serv@seminolecountyfl.gov or your community liaison, Brian Pelski at bpelski89@gmail.com.

Photo: Expanding native vegetation as result of the restoration events.

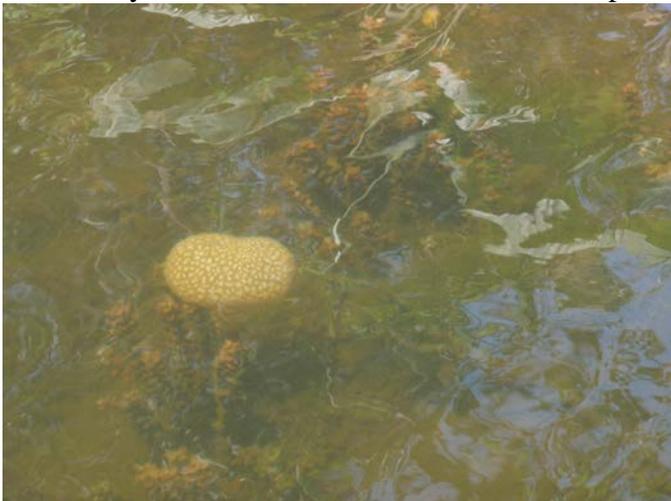
We observed several “alien eggs” in Springwood Waterway. These are freshwater bryozoans, or moss animals, that are made up of tiny aquatic invertebrates that forms a colony. Similar to sponges, they filter water for food. For more information on bryozoans, please visit <http://www.bio.umass.edu/biology/conn.river/bryozoa.html>.

Photo: Bryozoa found near end of canal. Multiple colonies are forming along the last half of canal.

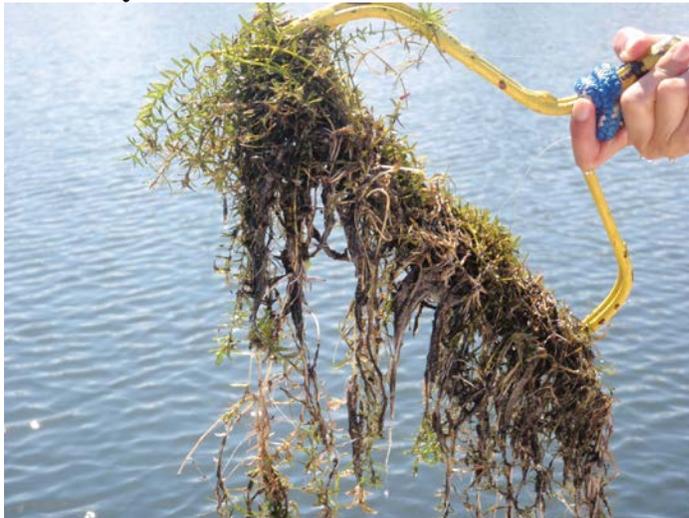
Hydrilla was found during the inspection to a depth of 6 feet intermixed with the native vegetation. There were few monocultures (single-crop) of hydrilla found within the lake and at the entry to Lake Destiny. These monocultures were spot treated on the same day as inspection. We will continue to closely monitor hydrilla to determine if further management action is required.

Photo: Hydrilla found intermixed with stonewort and southern naiad.

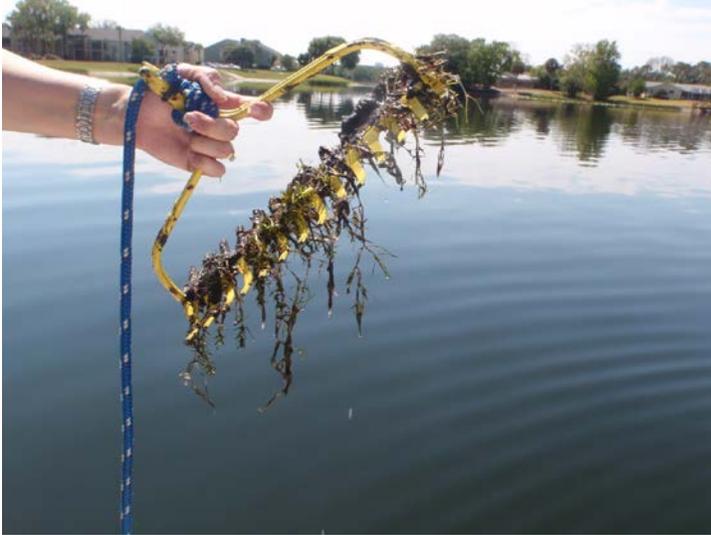
Beneficial native SAV found during inspection included; southern naiad to 10 feet and lemon bacopa to 3 feet. Southern naiad continues to expand throughout the lake and is considered the dominant SAV.

Photo: Southern naiad to 10 feet.

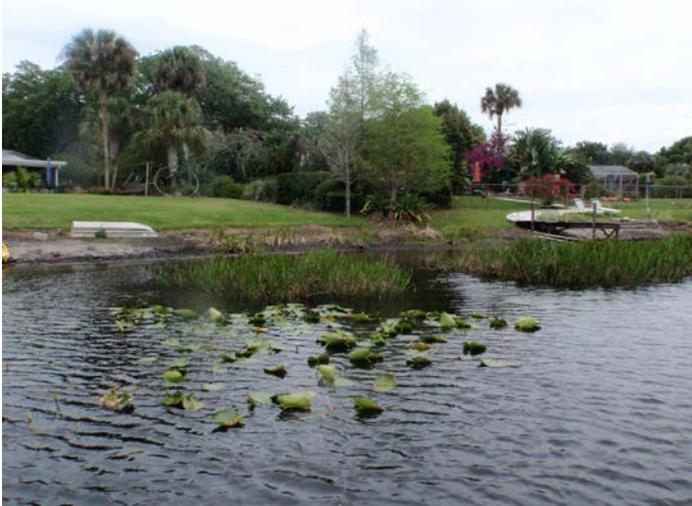
Native aquatic vegetation such as duck potato, pickerelweed, maidencane, and native rushes are the dominant emergent vegetation within Spring Wood Lake. This is a product of the multiple lake wide restoration events combined with the routine maintenance of the MSBU funded aquatic herbicide contractor.

Photo: Pickerelweed expanding around the shoreline.

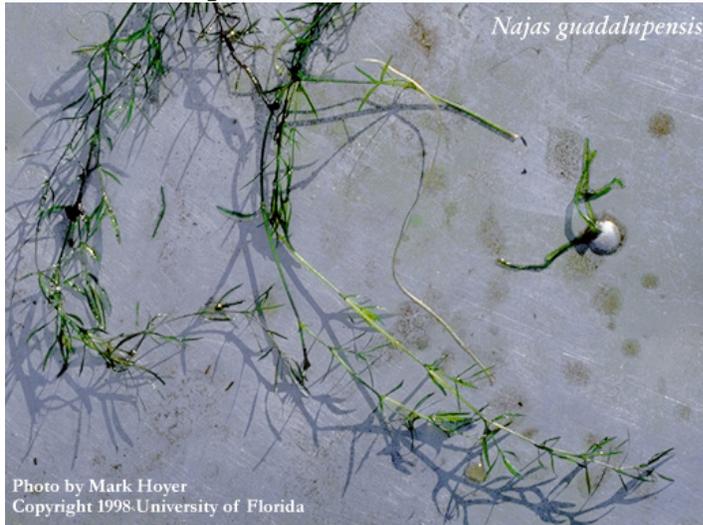
Beneficial native SAV found during inspection included; southern naiad to 9 feet and lemon bacopa to 3 feet. Southern naiad has expanded lake wide and can be found around the docks in the lake. Native SAV plays an important role in the ecosystem of the lake by providing habitat for aquatic species and helping reduce nutrients within the water column.

Photo: Close up of southern naiad.

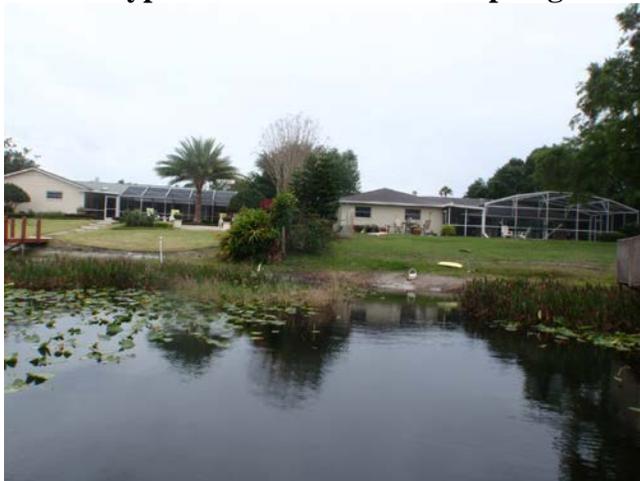
Native emergent aquatic vegetation found during the inspection included; rush fuirena, maidencane, pickerelweed, duck potato, fire flag and bulrush. Minimal torpedo grass was found during this inspection.

Photo: Typical shoreline found in Springwood Lake.

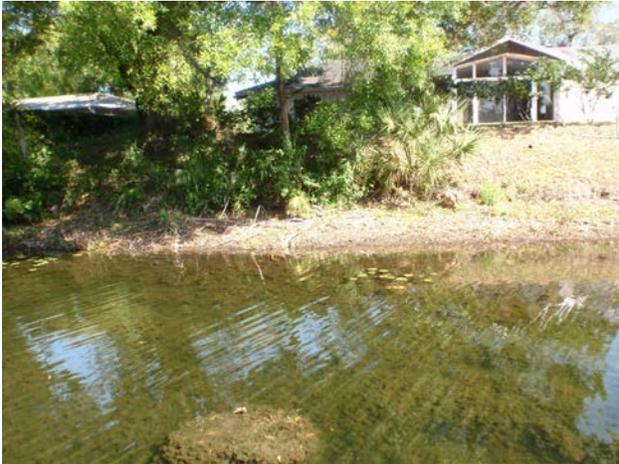
Native submersed aquatic vegetation (SAV) observed included; lemon bacopa to a depth of 2 feet, road grass to 2 feet, stonewort to 2 feet and purple bladderwort to 2 feet. Stonewort and bladderwort are found in 1 to 3 foot mats along the bottom at the entrance of the waterway. The entrance to canal is navigable and does not require mechanical harvesting for access at this time.

Photo: Stonewort and bladderwort found at the entrance to the waterway.

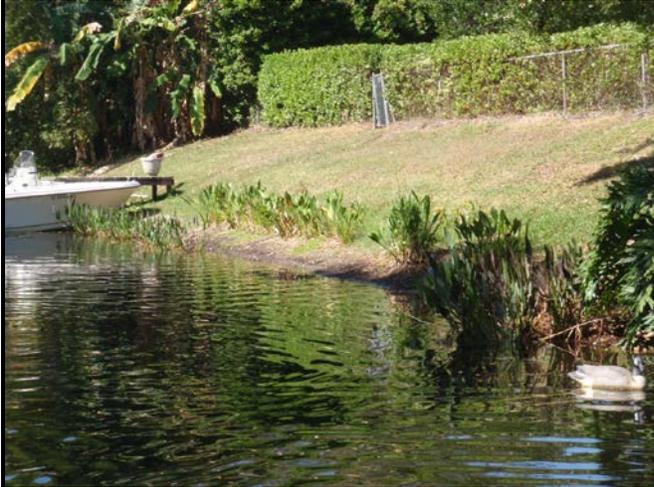
As result of the multiple restoration events and the routine MSBU funded maintenance, native plants are expanding well especially in the last 2/3 of the canal. To encourage more locations, **the next volunteer planting event is scheduled for June 29th, 2013 starting at 9am.** We are looking forward to seeing everyone and having another successful event. If you have any event questions or would like to sign up as a location please contact our SERV Program at serv@seminolecountyfl.gov or your community liaison, Brian Pelski at bpelski89@gmail.com.

Photo: Expanding native vegetation as result of the July 2012 restoration event.

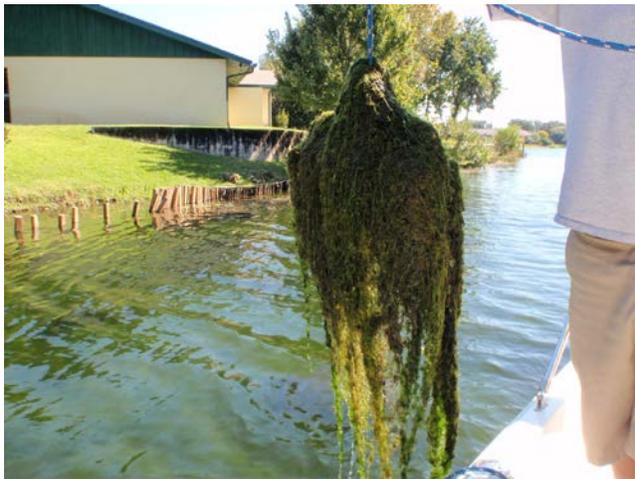
The entrance to the canal was very shallow and hard to access at the time of inspection. Vegetation was not impeding access therefore mechanical harvesting is not required at this time. Native SAV observed included: lemon bacopa to a depth of 2 feet, road grass to 2 feet, stonewort to 2 feet, and purple bladderwort to 2 feet. Stonewort and bladderwort are found in 1-3 foot mats along the bottom at the entrance of the water way.

Photo: Stonewort and bladderwort found at the entrance to the waterway.

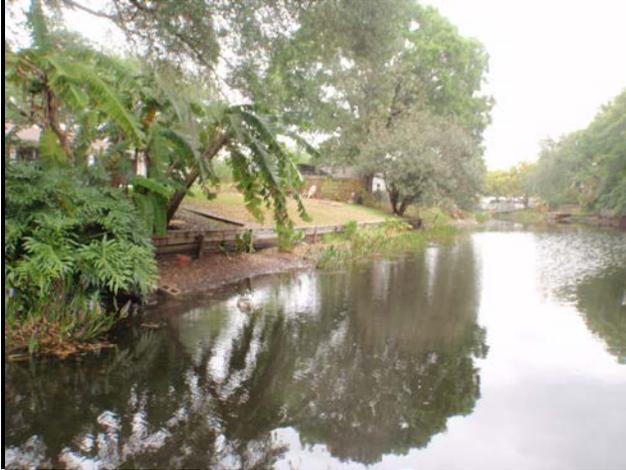
Photo: Expanding native vegetation as result of the July 2012 restoration event.

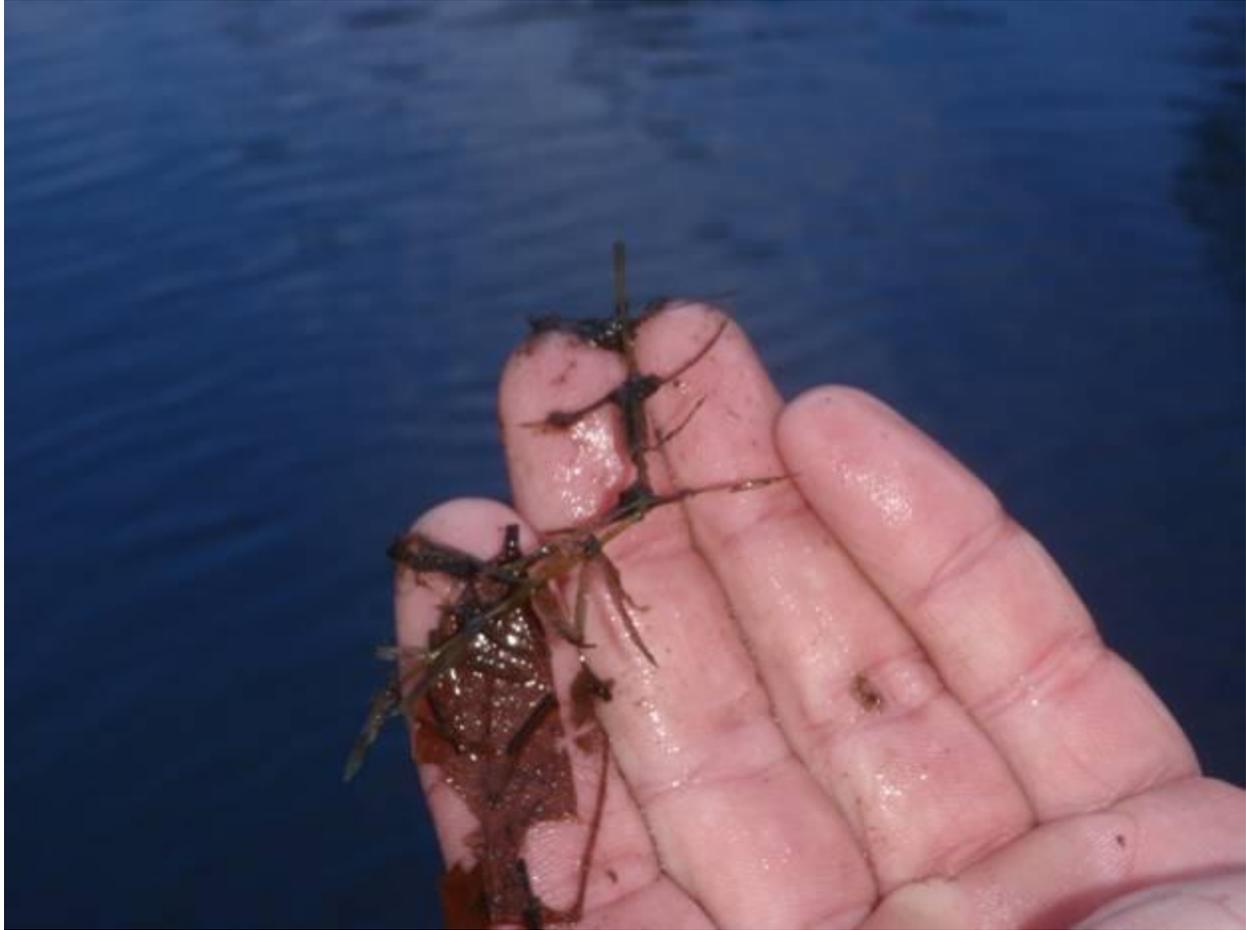
The spot treatments that took place for hydrilla in shallow water on December 19th, 2012 were successful with hydrilla showing signs of impact. However, hydrilla in deeper water 6 to 9 feet has expanded since the previous inspection. Seminole County Lake Management Program will be purchasing and stocking triploid (sterile) grass carp in Spring Wood Lake. This with the expanding amount of the native vegetation southern naiad will hopefully hold off the hydrilla.

Photo: Impacted hydrilla found in Spring Wood Lake.

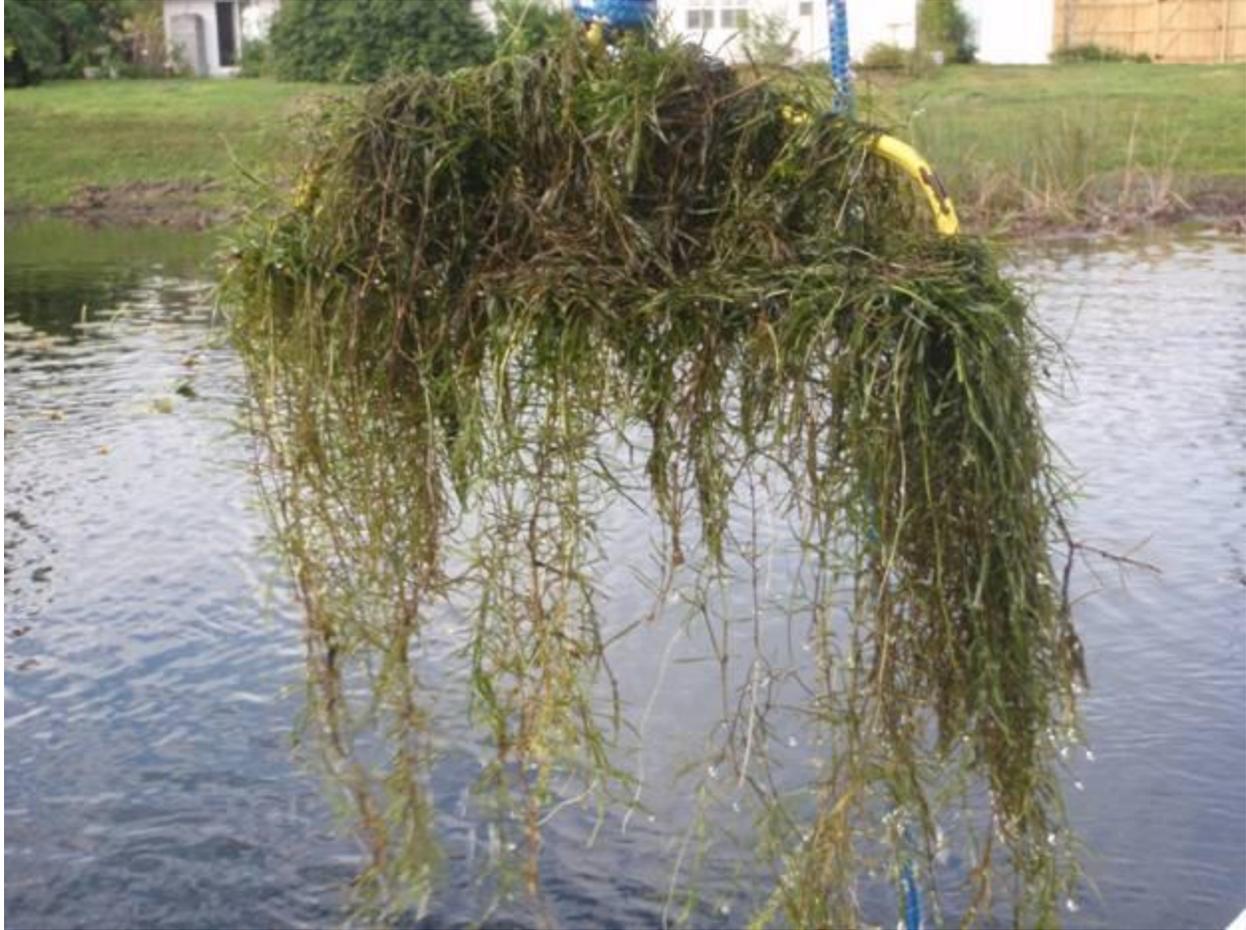
Beneficial native SAV found during inspection included: Stonewort to 5 feet, southern naiad to 10 feet, road grass to 6 feet, and lemon bacopa to 3 feet. Southern naiad is the dominant species found within Spring Wood Lake and will play an important role by competing for space with hydrilla.

Photo: Southern naiad.

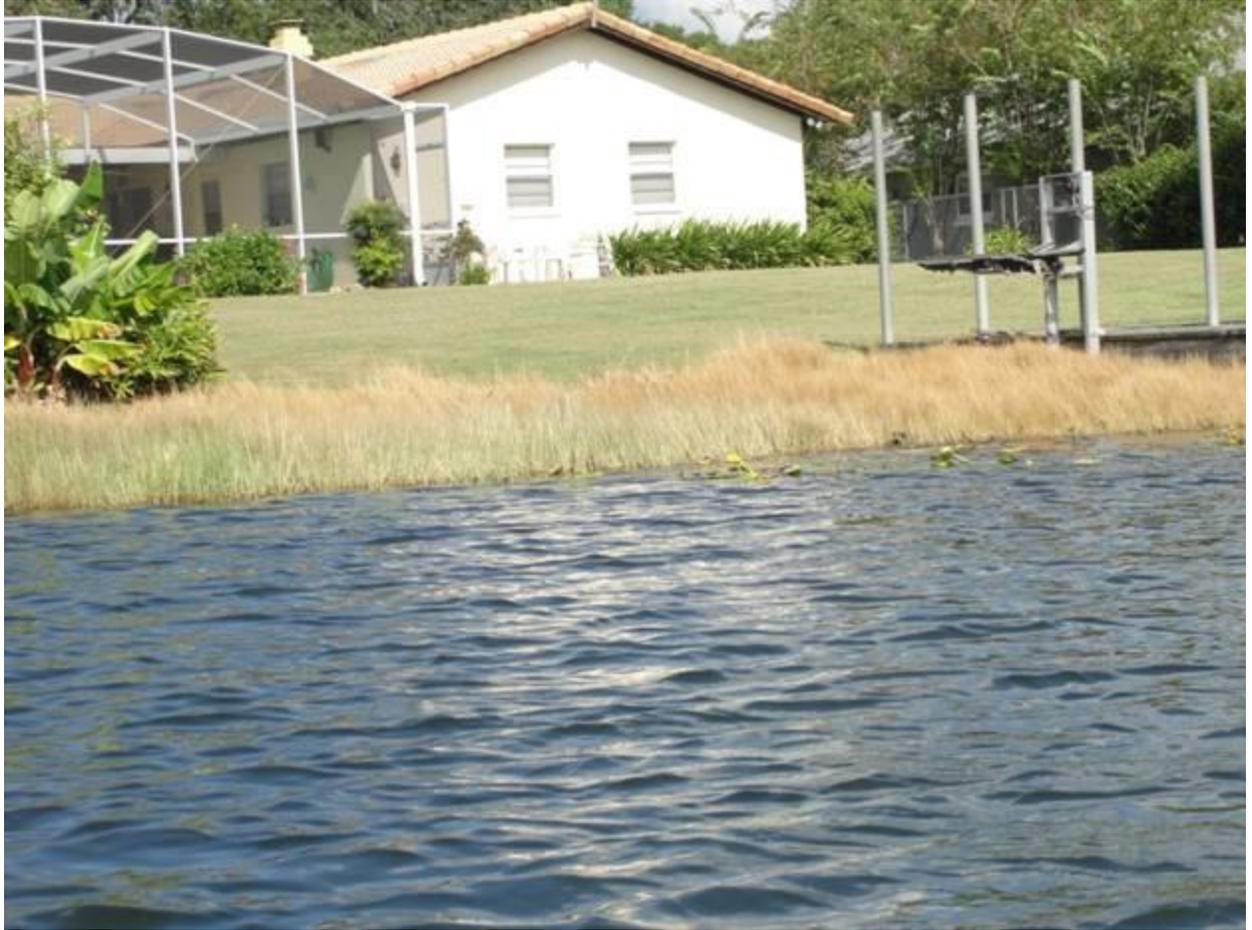
Due to the success of the herbicide program, torpedo grass is no longer a major concern in Spring Wood Lake. Native vegetation, including duck potato, pickerelweed, and canna planted during the lake restoration events, is expanding in areas where torpedo grass once was.

Photo: Torpedo grass in 2010.

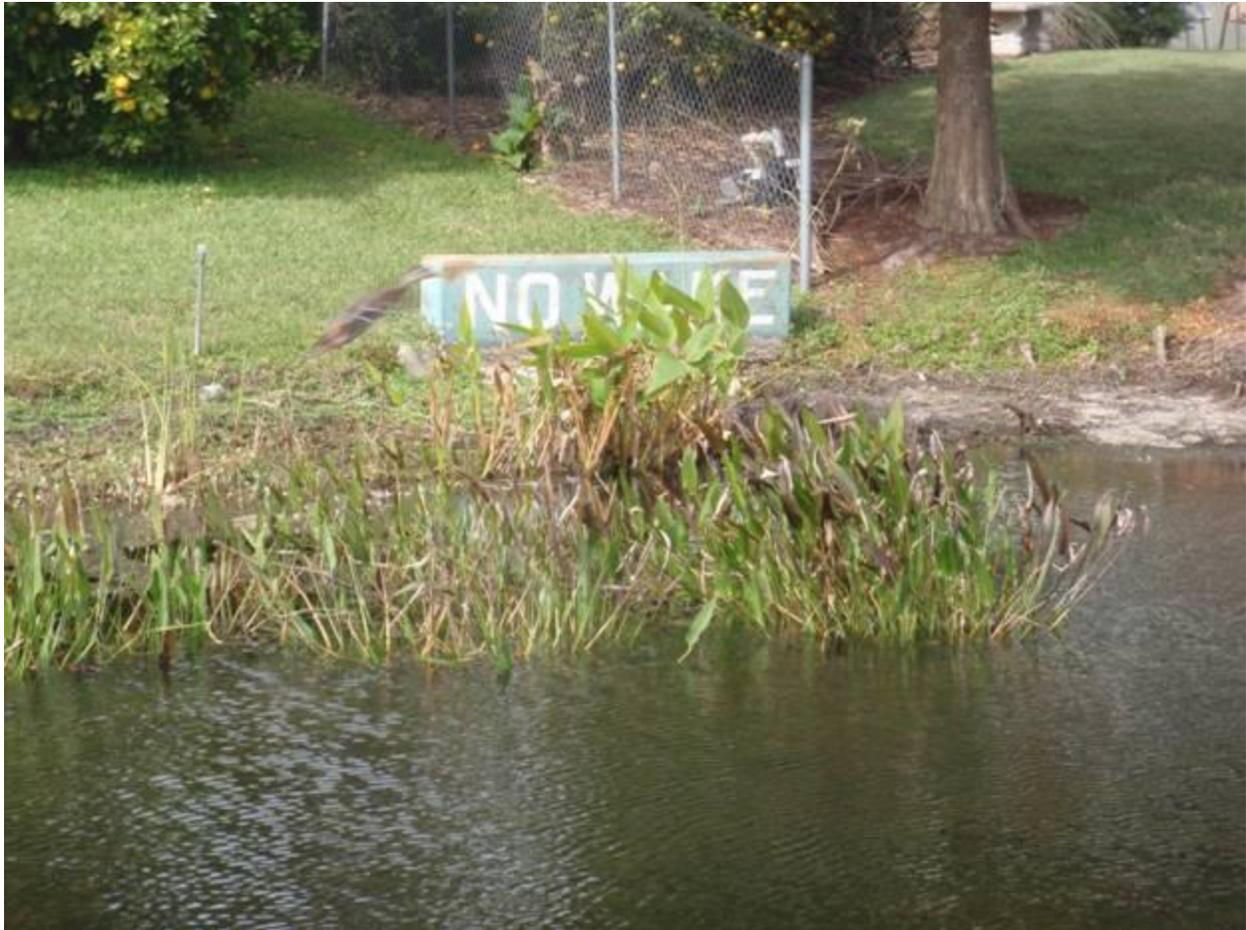
Photo: Native vegetation expanding along the shore of Spring Wood Lake.

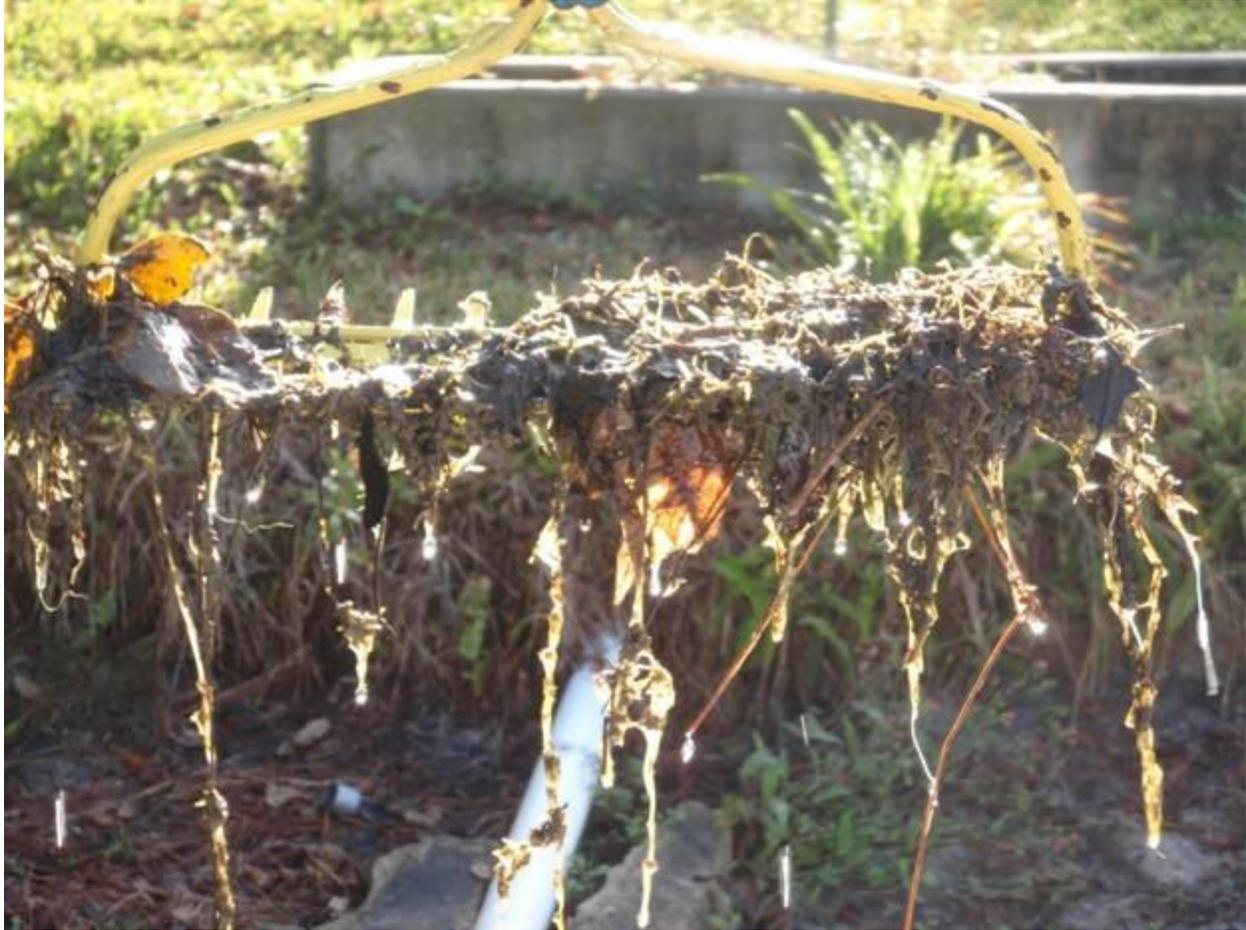
The spot treatment for the back half of Springwood Waterway was very successful with almost no hydrilla found during the inspection. We will continue to monitor the area to see if further treatments will be needed.

Photo: Decomposing hydrilla.

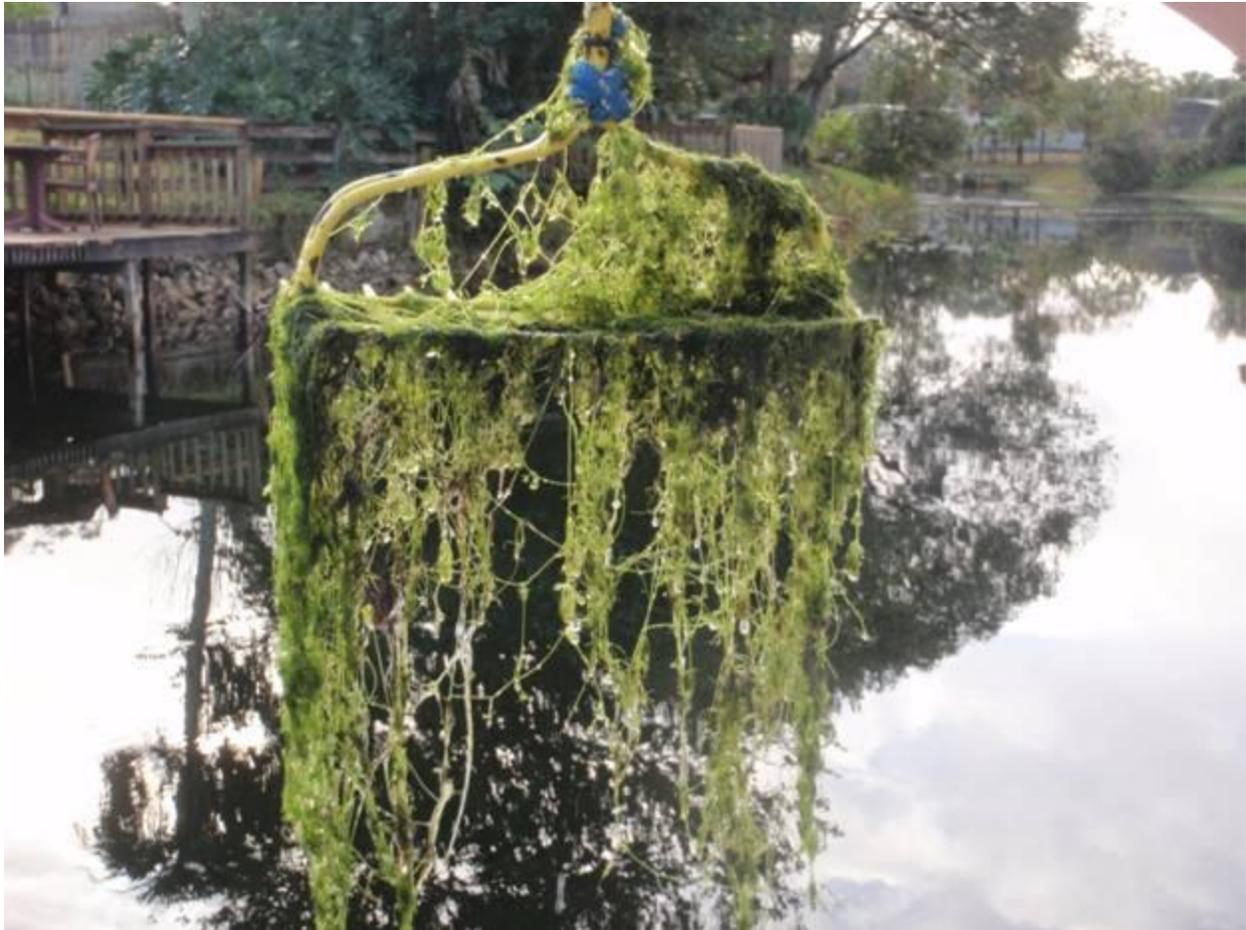
The entrance to the canal was navigable with a depth of 3 to 4 feet and does not require mechanical harvesting to maintain access at this time. Stonewort and bladderwort were found in 2 to 3 feet mats along the bottom at the entrance of the waterway. Observed native SAV included: lemon bacopa to a depth of 2 feet, road grass to 2 feet, stonewort to 3 feet, and purple bladderwort to 3 feet.

Photo: Stonewort found at the entrance to Spring Wood Waterway.

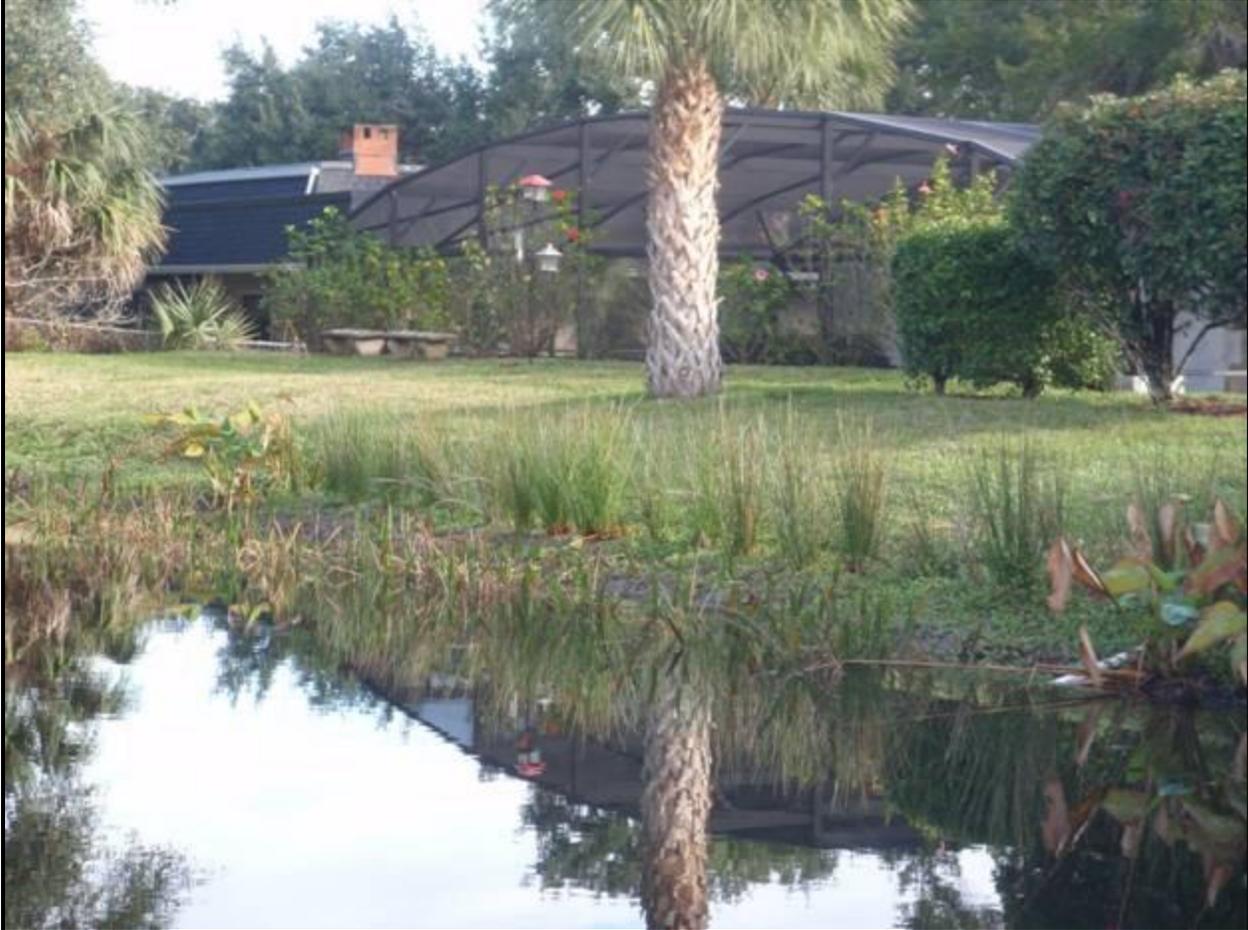
Once again, the success from the July 14th restoration event was outstanding! This was our most successful event with as much as 90% of the vegetation surviving. Much of the waterway is now free of torpedo grass. This should encourage the planted native vegetation to expand even more.

Photo: Expanding native vegetation as result of the July 2012 restoration event.

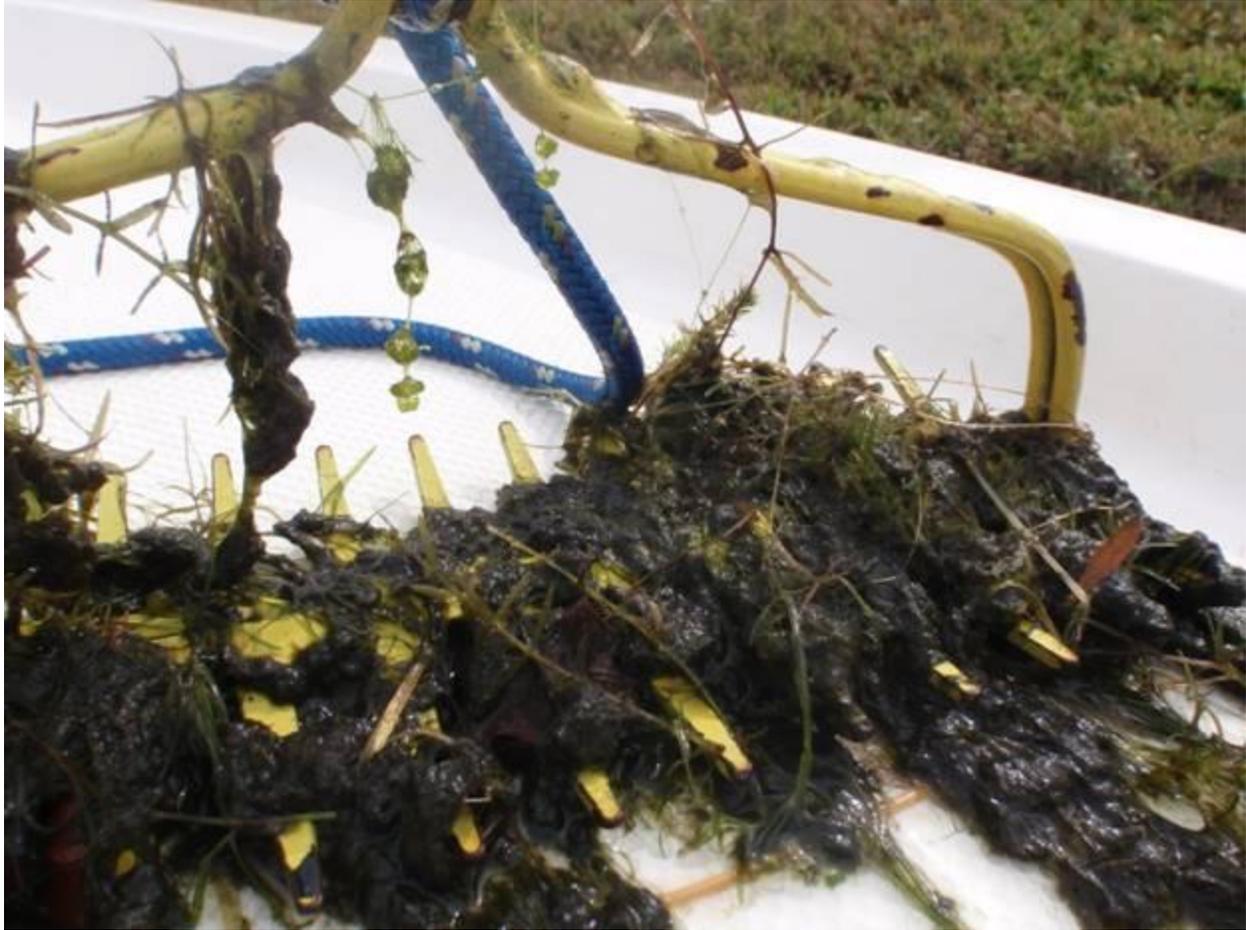
Hydrilla was found during the inspection to a depth of 10 feet intermixed with the native vegetation. Spring Wood Lake will be scheduled for spot treatment in several shallow areas around the lake in December.

Photo: Hydrilla found intermixed with stonewort and southern naiad.

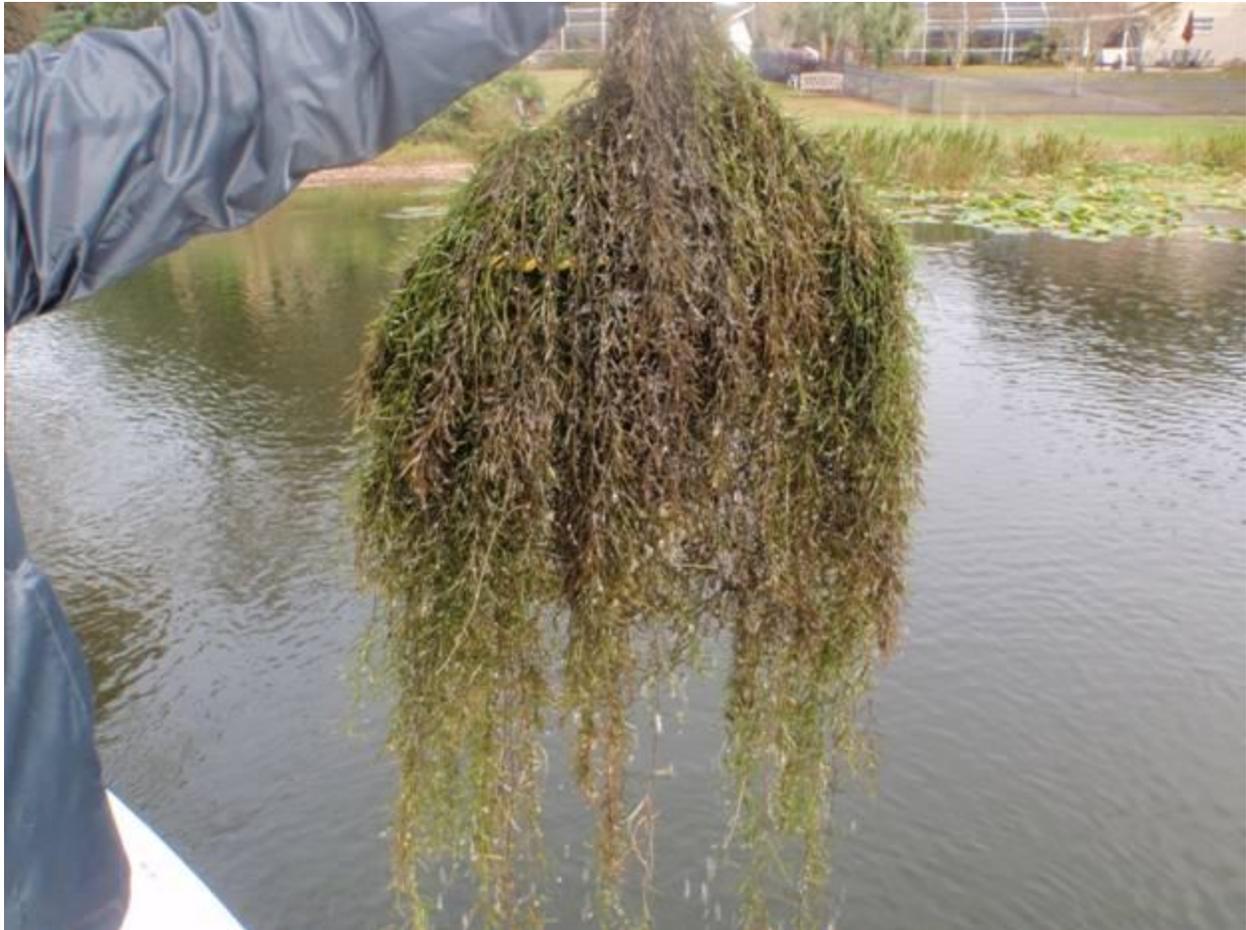
Beneficial native SAV found during inspection included: Stonewort to 10 feet, southern naiad to 10 feet, and lemon bacopa to 3 feet. Southern naiad has expanded to the point that is now the dominant species in the lake.

Photo: Southern naiad.

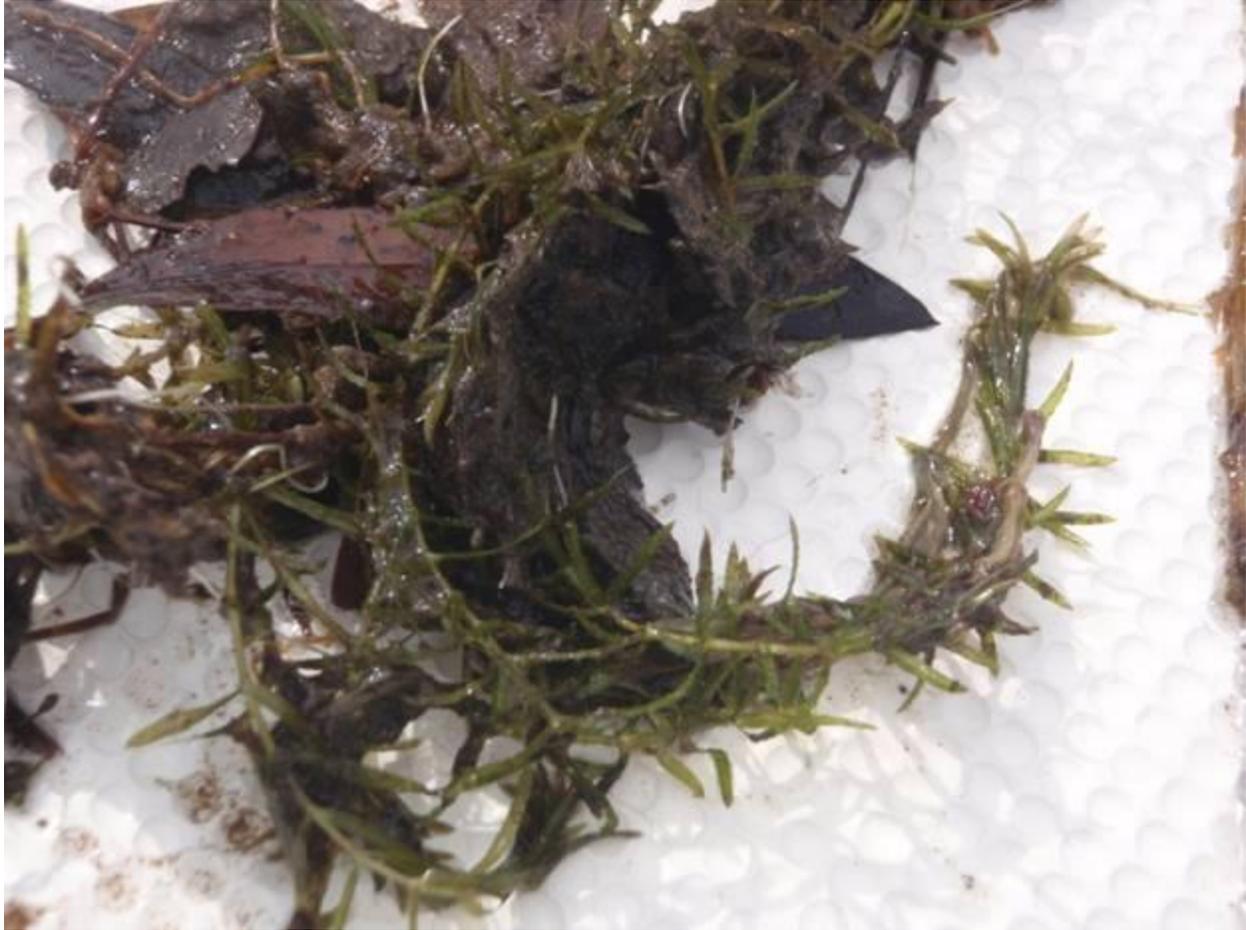
Hydrilla was found in the back half of the waterway. Spot treatment will be scheduled for this area in December.

Photo: Hydrilla found at the end of the waterway.

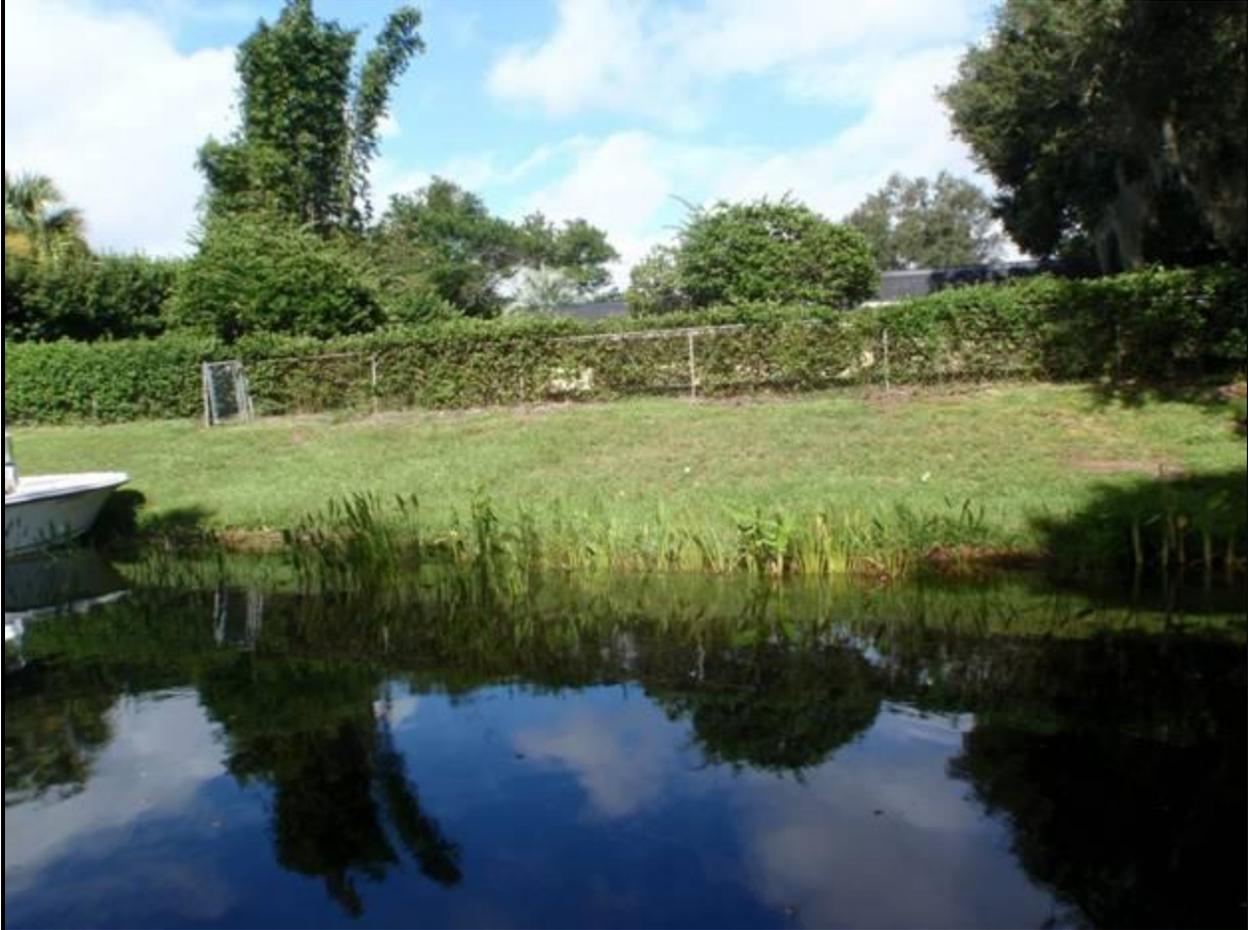
Native vegetation planted during the July 14th restoration event was in excellent condition! This was our most successful event with as much as 90% of the vegetation surviving. To continue to encourage expansion of the native plants, we recommend removing torpedograss once it has been treated.

Photo: Expanding native vegetation as result of the July 2012 restoration event.

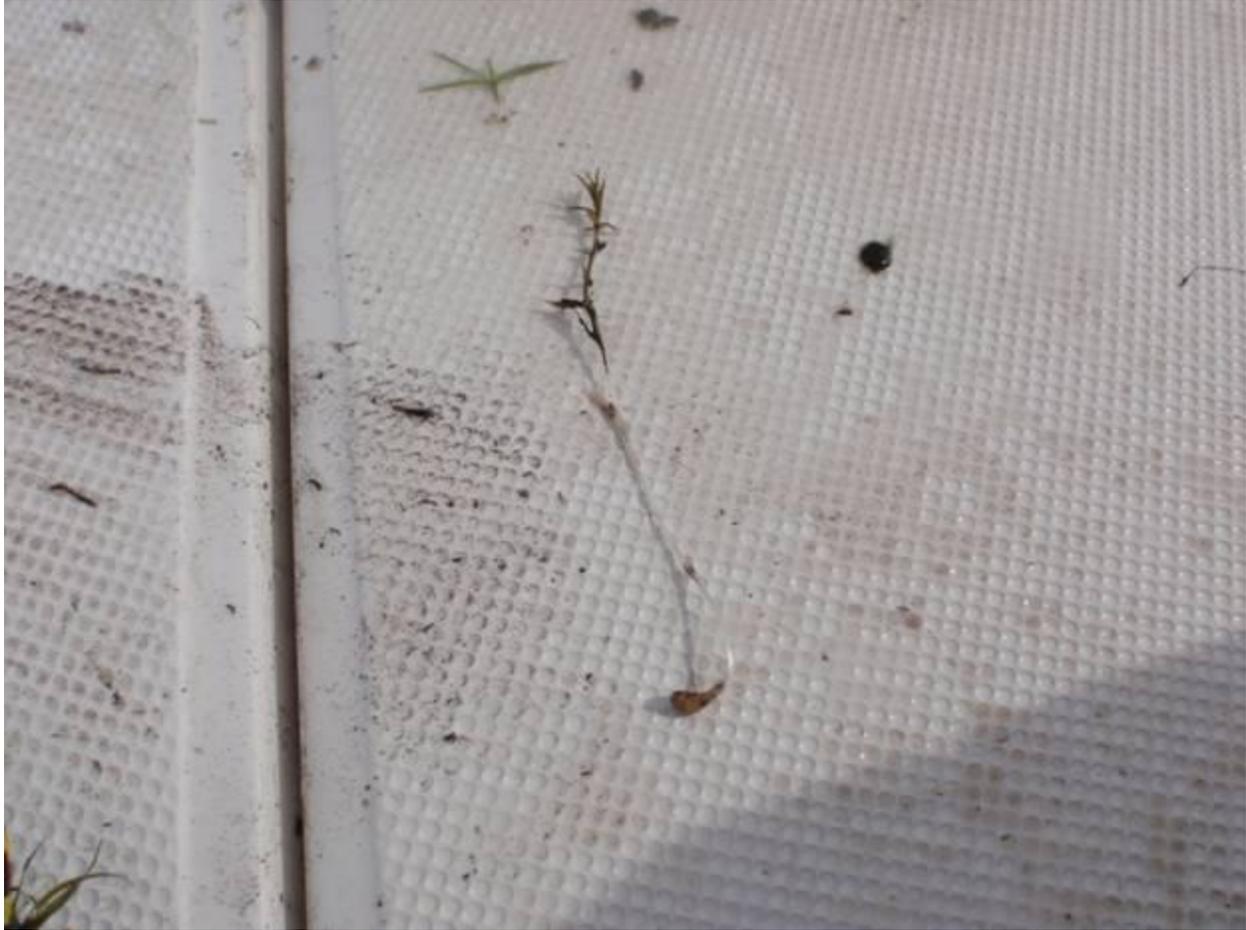
Hydrilla was found during the inspection to a depth of 11 feet. It was reduced by approximately 50% since the previous survey; however, many tubers were still found. Most hydrilla was found in small sprigs and intermixed within the native vegetation. We will continue to closely monitor the expansion of hydrilla.

Photo: Example of hydrilla tubers found during inspection.
