Greetings Spring Wood Lake and Springwood Waterway!

Spring Wood Lake

On **May 7th, 2013**, Seminole County Lake Management Program (SCLMP) staff Gloria Eby and Marie Lackey surveyed the aquatic plants in **Spring Wood Lake**.

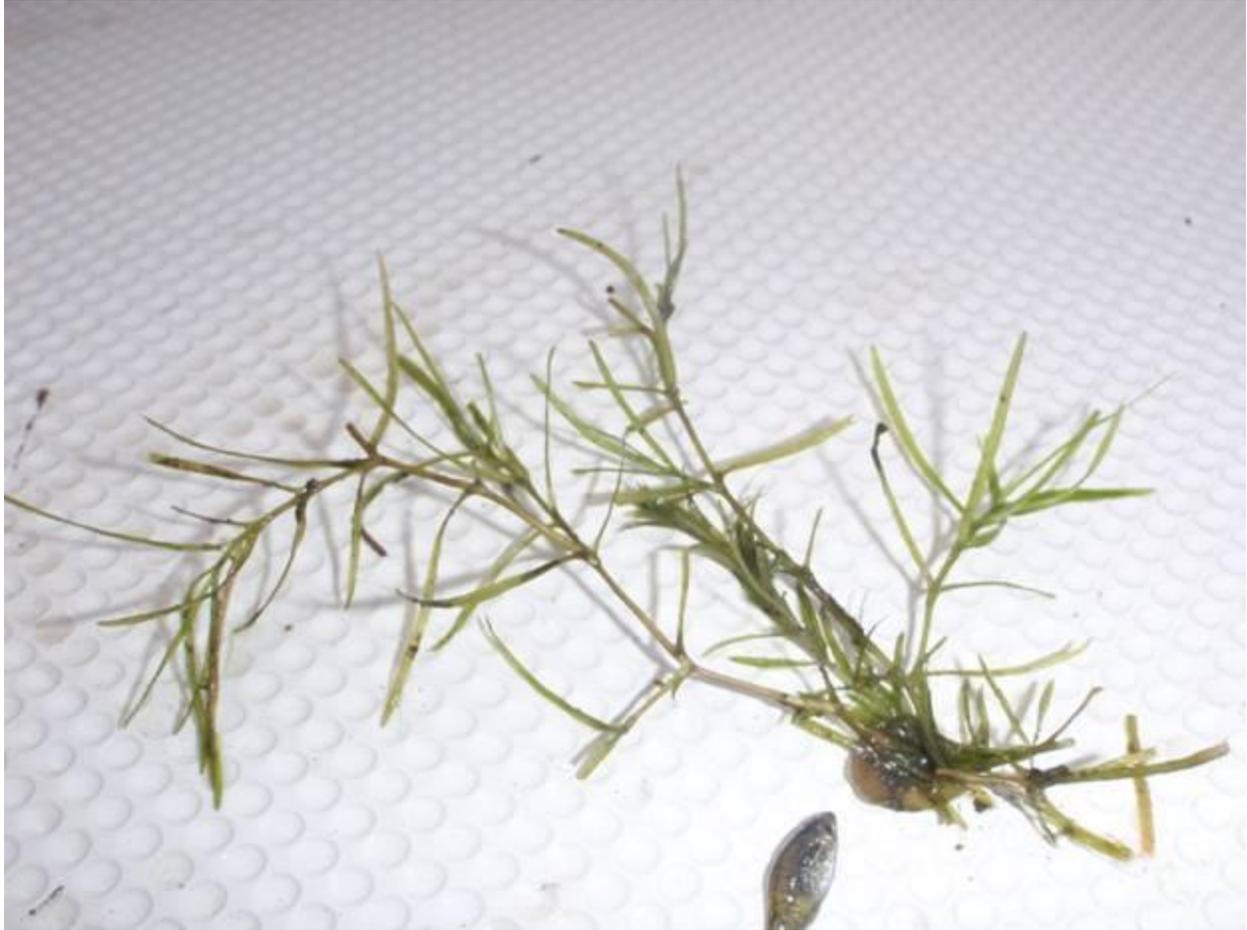
Beneficial native SAV found during inspection included: stonewort to 11 feet, southern naiad to 5 feet, and lemon bacopa to 2 feet. Stonewort was the dominant SAV observed during the inspection and was found topped out inshore along the north shore. Southern naiad was also expanding in much of the lake.

Photo: Southern naiad.

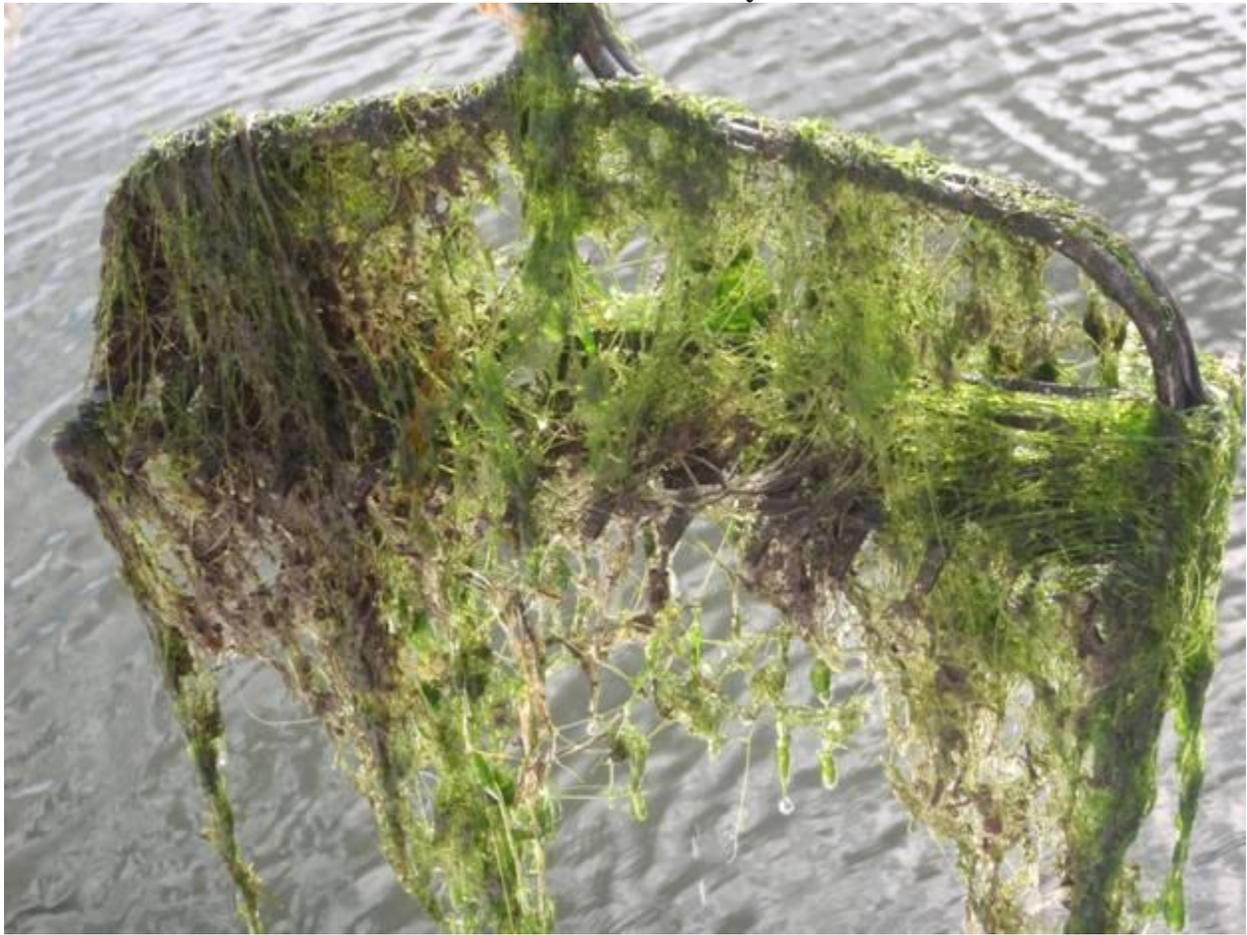
Observed native SAV included: lemon bacopa to a depth of 2 feet, road grass to 2 feet, stonewort to 3 feet, and purple bladderwort to 3 feet. Stonewort and bladderwort were found in 2 to 3 feet mats along the bottom at the entrance of the waterway. The entrance to canal was navigable and does not require mechanical harvesting to maintain access at this time.

Photo: Stonewort found at the entrance to the waterway.

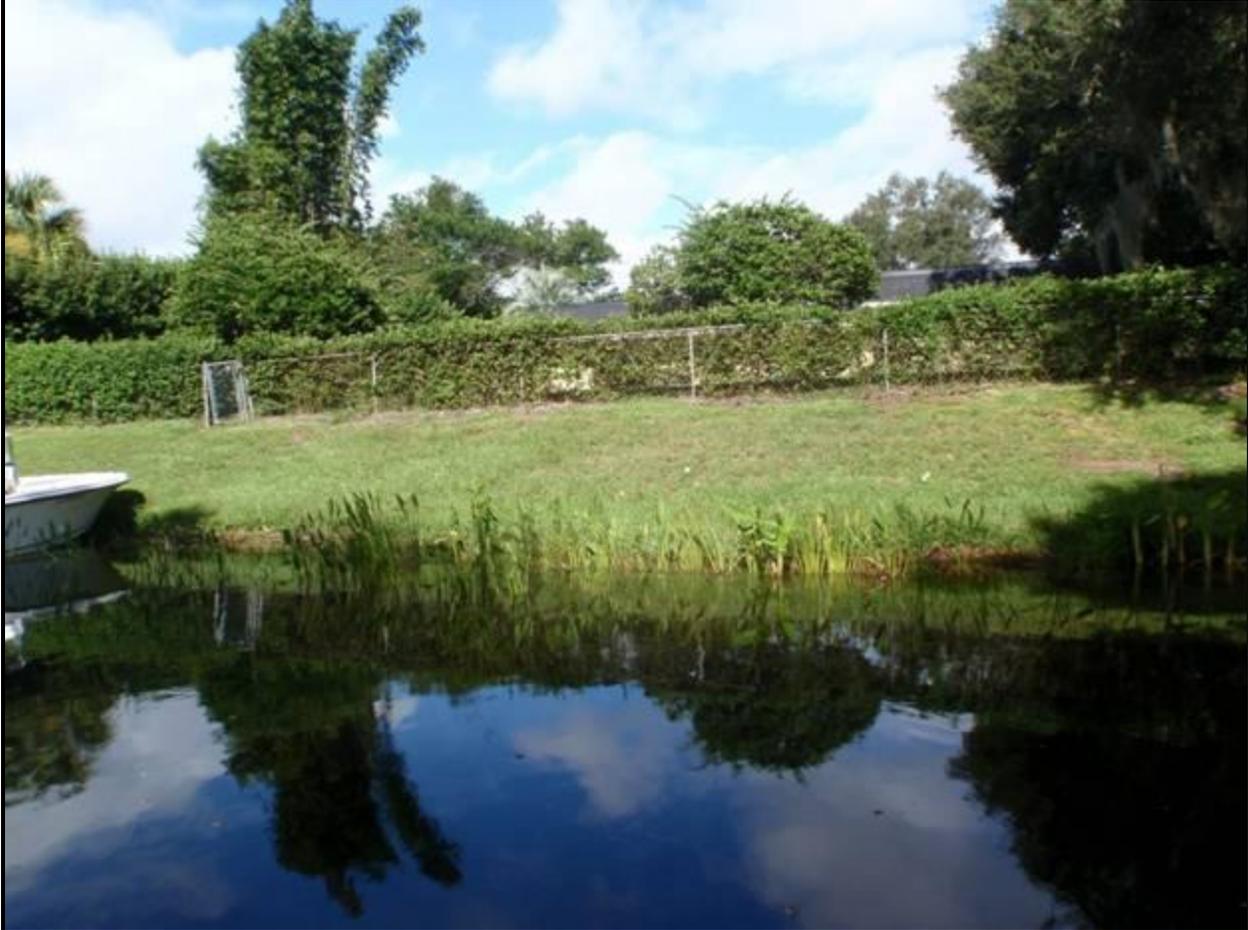
Native vegetation planted during the July 14th restoration event was in excellent condition! This was our most successful event with as much as 90% of the vegetation surviving. To continue to encourage expansion of the native plants we recommend removing torpedo grass once it has been treated.

Photo: Expanding native vegetation as result of the July 2012 restoration event.

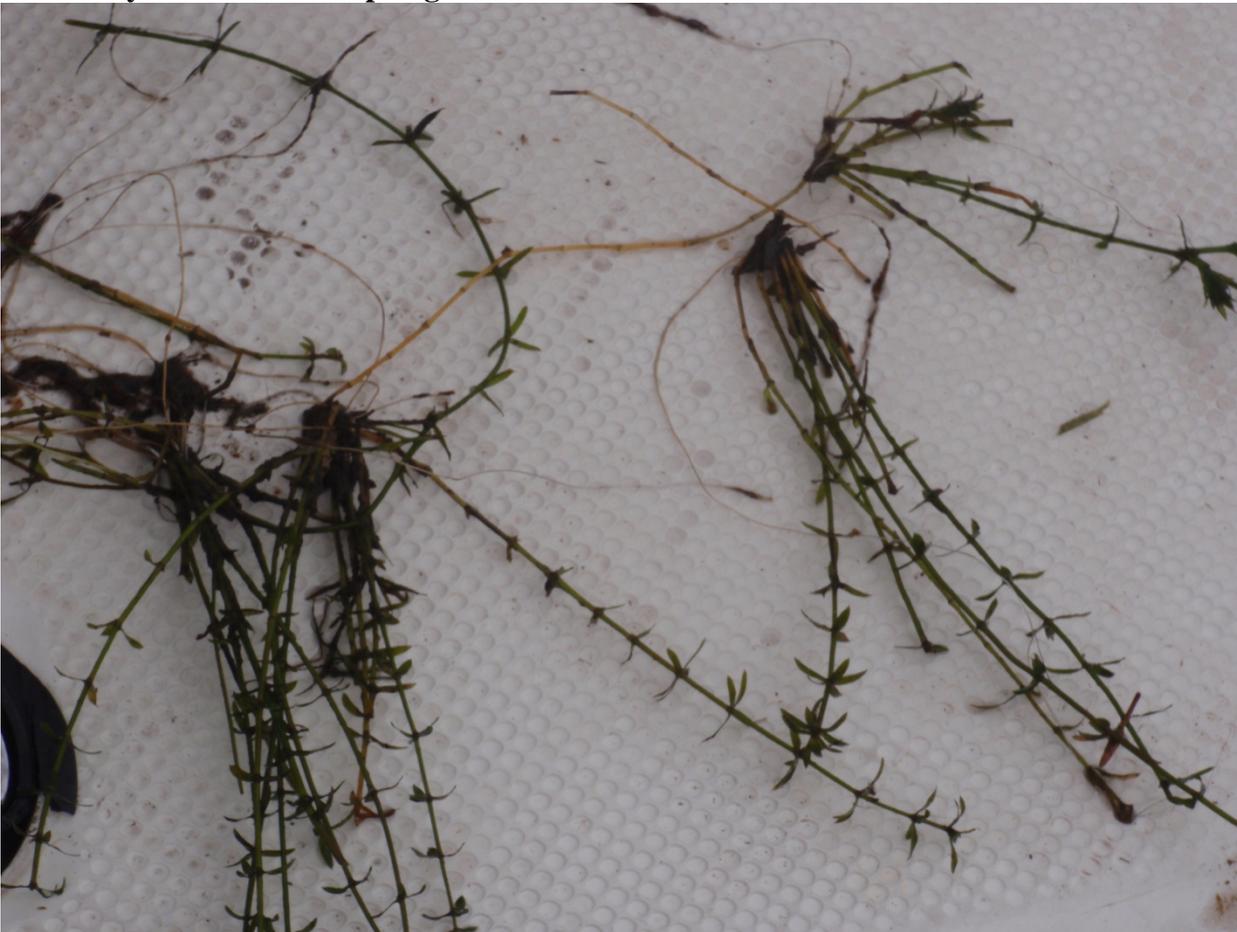
Hydrilla was found to a depth of 7 feet in less biomass than in the previous inspection. Also, hydrilla was competing for space with other native SAV within the lake, including southern naiad. We will continue to closely monitor hydrilla within the lake to see if any further treatments will be necessary.

Photo: Hydrilla found in Spring Wood Lake.

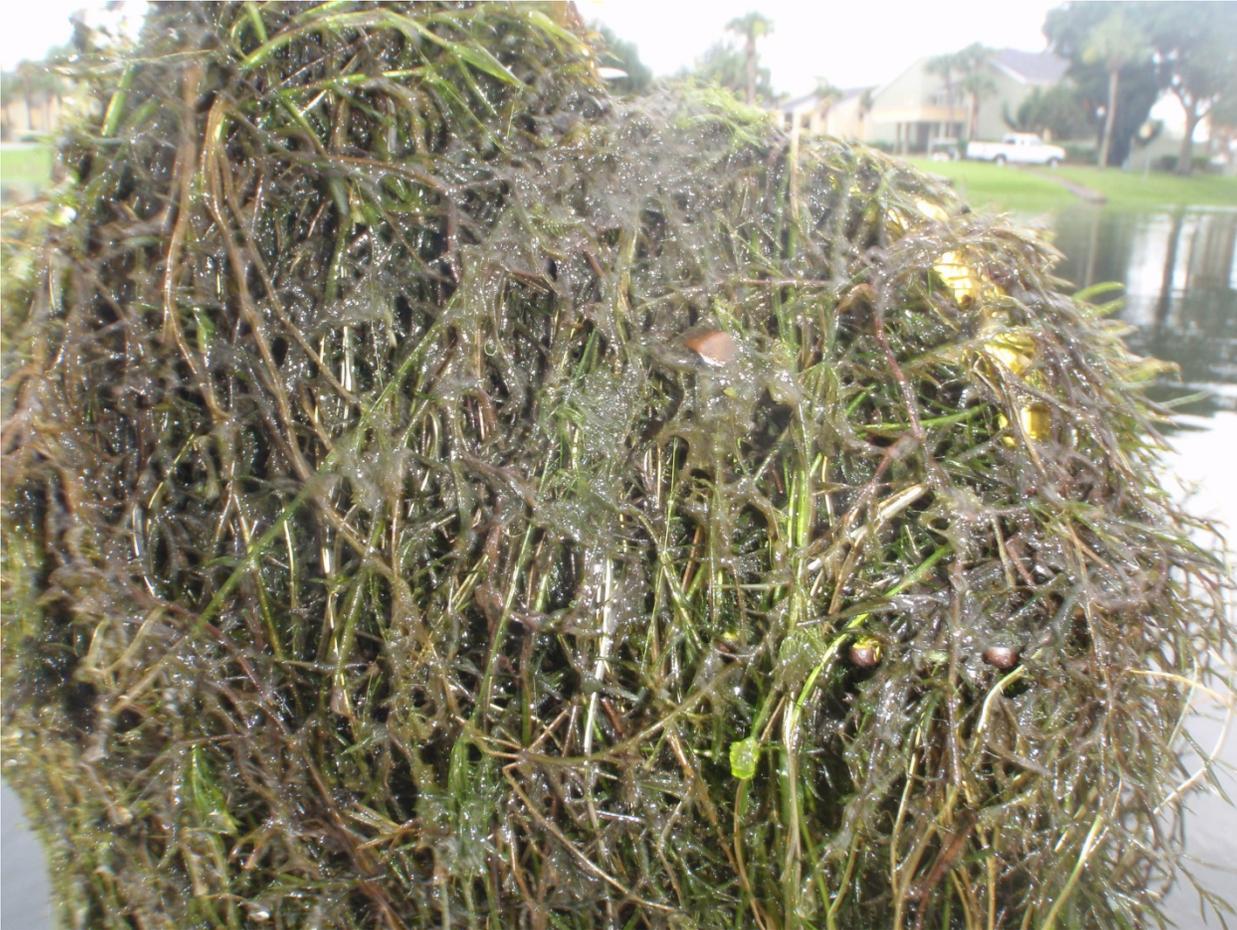
Beneficial native SAV observed during inspection included: southern naiad to a depth of 7 feet, stonewort to 6 feet, baby's tears to 2 feet, bladderwort to 6 feet, and lemon bacopa to 4.5 feet. Southern naiad has expanded lake-wide and is now the dominant species. This is positive as this species plays an important role in the lake

ecosystem by providing habitat for aquatic species, helping reduce nutrients within the water column, and making it more difficult for hydrilla to establish by competing for space.

Photo: Southern naiad and stonewort.

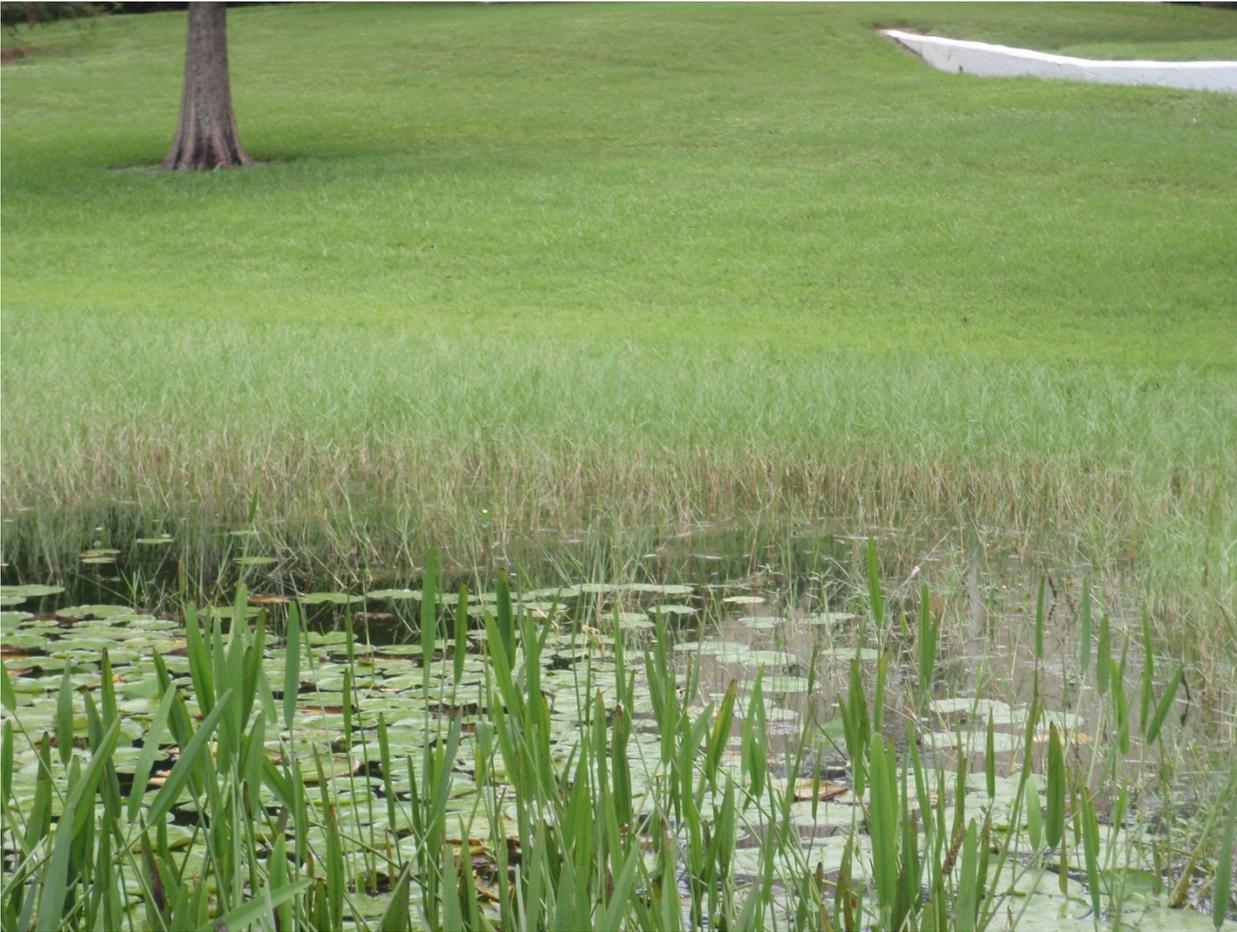
Native emergent vegetation found during the inspection included: rush fuirena, maidencane, pickerelweed, duck potato, fire flag, and bulrush. Observed invasive emergent vegetation included: alligator weed, wild taro, and torpedo grass. Torpedo grass has expanded and will be targeted in several locations. In areas where the torpedo grass is mixed in with natives, it is recommended to hand remove around the natives to where the contractor can then treat the remaining torpedo grass; otherwise the natives would be impacted from the herbicides due to close proximity. The MSBU funded herbicide contractor will continue to target torpedo grass over the next scheduled service dates.

Photo: Torpedo grass found in Springwood Lake.

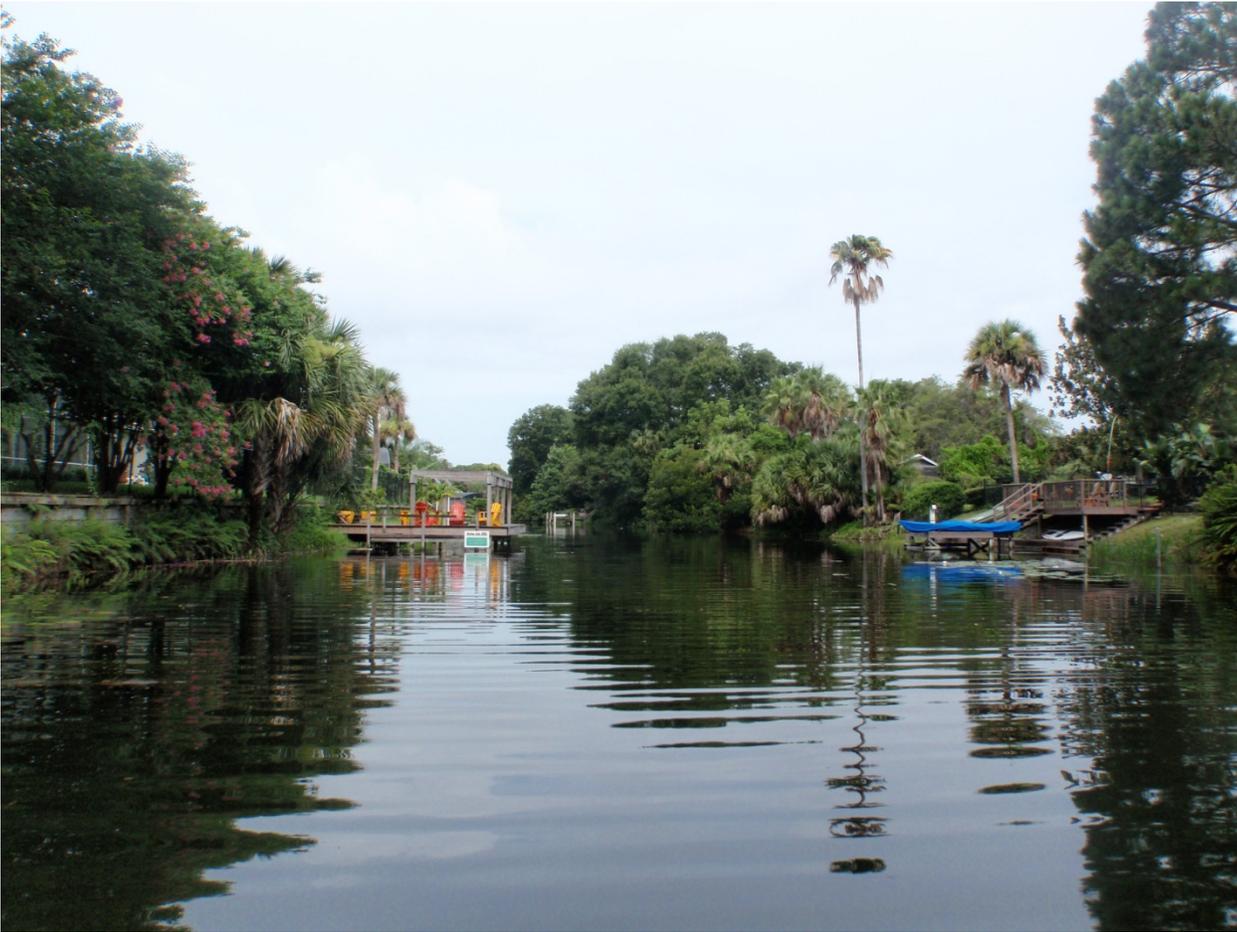
The water elevation has risen to 87.4 feet on the lake chain, which was a 1.45 foot increase since the January reading of 85.95 feet. Vegetation was not impeding access in the waterway therefore mechanical harvesting is not necessary at this time. Observed native SAV included: lemon bacopa to a depth of 5 feet, southern naiad to 6 feet, road grass to 2 feet, stonewort to 3 feet, and purple bladderwort to 2 feet. Stonewort and bladderwort were found in wide mats along the bottom at the entrance of the waterway. No hydrilla was found within the waterway during this inspection.

Photo: Entrance to Springwood Waterway.

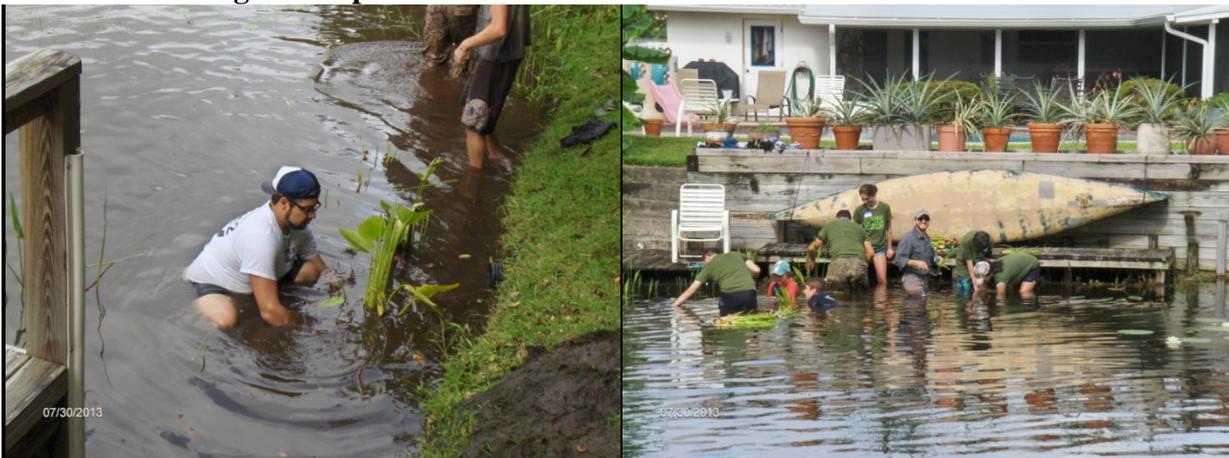
Both SCLMP and SERV Programs, with the help of Springwood Waterway residents, held a lake restoration event on Saturday, June 29th. Through the hard work of 61 volunteers at 11 sites we planted over 4,000 native aquatic plants (200 golden canna, 1300 duck potato, 60 fire flag, 40 soft rush, 2400 pickerelweed, 5 bulrush)! On behalf of Seminole County, thank you so much for your incredible effort! Special thanks go to Sarafaith Pekor and Brian Pelski who coordinated site locations and planted additional areas of the waterway!!

Photo: Native vegetation planted on the June 29th restoration event.

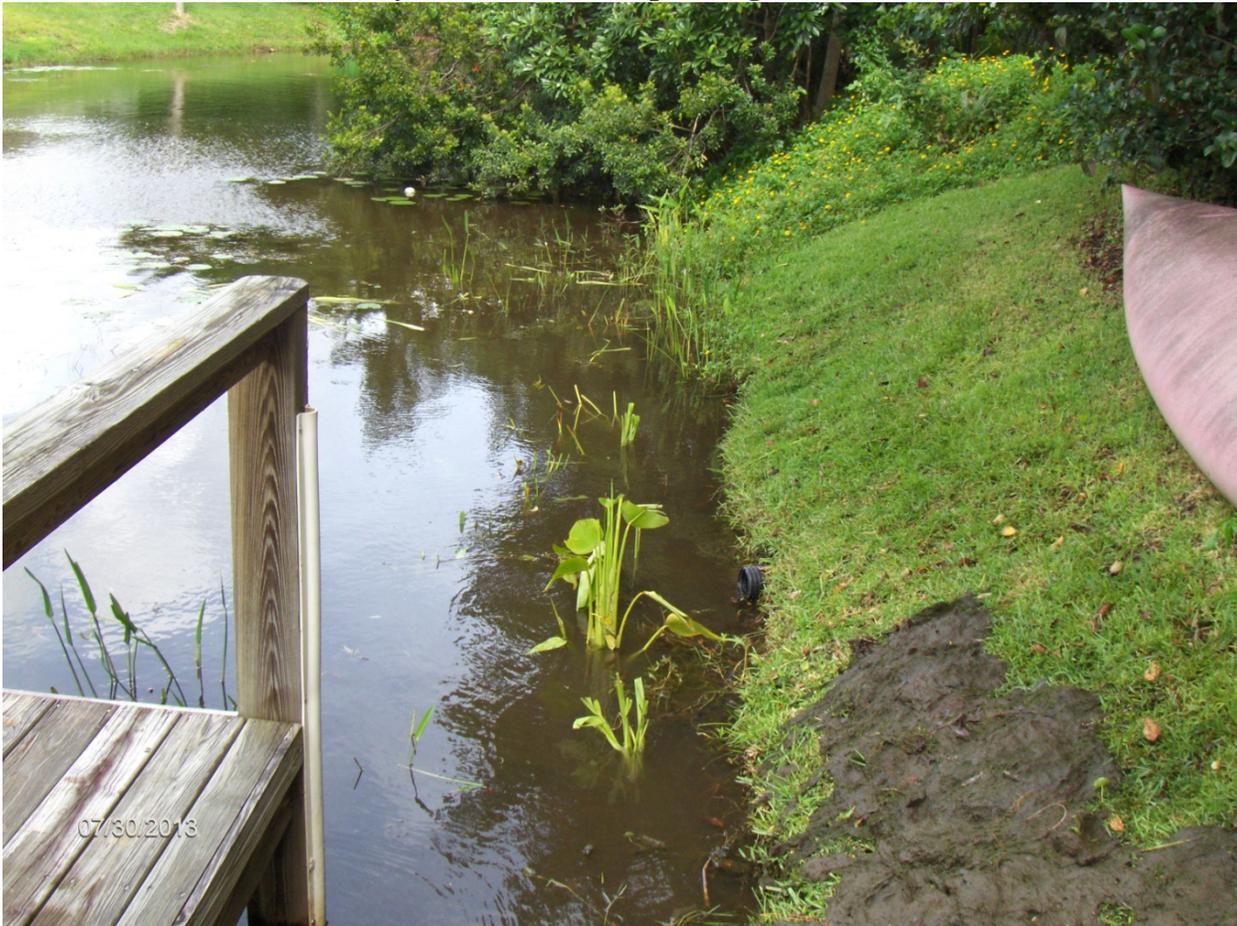
Photo: Shoreline immediately after restoration planting.
