### **Spring Wood Lake**

On **July 1<sup>st</sup>, 2014**, Seminole County Lake Management Program (SCLMP) staff, Thomas Calhoun and Gloria Eby, surveyed the aquatic plants in **Spring Wood Lake**.

### **Springwood Waterway**

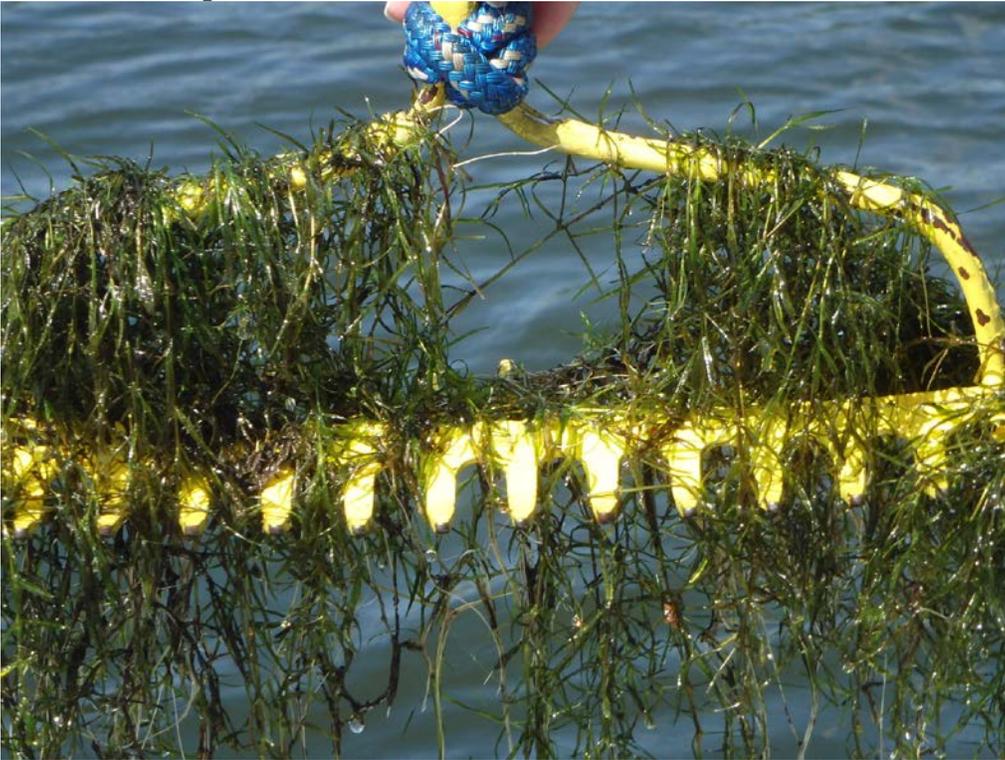
Spring Wood Lake has a healthy diversity of native submersed aquatic vegetation (SAV). The beneficial native SAV observed during the inspection included: lemon bacopa to 3 feet, Southern naiad to 7 feet, and bladderwort to 4 feet. Southern naiad is the dominant SAV within Springwood Lake and is currently playing an important role by competing for space with hydrilla.

**Photo: Close up of southern naiad.**

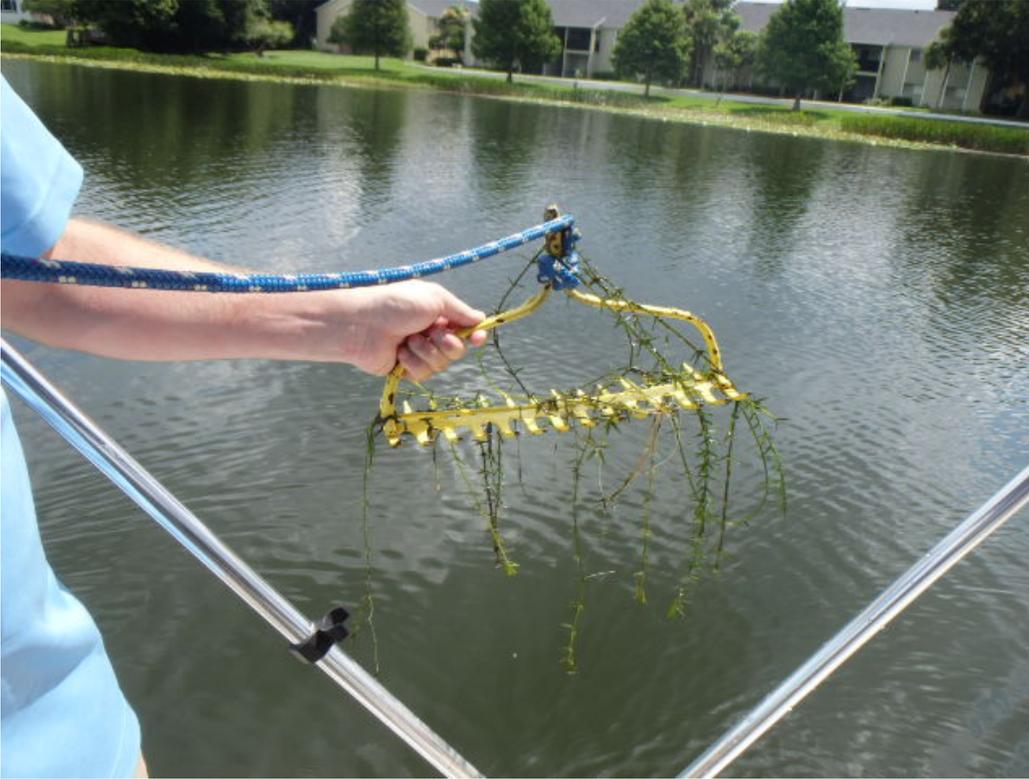
Sprigs of hydrilla were found in Spring Wood Lake to a depth of 3 feet. Although this depth is less than in the previous inspection, no treatment of hydrilla is required at this time.

**Photo: Typical length of hydrilla found during the inspection.**

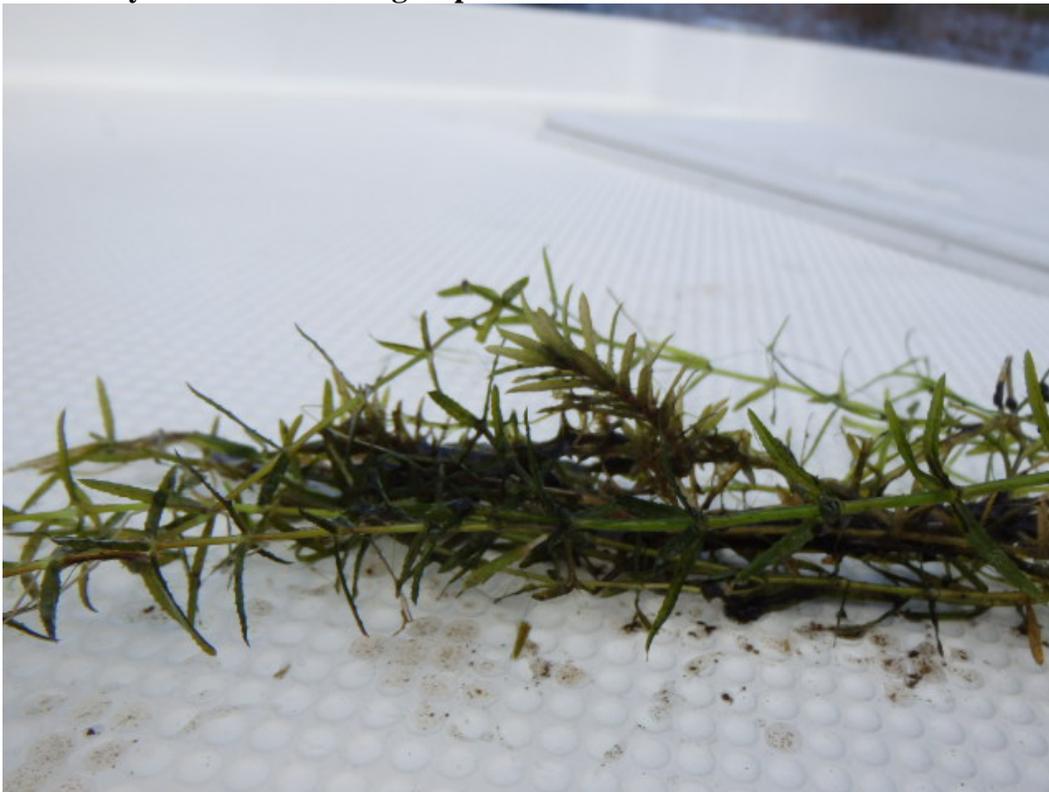
Hydrilla was present to a depth of 8 feet intermixed with the native vegetation. This is an increase from previous inspections. We will continue to closely monitor the impacts of the grass carp fish on hydrilla. Currently, no hydrilla treatments are required.

**Photo: Hydrilla found during inspection.**

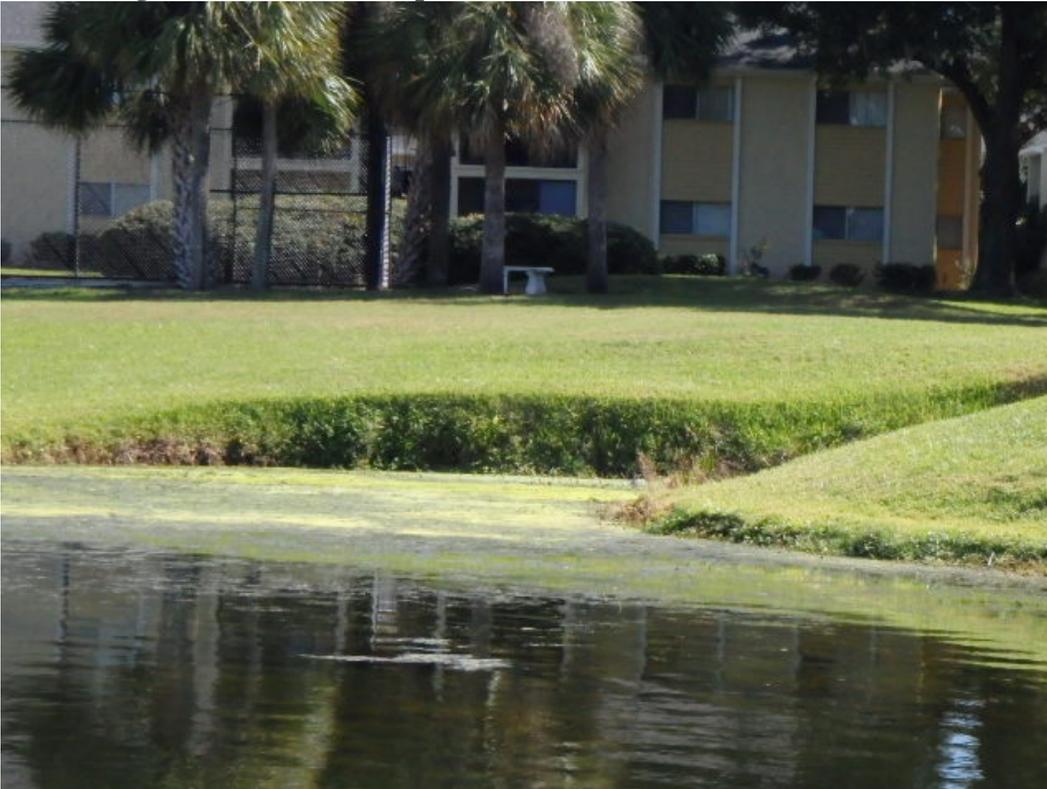
The observed invasive emergent vegetation included: alligatorweed, torpedo grass, and barn-yard grass. All of these species were found in small amounts. Native emergent vegetation has continued to expand around the lake. This vegetation included: pickerelweed, canna, fire flag, duck potato, and maidencane. A small algae bloom was present at the stormwater input on the east side of the lake.

**Photo: Algae at stormwater input.**

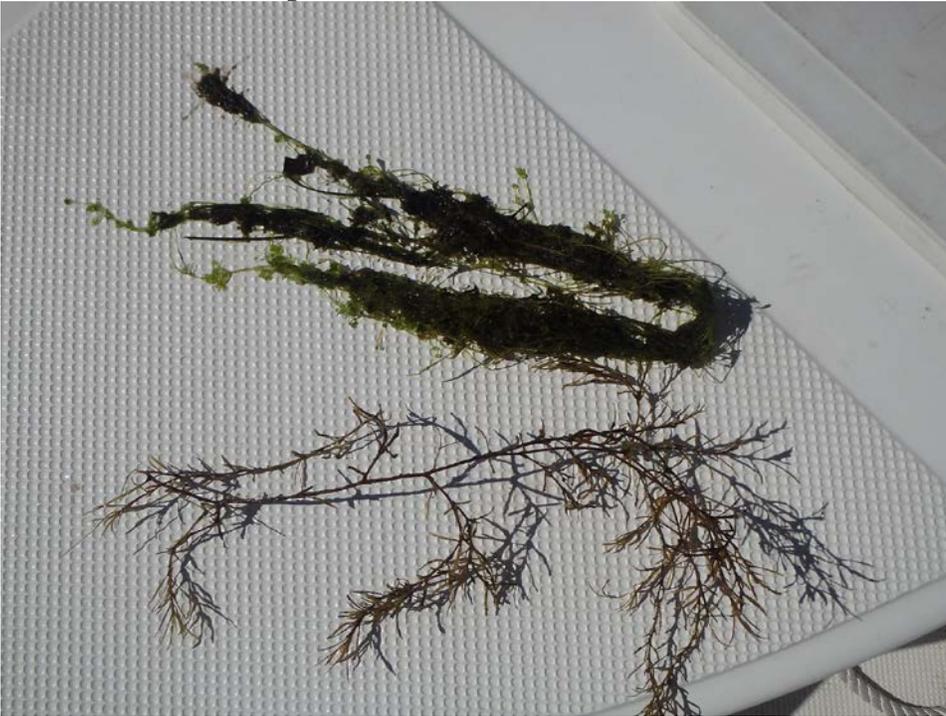
Native SAV is expanding in the waterway. These species included: lemon bacopa, stonewort, southern naiad, and bladderwort. Lemon bacopa has expanded along the majority of the banks within the waterway and is reaching the surface in many areas. The waterway was found to be open and navigable; therefore, mechanical harvesting is not needed at this time.

**Photo: Stonewort (top) and southern naiad (bottom).**

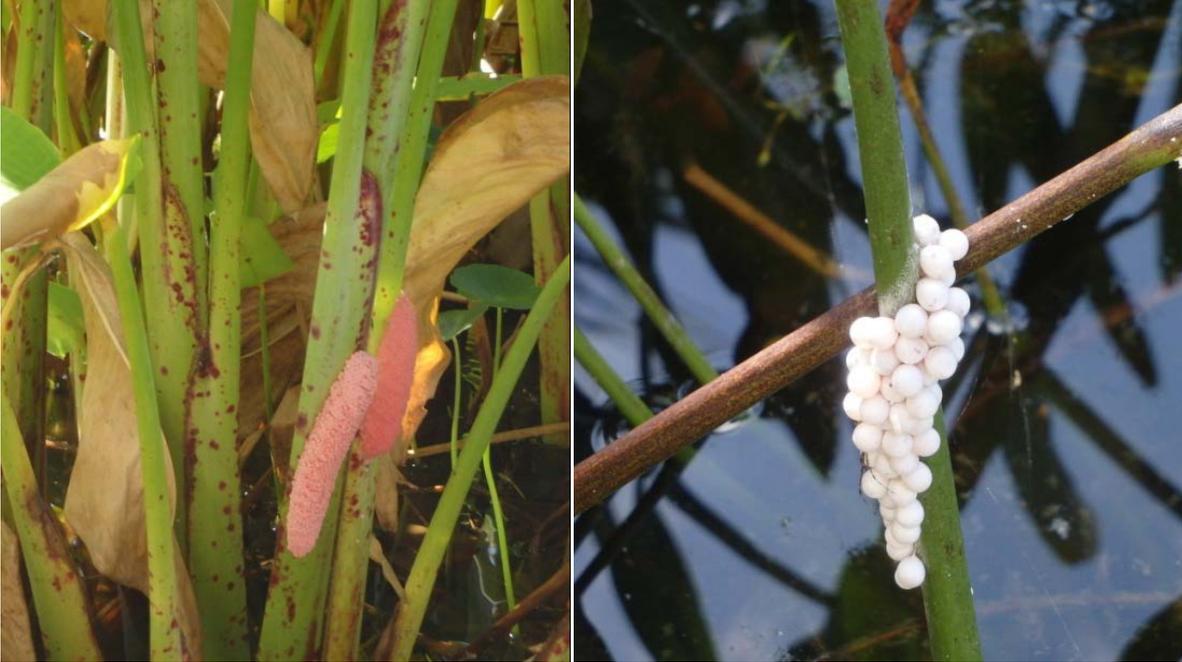
The invasive exotic Island Apple snail eggs were found in Springwood Waterway during the inspection. Due to their high rate of reproduction, they have the potential to negatively impact the ecosystem of the lakes and canal. They have been known to decimate aquatic plant populations in other areas. The best method of control

**Photo:** **Exotic** snail eggs on left (bright pink with small eggs), **native** apple eggs snail on right (white to peachy white with larger eggs).

is hand removal of the large adult snails and scraping and crushing the egg clutches (clusters). Please only remove the bright pink egg clutches. More information can be found on the FWC website here [http://myfwc.com/media/673720/FWC\\_applesnails\\_FLMS\\_handout.pdf](http://myfwc.com/media/673720/FWC_applesnails_FLMS_handout.pdf).

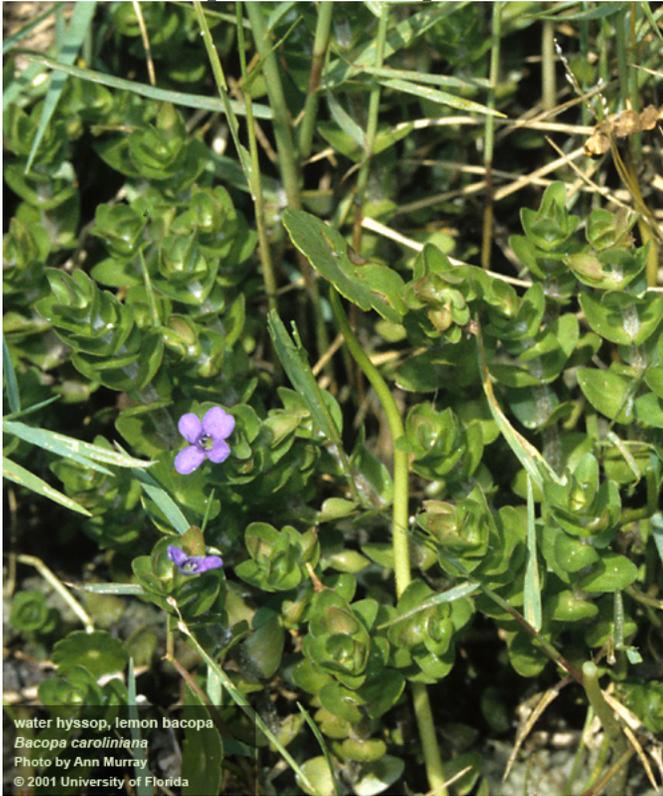
Lemon bacopa has expanded throughout the waterway. Lemon bacopa is **beneficial native** aquatic vegetation that is known by the lemony scent of its crushed leaves. It will only be treated if the waterway becomes unnavigable. The waterway was observed to be open and navigable; therefore, mechanical harvesting is not needed at this time.

**Photo: Close-up of lemon bacopa.**

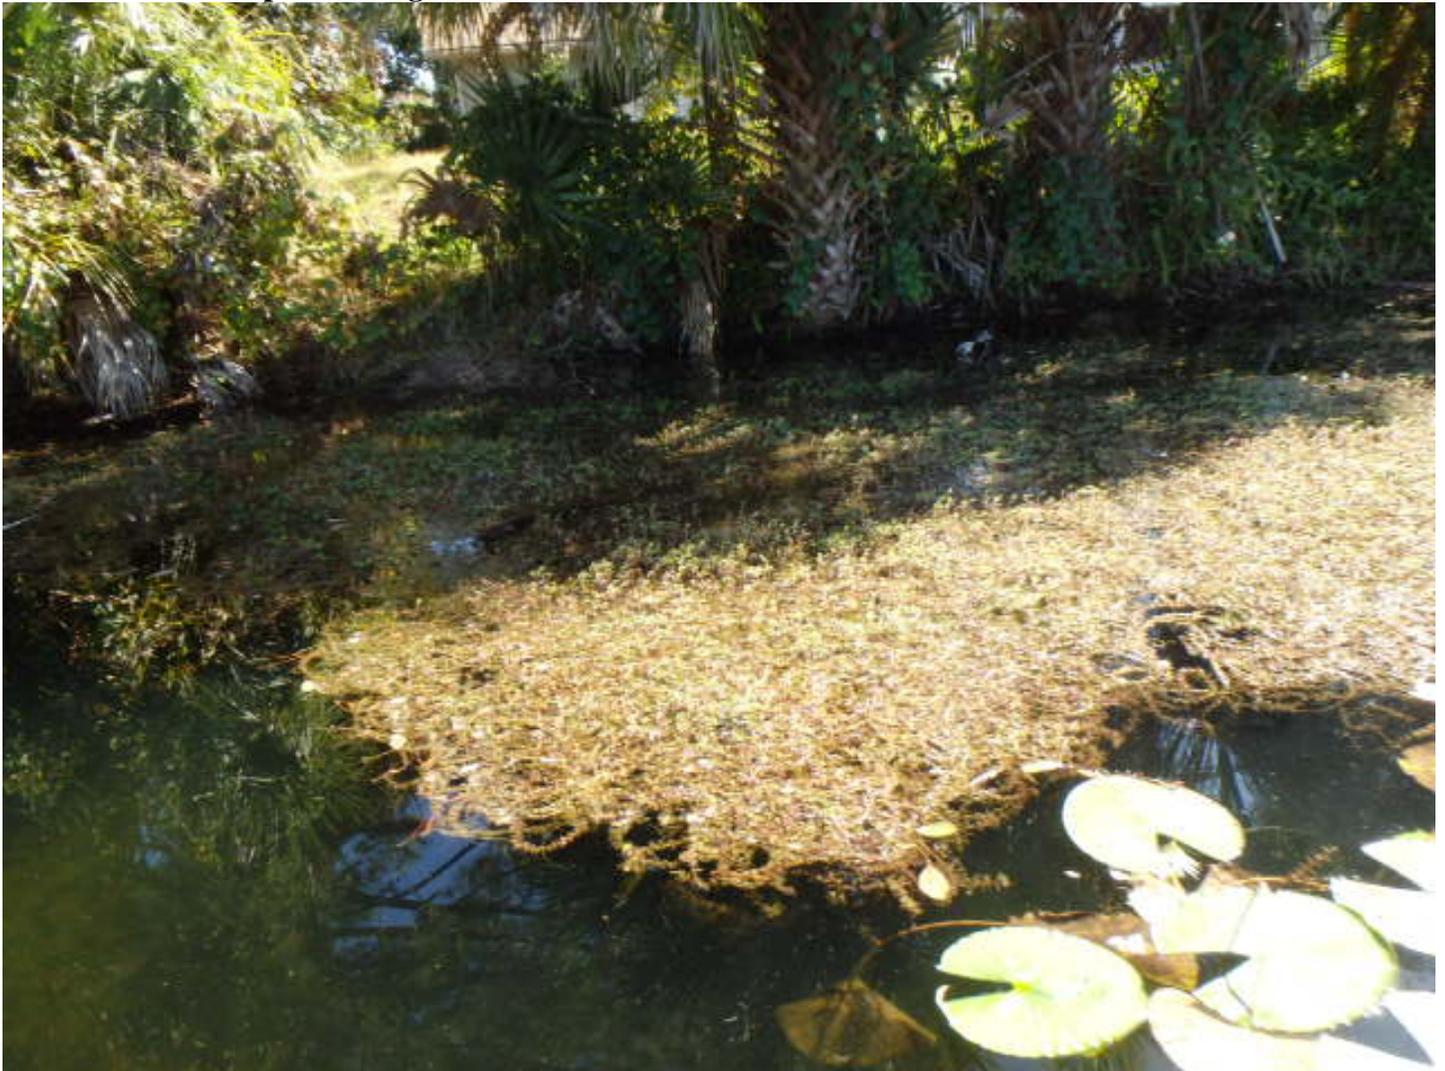
Lemon bacopa continues to expand along the majority of the banks within the waterway and is reaching the surface in many areas. The waterway was found to be open and navigable; therefore, mechanical harvesting is not needed at this time. Native SAV found included: roadgrass, stonewort, southern naiad, and 2 types of bladderwort. Harvesting is not necessary at this time.

**Photo: Lemon bacopa reaching the surface.**

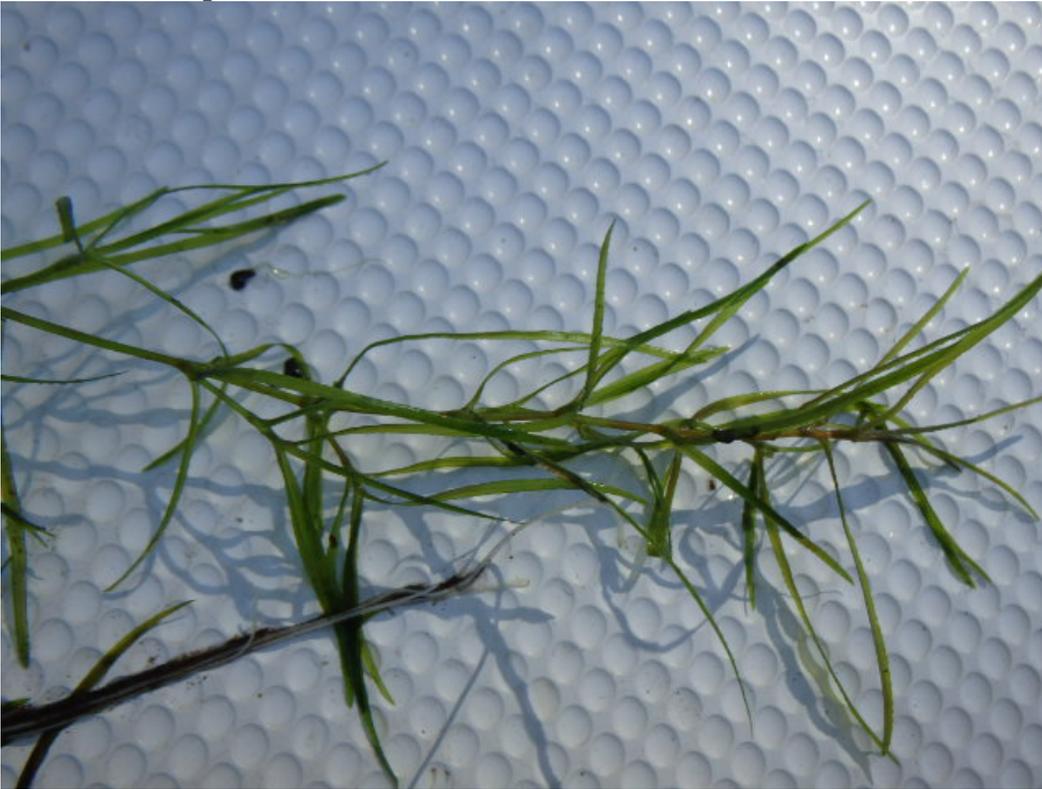
**Photo: Close up of southern naiad.**

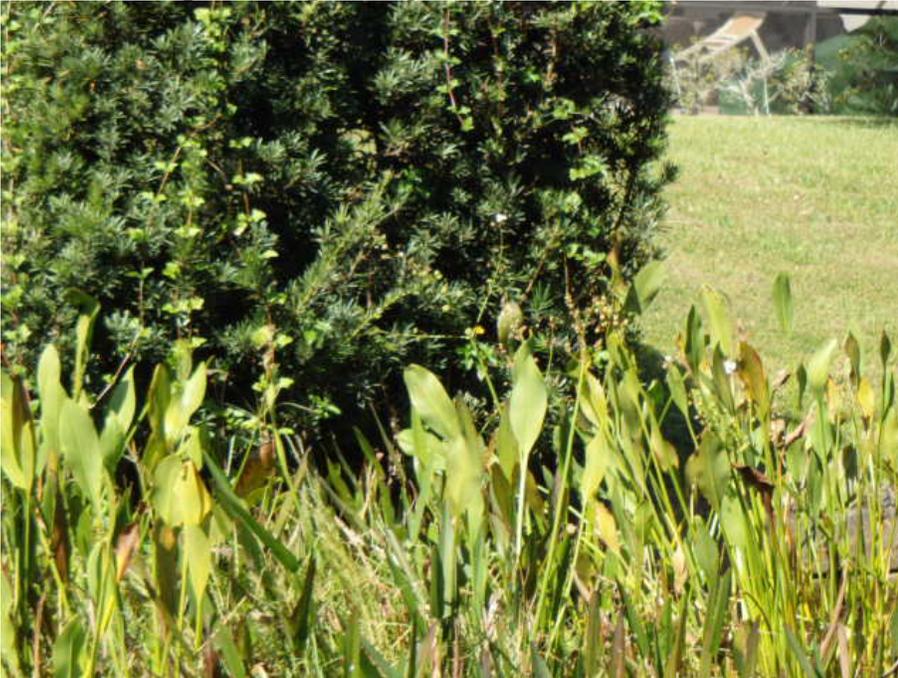
Native emergent vegetation continues to be found in many locations, in good condition, and expanding! To ensure the success of the native vegetation we recommend to hand remove torpedo grass.

**Photo: Duck potato expanding along the shoreline.**

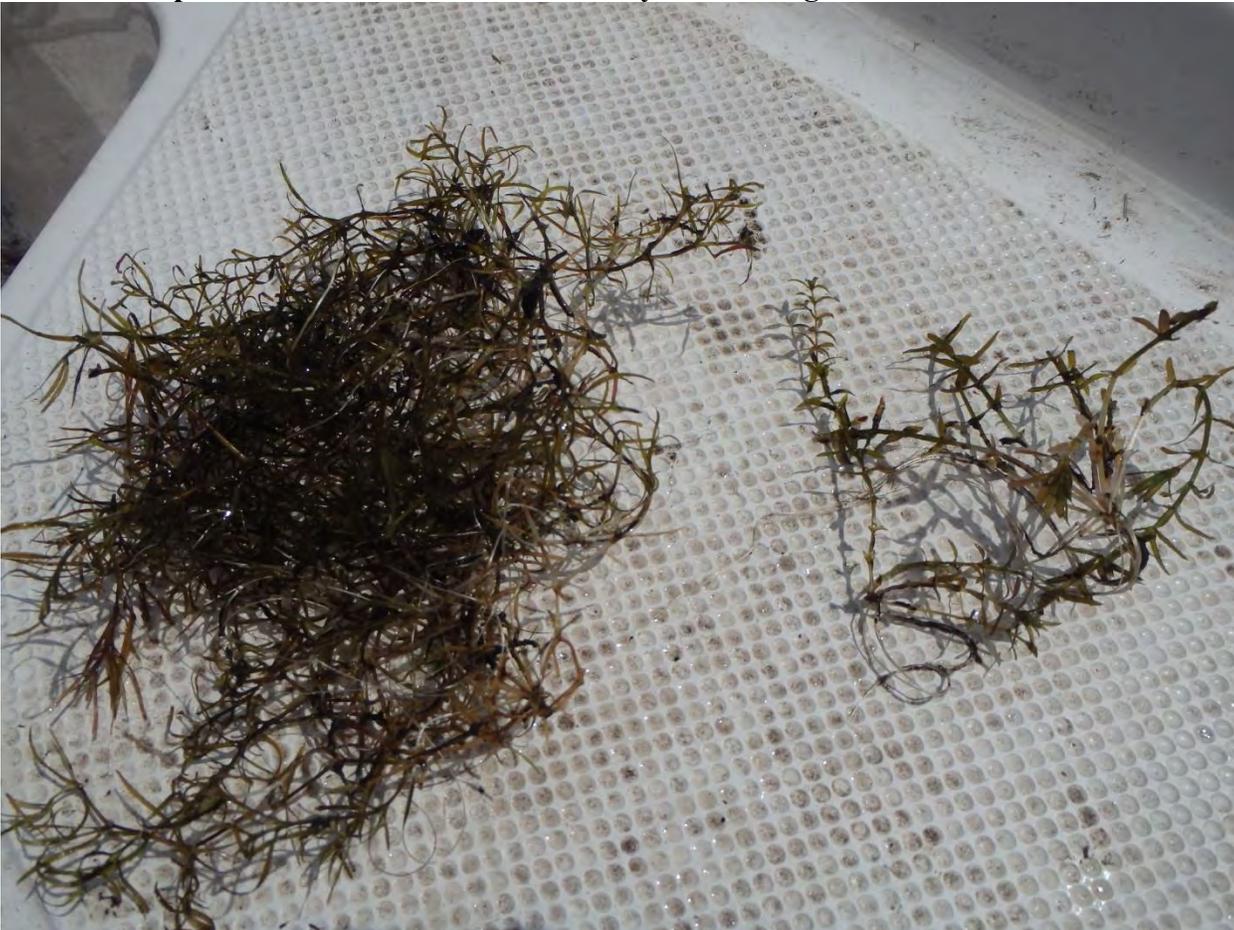
A small amount of hydrilla was found in Spring Wood Lake to a depth of 6 feet. The current amount of hydrilla does not require any action from the Lake Management Program. We will continue to closely monitor hydrilla within the lake.

**Photo: Example of southern naiad on left and hydrilla on right.**

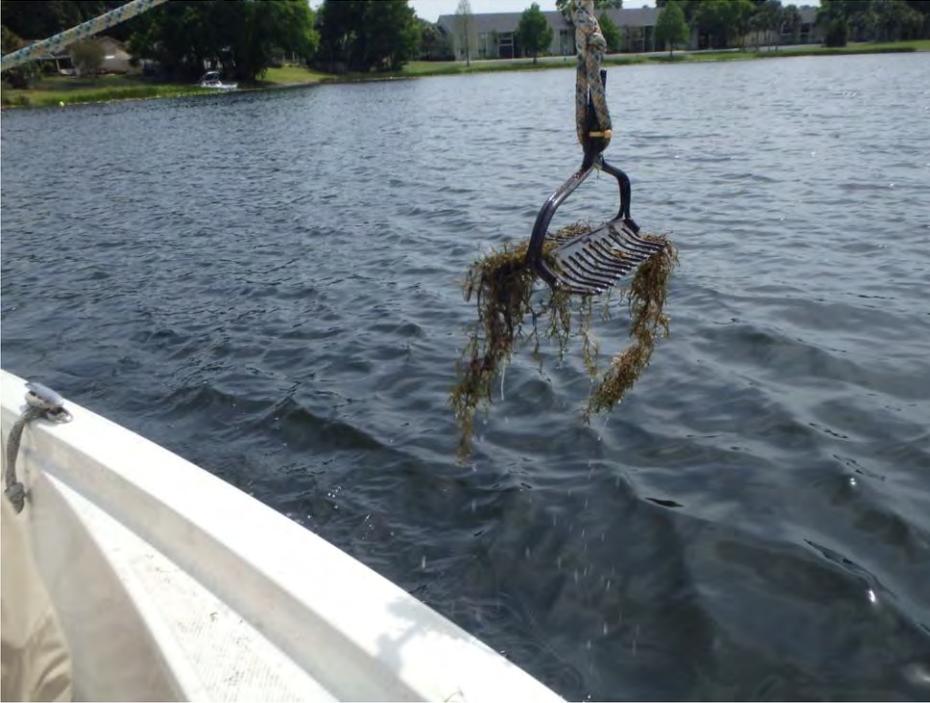
Native SAV was found to have expanded in Spring Wood Lake. Southern naiad was the dominant species of SAV found to a depth of 8 feet. Other beneficial native SAV observed during the inspection included: lemon bacopa to 3 feet, baby's tears to 1 foot, and road grass to 3 feet.

**Photo: Typical grab of southern naiad to a depth of 8 feet.**

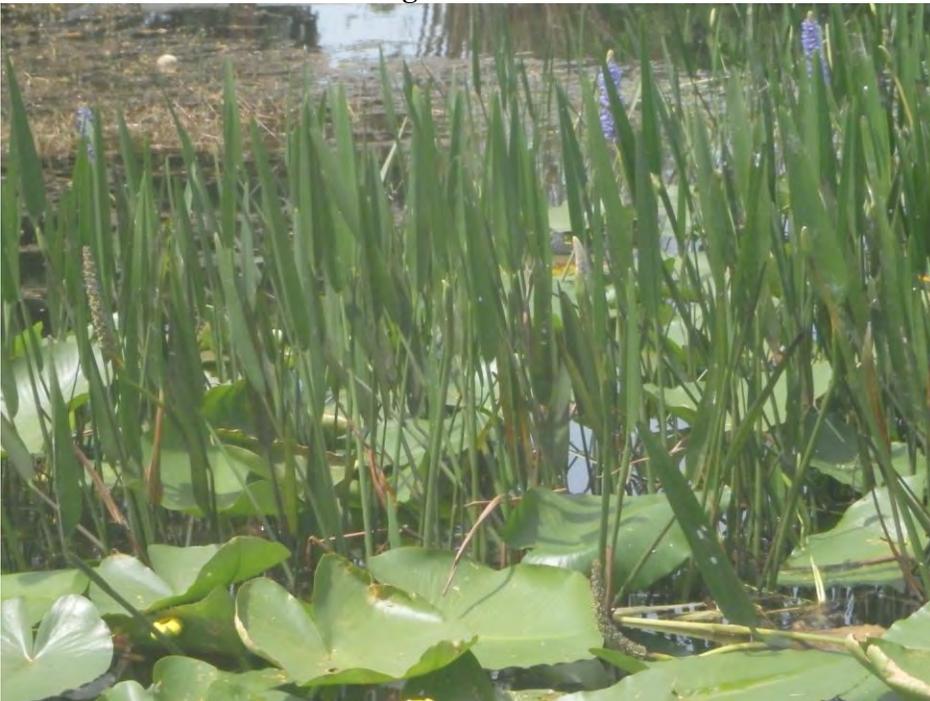
Native emergent vegetation has continued to expand around the lake. This vegetation includes pickerelweed, duck potato, and maidencane. Invasive emergent vegetation, such as alligator weed, wild taro, and torpedo grass, continues to be treated by the MSBU funded herbicide contractor.

**Photo: Pickerelweed blooming.**

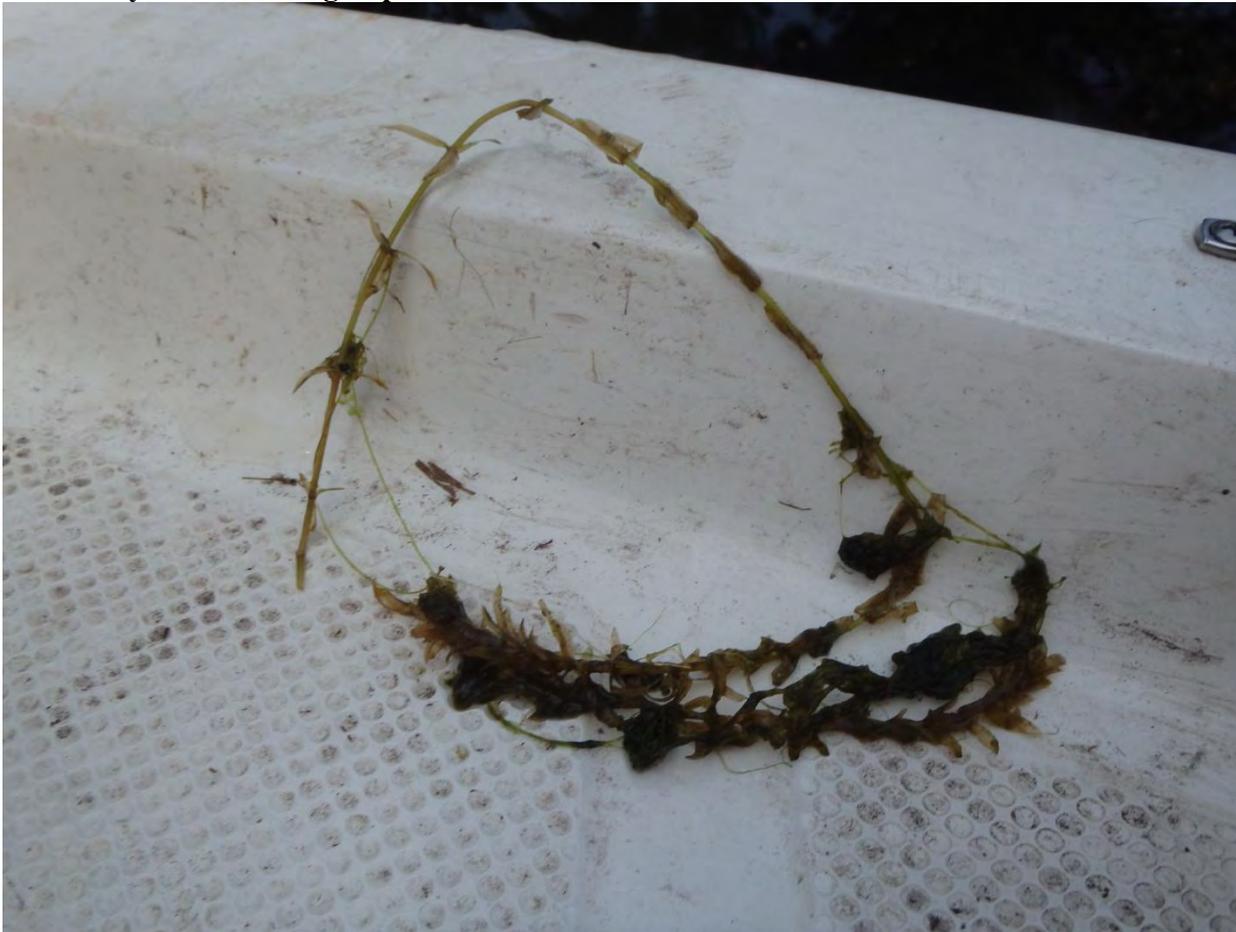
Treatment for hydrilla was conducted Thursday, March 20<sup>th</sup> in the back half of the waterway. During the inspection hydrilla was showing signs of impact from the treatment. We will continue to monitor hydrilla to see if any further actions will be necessary. The waterway was observed open and navigable therefore mechanical harvesting is not needed at this time.

**Photo: Hydrilla showing impacts of treatment.**

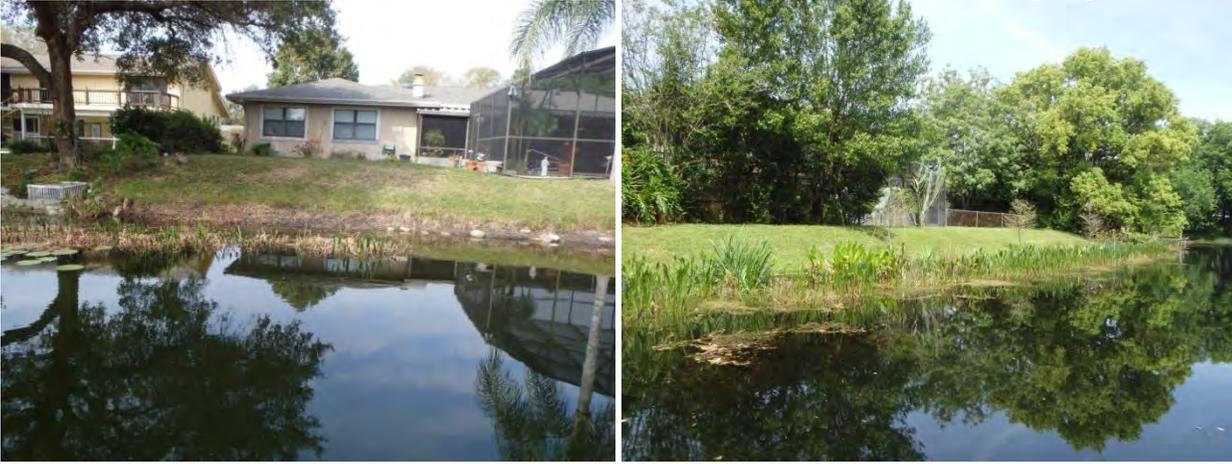
Native emergent vegetation is doing very well throughout the waterway and is recovering/expanding from the “winter die back”. Sites from the June 29<sup>th</sup> restoration event have established and are beginning to expand very nicely. Kudos to all who have made this so successful!

**Photo: Pickerelweed showing “winter die back” (left). Recovered/expanding vegetation (right).**

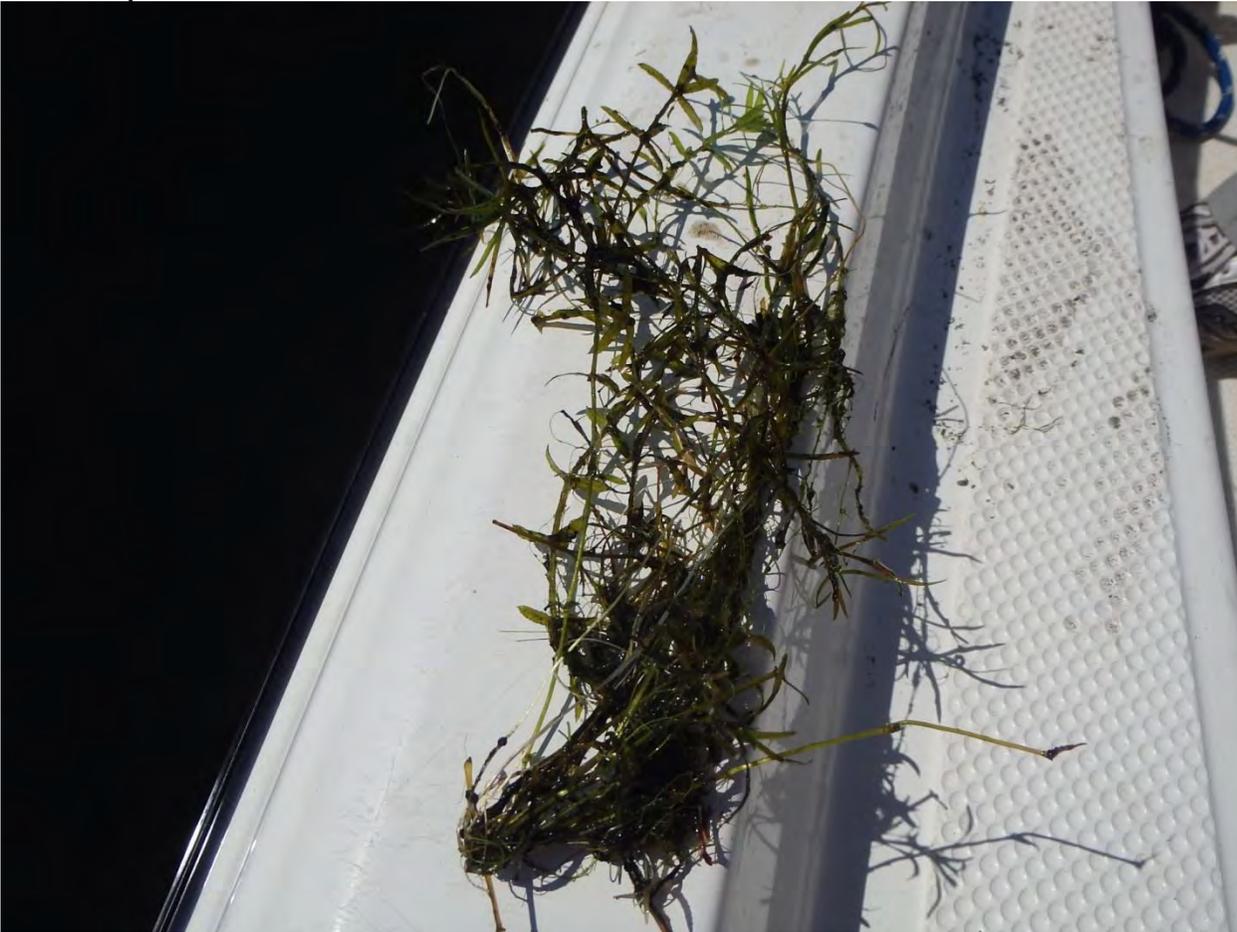
A few sprigs of hydrilla were found in Spring Wood Lake to a depth of 9 feet. This was a lesser amount than in the previous inspections. It is assumed that the grass carp fish and competition with native SAV is reducing the hydrilla within the lake. We will continue to closely monitor hydrilla within the lake.

**Photo: Hydrilla mixed in with southern naiad.**

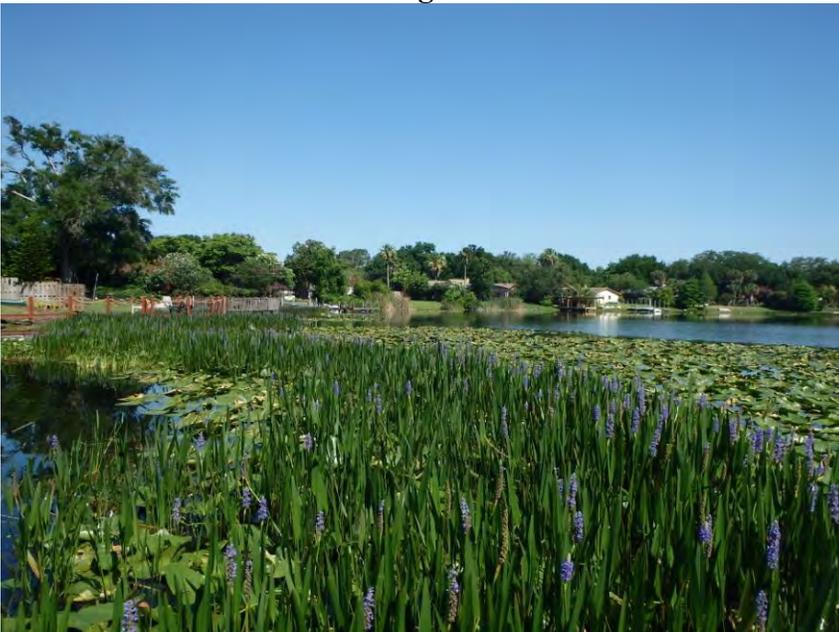
Native emergent vegetation has continued to expand around the lake. This vegetation includes: pickerelweed, canna, fire flag, duck potato, and maidencane. Native emergent vegetation plays an important role in the ecosystem of the lake by reducing nutrients from runoff, preventing erosion, and providing habitat for wildlife. Invasive emergent vegetation (such as alligator weed, cattails, wild taro, and torpedo grass) continues to be treated.

**Photo: Pickerelweed creates a great shoreline buffer.**

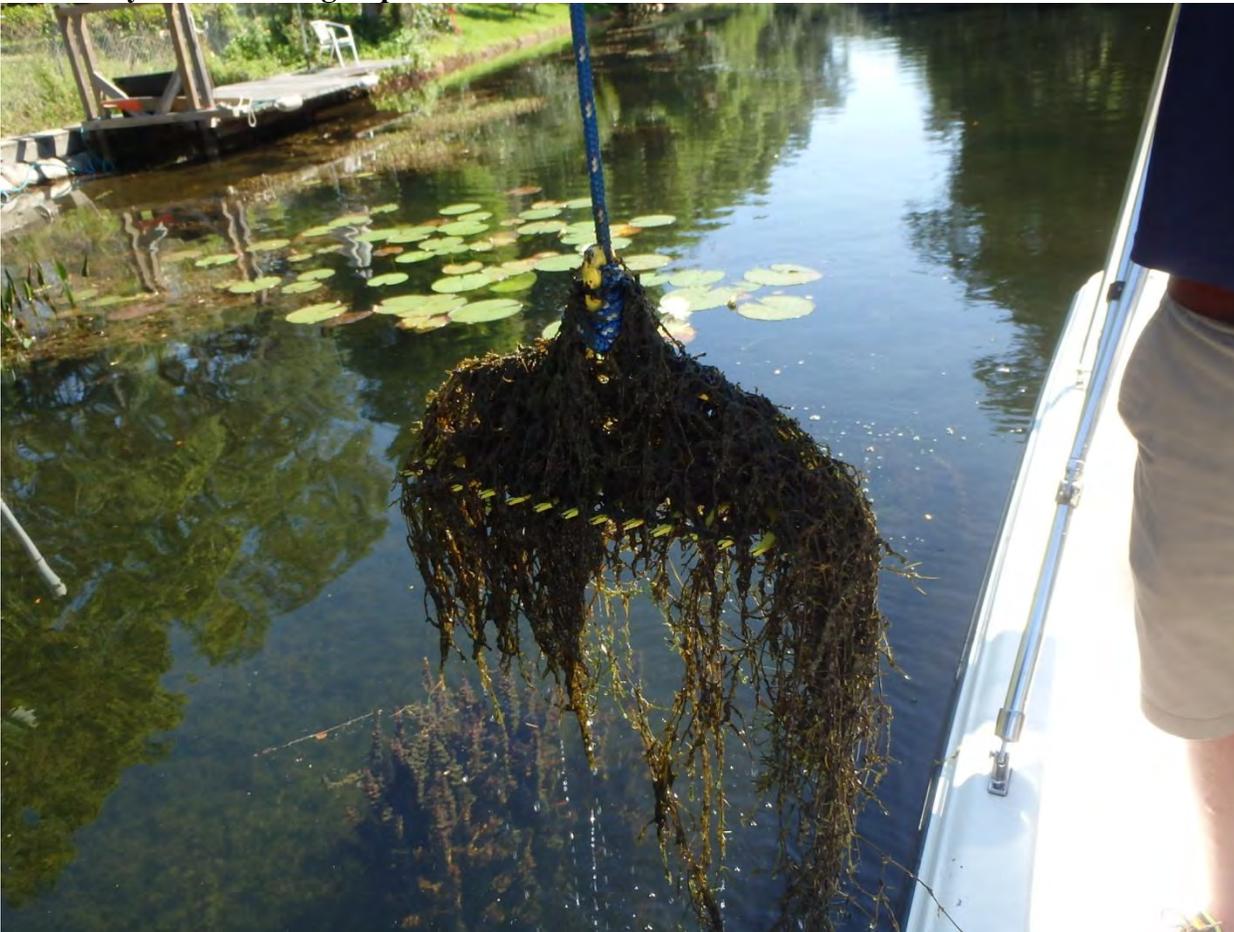
Treatment for hydrilla was conducted Thursday, March 20<sup>th</sup> in the back half of the waterway. All hydrilla found during this inspection was heavily impacted by the treatment and is anticipated to die. We will continue to monitor hydrilla to see if any further actions will be necessary.

**Photo: Hydrilla showing impacts of treatment.**

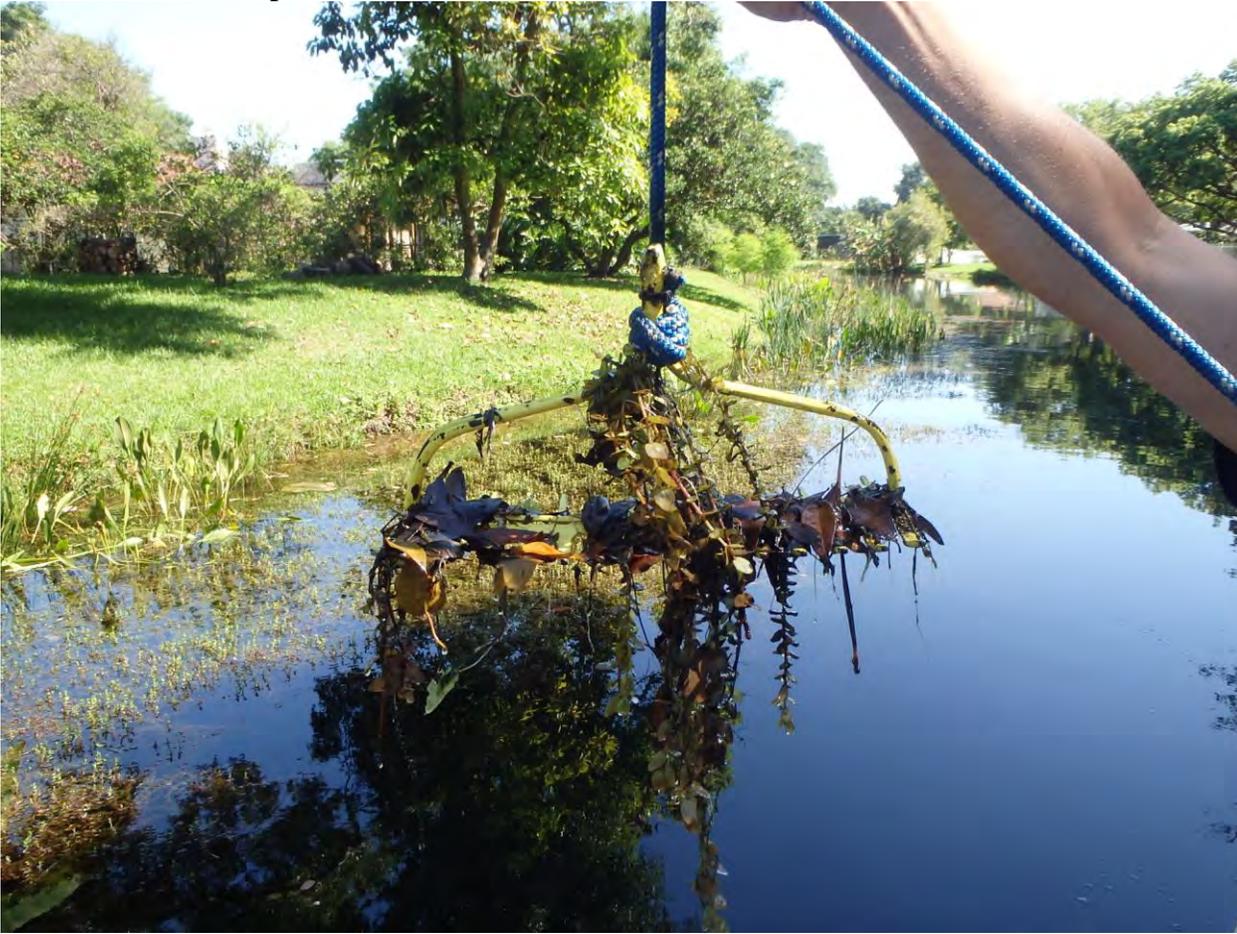
Native SAV is expanding in the waterway. These species includes lemon bacopa, stonewort, and bladderwort. Lemon bacopa has expanded along the majority of the banks within the waterway and is reaching the surface in many areas. The waterway was observed open and navigable therefore mechanical harvesting is not needed at this time.

**Photo: Lemon bacopa.**

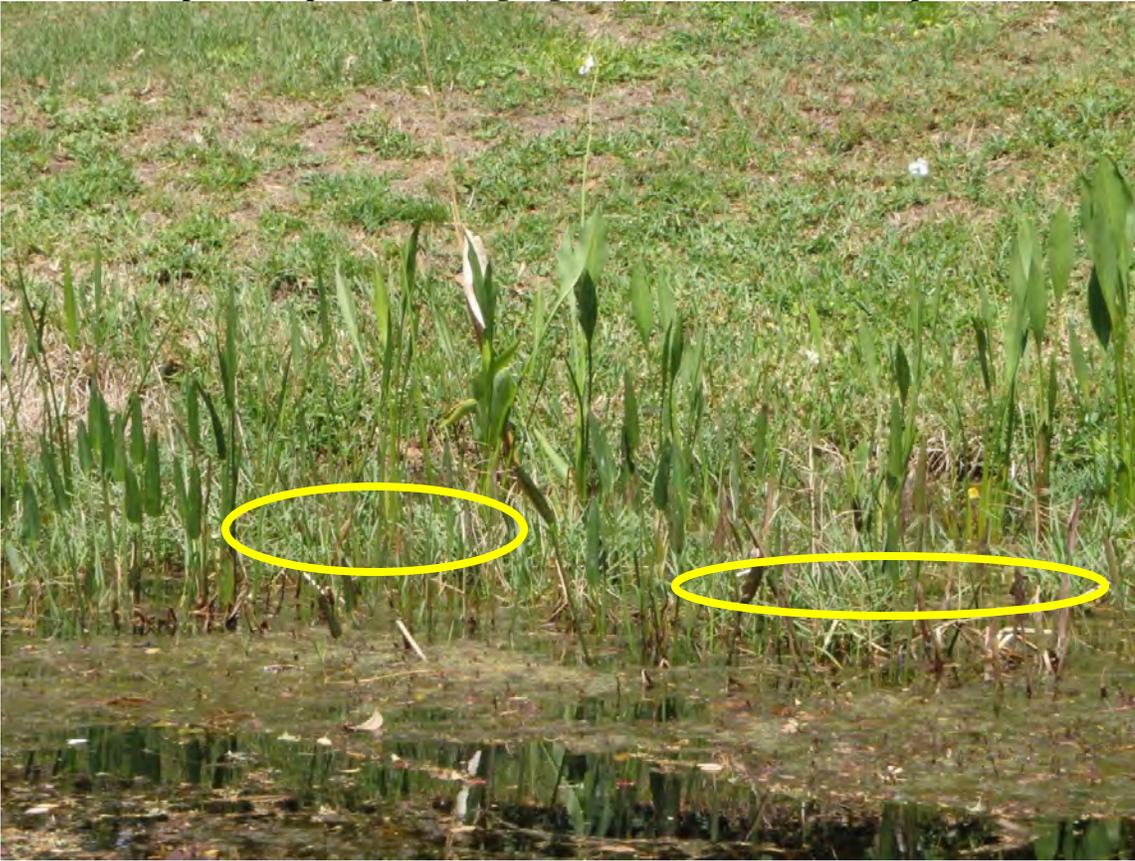
Native emergent vegetation continues to be found in many locations, in good condition, and expanding! The exotic vegetation, such as torpedo grass, alligator weed and elephant ear, will continue to be targeted by the MSBU funded herbicide contractor. As native emergent plants expand, we recommend hand removing any torpedo grass that is found mixed within.

**Photo: Example of torpedo grass (highlighted) mixed in with duck potato.**

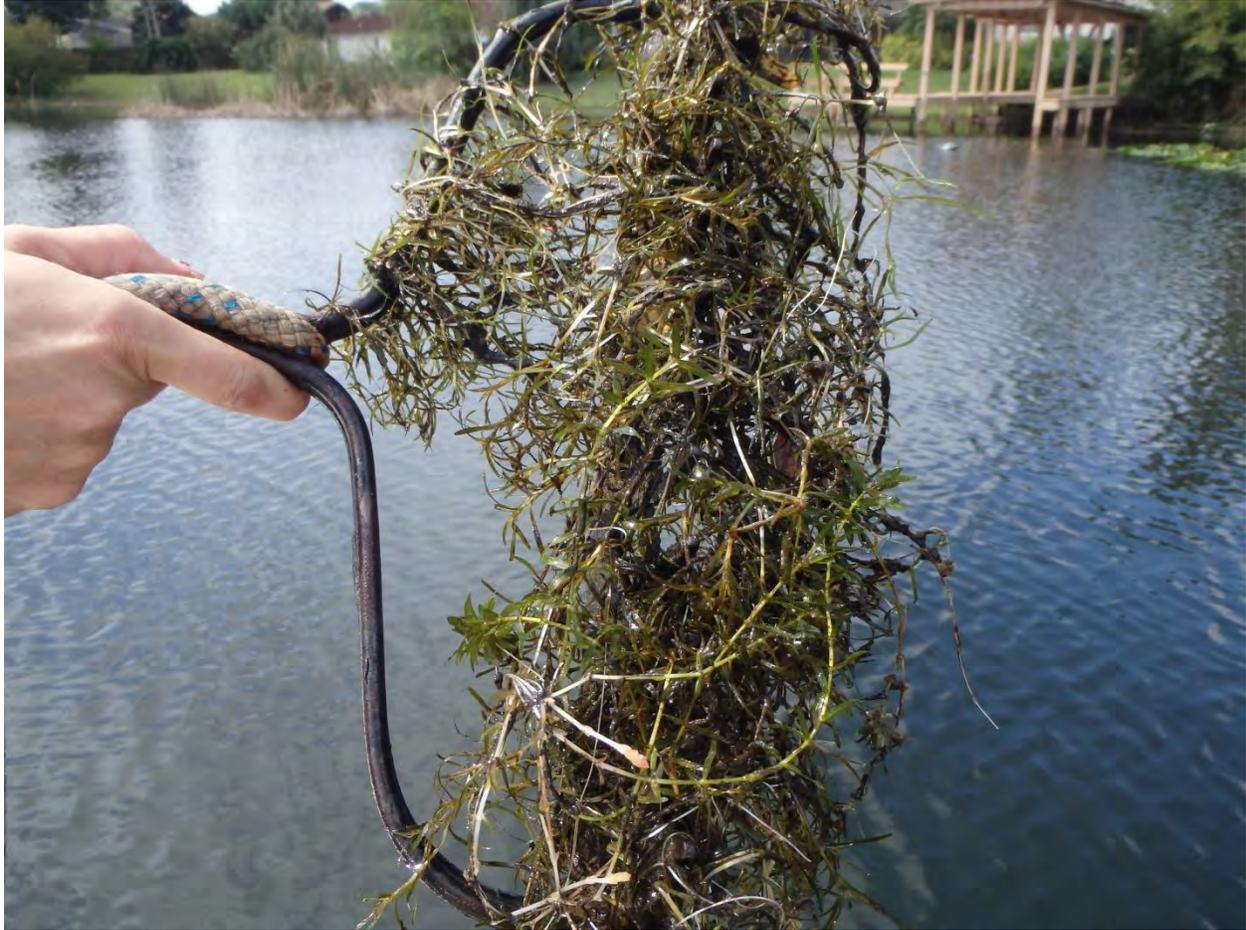
A small amount of Hydrilla was found in Springwood Lake to a depth of 6.5 feet and tubers found to a depth of 9 feet. Hydrilla tubers can be found throughout the sediment and can lay dormant for several years. Currently the amount of hydrilla found doesn't require any action from the Lake Management Program. We will continue to closely monitor hydrilla within the lake.

**Photo: Hydrilla found mixed in with native SAV southern naiad.**

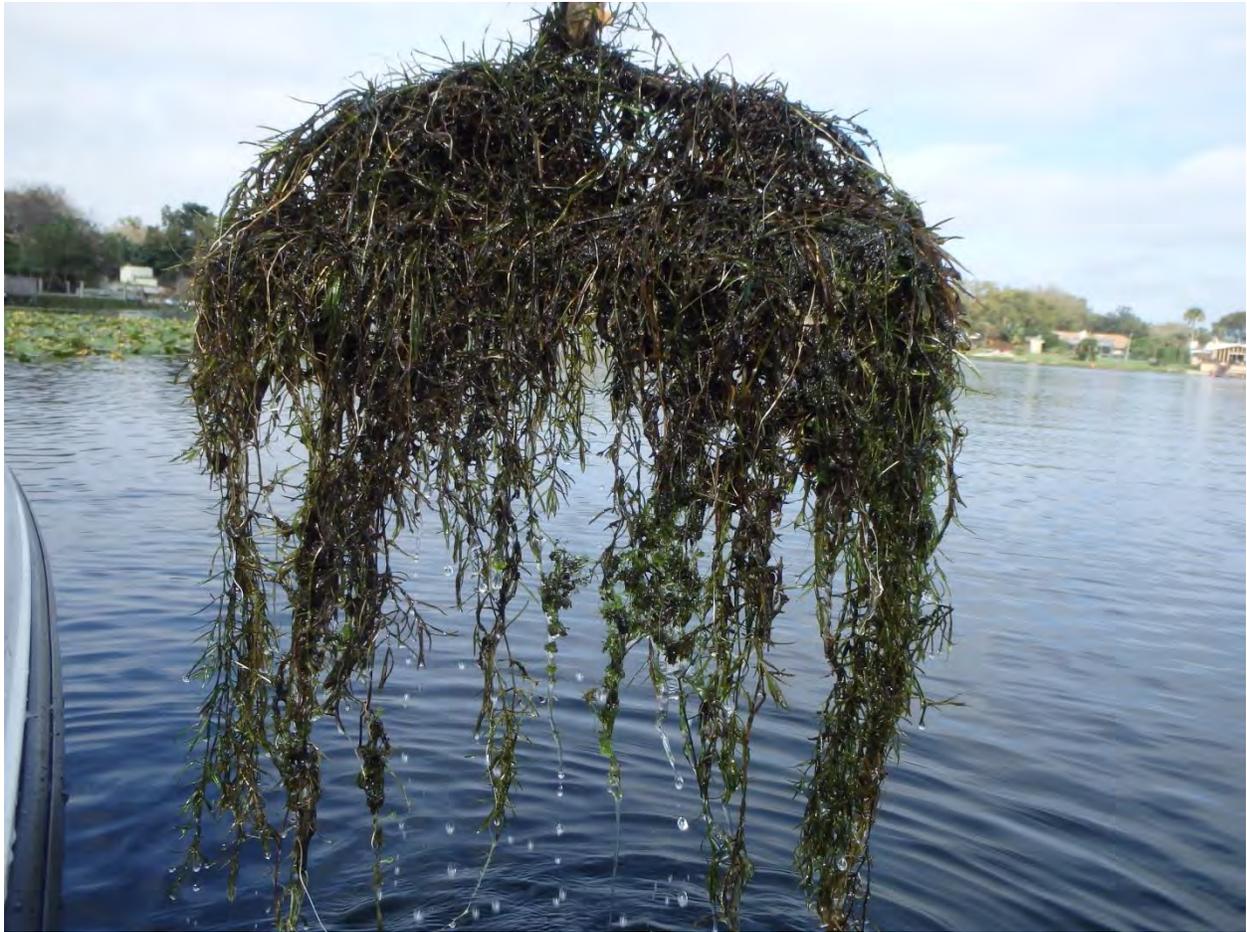
Native SAV was found expanding in Springwood Lake. Southern naiad is the dominant species of SAV found to a depth of 10 feet. Other beneficial native SAV observed during the inspection included: lemon bacopa to 3 feet, road grass to 4 feet, and stonewort to 5 feet. These plants are playing an important role in competition for space with hydrilla. This factored in with the triploid (sterile) grass carp, hydrilla is not recurring as much as in previous years.

**Photo: Southern naiad and stonewort found in thick mats along the bottom.**
