### **Spring Wood Lake**

On **July 1<sup>st</sup>, 2014**, Seminole County Lake Management Program (SCLMP) staff, Thomas Calhoun and Gloria Eby, surveyed the aquatic plants in **Spring Wood Lake**.

### **Springwood Waterway**

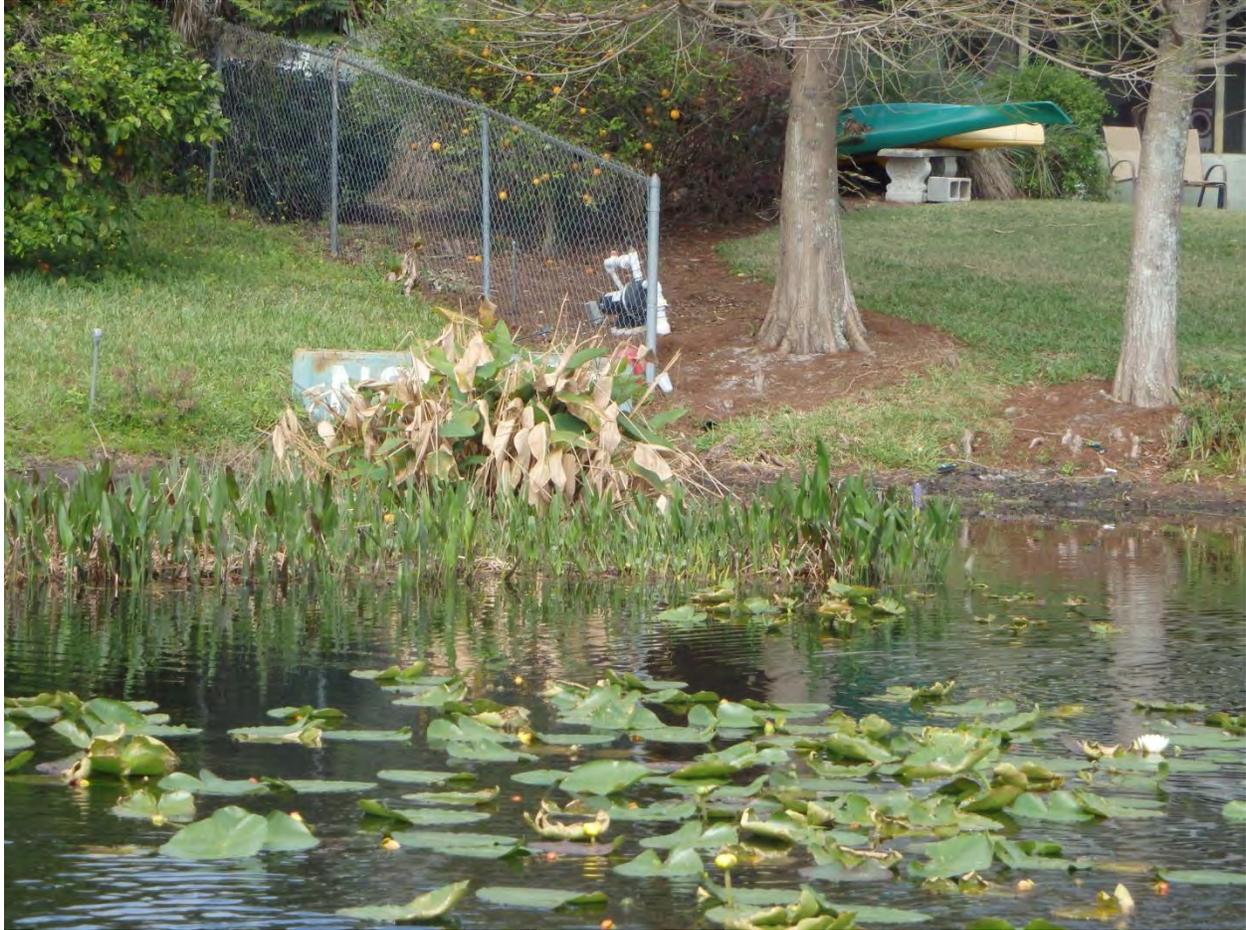
Springtime has native emergent vegetation expanding around Springwood Lake. This vegetation included: rush fuirena, maidencane, pickerelweed, duck potato, fire flag, and bulrush. Invasive emergent vegetation has been reduced greatly around the lake. This has allowed pickerel weed and other native vegetation to fill in very nicely. Observed invasive emergent vegetation included: alligator weed, wild taro, and torpedo grass.

**Photo: Treated torpedo grass and alligator weed.**

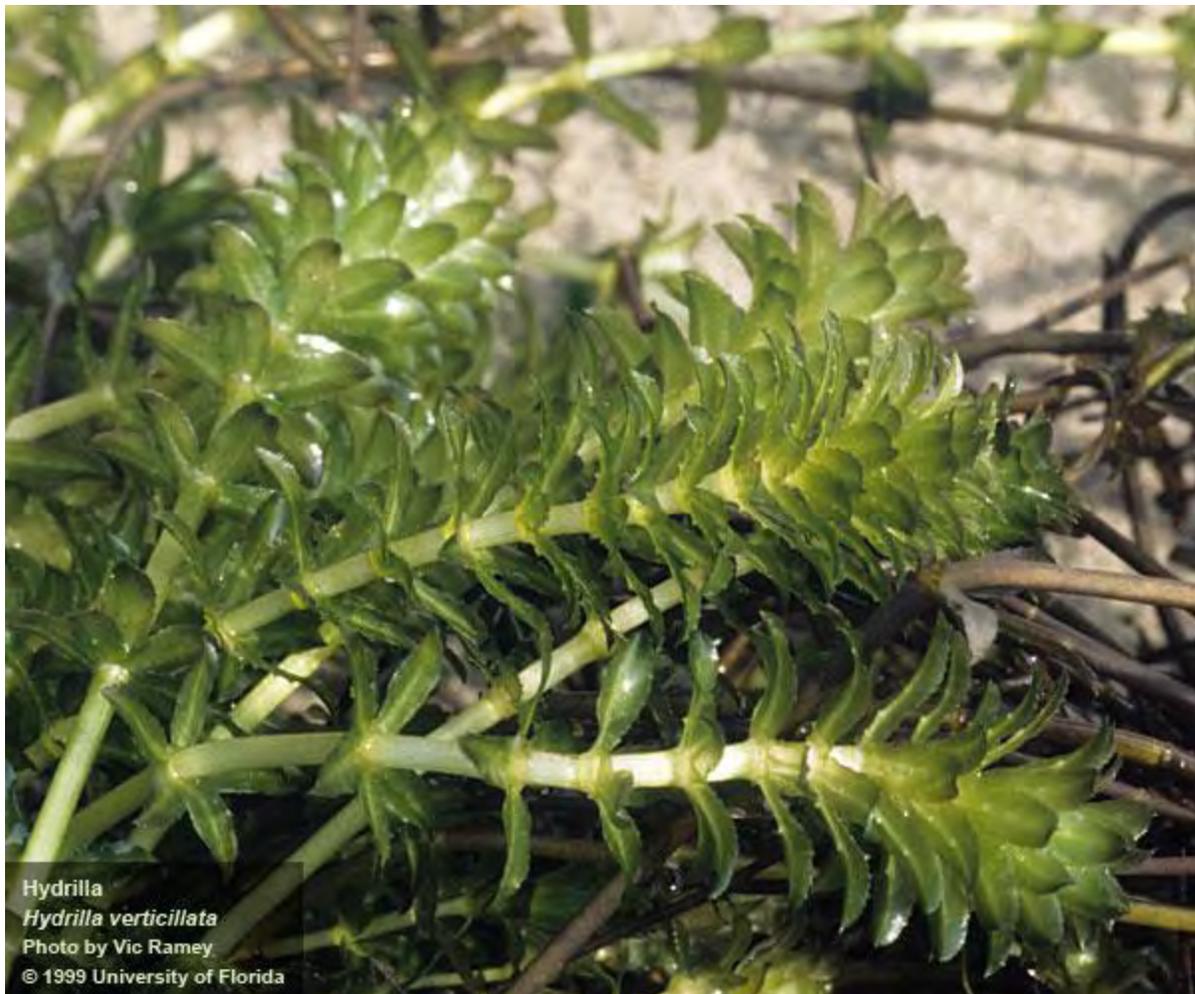
The exotic SAV hydrilla was found throughout the back half of the waterway at the time of inspection. Treatment for the hydrilla was scheduled for Thursday March 20<sup>th</sup>.

**Photo: Up close example of Hydrilla.**

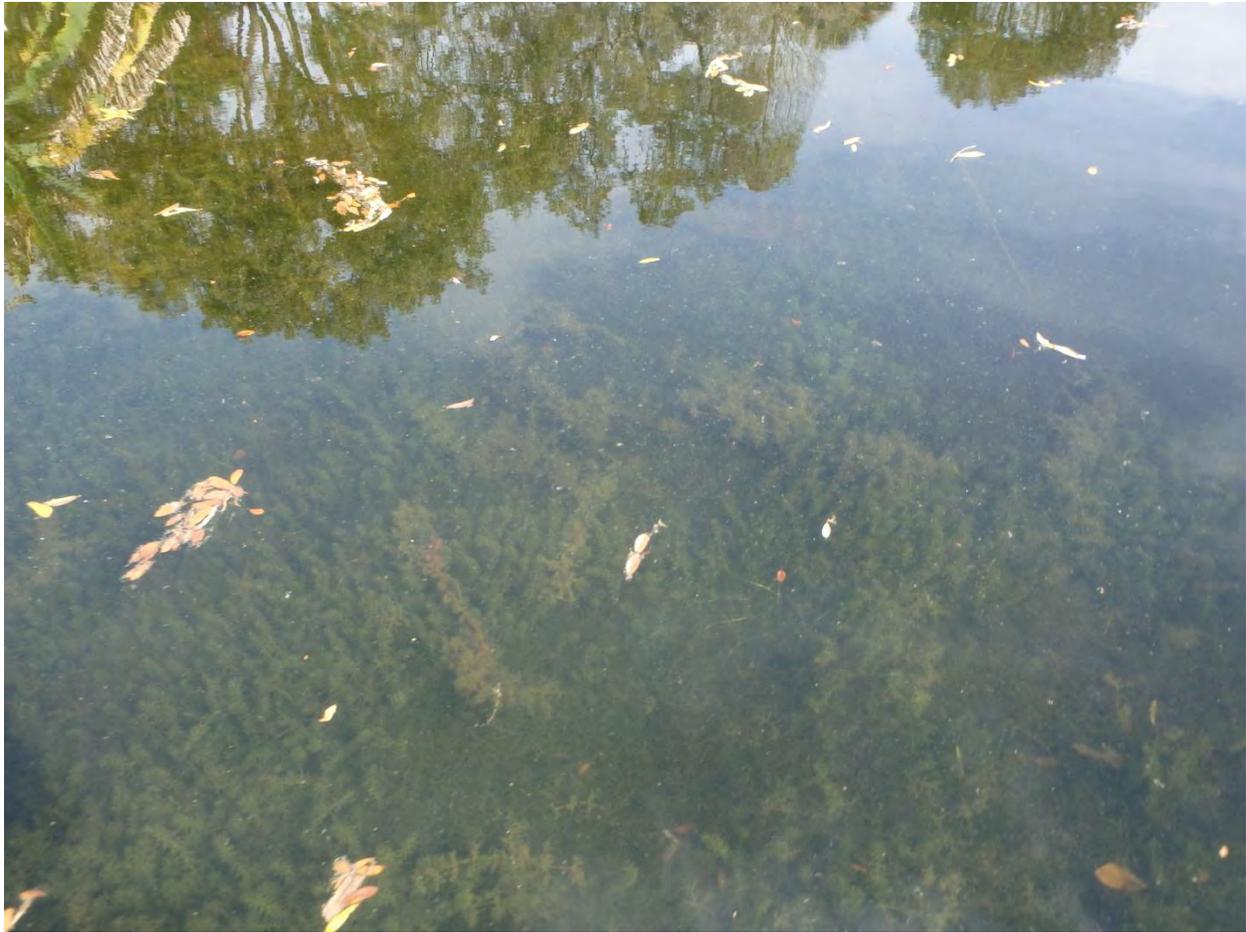
Eight SAV were found during this inspection 7 native and 1 exotic. Observed native SAV included: lemon bacopa to a depth of 3 feet, road grass to 3 feet, baby's tears to 1 foot, eelgrass to 2 feet, stonewort to 4 feet, and 2 bladderworts to 4 feet. Native SAV are expanding in the waterway. Bladderwort and stonewort are reaching the surface around many docks along the first half of the waterway. However the waterway is still navigable. We will continue to monitor the canal to see if it requires mechanical harvesting; at this time it is not necessary.

**Photo: Nitella and bladderwort growing along the bottom of the waterway.**

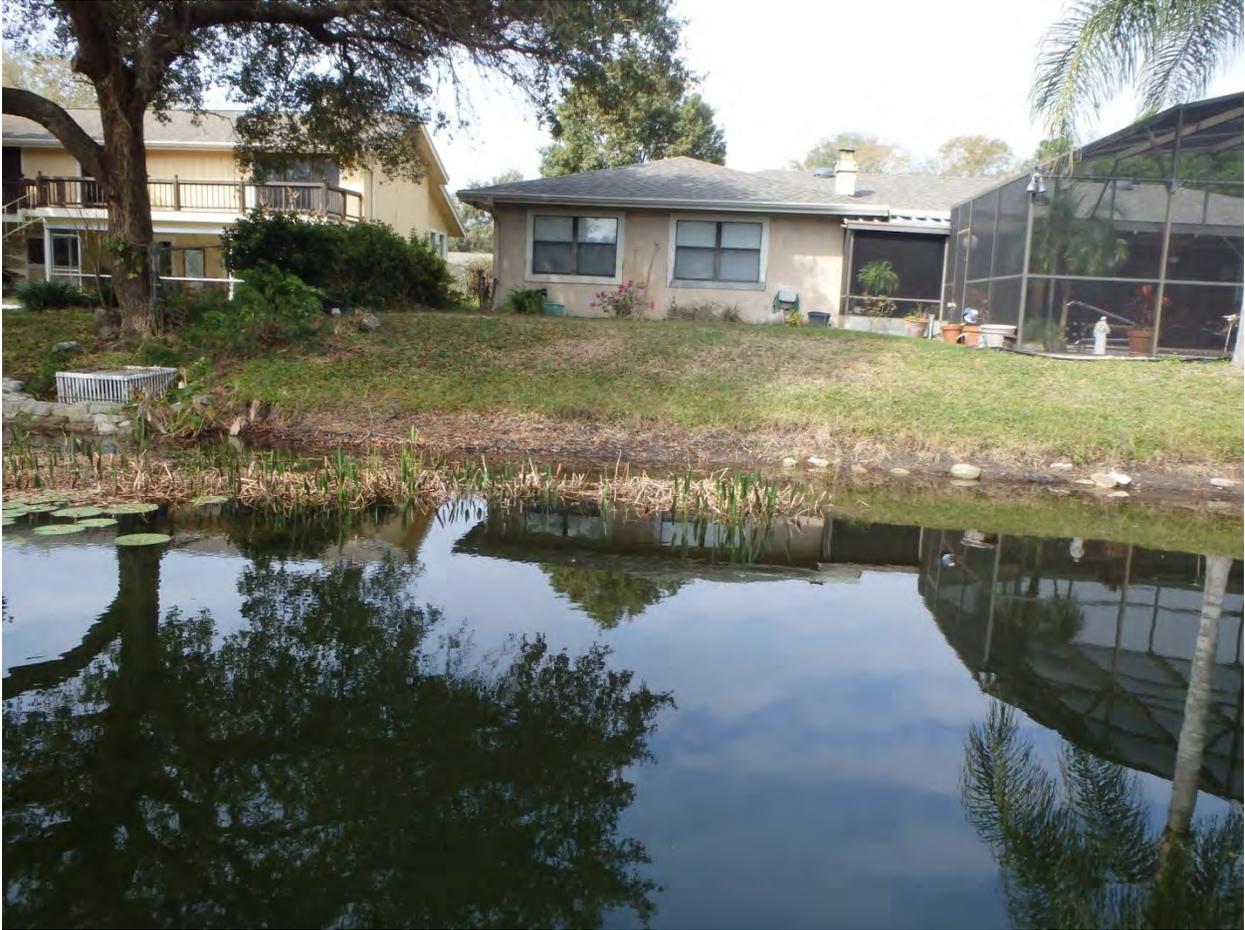
Native emergent vegetation is doing very well throughout the waterway with some “winter die back” observed. Sites from the June 29<sup>th</sup> restoration event have established and are beginning to expand very nicely.

**Photo: Pickerel weed showing “winter die back”.**

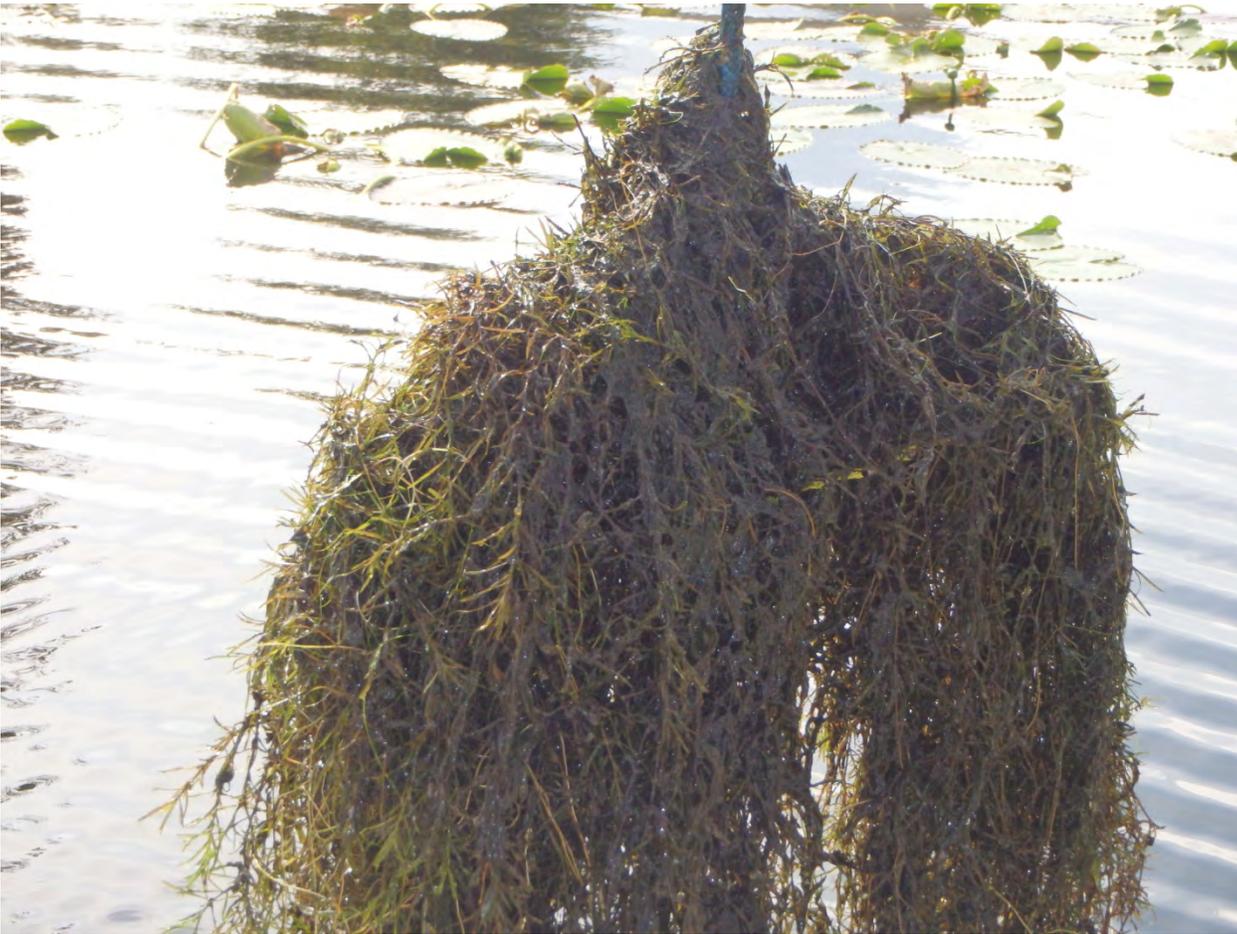
Large amounts of southern naiad are carpeting the bottom of the lake to a depth of 10 feet. This plant is playing an important role in competing for space with hydrilla as well as providing habitat for wildlife and reducing nutrients that can cause algae blooms within the lake. This factored in with the triploid (sterile) grass carp fish has allowed for a reduction in the re-occurrence/re-growth of hydrilla within the lake as compared to previous years. Other beneficial native SAV observed during this inspection included: lemon bacopa to 2 feet, road grass to 4 feet, and stonewort to 4 feet.

**Photo: Southern naiad found in dense mats along the bottom of Spring Wood Lake.**

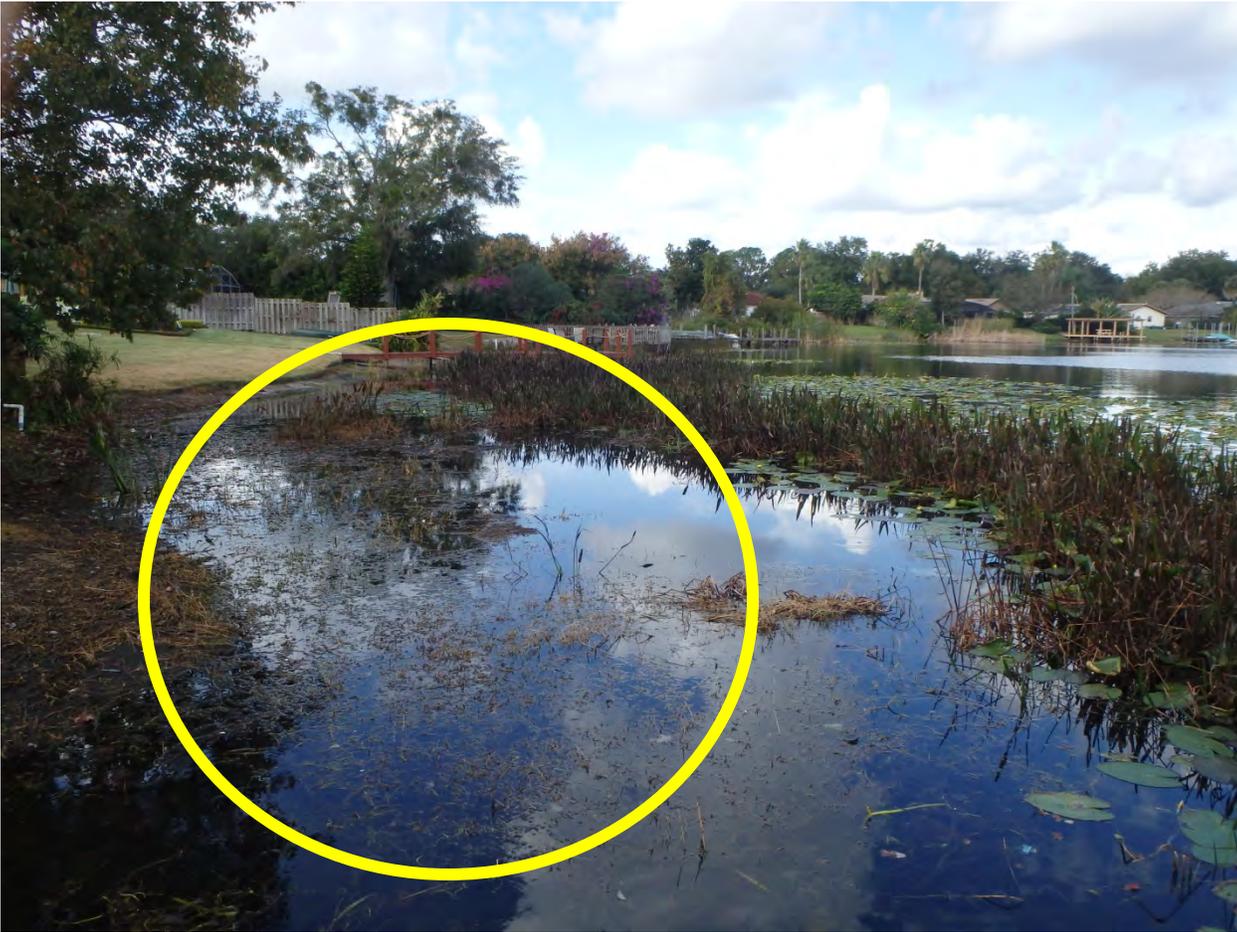
The access corridors remained open and maintained. These corridors are created to provide a small access from the shoreline to open water for navigational and recreational use. Observed invasive emergent vegetation included alligator weed, wild taro, and torpedo grass. Observed native emergent vegetation included: rush fuirena, maidencane, pickerelweed, duck potato, fire flag, and bulrush. Invasive emergent vegetation has been greatly reduced around the lake which has allowed pickerelweed and other native vegetation to fill in very nicely.

**Photo: Treated torpedo grass and alligator weed within Spring Wood Lake.**

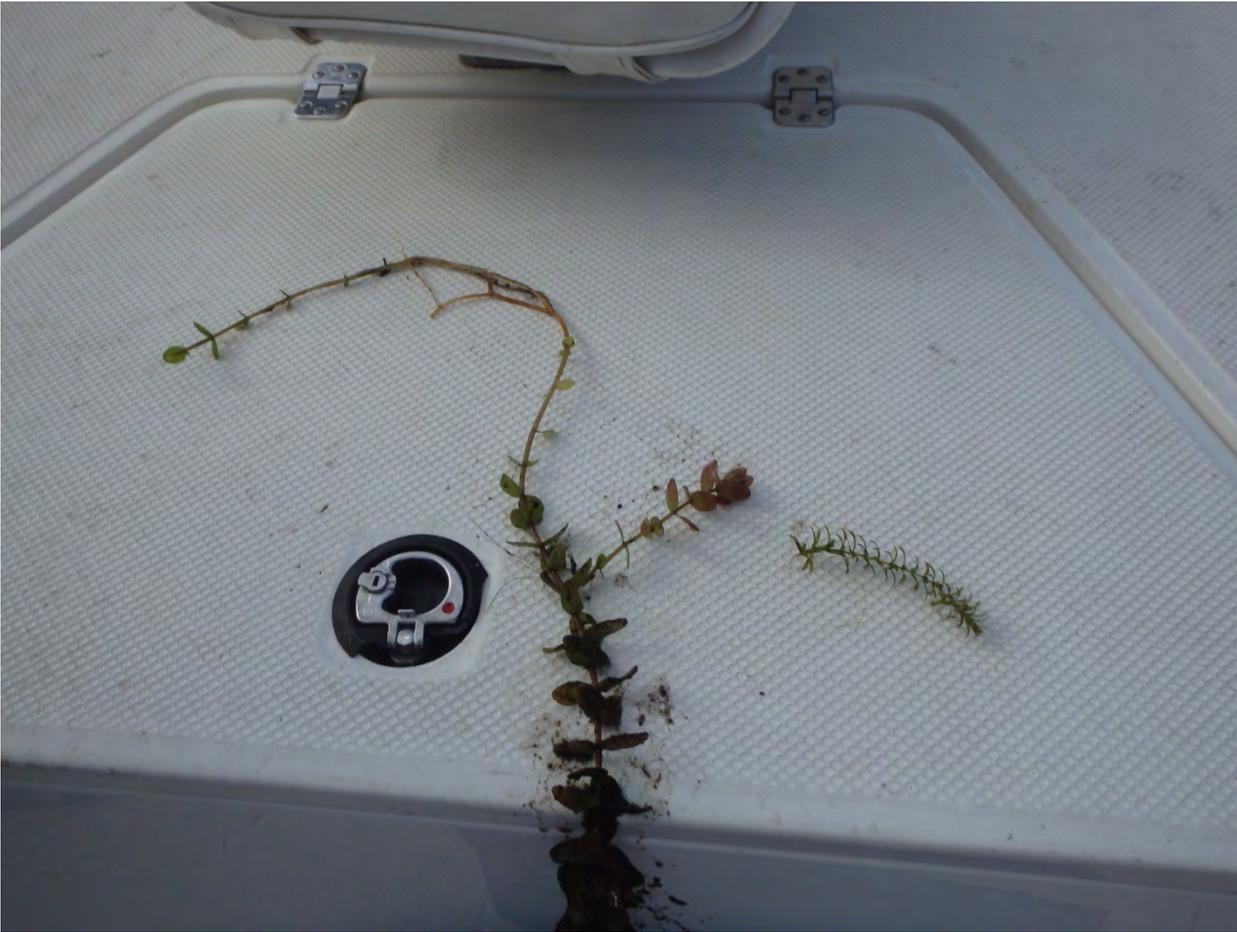
The exotic SAV hydrilla was found in patches throughout the back half of the waterway. These patches have slightly expanded since the previous inspection. At this time, treatment for hydrilla is not necessary. We will closely watch this area for further growth and treatment needs.

**Photo: Lemon bacopa strand (left) compared to a hydrilla sprig (right).**

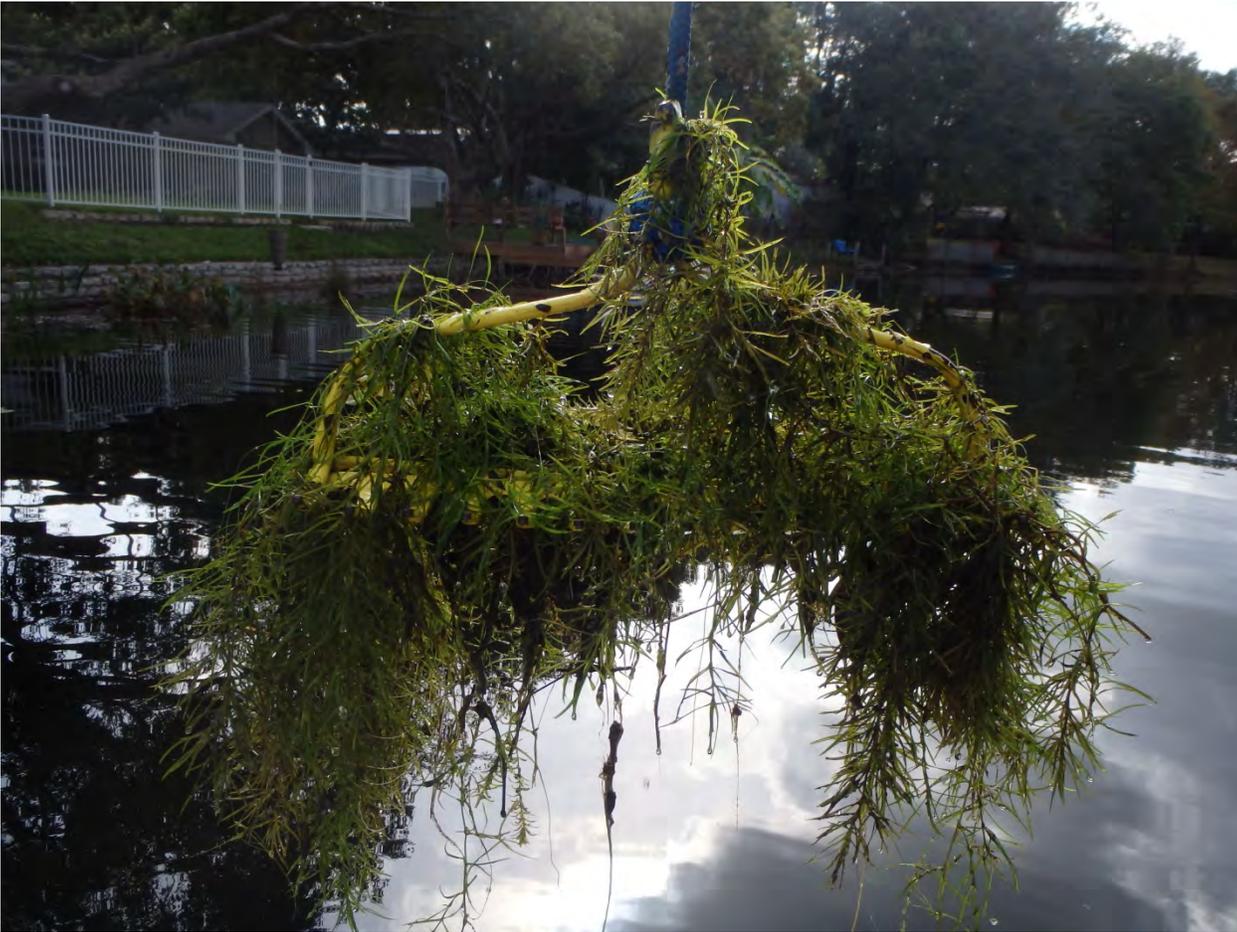
Eight different SAV species were found during this inspection; seven native and one exotic. Observed native SAV included: lemon bacopa to a depth of 4 feet, road grass to 3 feet, baby's tears to 1 foot, eelgrass to 2 feet, stonewort to 3 feet, and two bladderworts to 4 feet. Southern naiad and nitella are both expanding throughout the canal. Bladderwort and stonewort are reaching the surface around many docks along the first half of the waterway; however the waterway is still navigable. We will continue to monitor the canal to see if it requires mechanical harvesting; at this time it is not necessary.

**Photo: Example of southern naiad in Springwood Waterway.**

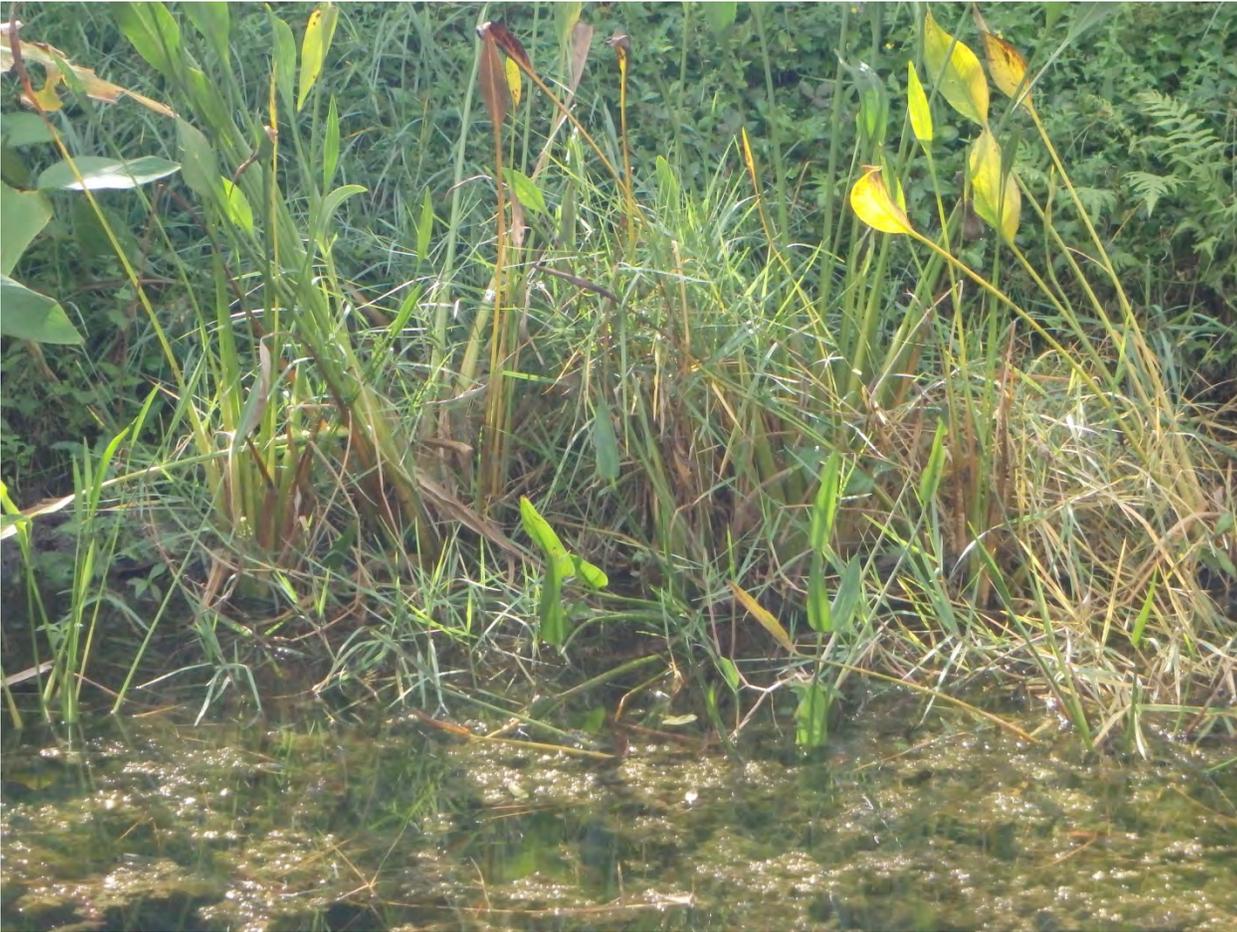
Native emergent vegetation is doing very well throughout the waterway. Sites from the June 29<sup>th</sup> restoration event have established and are beginning to expand very nicely. As the native vegetation expands it may become difficult for the herbicide contractor to treat invasives without impact to the native vegetation. It is recommended that torpedo grass be hand pulled in these areas.

**Photo: Example of torpedo grass intermixed with duck potato that should be hand pulled.**
