Please find the latest bioassessment for your lake below. Our next lake inspection is scheduled for **June 10th, 2014**, weather permitting. Key highlights of this update include:

On **May 15th, 2014**, Seminole County Lake Management Program staff, Thomas Calhoun and Gloria Eby, surveyed the aquatic plants in **Lake Mills**.

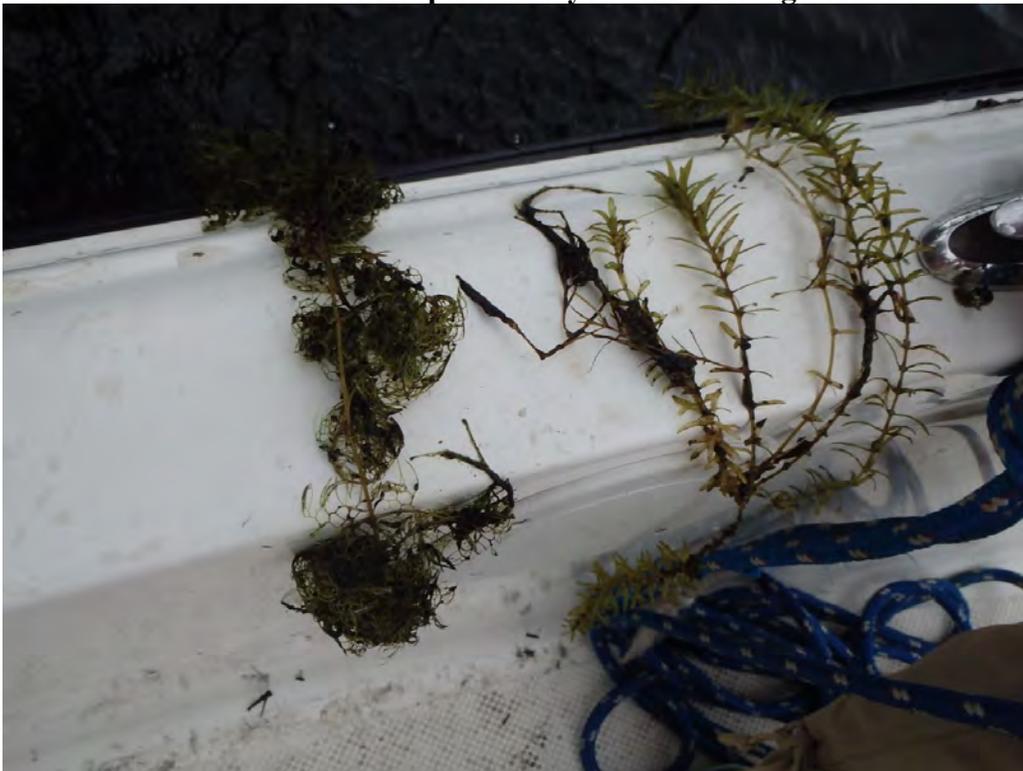
Hydrilla was present along the north shore of Lake Mills to a depth of 4 feet. This area will be targeted for treatment. Hydrilla was also present at the Mills Creek cove on the eastern side of the lake. At this time no grass carp fish will need to be stocked. These areas will be heavily monitored during the next several months to evaluate if further treatments will be necessary.

Photo: Bladderwort on left compared to hydrilla on the right.

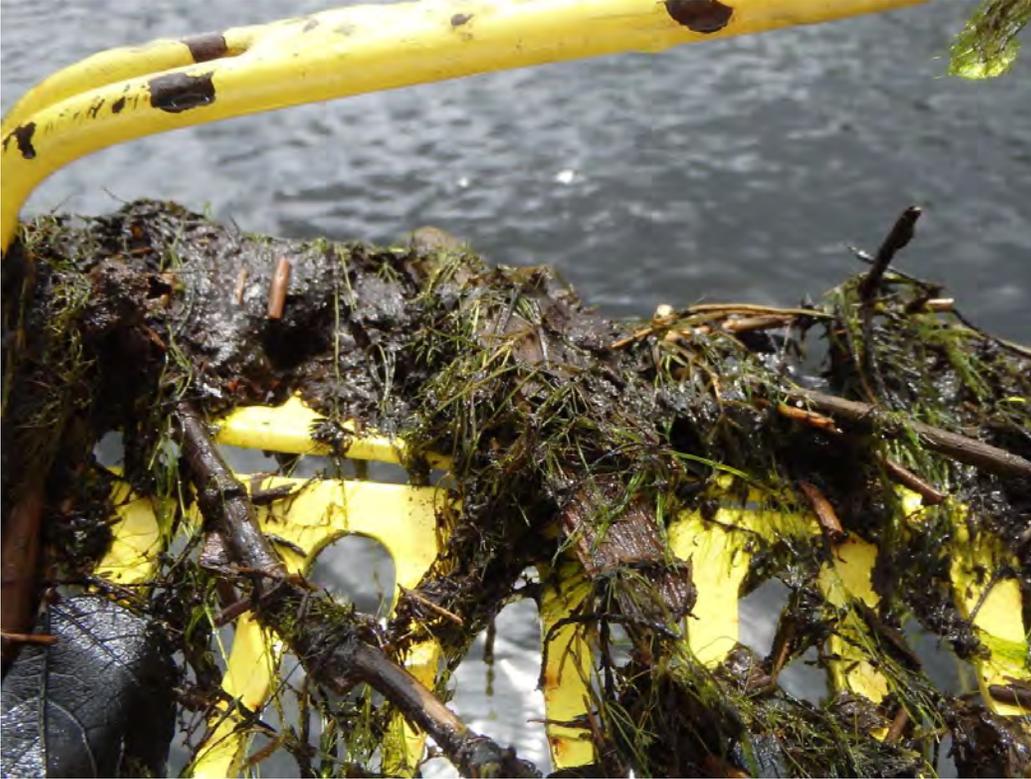
Nine species of native SAV were observed which have expanded since prior inspection. This is a great number of species for Lake Mills! Native SAV plays an important role in the lake ecosystem by absorbing nutrients coming in from the local watershed, by providing habitat for aquatic species, and by competing for space with hydrilla. These species included: lemon bacopa to a depth of 4 feet, coontail to a depth of 4 feet, road grass to a depth of 4 feet, eelgrass to a depth of 2 feet, bladderwort to a depth of 2 feet, baby's tears to a depth of 2 feet, southern naiad to 4 feet, stonewort to 4 feet, and pondweed to 4 feet.

Photo: Native SAV stonewort.

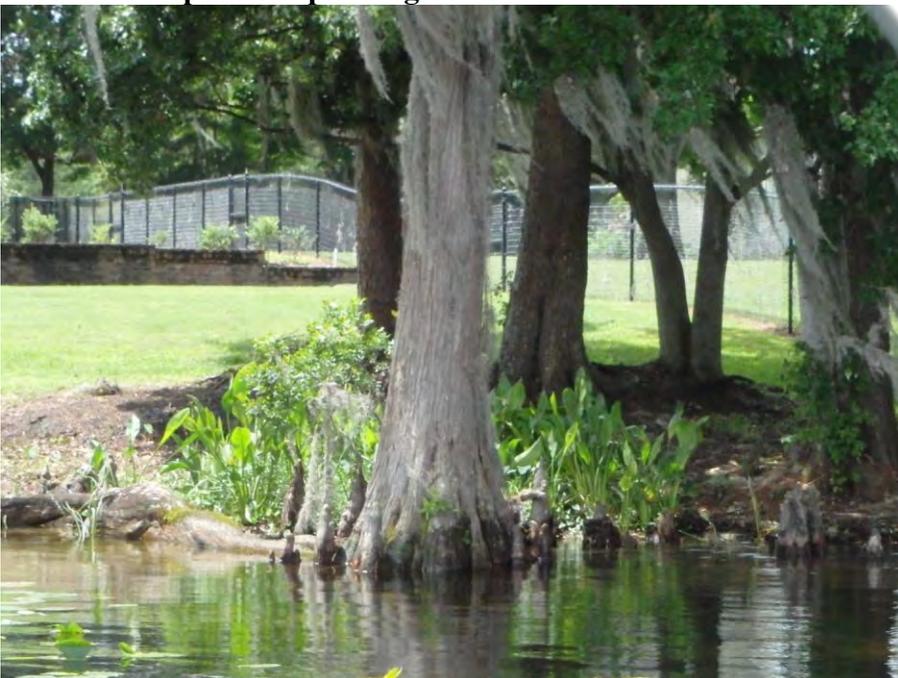
Native emergent vegetation observed during inspection included duck potato, pickerelweed, and canna. These beneficial natives are expanding nicely around the lake.

Photo: Duck potato expanding!

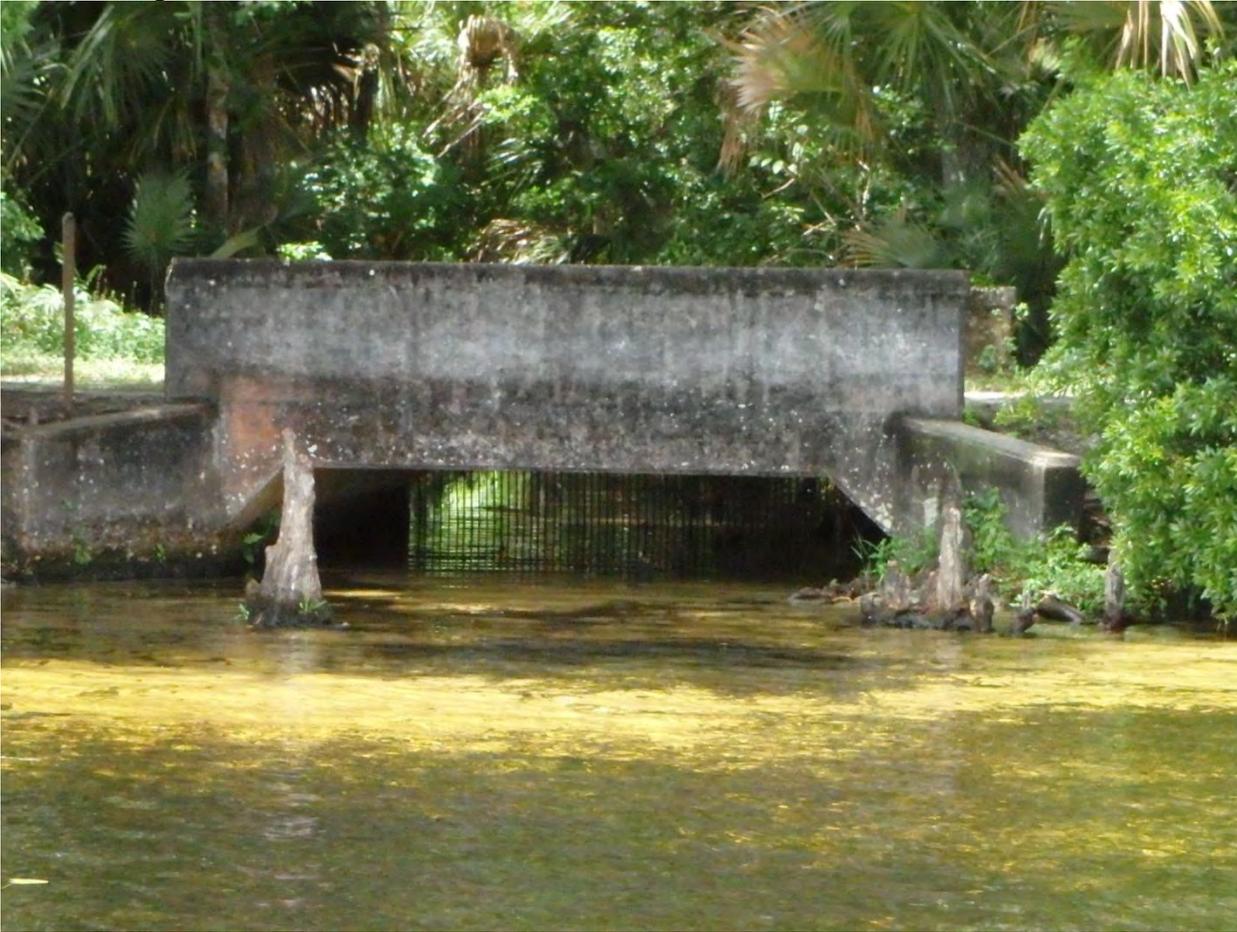
The Secchi (water clarity) value was 9.6 feet out of a total depth of 12.1 feet. The grass carp barrier was operational and free from debris. The water elevation at the time of inspection was 40.7 feet above sea level.

Photo: Carp barrier at Lake Mills Park.

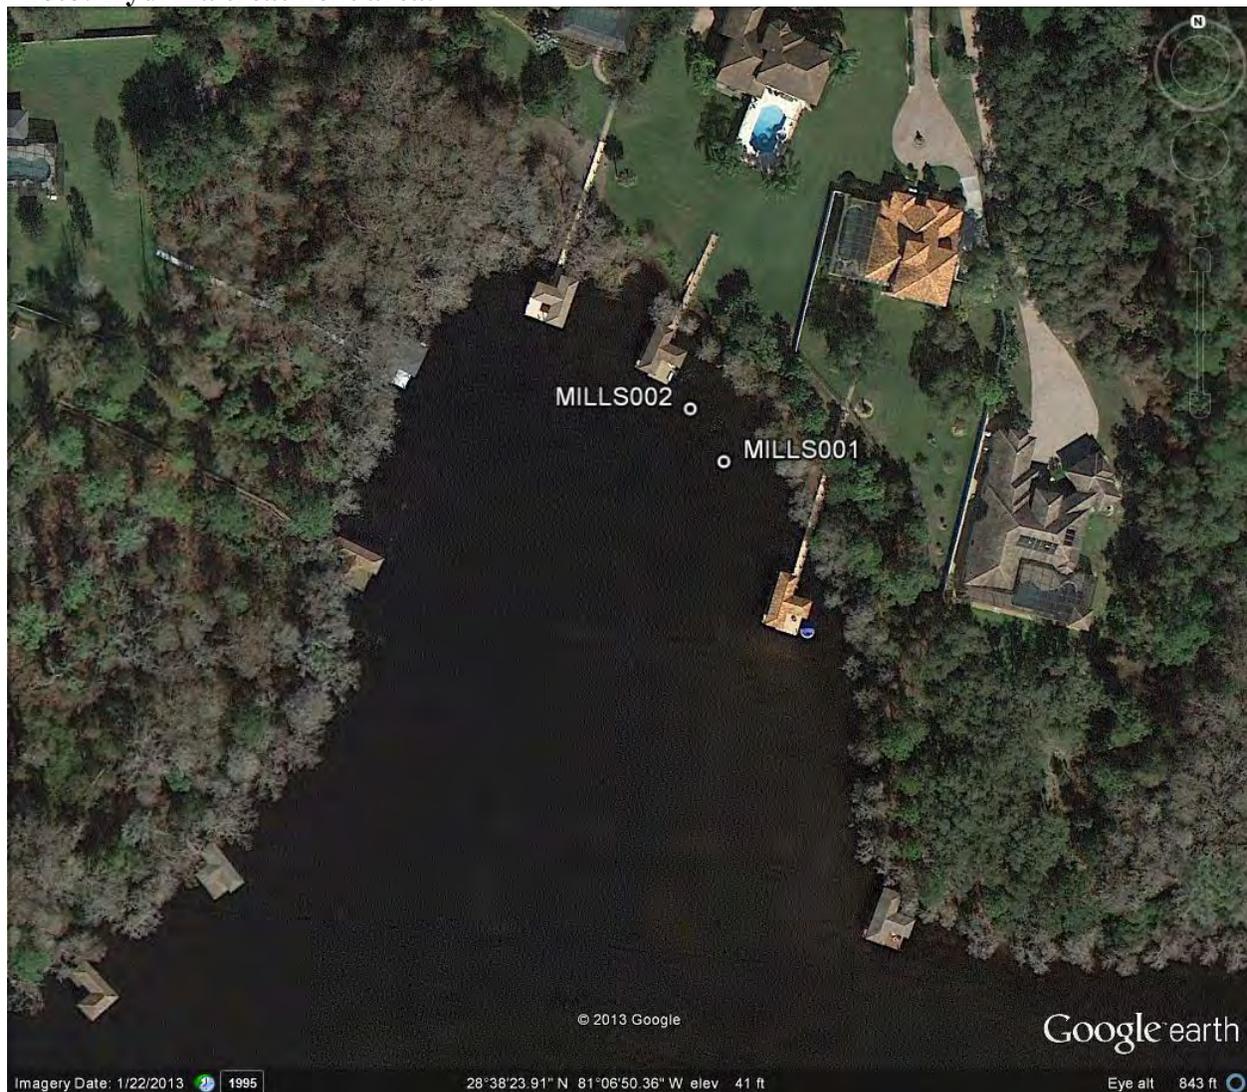
Hydrilla was present in one area along the north shore of Lake Mills to a depth of 3 feet. This area will be targeted for a spot treatment. At this time no grass carp will need to be stocked. These areas will be heavily monitored during the next several months.

Photo: Hydrilla treatment area.

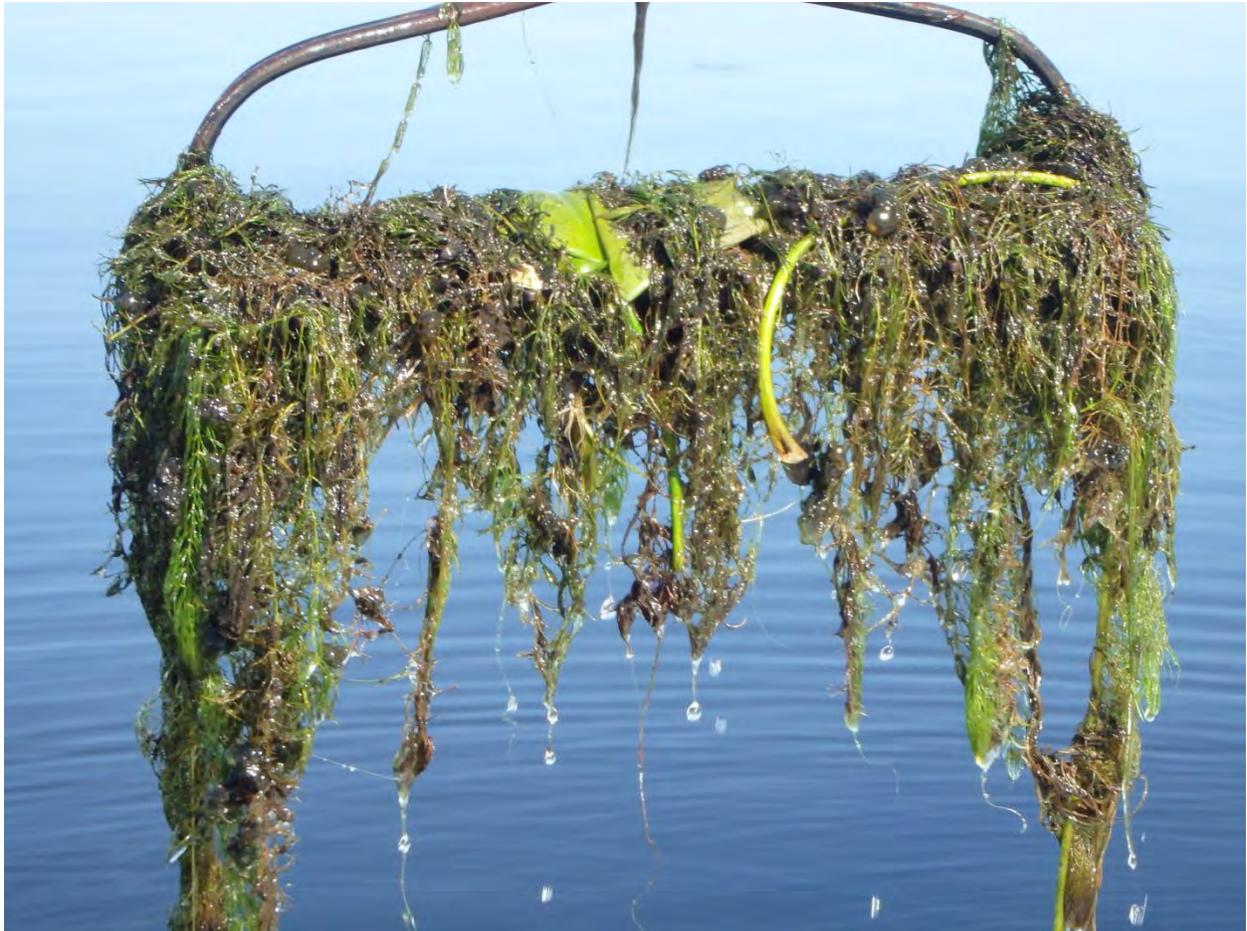
Six native SAV was found expanding during the inspection. This is a great diversity for Lake Mills. Native SAV plays an important role in the lake ecosystem by up taking nutrients coming in from the local watershed, providing habitat for aquatic species and competing for space with hydrilla. These species included; lemon bacopa to a depth of 4 feet, coontail to a depth of 5 feet, road grass to a depth of 3 feet, eelgrass to a depth of 3 feet, bladderwort to a depth of 5 feet and baby's tears to a depth of 5feet.

Photo: Coontail and bladderwort.

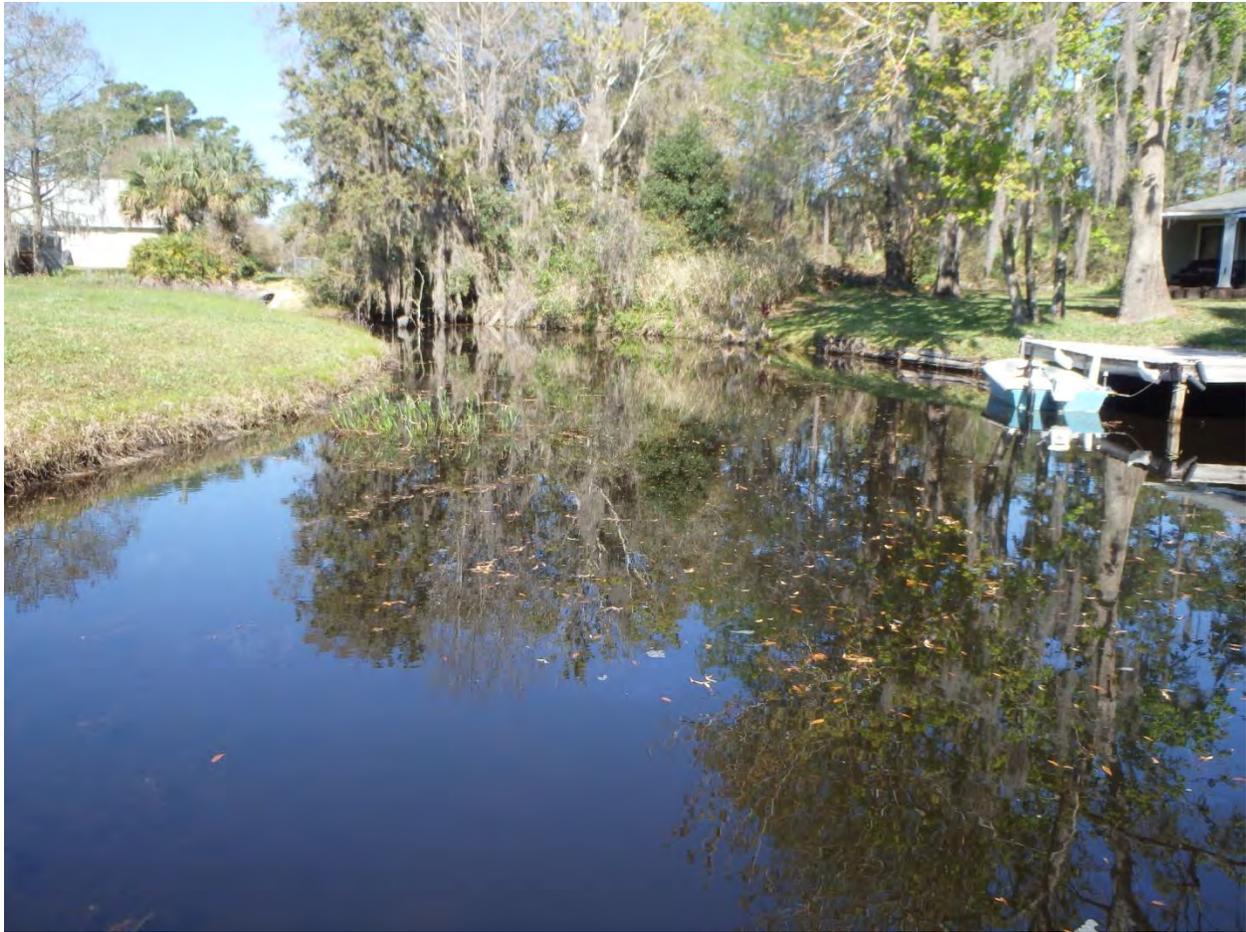
The end of the canal system on the west side of lake mills was successfully treated for parrot feather and bladderwort.

Photo: End of canal.

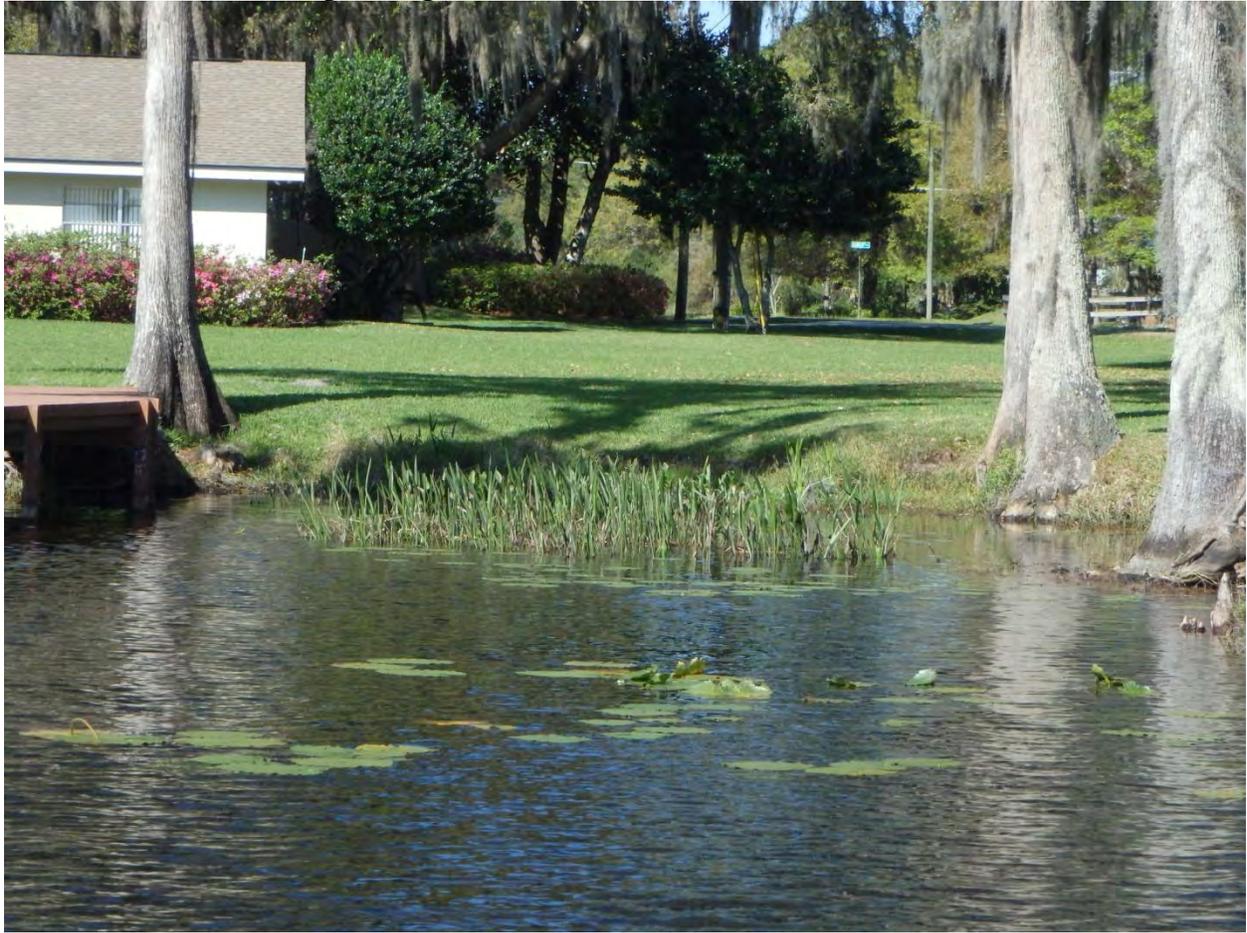
The native emergent vegetation was showing signs of coming back from “winter die back”. Duck potato and pickerel weed in particular are expanding in many locations.

Photo: Pickerelweed expanding.

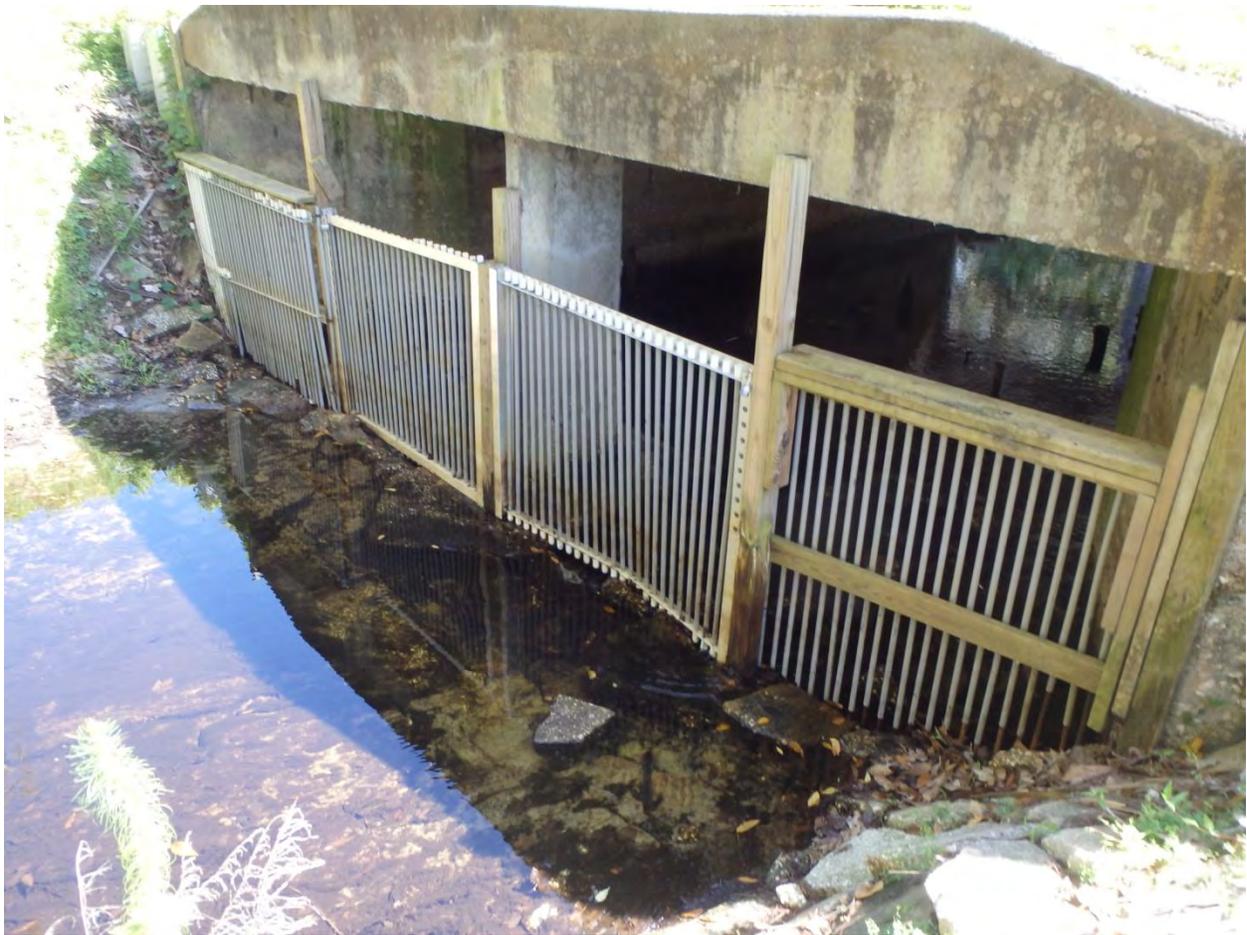
The Secchi (water clarity) was 11.9feet out of a total depth of 13.1 feet. The grass carp barrier was free from debris and operational. The water elevation at the time of inspection was 40.65 feet above sea level.

Photo: Carp barrier at Lake Mills Rd.

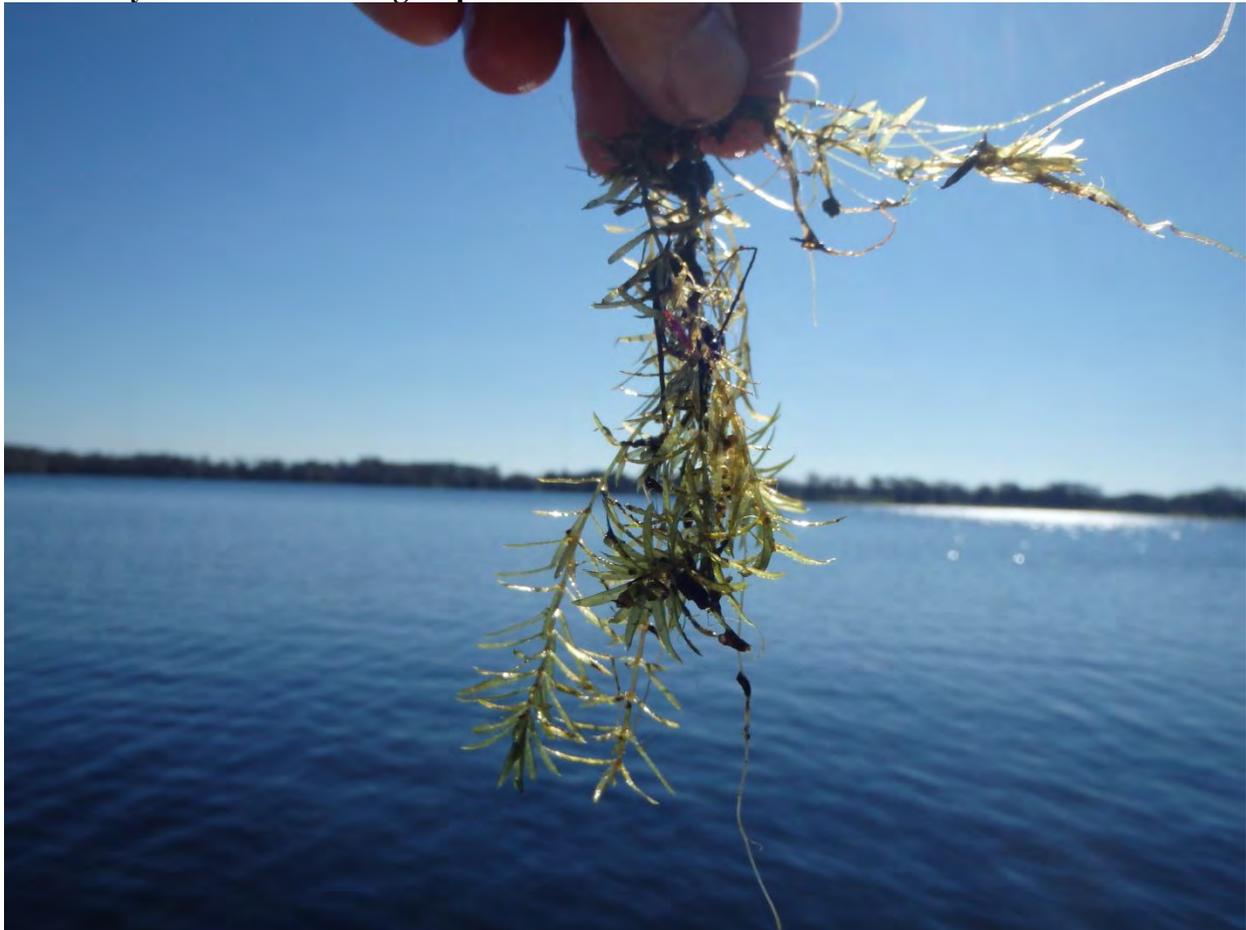
Hydrilla was present in areas along the north shore of Lake Mills to a depth of 4 feet. However there was an overall reduction since the previous month’s inspection. Three small areas will be targeted for spot treatment of hydrilla in February. At this time no grass carp will need to be stocked. These areas will be heavily monitored during the next several months.

Photo: Hydrilla found during inspection.

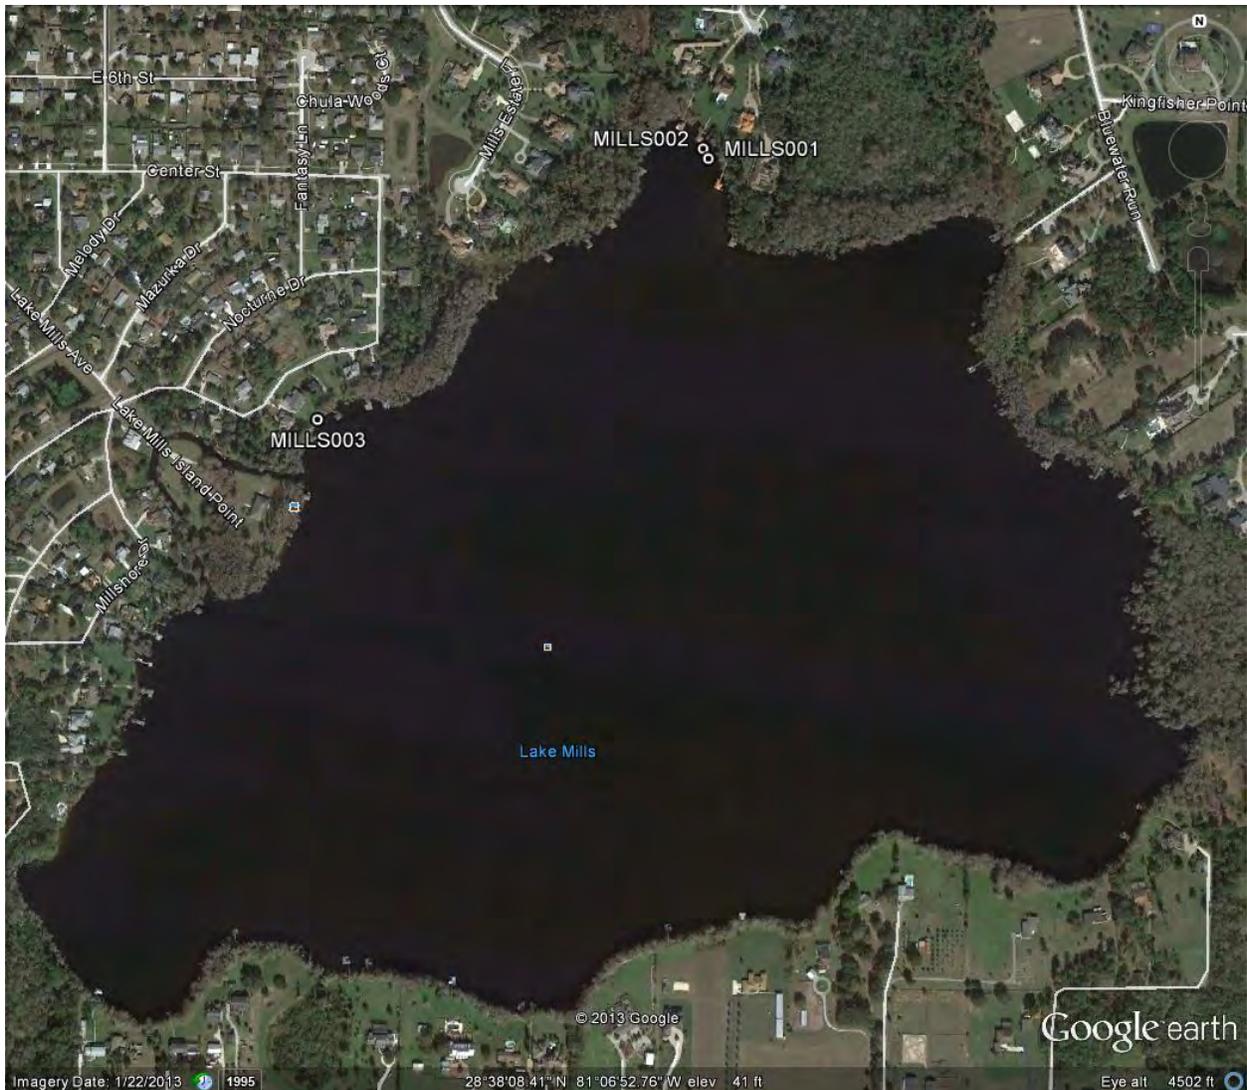
Photo: Hydrilla treatment areas.

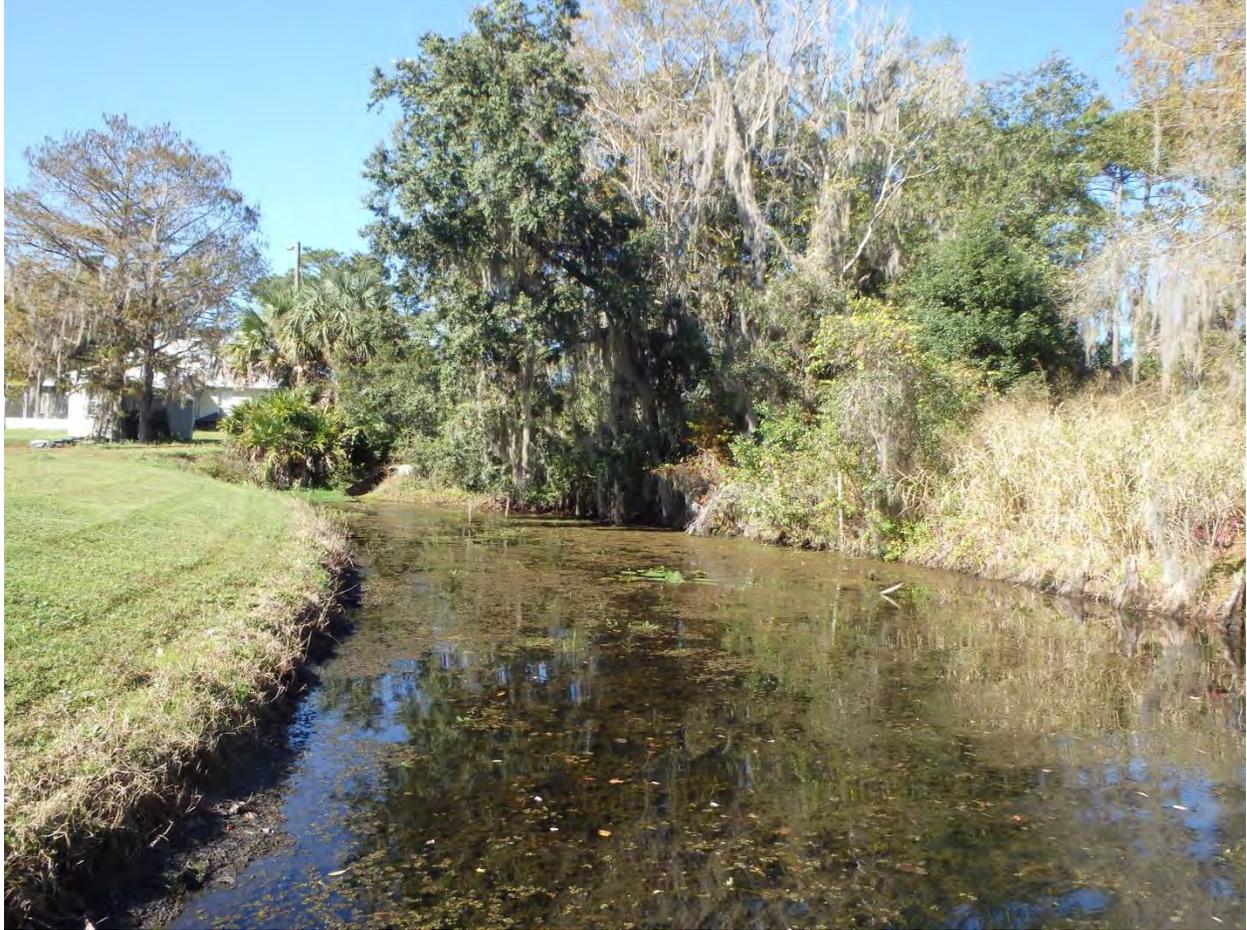
The native SAV found in Lake Mills included: lemon bacopa to a depth of 4 feet, coontail to a depth of 6 feet, road grass to a depth of 4 feet, eelgrass to a depth of 4 feet, and baby’s tears to a depth of 3feet. Eelgrass has expanded in some areas but overall there was a decrease in native SAV from the previous inspection due to the winter conditions. The end of the north canal system on the west side of Lake Mills is topped out with exotic parrot feather and native bladderwort. This area is scheduled to be targeted during the February herbicide treatment and will be closely monitored for further action. Bladderwort can be unresponsive to chemical treatments.

Photo: Topped out vegetation at the end of the canal.

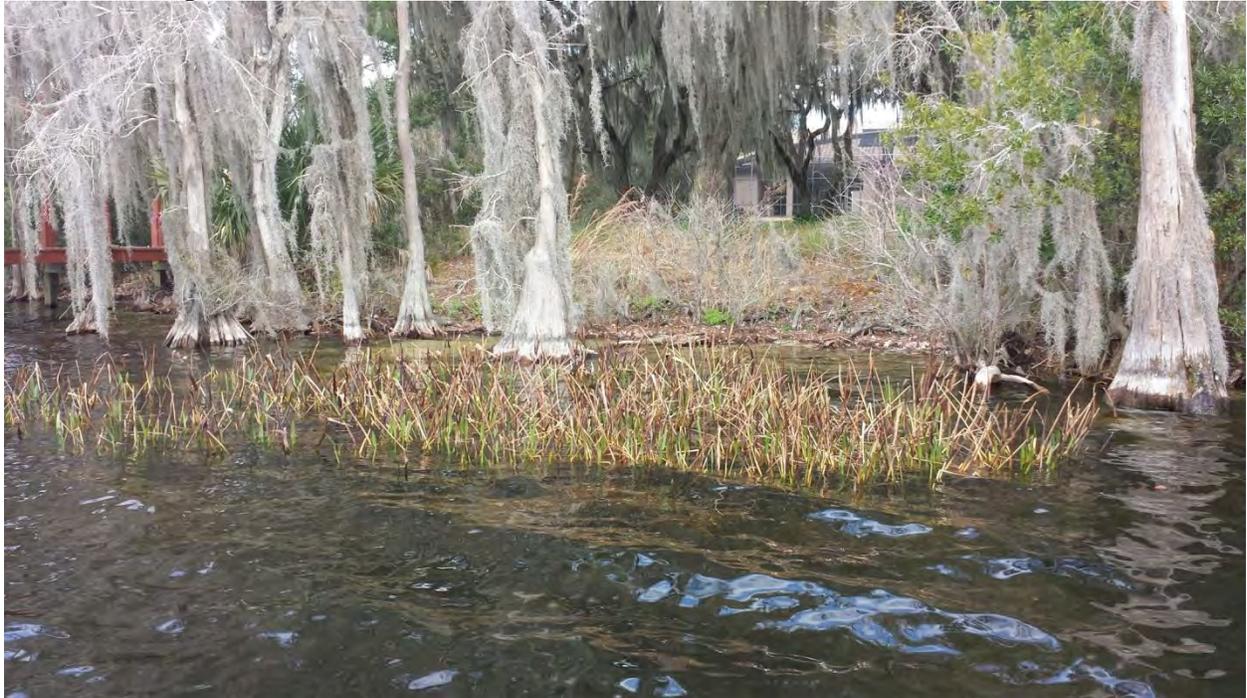
The native emergent vegetation was showing signs of “winter die back”. Cold weather is turning the leaves brown on many of the native vegetation including: pickerelweed, duck potato, fire flag and maidencane.

Photo: Example of “winter dieback” in pickerelweed.

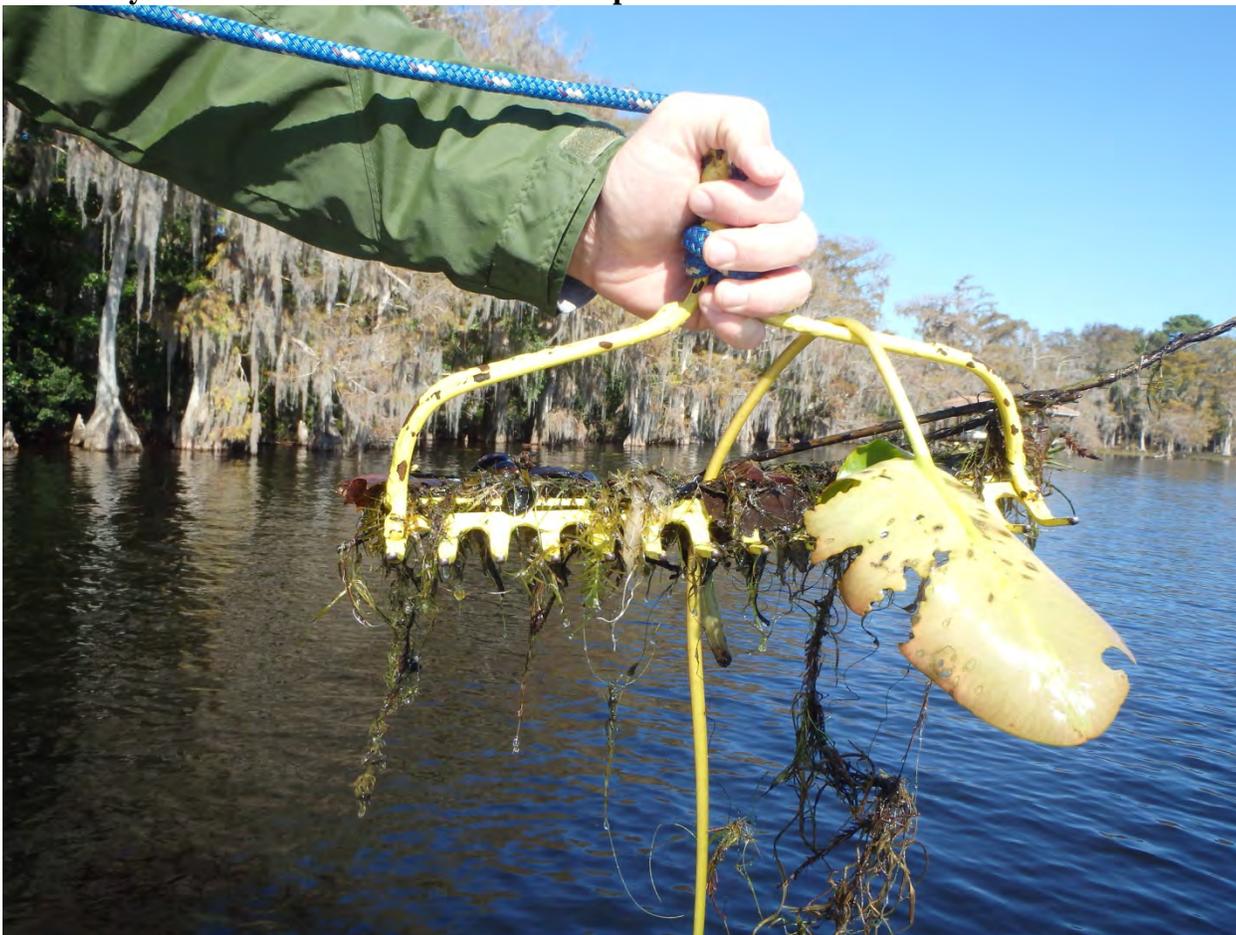
Hydrilla was found expanding in the north cove and northeast corner of the lake to a depth of 5 feet. Currently the hydrilla is competing for space with eelgrass, coontail, and southern naiad. It is expected that the grass carp fish and winter conditions will reduce these new plants. Hydrilla was also found in both the north and south canals along the west shore. We will continue to closely monitor hydrilla to see if any further action will need to be taken.

Photo: Hydrilla found mixed in with native species.

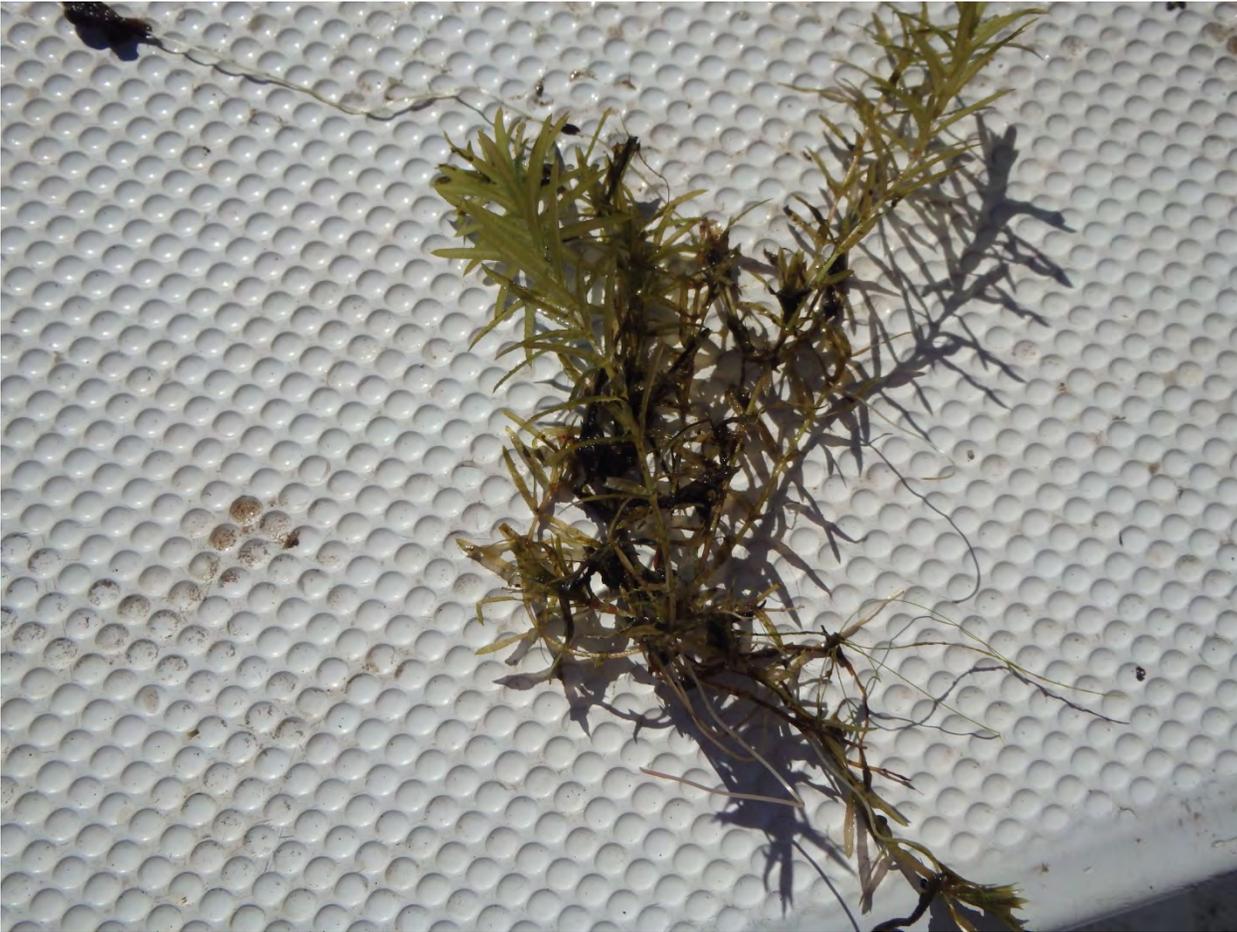
Photo: Hydrilla sprig found along northern shore of Lake Mills.

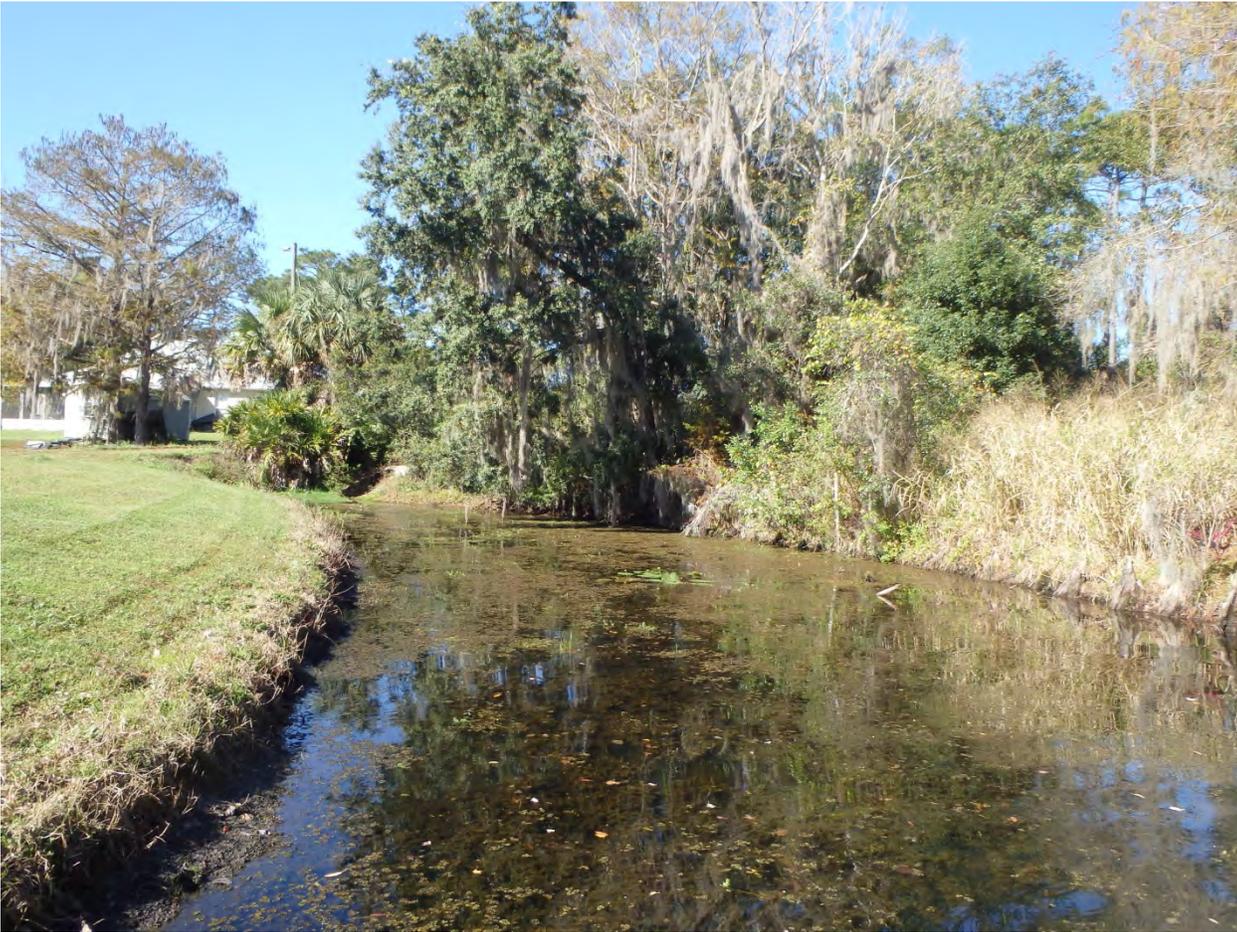
Native SAV in Lake Mills continues to expand lake wide since the previous month. These species play an important role within the lake by providing habitat, reducing nutrients, and competing for space with hydrilla. The native SAV found included: southern naiad to a depth of 4.5 feet, lemon bacopa to a depth of 3 feet, coontail to a depth of 4.5 feet, road grass to a depth of 2 feet, eelgrass to a depth of 3 feet, stonewort to a depth of 3 feet, bladderwort to a depth of 2 feet and baby's tears to a depth of 1foot. Several new shoots of eelgrass were found in shallow areas of the lake. Bladderwort has expanded within the canal system and is beginning to top out at the end of both the north and south sections.

Photo: Bladderwort found topped within the canal system.

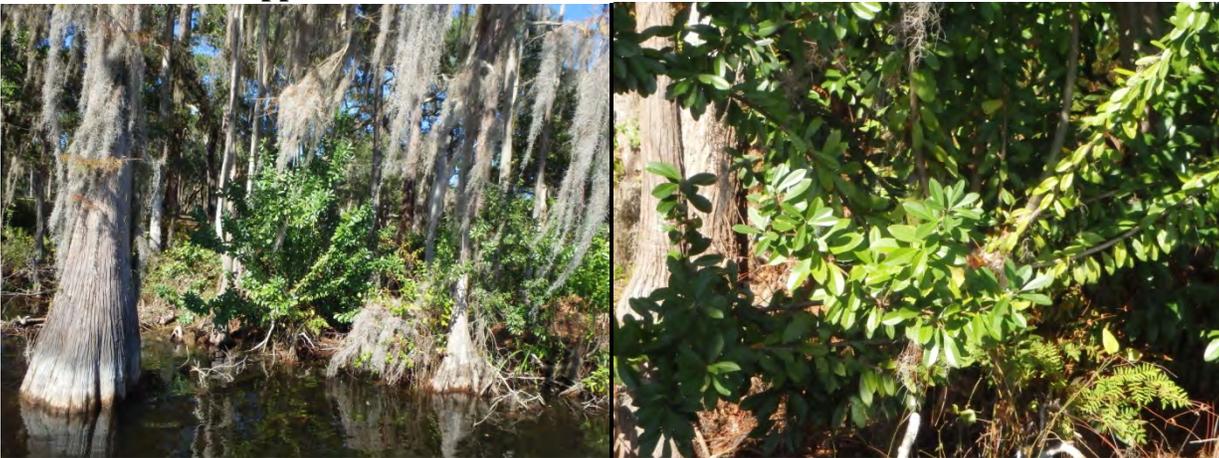
Brazilian pepper was found at 3 sites on the southern shore of Lake Mills. This tree is one of the most aggressive invasive exotic pest plants of Florida. It is recommended that this tree is removed before it disrupts and dominates the native communities of the Lake Mills Shoreline.

Photo: Brazilian Pepper tree.

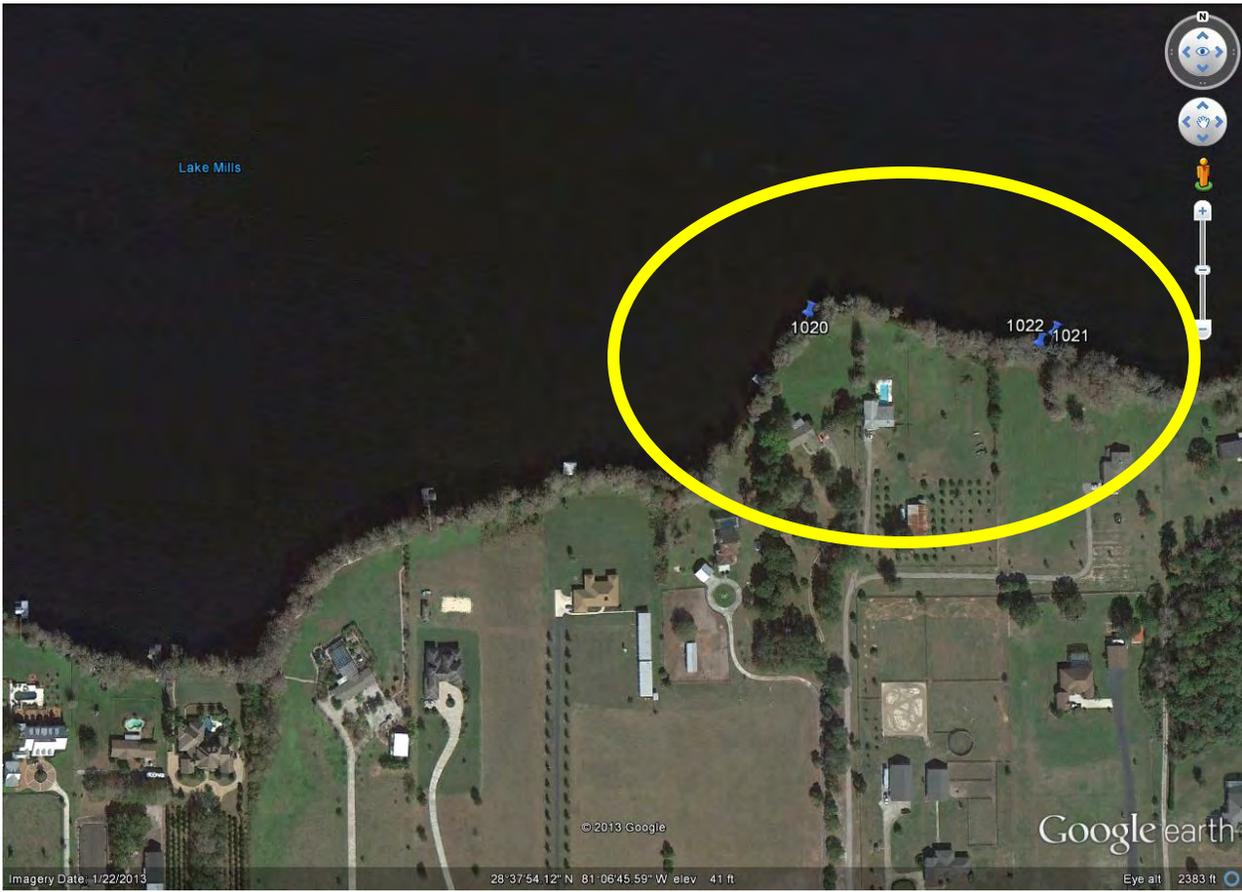
Photo: Brazilian Pepper sites on south side of the lake.

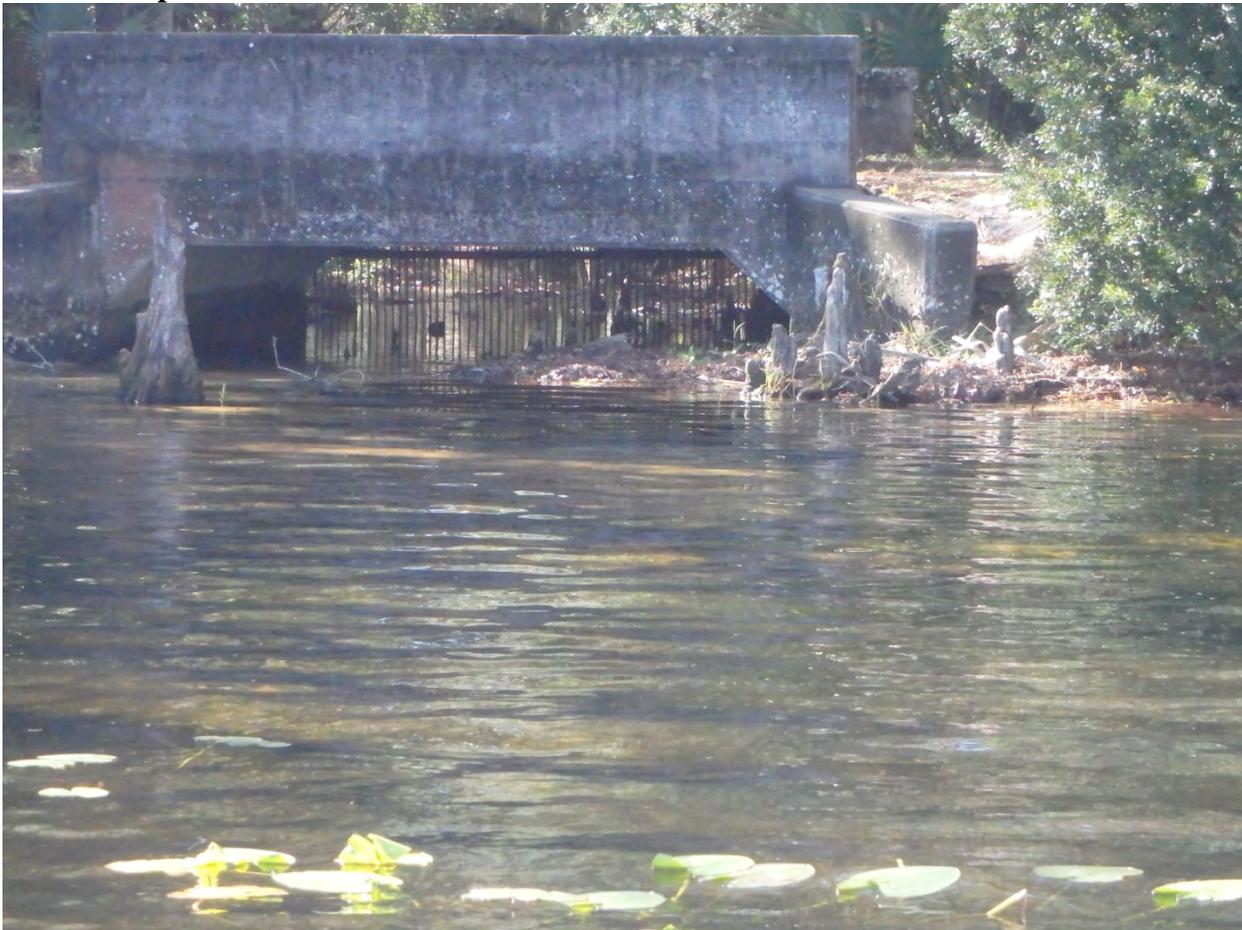
Photo: Carp barrier at Lake Mills Park.

The Secchi (water clarity) was 8.5 feet compared to the previous inspections reading of 8.8 feet. The grass carp barriers were free from debris and operational. The water elevation at the time of inspection was 40.57 feet above sea level.
