Please find the latest bioassessment for your lake below. Our next lake inspection is scheduled for **June 10th, 2014**, weather permitting. Key highlights of this update include:

On **May 15th, 2014**, Seminole County Lake Management Program staff, Thomas Calhoun and Gloria Eby, surveyed the aquatic plants in **Lake Mills**.

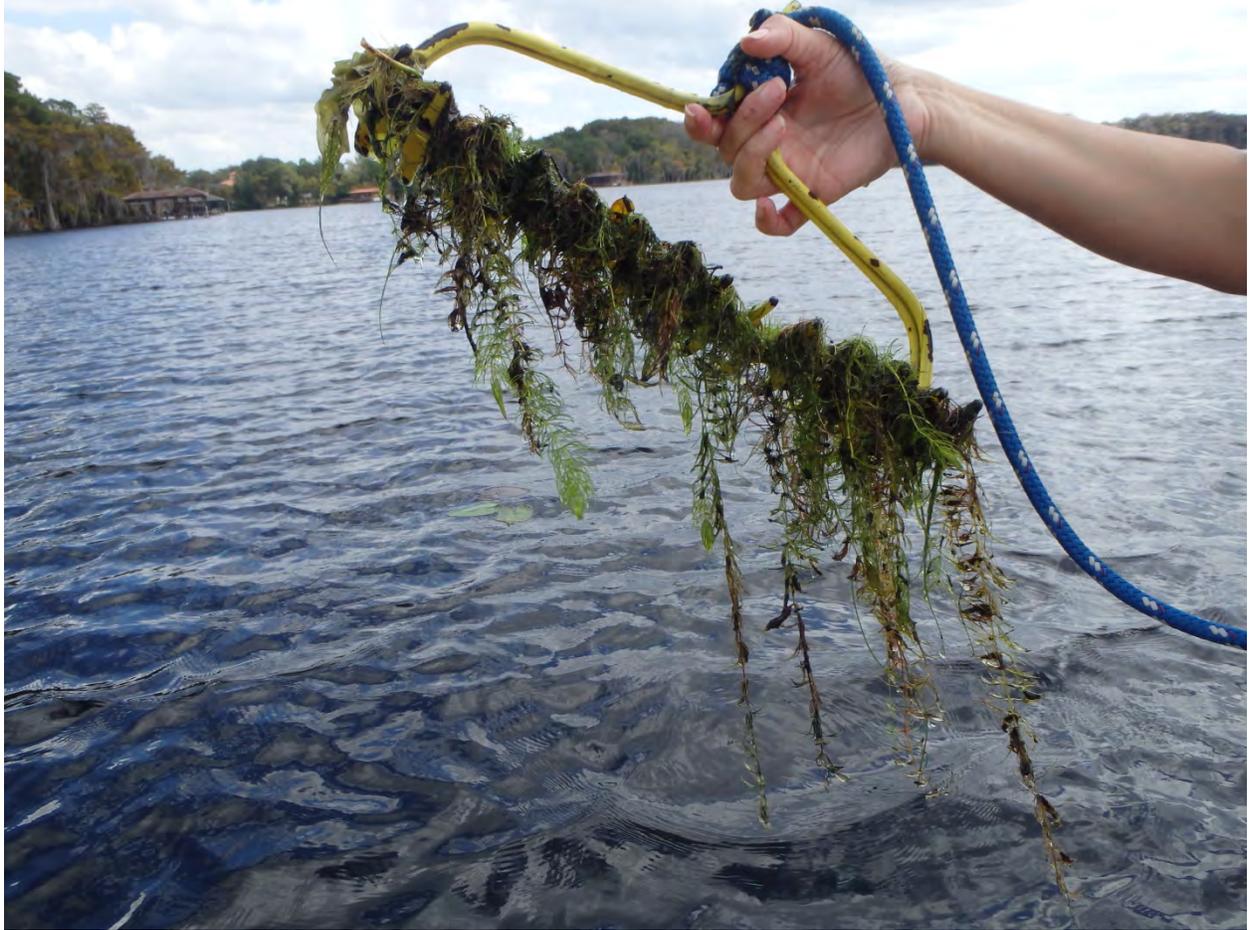
Native SAV in Lake Mills continues to expand lake-wide since the previous month. These species play an important role within the lake by providing habitat, reducing nutrients, and competing with hydrilla for space. The native SAV found included: southern naiad to a depth of 7 feet, lemon bacopa to a depth of 5 feet, coontail to a depth of 7 feet, road grass to a depth of 7 feet, eelgrass to a depth of 2 feet, stonewort to a depth of 4 feet, bladderwort to a depth of 4 feet, and baby's tears to a depth of 2 feet.

Photo: Native submersed plant, coontail, expanding in Lake Mills.

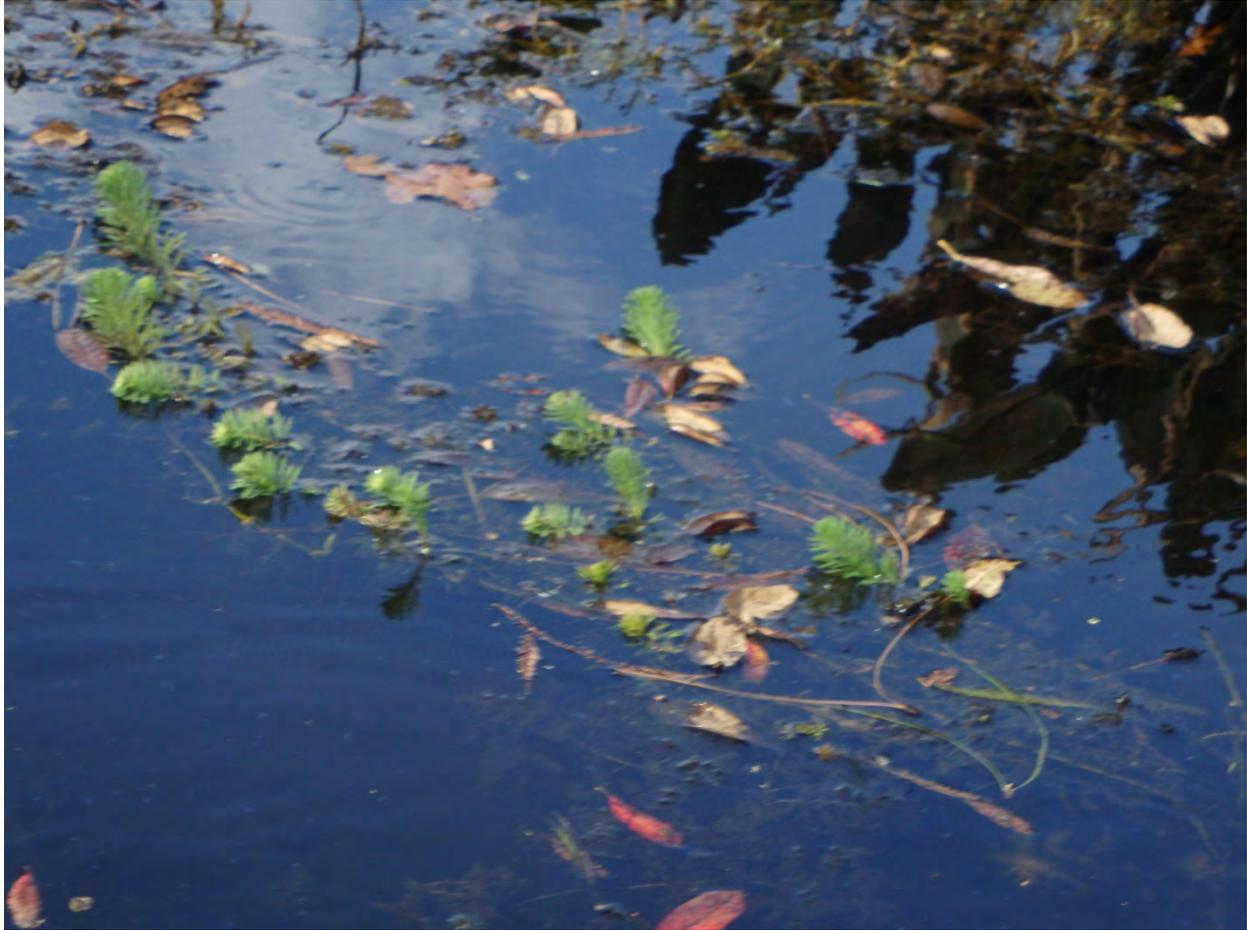
A small amount of hydrilla was found at a private boat ramp along the north western shoreline and in the northwest canal. The invasive species parrot's feather was also found in the northwest canal. Both areas and species will be scheduled for treatment upon next service date.

Photo: Parrot's feather found within west canal.

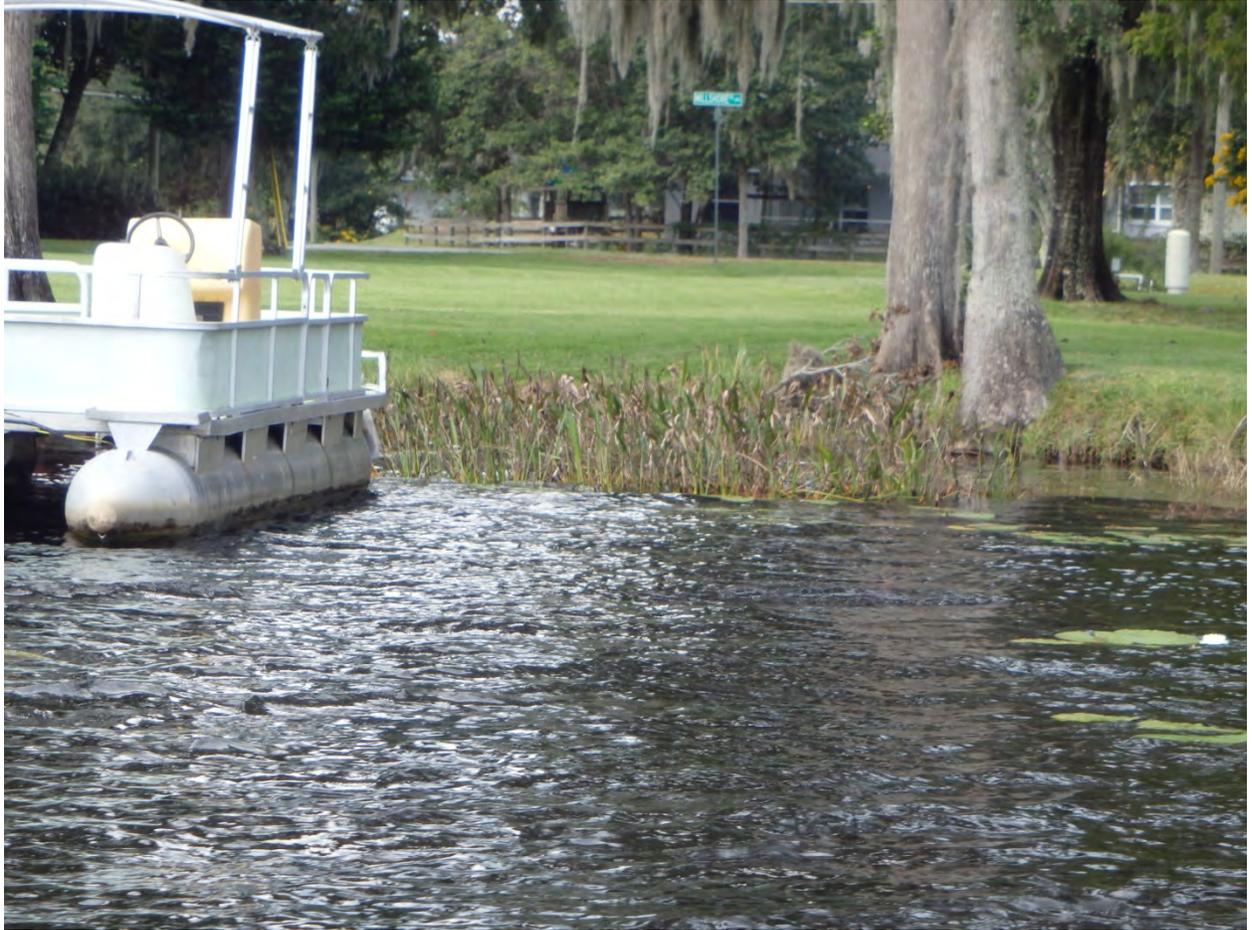
Emergent vegetation around Lake Mills continues to be treated by the MSBU funded herbicide contractor. Very few stands of torpedo grass remain in Lake Mills. This is allowing native vegetation (such as maidencane, pickerelweed and duck potato) to continue to expand along many of the shorelines.

Photo: Pickerelweed expanding at a previous restoration site.

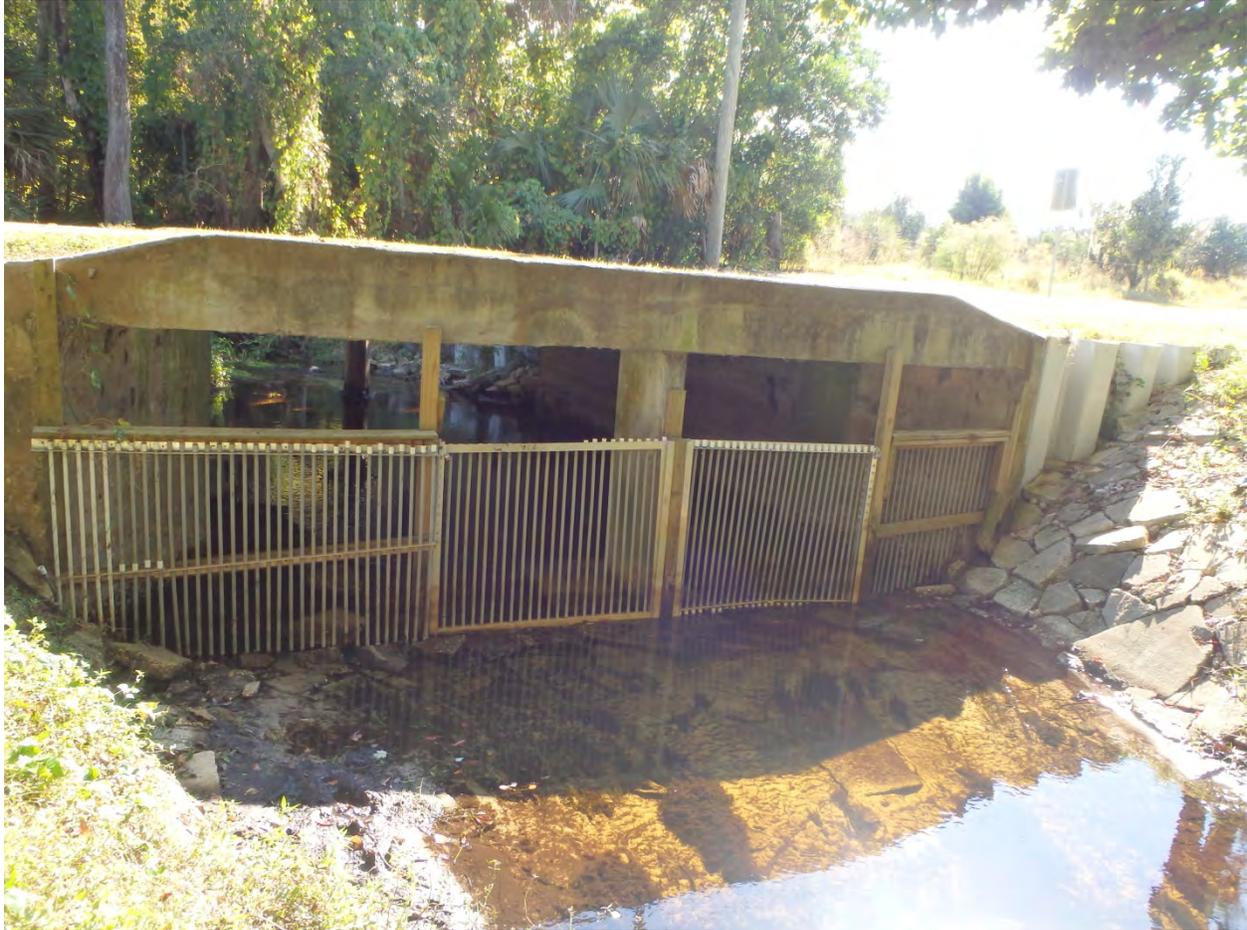
Photo: Grass carp barrier at Lake Mills Rd.

The Secchi (water clarity) was 8.8 feet compared to the previous inspections reading of 8.6 feet. The grass carp barriers were observed free from debris and operational. The water elevation at the time of inspection was 40.91 feet above sea level.

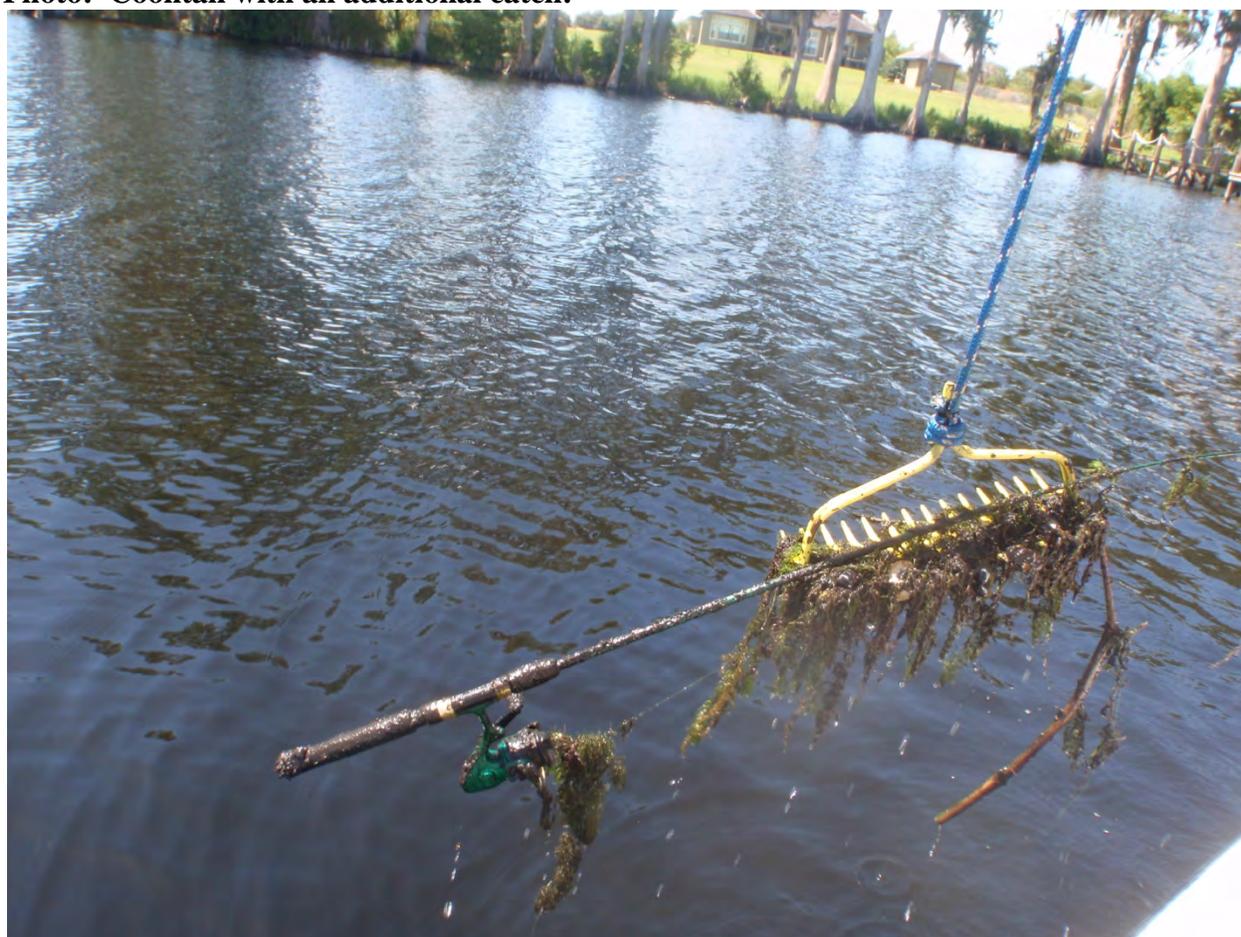
The native SAV found included: lemon bacopa to a depth of 5 feet, coontail to a depth of 5 feet, road grass to a depth of 5 feet, eelgrass to a depth of 2 feet, stonewort to a depth of 6 feet, bladderwort to a depth of 3 feet, and baby's tears to a depth of 3 feet. Again coontail continues to expand throughout the lake.

Photo: Coontail with an additional catch!

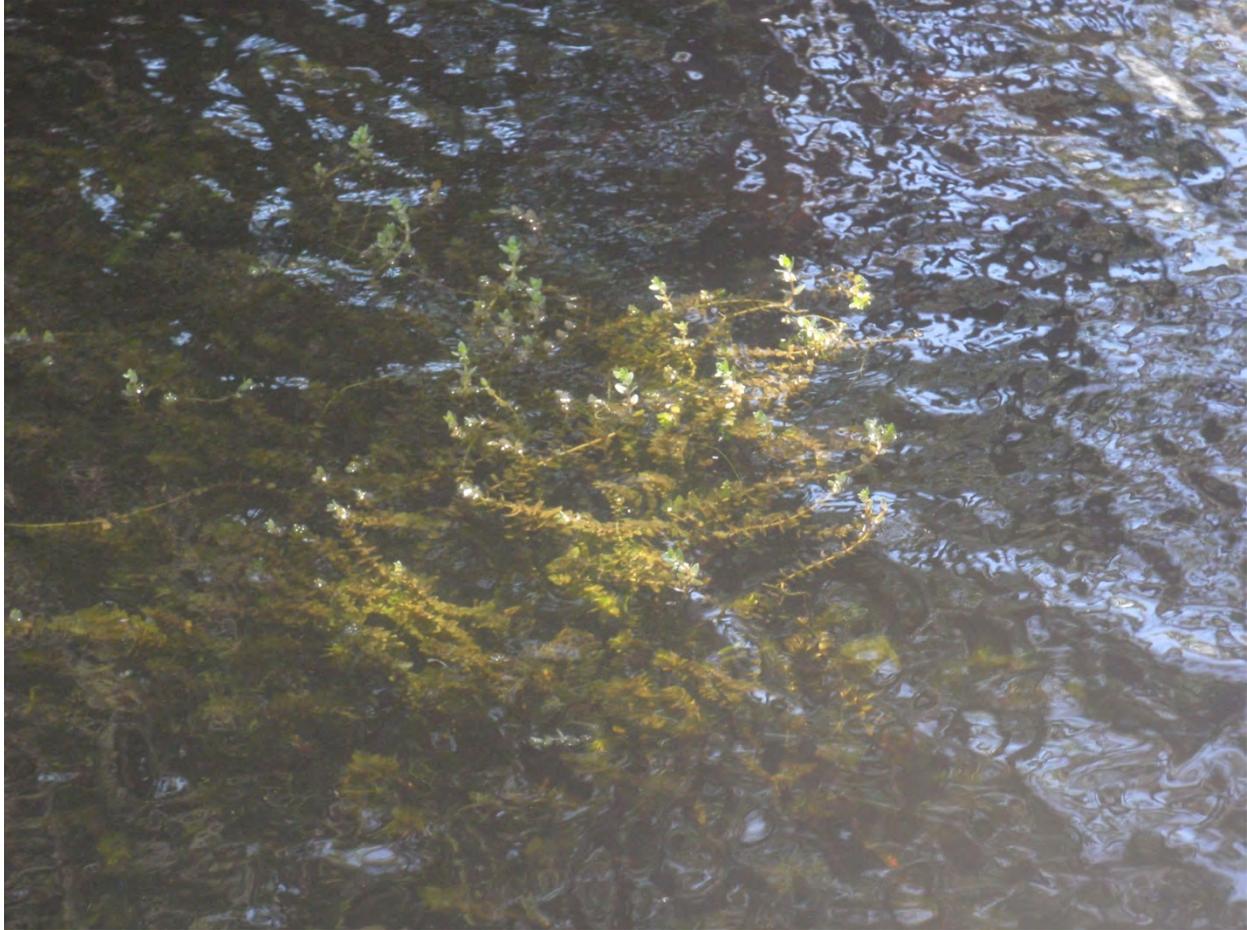
Photo: Native lemon bacopa found in depths up to 4 feet.

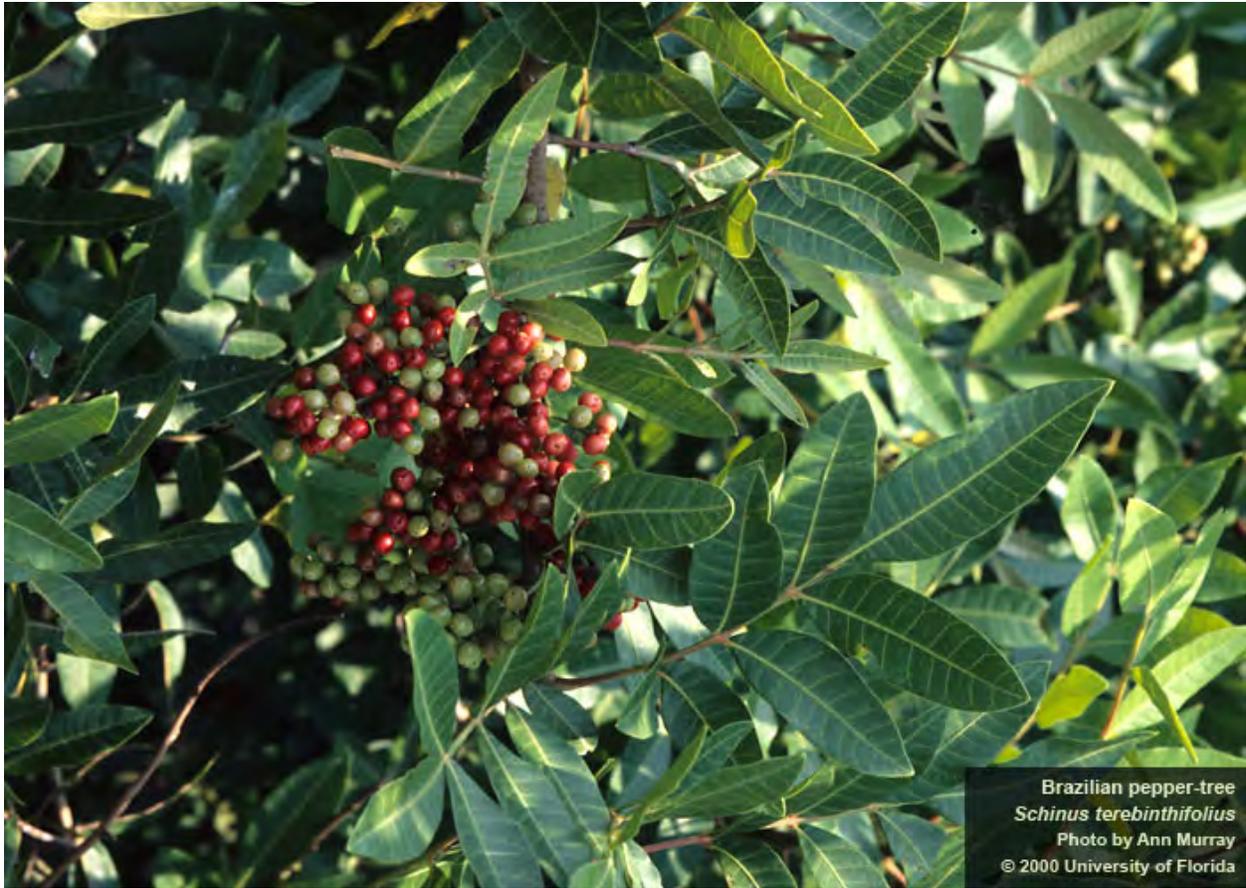
Emergent vegetation around Lake Mills continues to be treated by the MSBU funded herbicide contractor. Native vegetation such as maidencane, pickerelweed, and duck potato continues to expand along many of the shorelines. The invasive exotic tree Brazilian Pepper was found along the southern shoreline of the lake. It is recommended that these trees be removed due to its ability to rapidly expand and shade out native plant communities. More information on Brazilian Pepper can be found on-line at: <http://plants.ifas.ufl.edu/node/405>.

Photo: Example of Brazilian Pepper.

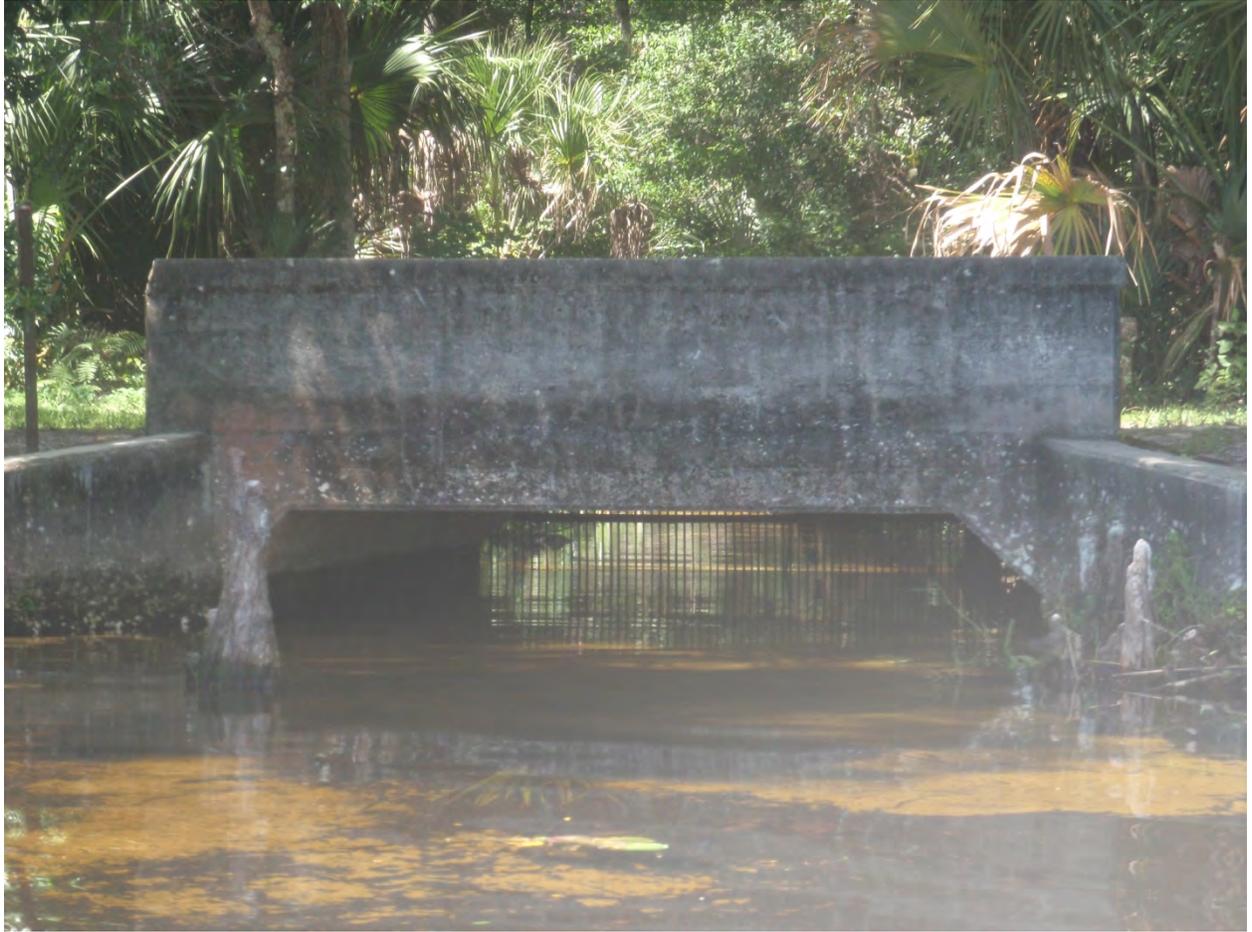
The Secchi (water clarity) was 8.6 feet compared to the previous inspections reading of 8.2 feet. The grass carp barriers were observed free from debris and operational. The water elevation at the time of inspection was 41.05 feet above sea level.

Photo: Condition of grass carp barrier at Lake Mills Park.

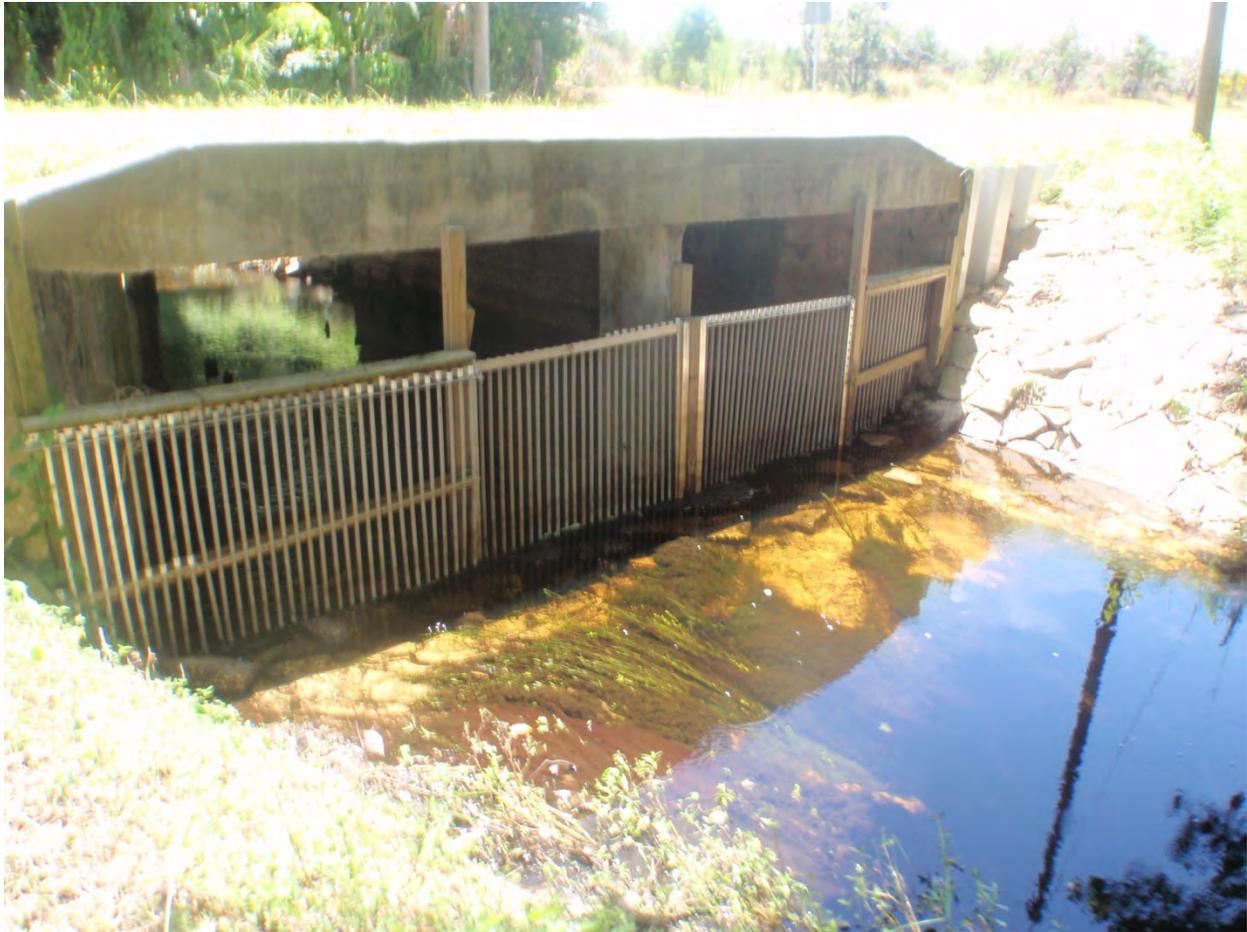
Photo: Condition of grass carp barrier at Lake Mills Rd.
