Greetings Lake Brantley residents!

On **September 25th, 2014**, Seminole County Lake Management personnel (Thomas Calhoun, Marianne Pluchino, and Beth Stephens) surveyed the aquatic plants in **Lake Brantley** and conducted a Lake Vegetation Index (LVI).

On **March 27th, 2014**, Seminole County Lake Management personnel, Thomas Calhoun and Michelle Shelton, surveyed the aquatic plants in **Lake Brantley**.

On **October 25th, 2013**, Seminole County Lake Management personnel Gloria Eby and Marianne Pluchino, surveyed the aquatic plants in **Lake Brantley** and also conducted a Lake Vegetation Index (LVI).

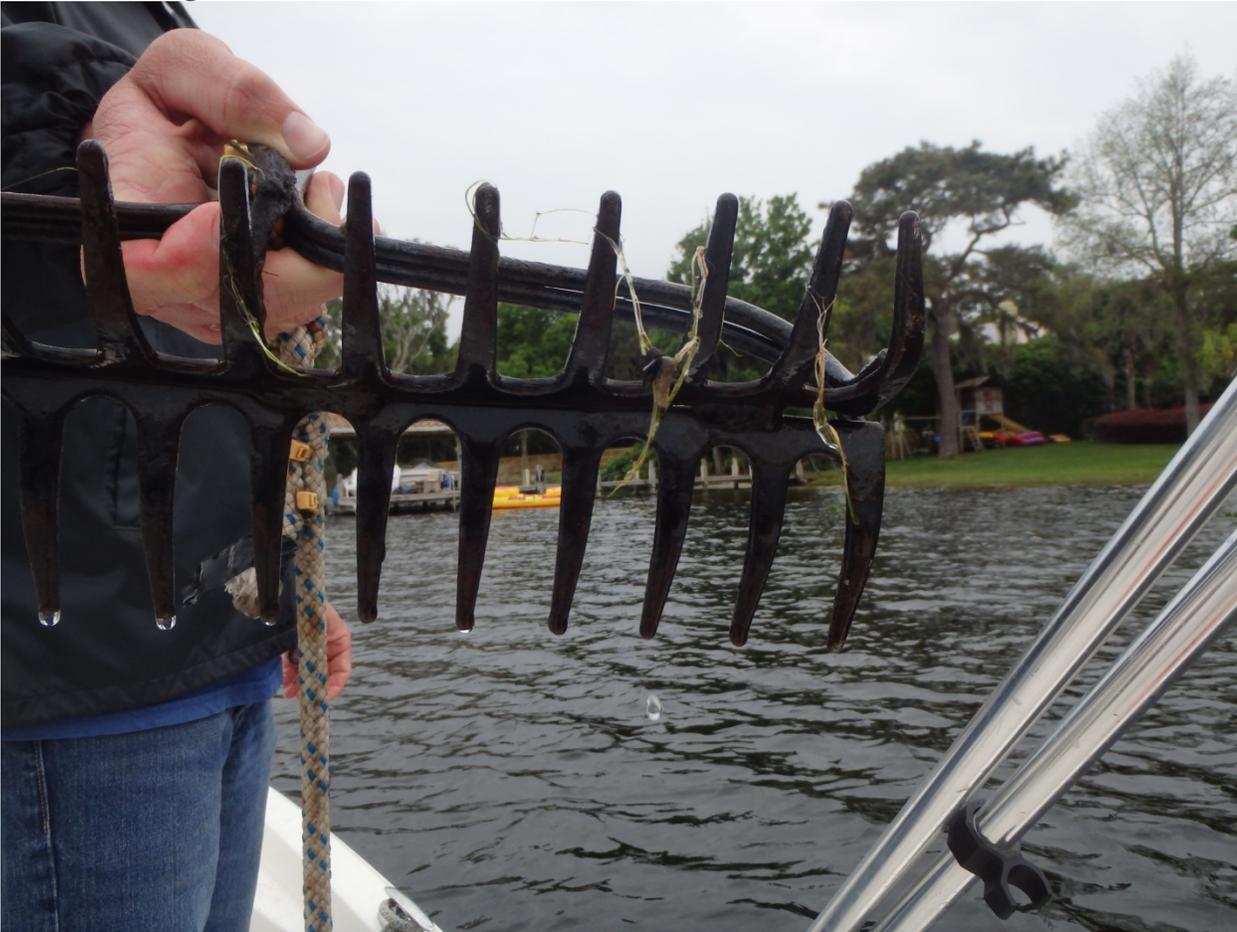
Two species of native submersed aquatic vegetation (SAV) was observed during the inspection; road grass and bladderwort were found to a depth of 7 feet. Native SAV plays an important role within the ecosystem of Lake Brantley by providing habitat for wildlife, reducing nutrients from run-off, and competing for space with hydrilla. Detritus (decaying organic matter) still covers much of the bottom of the lake. Hydrilla was not observed during this inspection.

Photo: Road grass.

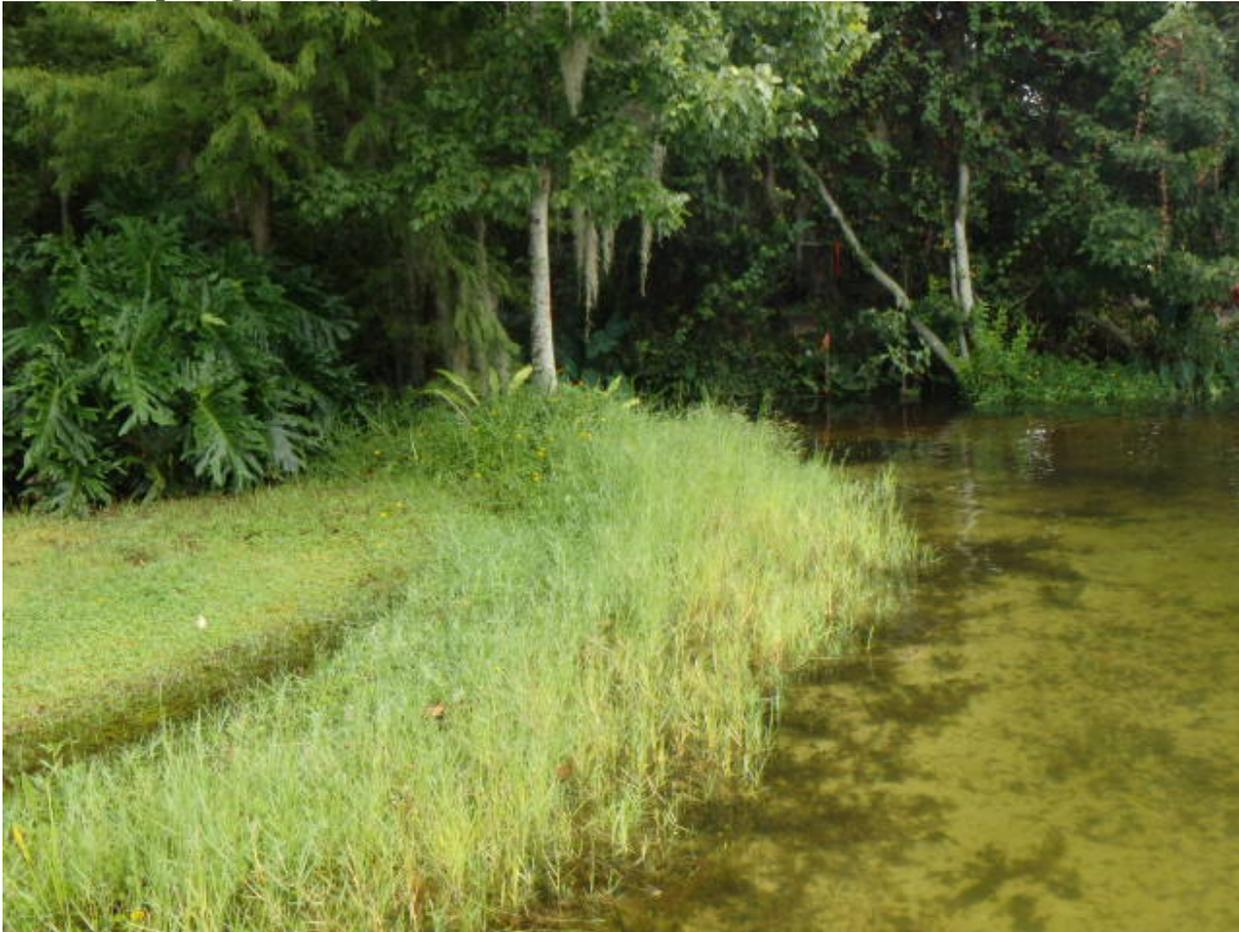
Exotic emergent plants observed included alligatorweed, elephant ear, primrose willow, and torpedo grass. The dominant species along many shorelines continues to be torpedo grass. Two water hyacinth plants were present in the canal along the south eastern shore.

Photo: Torpedo grass along shoreline.

2. Treat invasive torpedo grass, melaleuca, and other invasive aquatic plants along your waterfront. Either do it yourself by hand removal or obtain the necessary aquatic herbicide (we can provide some sources) or hire a contracted aquatic herbicide application company (we can provide a list of vendors from the state). Control of aquatic and wetland plants will in most cases requires a free Florida Fish and Wildlife Conservation Commission (FWC) aquatic plant control permit. Contact Alicia Knecht at (321-246-0682) or Alicia.Knecht@myFWC.com for a permit.

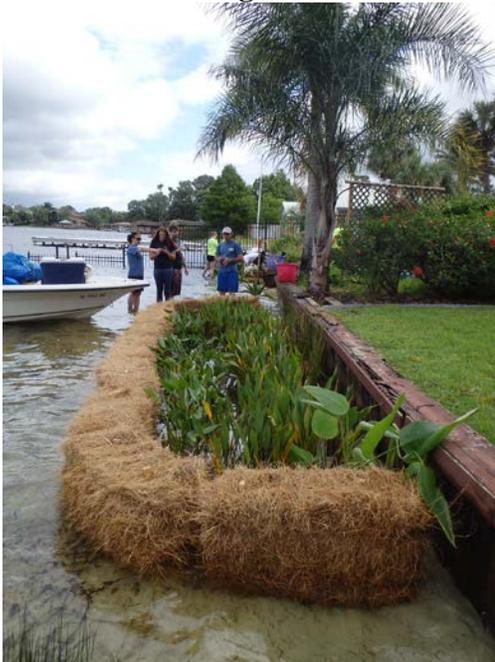
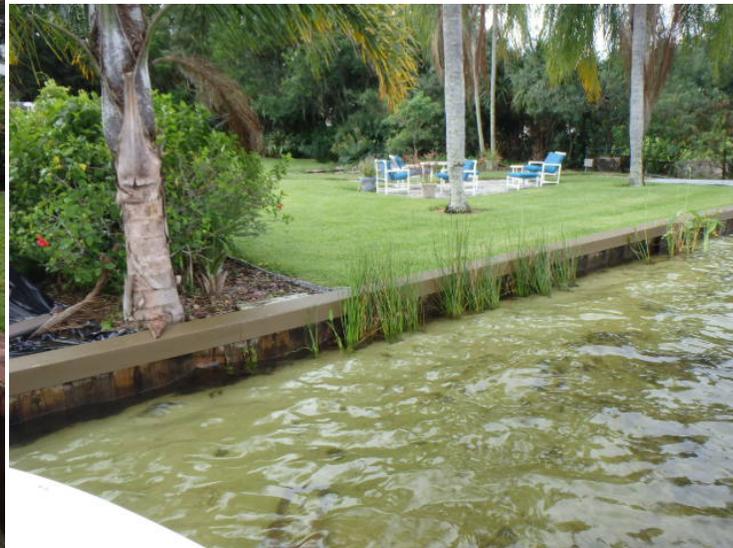
Much of the vegetation from the April 19th restoration event has been reduced by the grass carp fish; however, in areas where plants have remained protected (behind an installed grass carp fish exclusion barrier), the plants are establishing.

Photo: Native vegetation before and after barrier removal.

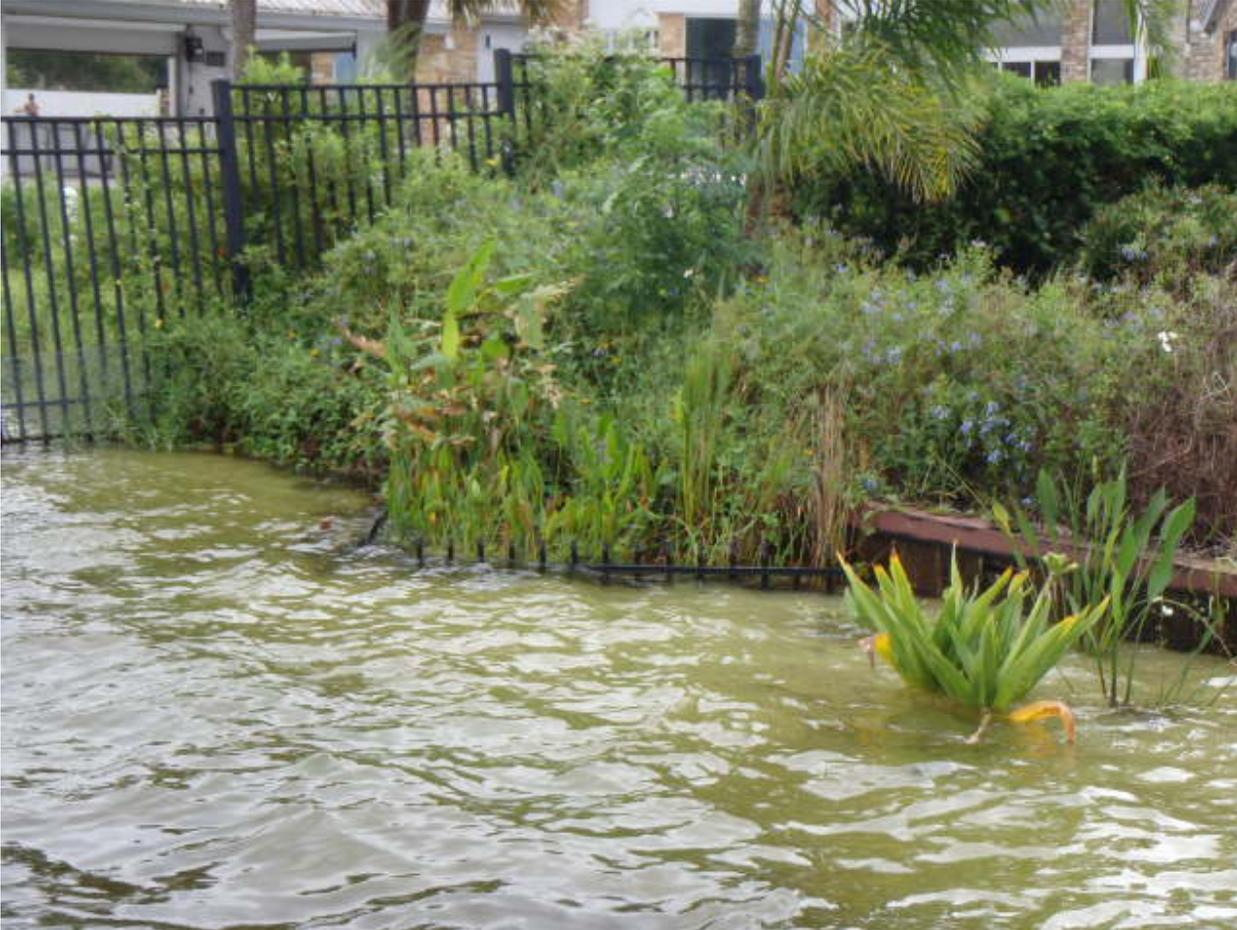
Photo: Native vegetation behind barrier.

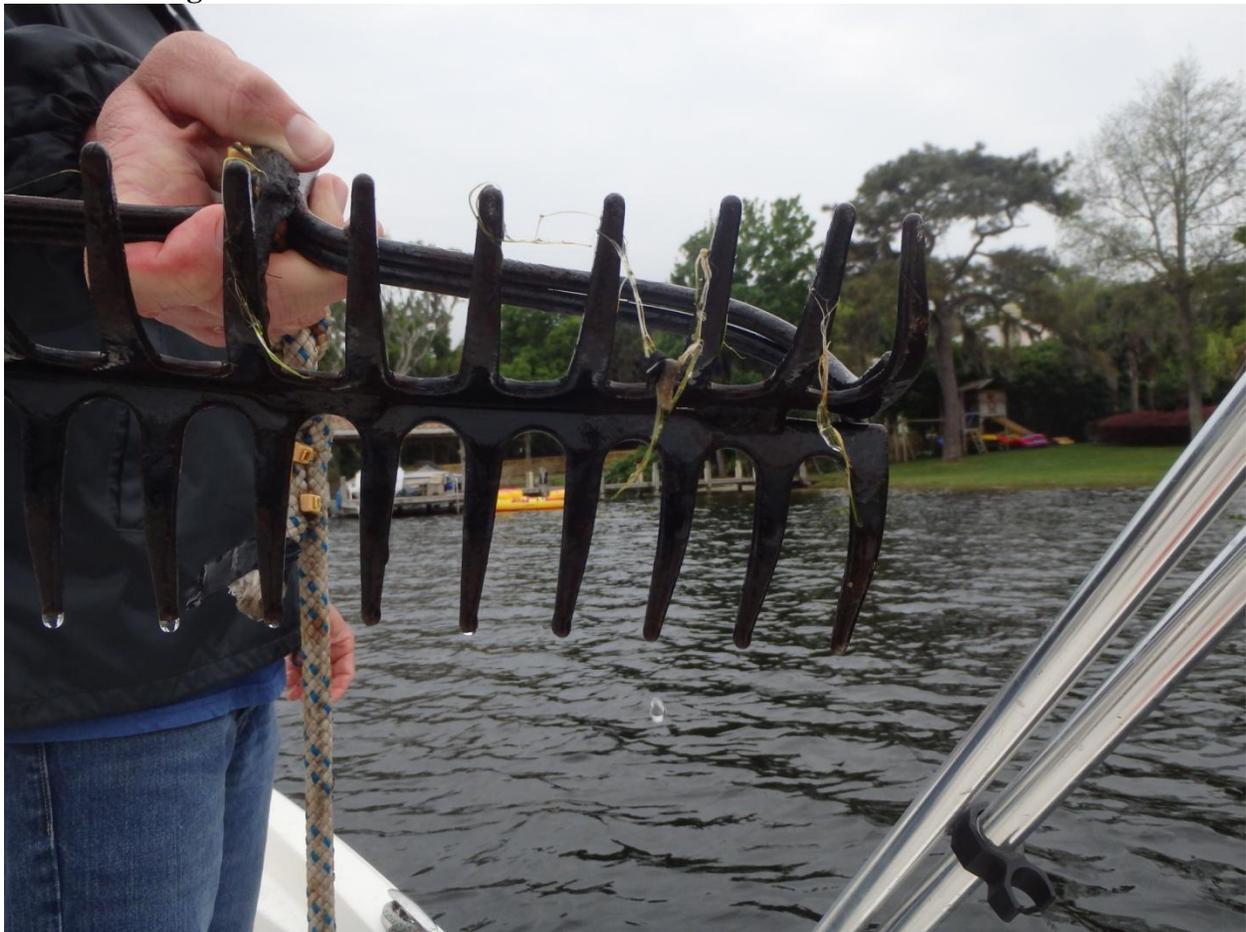
One species of submersed aquatic vegetation (SAV) was observed during the inspection; road grass was found to a depth of 4 feet. Native SAV plays an important role within the ecosystem of Lake Brantley by providing habitat for wildlife, reducing nutrients from run-off, and competing for space with hydrilla. Detritus (decaying organic matter) still covers much of the bottom of the lake. Hydrilla was not observed during this inspection.

Photo: Road grass.

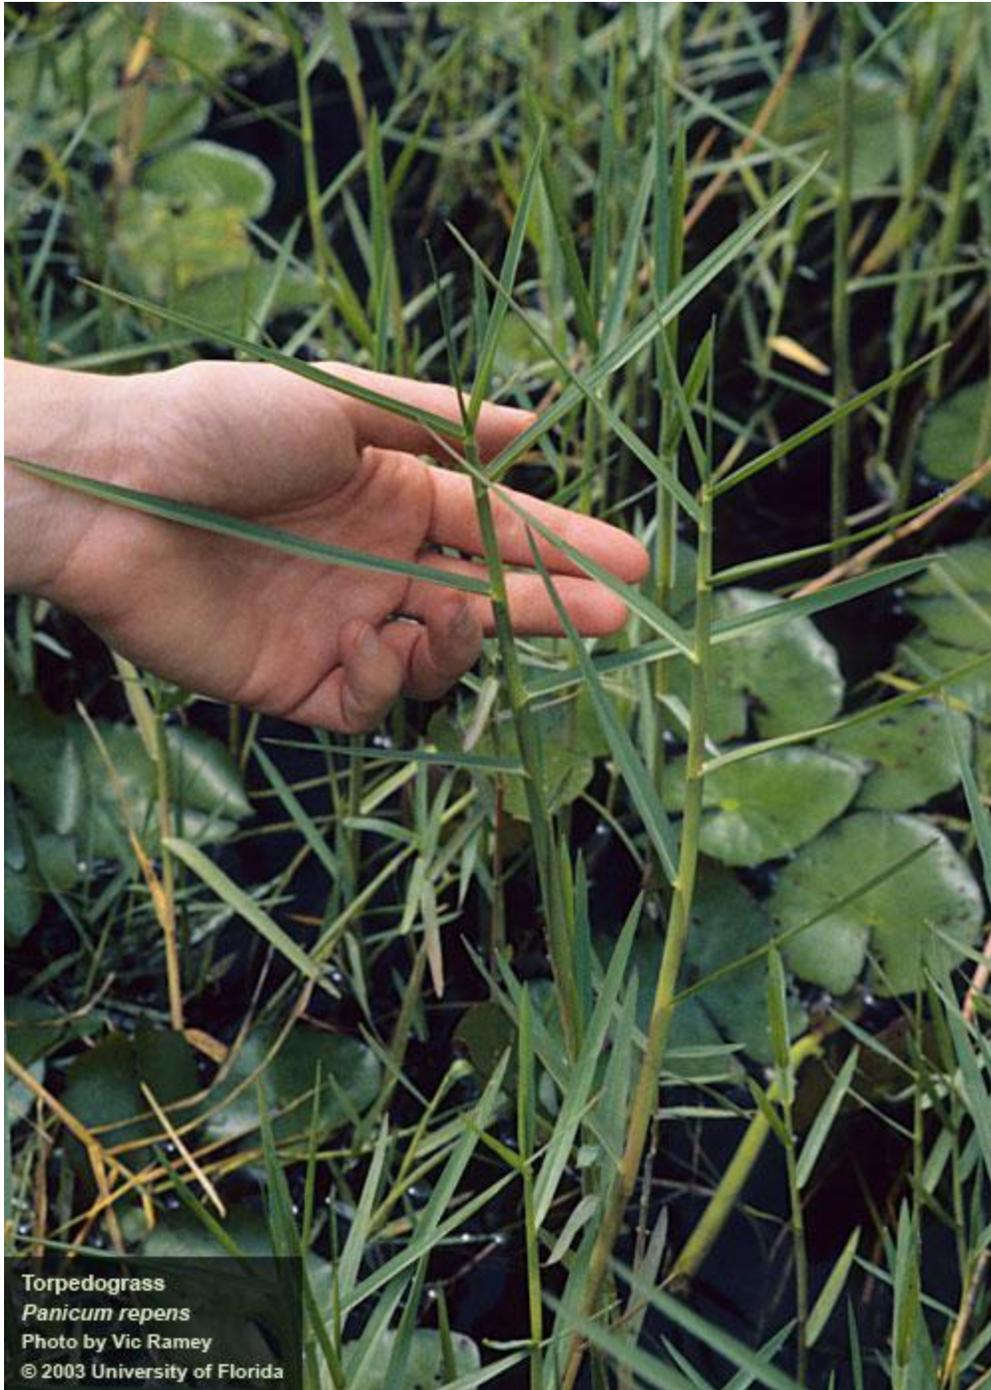
Exotic emergent plants observed included alligator weed, elephant ear, primrose willow, and torpedo grass. The dominant species along many shorelines continues to be torpedo grass. No water hyacinths were observed during the inspection. Please remember that in order to alter your shoreline or treat exotic vegetation with an herbicide, you must apply for a free aquatic plant removal permit through the Florida Wildlife Conservation Commission <http://www.myfwc.com/license/aquatic-plants> or contact FWC Regional Biologist Alicia Knecht at Alicia.Knecht@myfwc.com or 321-246-0682.

Photo: Example of torpedo grass along shoreline.

2. Treat invasive torpedo grass, melaleuca, and other invasive aquatic plants along your waterfront. Either do it yourself by hand removal or obtain the necessary aquatic herbicide (we can provide some sources) or hire a contracted aquatic herbicide application company (we can provide a list of vendors from the state). This recommendation could be managed by Seminole County by establishing an MSBU, Municipal Service Benefit Unit, for aquatic weed control services. For additional information contact Carol Watral at (407) 665-7164 or cwatral@seminolecountyfl.gov or <http://www.seminolecountyfl.gov/fs/msbu/>. Control of aquatic and wetland plants will in most cases requires a free Florida Fish and Wildlife Conservation Commission (FWC) aquatic plant control permit. Contact Alicia Knecht at (321-246-0682) or Alicia.Knecht@myFWC.com for a permit.

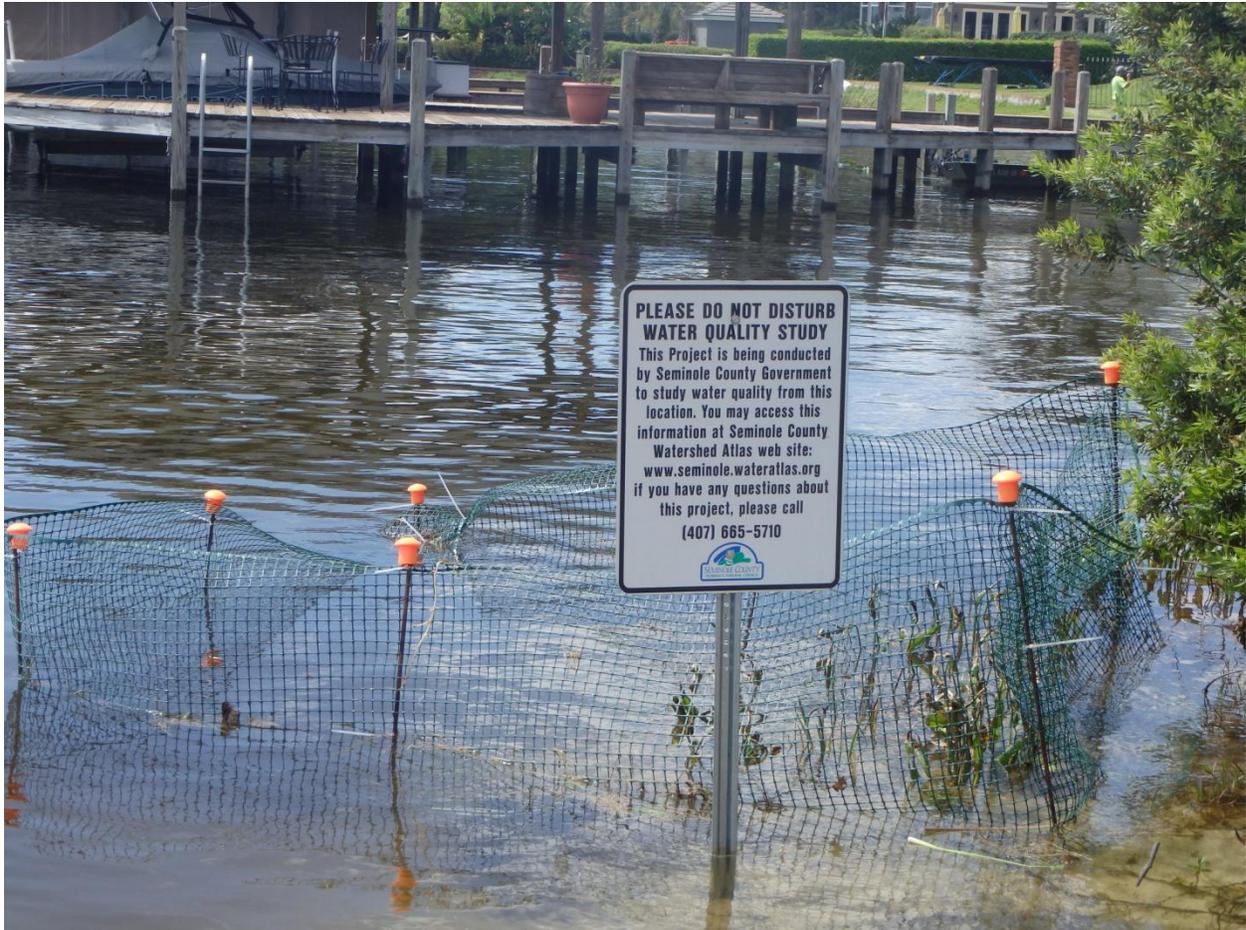
A grass carp fish exclusion cage was installed at the Sweetwater Beach. This is an experiment designed to determine if the grass carp fish are having an effect on the emergent vegetation in Lake Brantley. Emergent vegetation was planted inside and outside of the cage. As last of inspection, plants inside the cage were growing well, but plants outside the cage were greatly eaten by grass carp.

Photo: Grass carp fish exclusion cage.

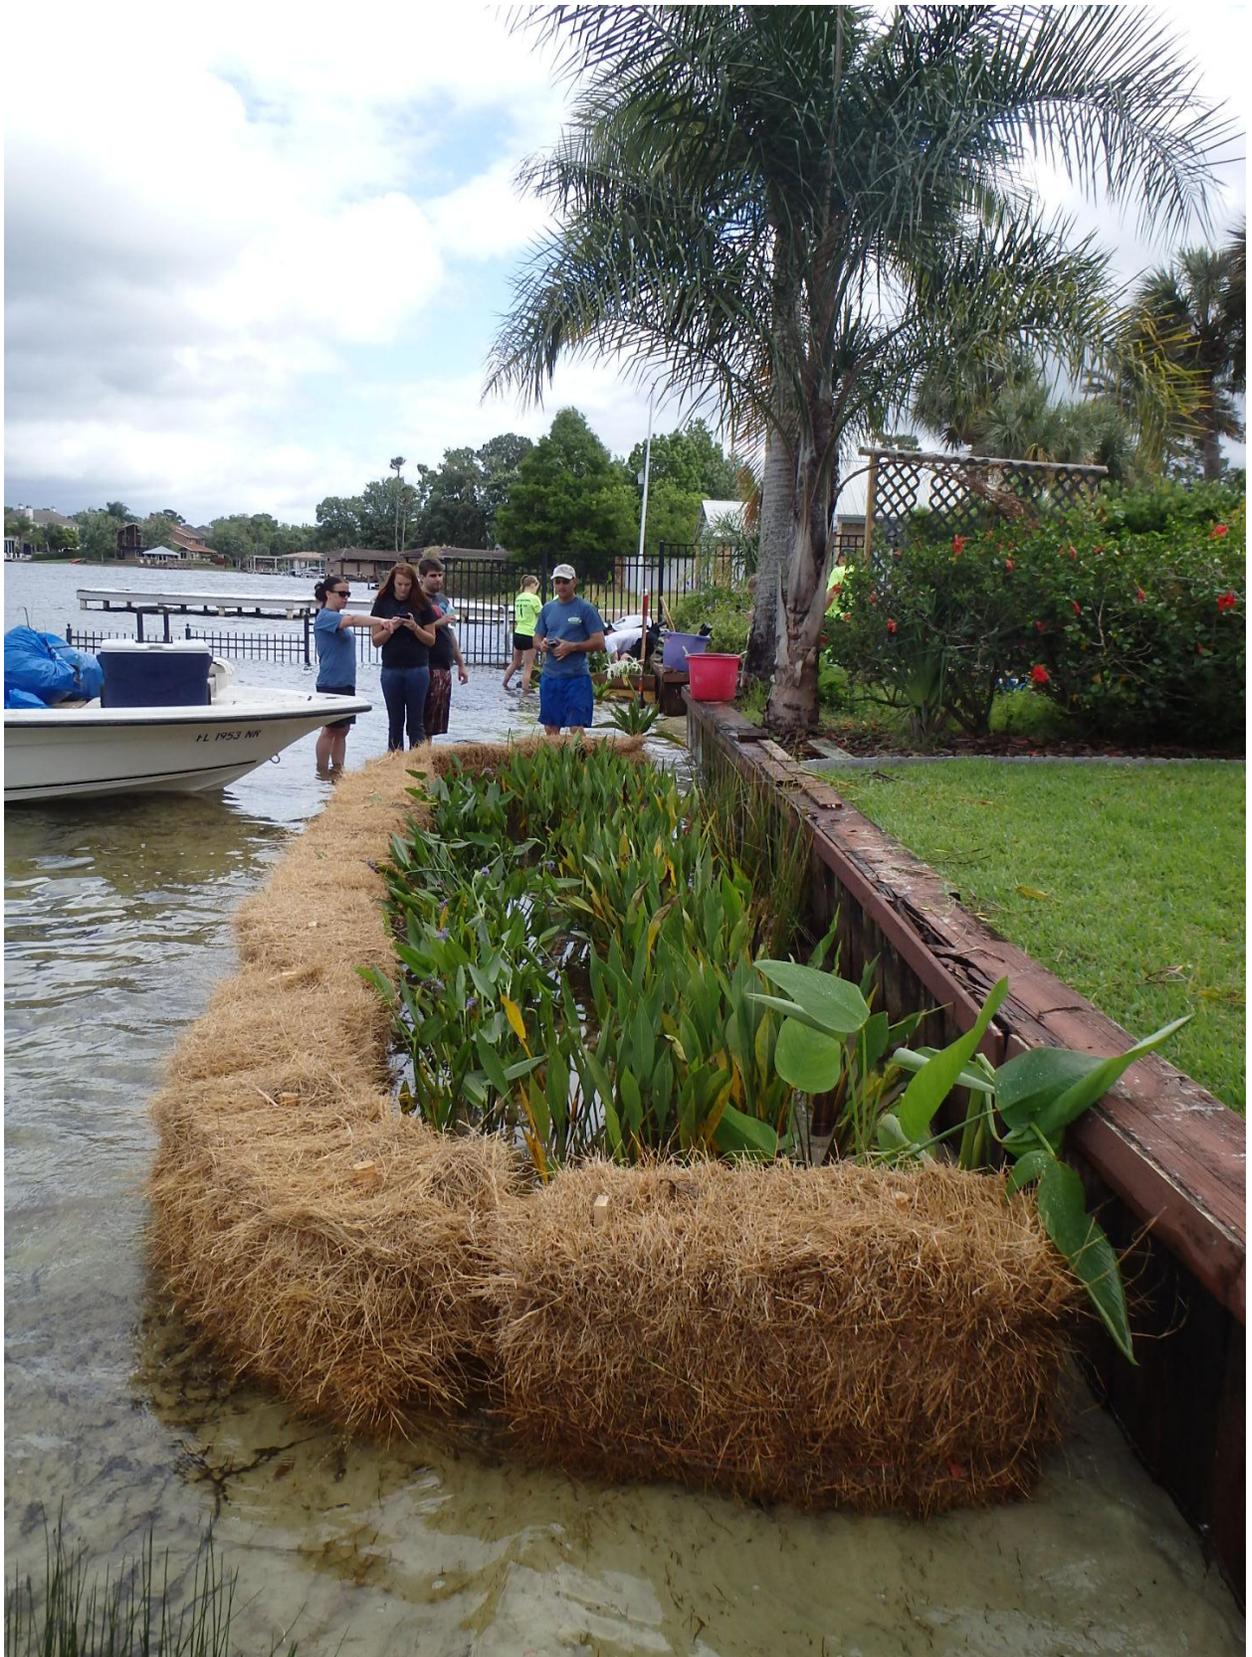
The Lake Brantley restoration event took place on April 19th, 2014. Thirty six volunteers donated their time to plant 3,000 native plants and remove 36 bags of torpedo grass and alligator weed from the lake. Wave action barriers (hay bales) were installed at 2 sites to aid the new vegetation in establishment.

Photo: Native vegetation planted behind wave action barriers.

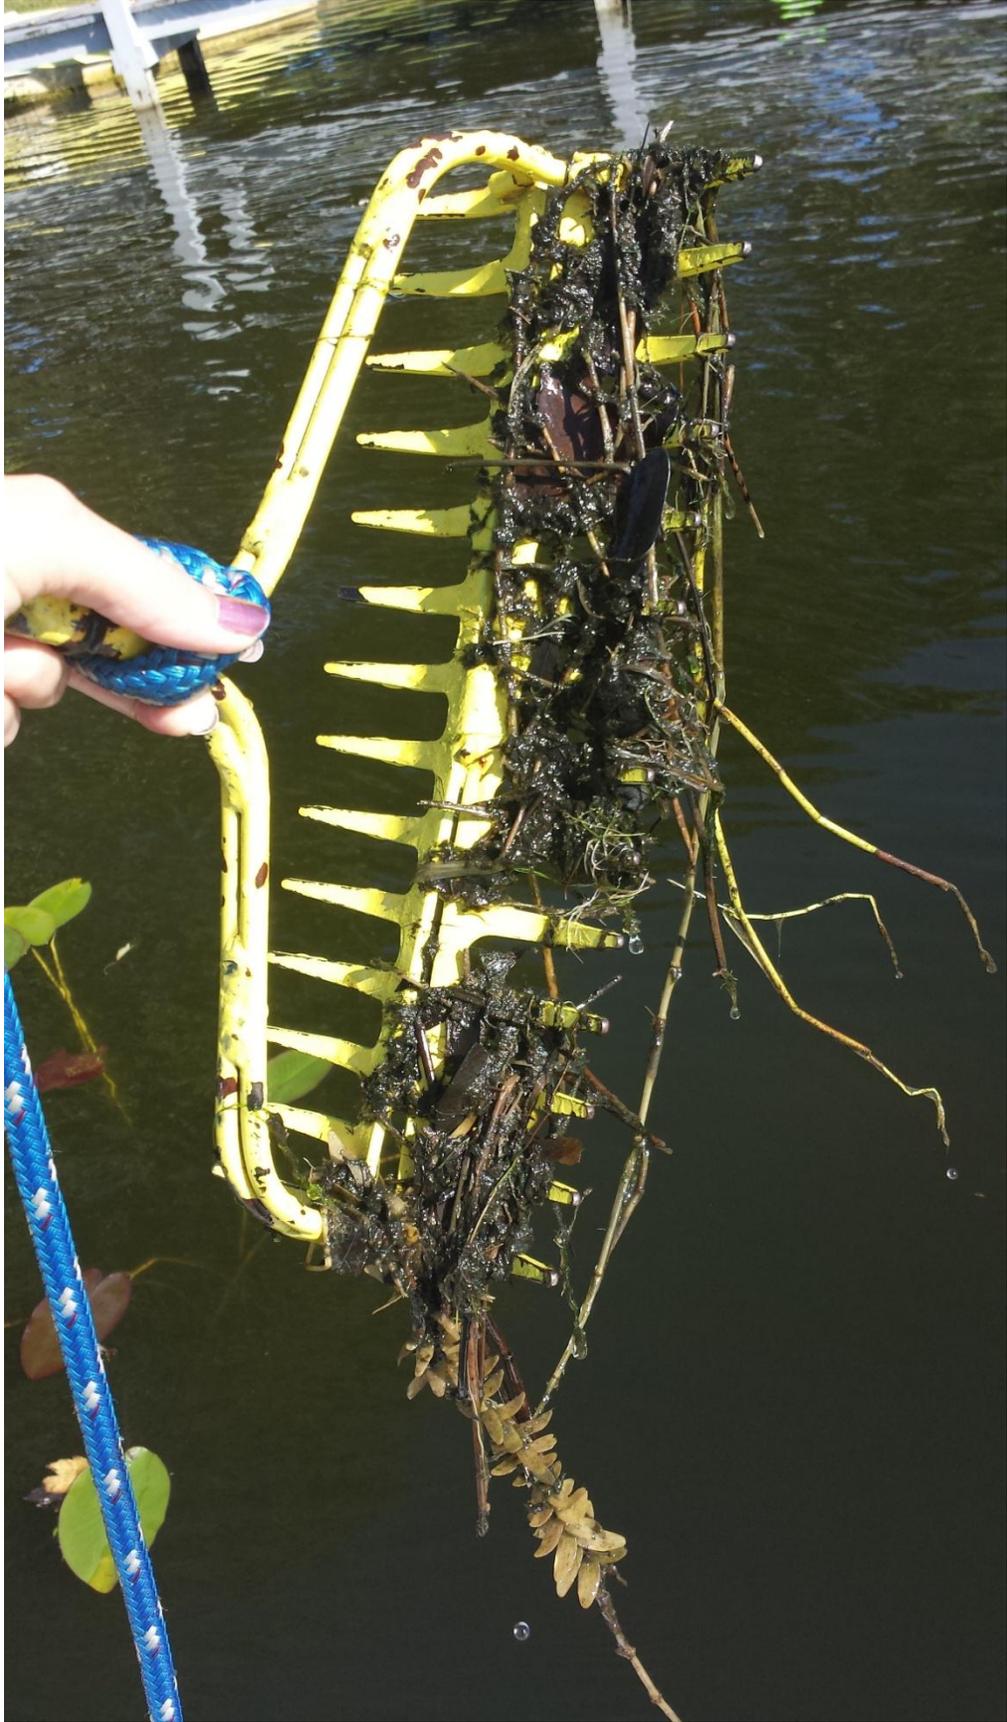
Submersed aquatic vegetation (SAV) observed during the inspection included lemon bacopa, road grass, baby's tears, and stonewort. Road grass has expanded to a total depth of 13 feet and was observed to be the dominant SAV. Stonewort has also expanded to a total depth of 7 feet. Native SAV plays an important role within the ecosystem of Lake Brantley by providing habitat for wildlife, reducing nutrients from runoff, and competing for space with hydrilla. Detritus (decaying organic matter) still covers much of the bottom of the lake. Hydrilla was not observed during this inspection.

Photo: Lemon bacopa and road grass mixed in with detritus.

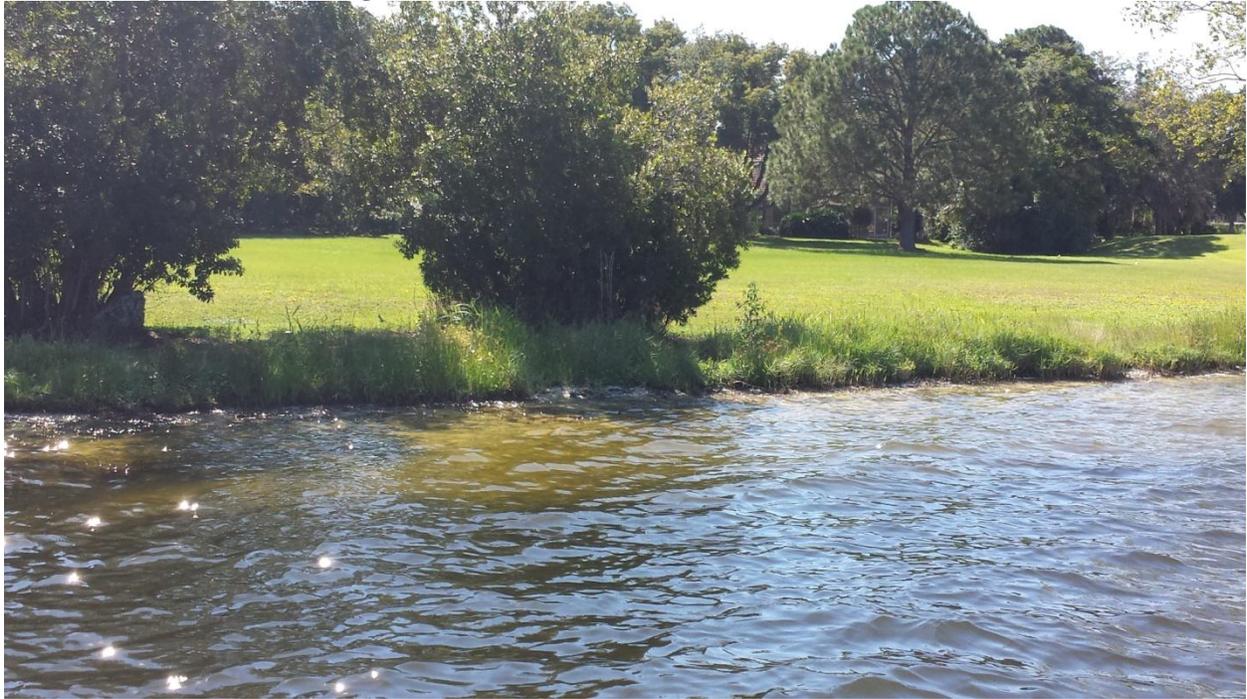
Exotic emergent plants observed included alligator weed, elephant ear, primrose willow, and torpedo grass. Only a few small water hyacinths were observed during the inspection. The dominant species along many shorelines continues to be torpedo grass. Please remember that in order to alter your shoreline or treat exotic vegetation with an herbicide, you must apply for a free aquatic plant removal permit through the Florida Wildlife Conservation Commission <http://www.myfwc.com/license/aquatic-plants> or contact FWC Regional Biologist Alicia Knecht at Alicia.Knecht@myfwc.com or 321-246-0682.

Photo: Torpedo grass along shoreline.
