Greetings Howell Creek Residents!

Please find the latest bioassessment report for your creek below. Our next inspection date will be October 20th; weather permitting. Some of the key highlights from this report will include:

On **August 20th, 2014**, Thomas Calhoun (Seminole County Lake Management Program) and Joey Cordell (Seminole County Watershed Management Intern) surveyed the aquatic plants in **Howell Creek and Lake Waumpi**.

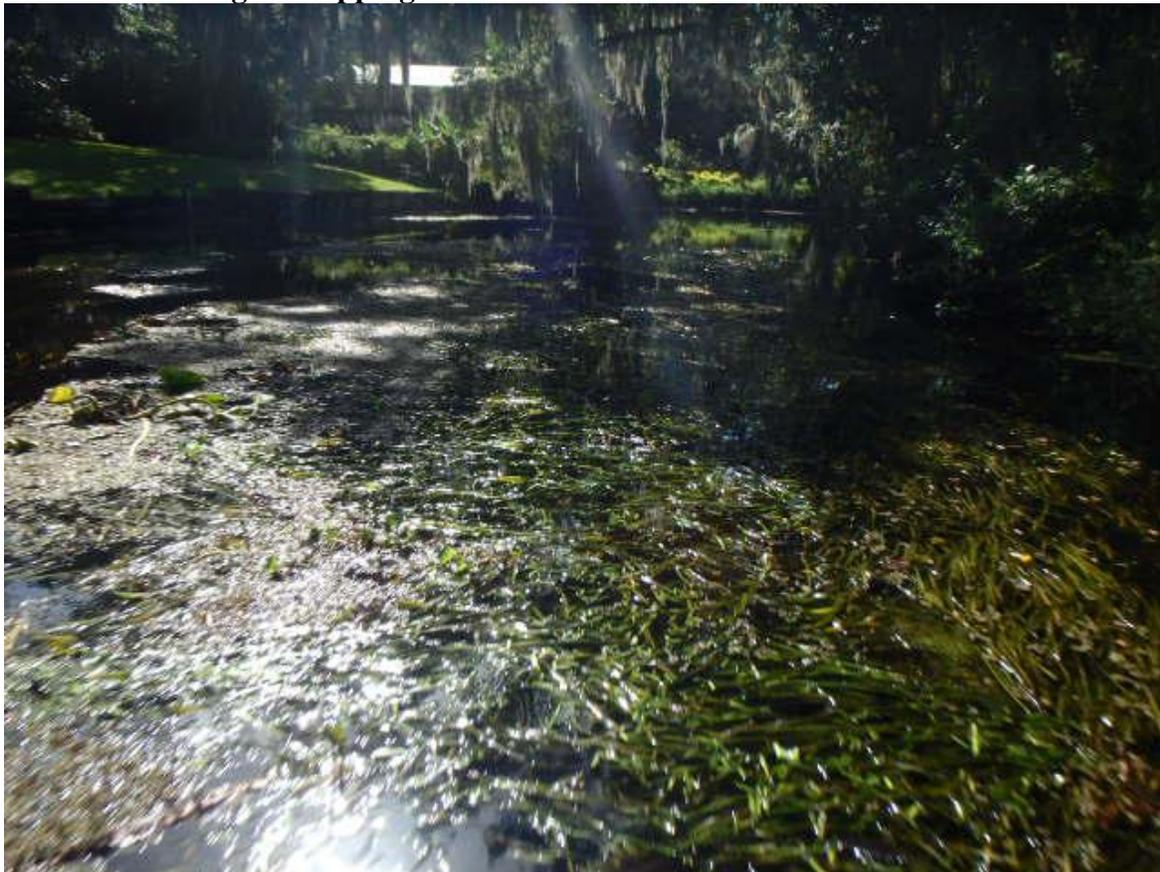
Six species of submersed aquatic vegetation (SAV) were found during the inspection; five natives and 1 exotic. These SAV species included road grass, bladderwort, eelgrass, coontail, southern naiad, and hydrilla (exotic). All of the SAV species are expanding, except for hydrilla; only one sprig of hydrilla was observed. We will continue to monitor the creek for hydrilla. Eelgrass (a beneficial native) was topping out and causing a blockage near the west end of the creek.

Photo: Native eelgrass topping out.

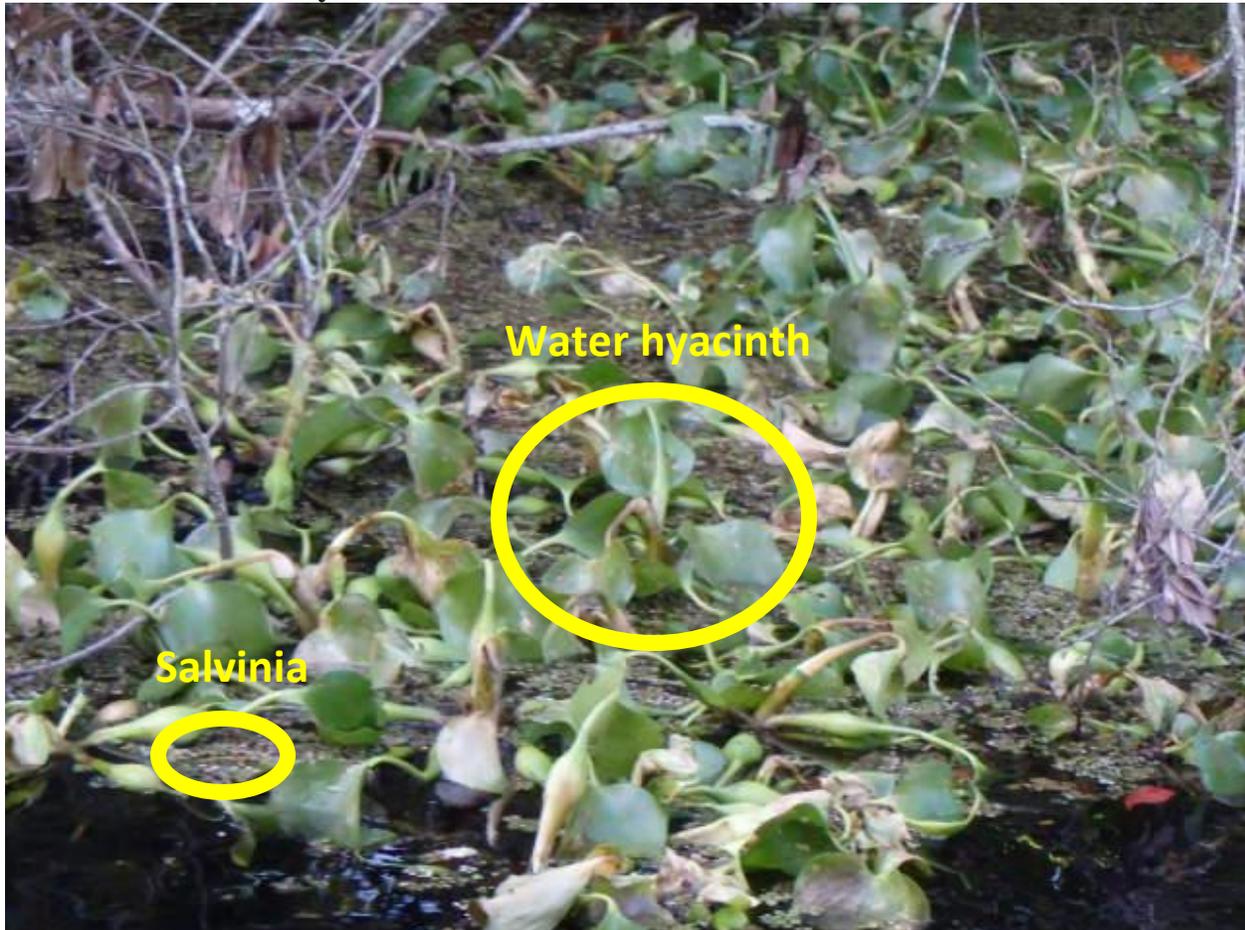
Invasive emergent vegetation observed during the inspection included: alligatorweed, wild taro, salvinia, and water hyacinth. The water hyacinth and salvinia were abundant, but showed signs of recent treatment by the MSBU funded herbicide contractor. The alligatorweed had also been treated. Torpedo grass was not present in the creek at time of inspection.

Photo: Treated water hyacinth and salvinia.

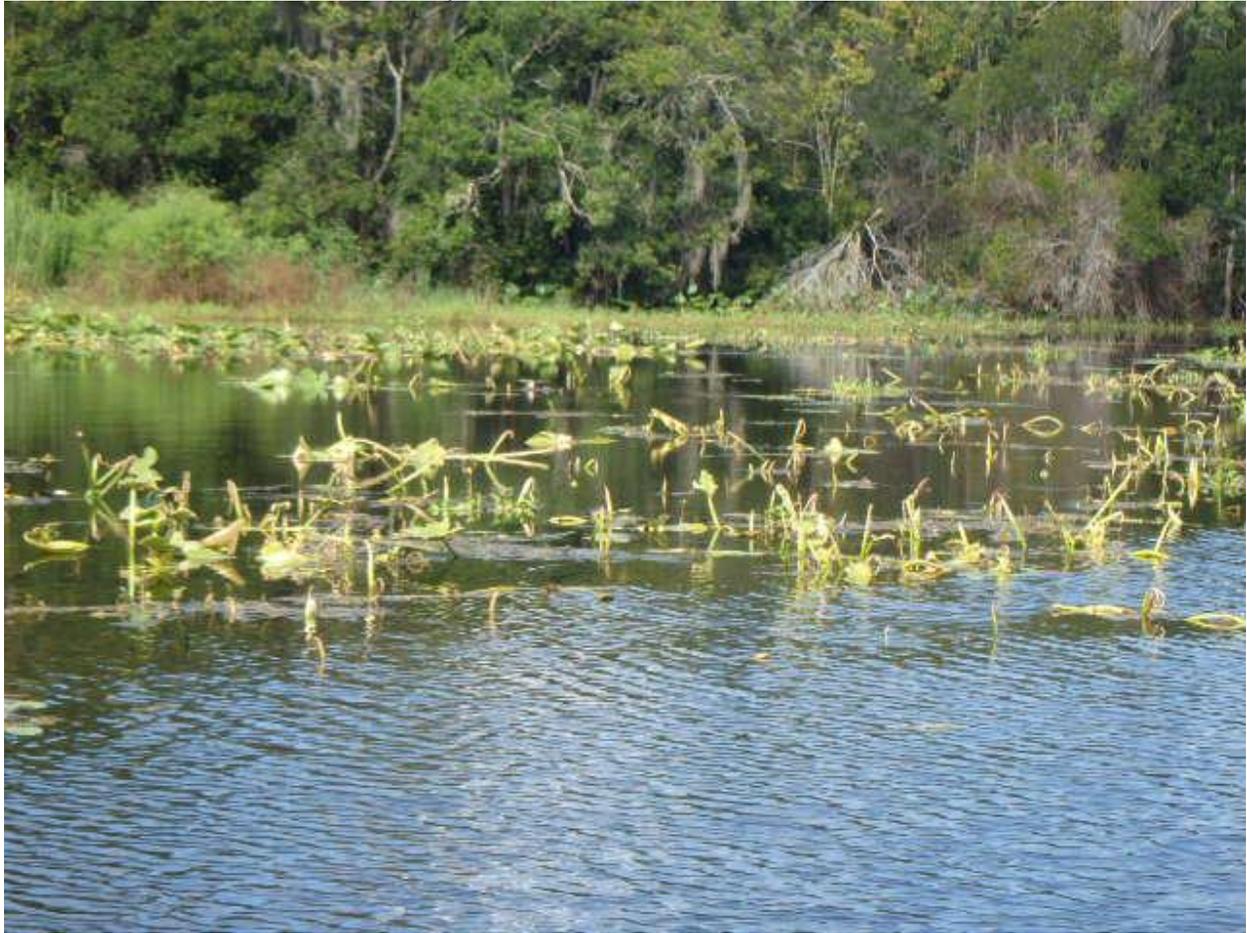
Lake Waumpi was also surveyed during this inspection. The lake was recently treated by the City of Winter Park. The treatment resulted in a reduction of yellow cow lily, water hyacinth, alligatorweed, torpedo grass, salvinia, cattails, primrose willow, and burhead sedge. SAV species found in the lake included native coontail, southern naiad, and bladderwort. In areas on the west side of the lake, both southern naiad and coontail are topping out and hindering navigation.

Photo: Treated lilies and water hyacinth.

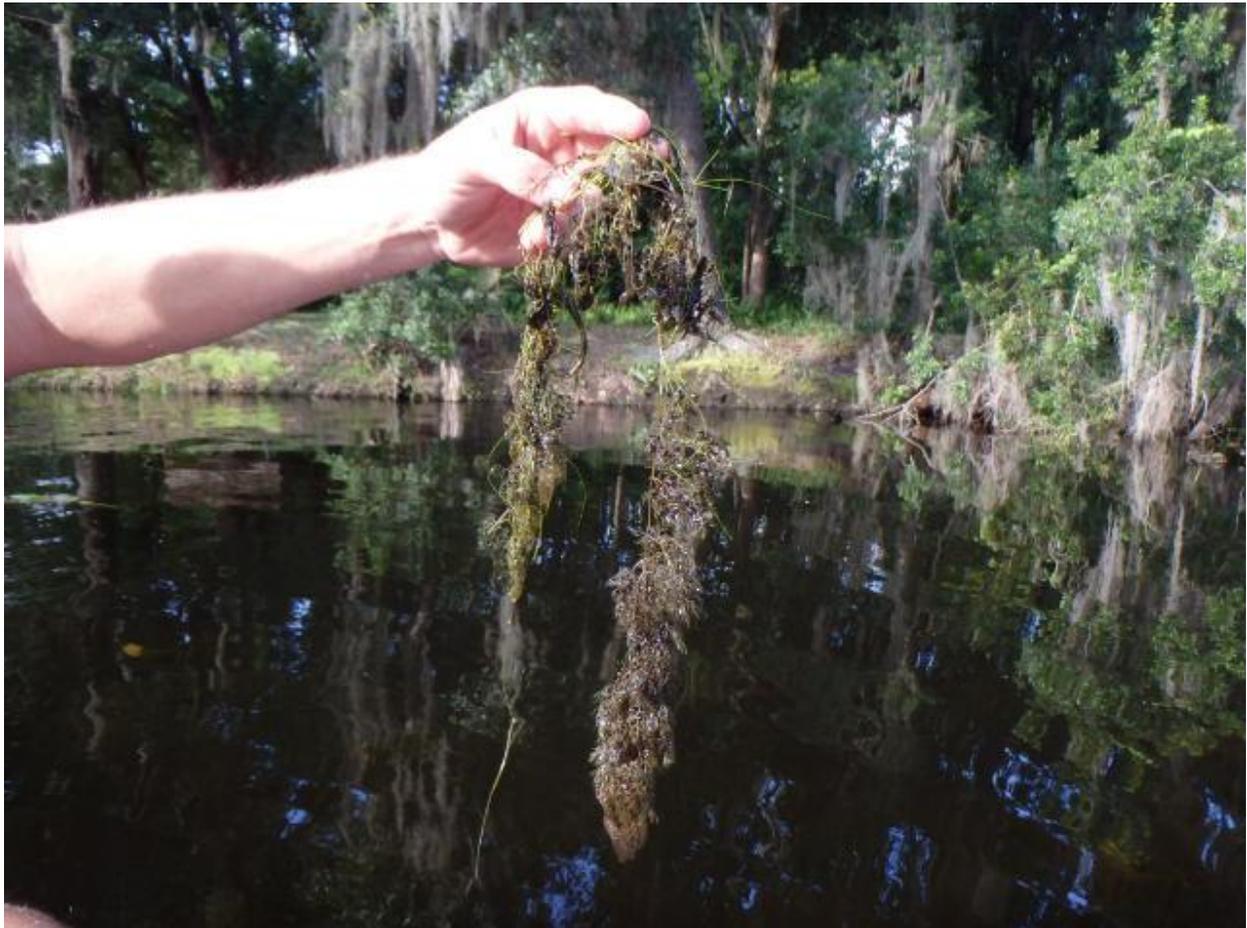
Four species of submersed aquatic vegetation (SAV) were found during the inspection. These SAV species included road grass, bladderwort, eelgrass, and hydrilla. Only one sprig of hydrilla was found. We will continue to monitor the growth of hydrilla.

Photo: Bladderwort.

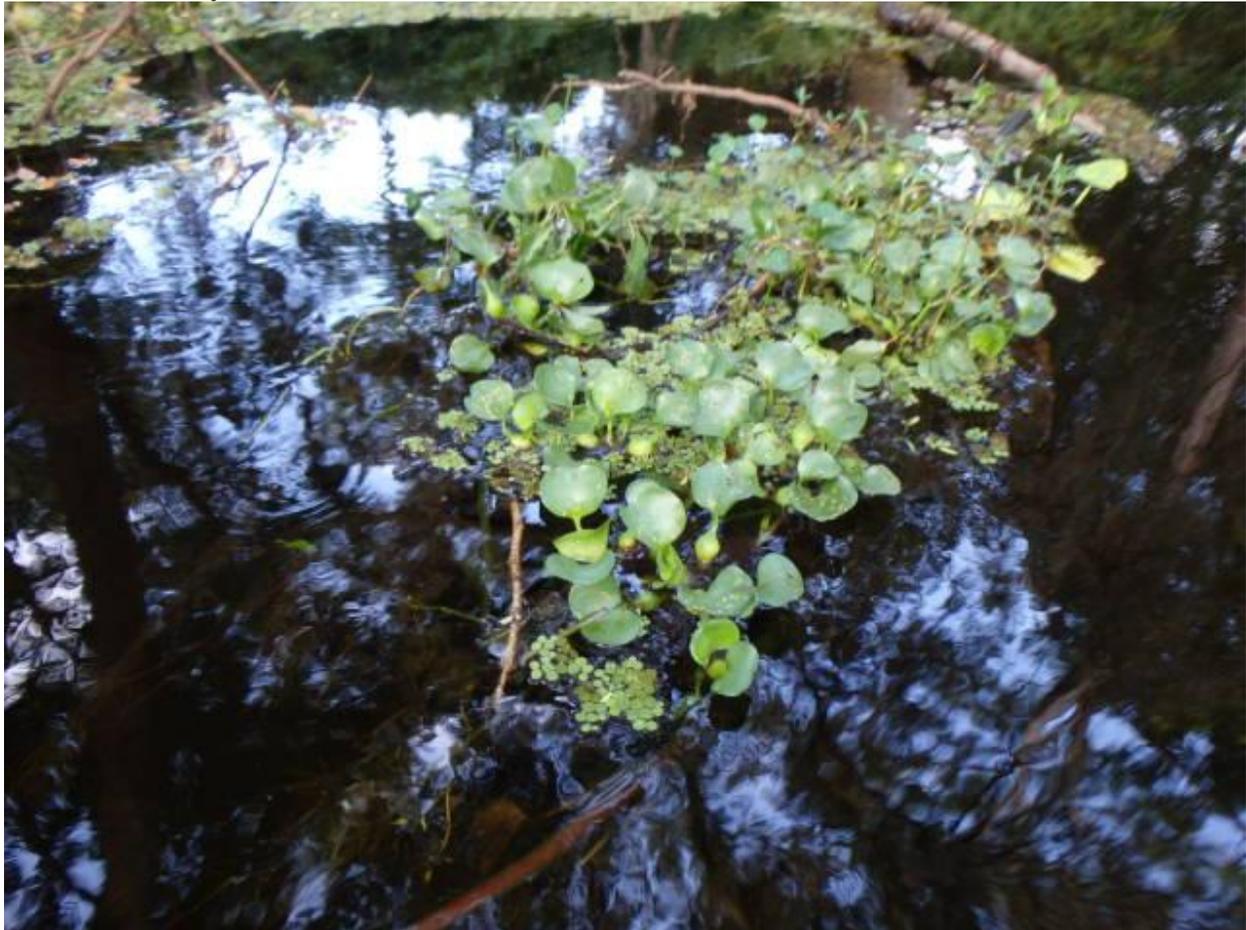
Invasive emergent vegetation found during the inspection included: alligatorweed, wild taro, salvinia, and water hyacinth. Recent heavy rains have increased the water level and flow of Howell Creek. The faster flowing water carried water hyacinth and salvinia from upstream and deposited them as clusters in the creek. Torpedo grass was not present in the creek at time of inspection.

Photo: Water hyacinth and Salvinia.

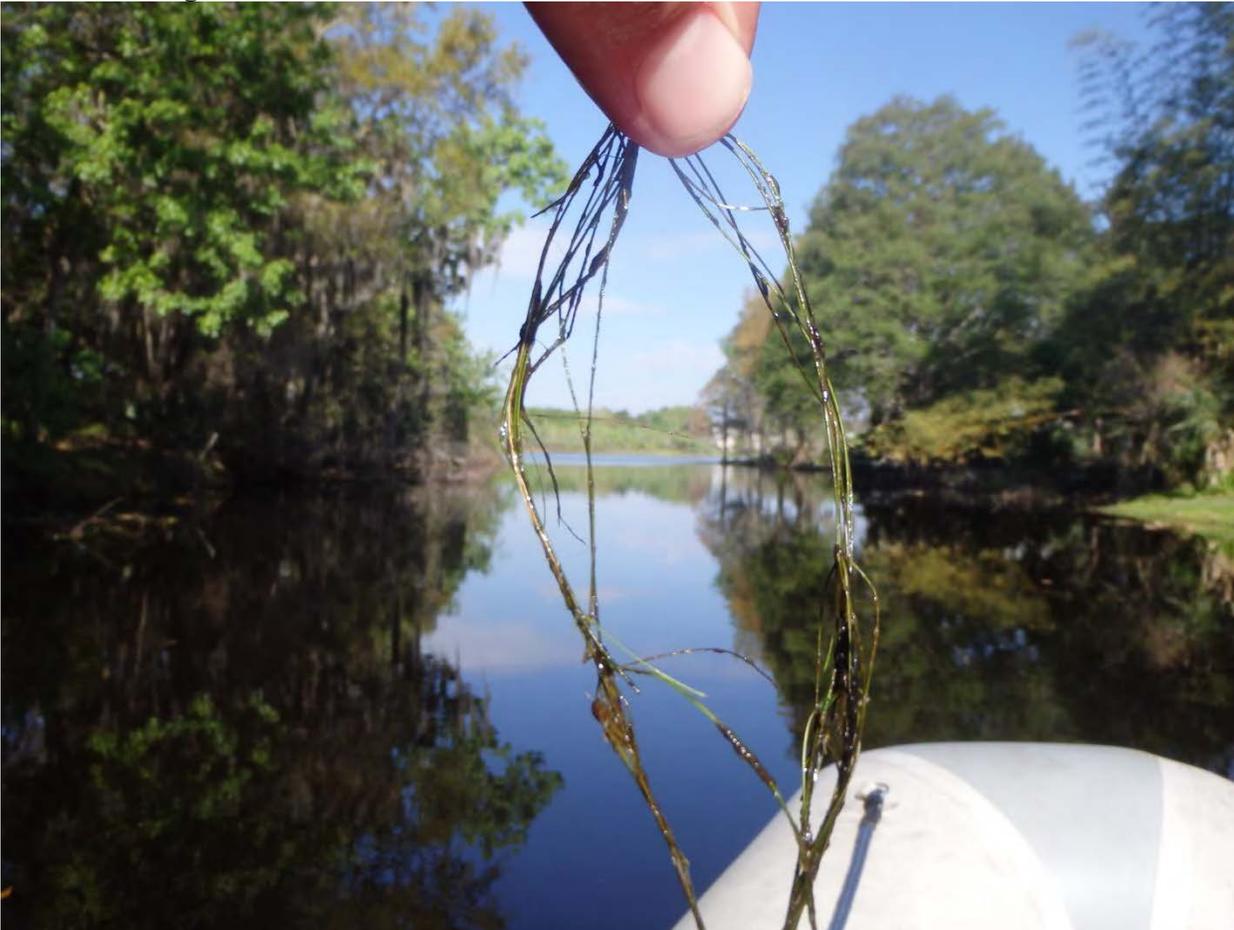
Five species of submersed aquatic vegetation (SAV) were found during the inspection. These SAV species (all beneficial natives) included road grass, bladderwort, eelgrass, southern naiad, and coontail. The invasive species hydrilla was not observed during this inspection.

Photo: Road grass.

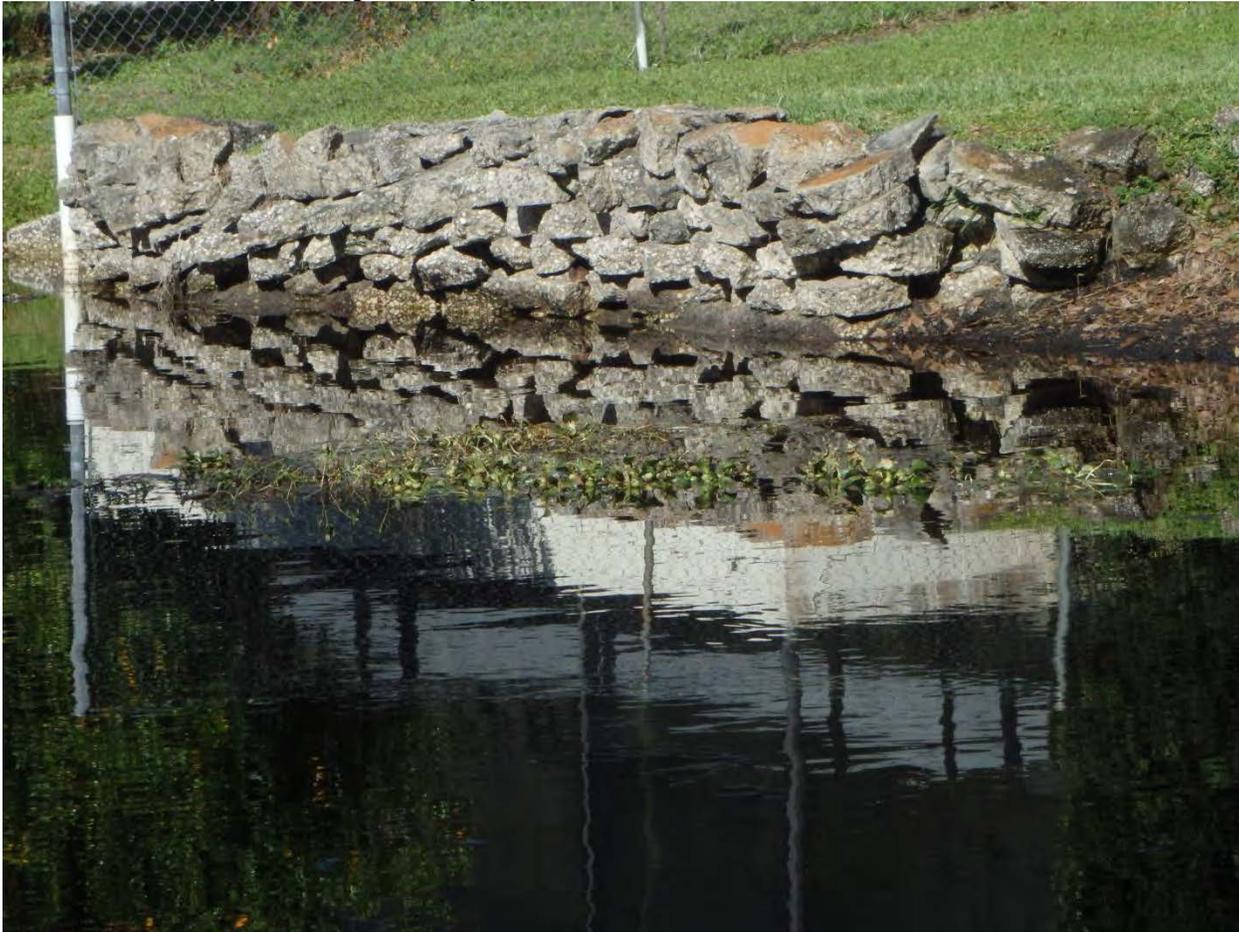
Invasive emergent vegetation observed during the inspection included: alligator weed, elephant ear, and cattail. Water hyacinth was found throughout the creek but was impacted due to the herbicide treatment conducted the week prior.

Photo: Water hyacinth impacted by herbicides.

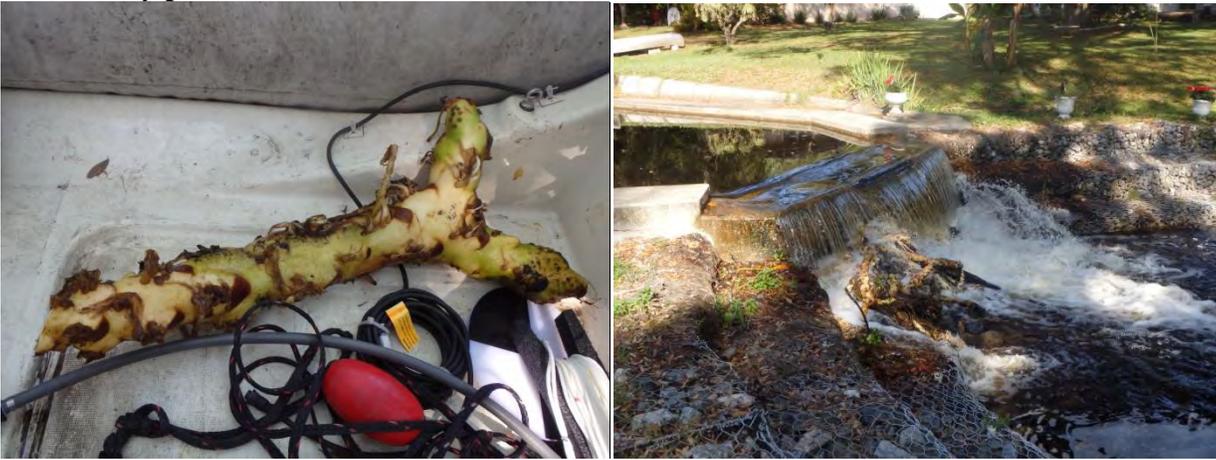
Lake Waumpi was also surveyed during this inspection. There were significantly fewer lily pads on the lake than in the previous inspection due to a recent herbicide treatment conducted by City of Winter Park/Maitland. The rhizomes (root system) of these dying lily pads are now washing downstream and accumulating in various locations in the creek.

Photo: Lily pad rhizomes in Howell Creek.

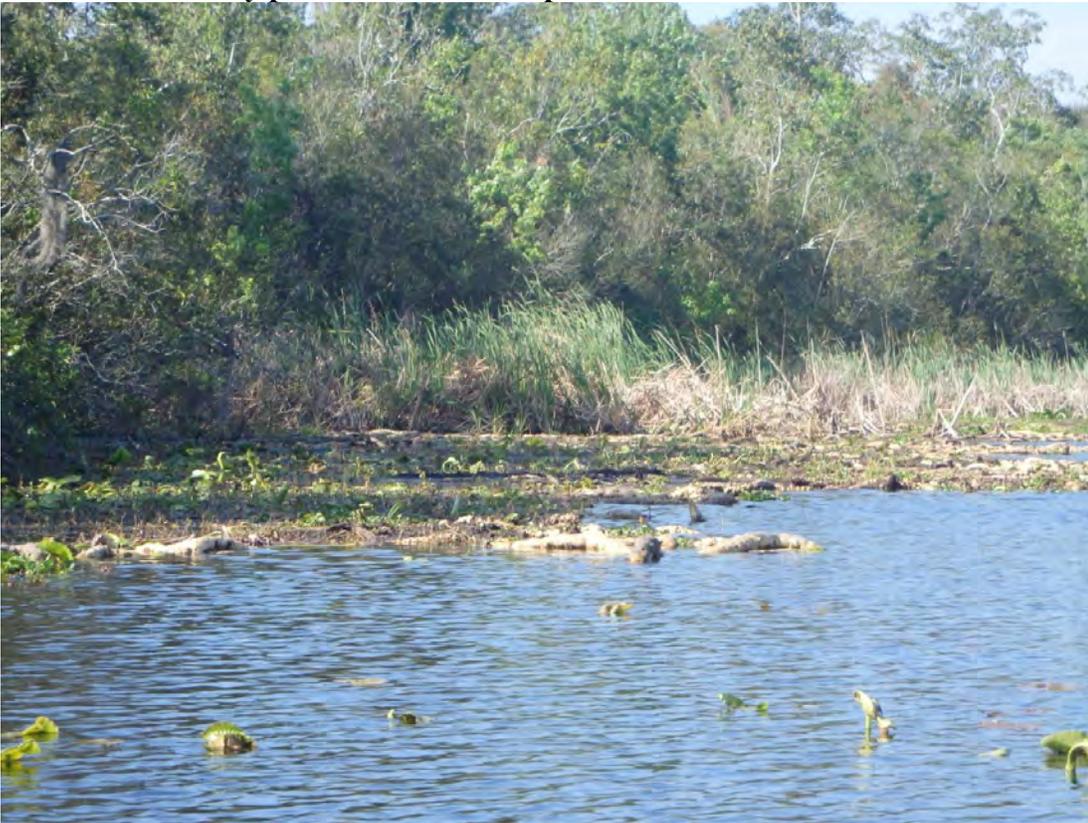
Most of Lake Waumpi's shoreline was dominated by invasive species including: burhead sedge, primrose willow, Carolina willow, cattails, alligator weed, and salvinia. Some of the floating mats that were extending from the shoreline showed signs of herbicide treatment.

Photo: Treated lily pads in Lake Waumpi.

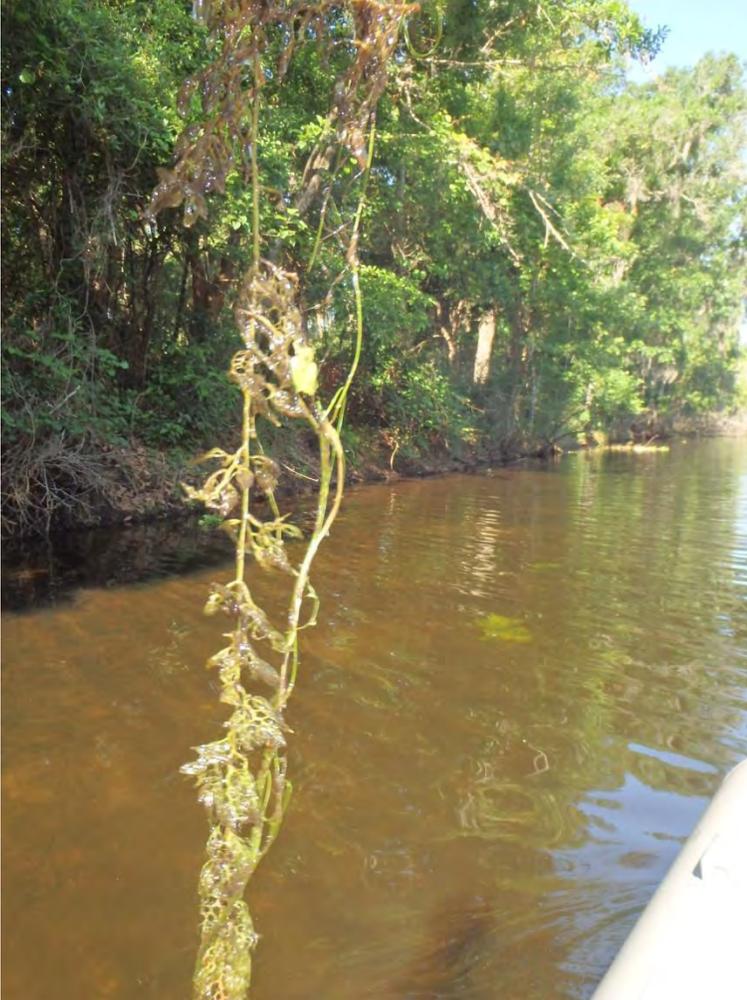
Four species of SAV were found during the inspection; one was exotic. These SAV species included road grass, bladderwort, eelgrass, and exotic hydrilla. Only two small sprigs of hydrilla were collected in sample.

Photo: Bladderwort.

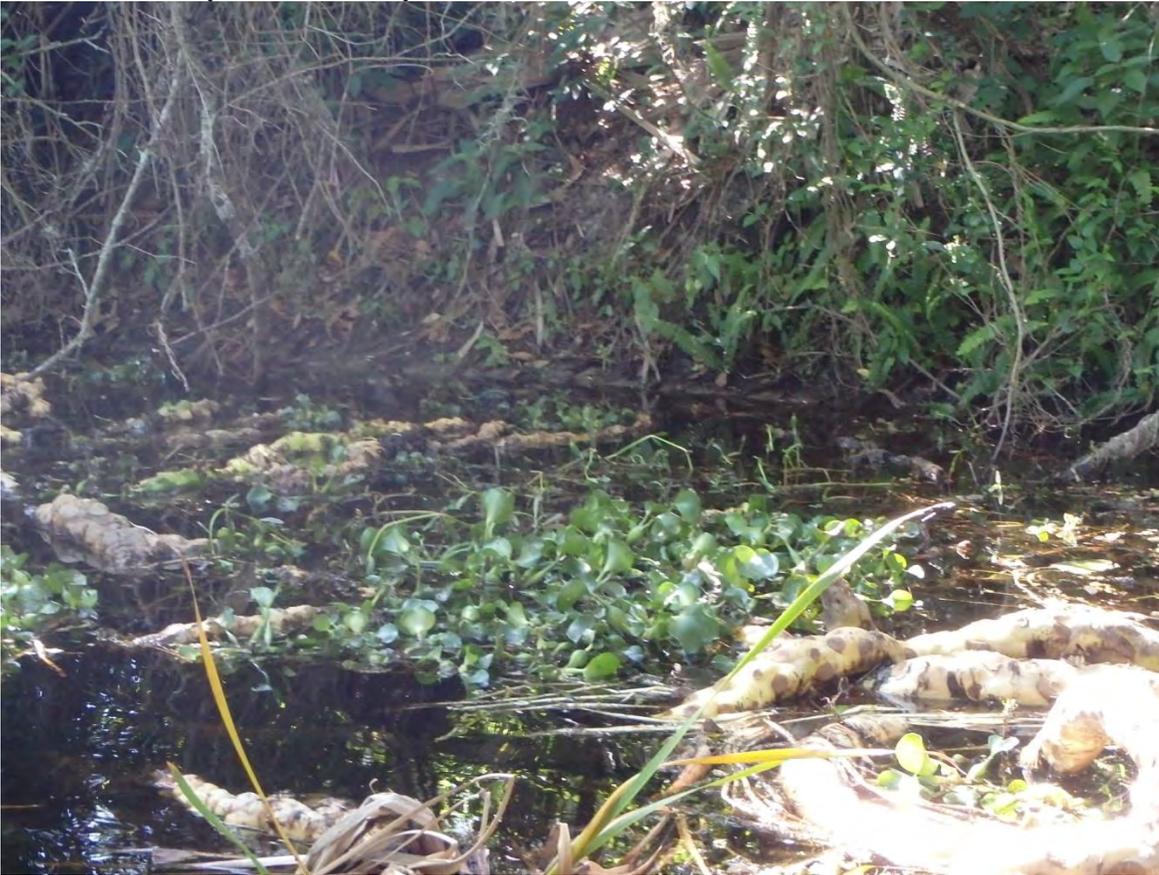
Invasive emergent vegetation observed during the inspection included: alligator weed, elephant ear, cattail, torpedo grass, and water hyacinth. Water hyacinth was in large quantity. Increased flow from recent rains has carried the water hyacinth from upstream of Lake Waumpi into the creek. Some floating lily rhizomes were still present from the previous upstream herbicide treatment.

Photo: Water hyacinth and lily rhizomes.

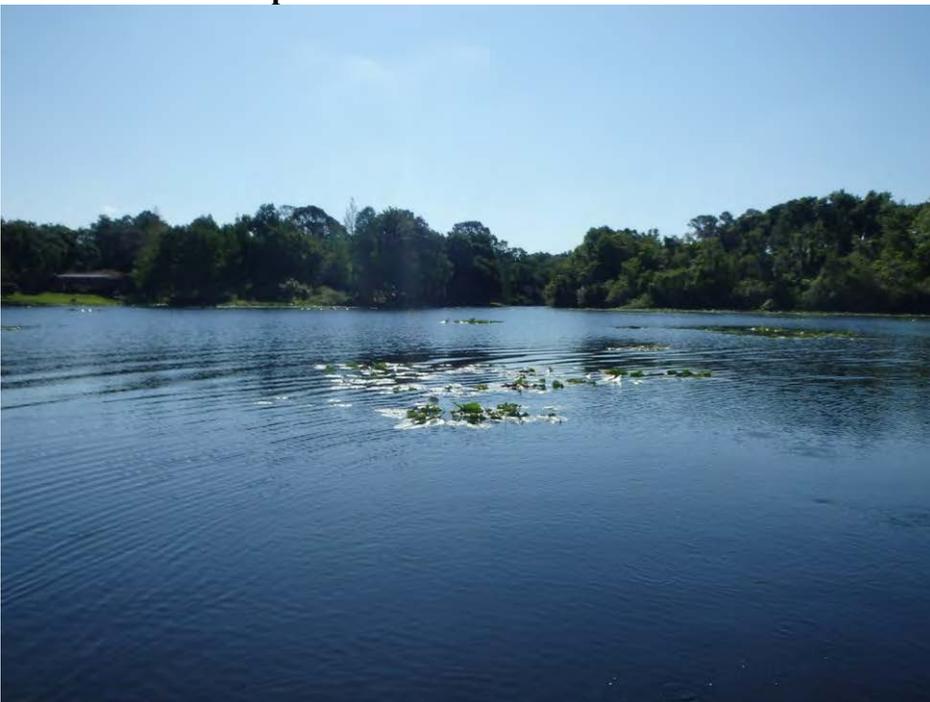
Lake Waumpi was also surveyed during this inspection. The center of the lake had only a few lilies. Most of Lake Waumpi's shoreline was dominated by invasive species including: burhead sedge, primrose willow, Carolina willow, cattails, alligator weed, and salvinia. Two submersed aquatic vegetation species were found in Waumpi: coontail and bladderwort.

Photo: Lake Waumpi.

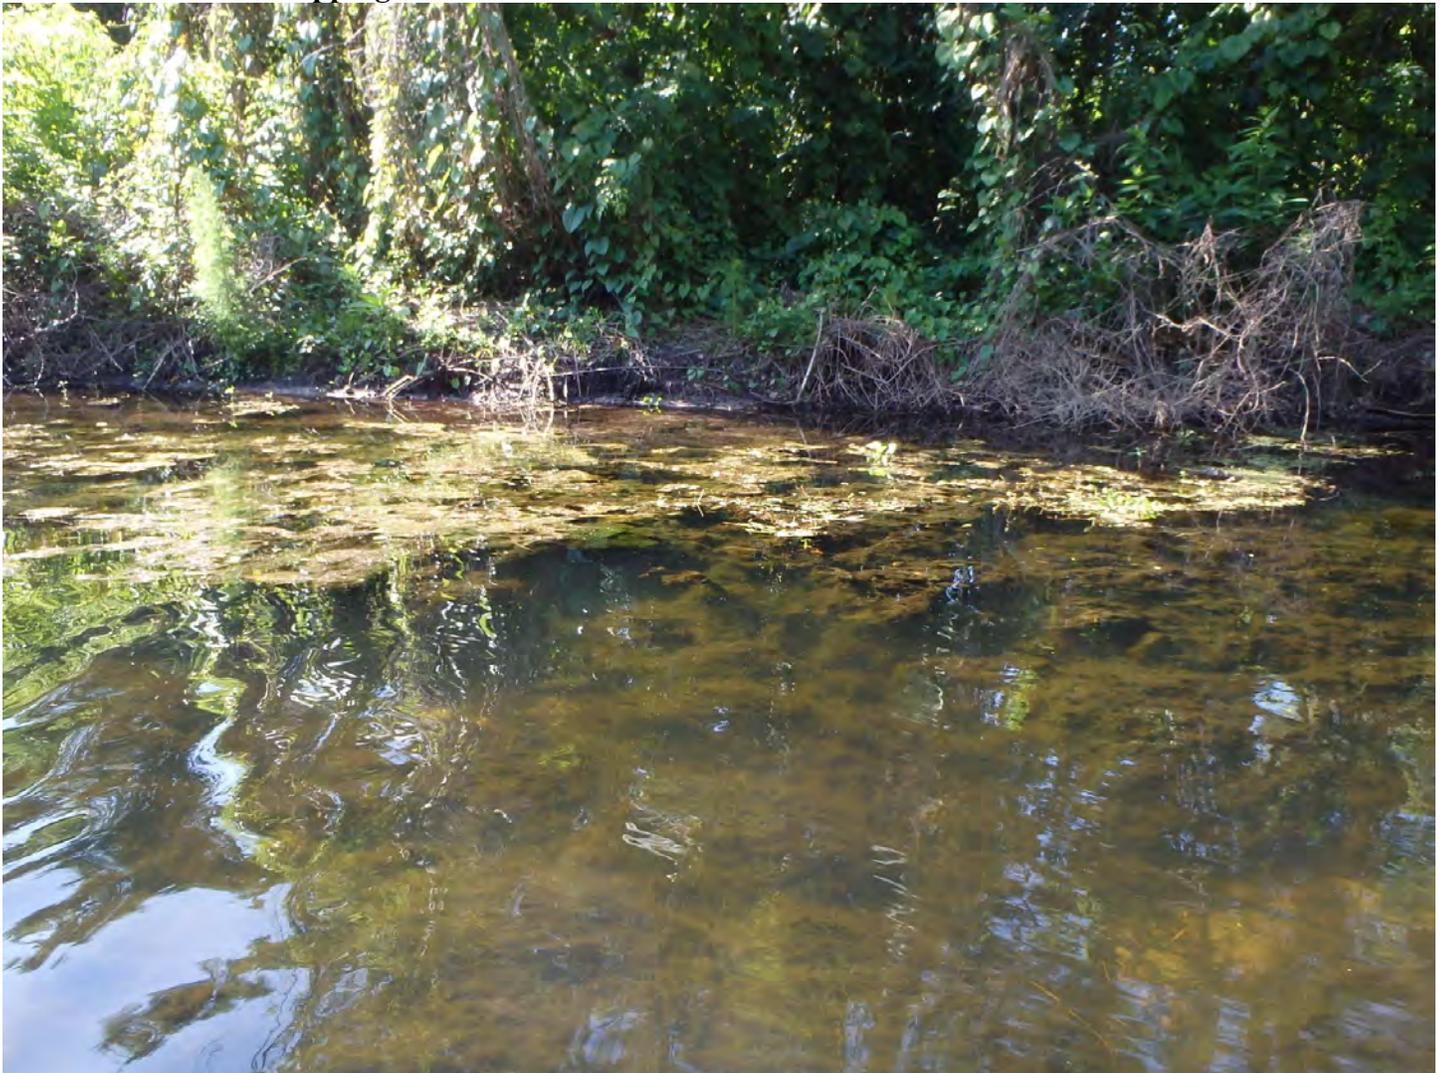
Four species of beneficial native SAV were found during the inspection. These SAV species included road grass, bladderwort, eelgrass, and southern naiad. Road grass, bladderwort and eelgrass have all expanded throughout the creek with bladderwort topping out (reaching the surface) in some areas. Some substrate algae was present during the inspection. The invasive species hydrilla was not observed during this inspection.

Photo: Bladderwort topping out..

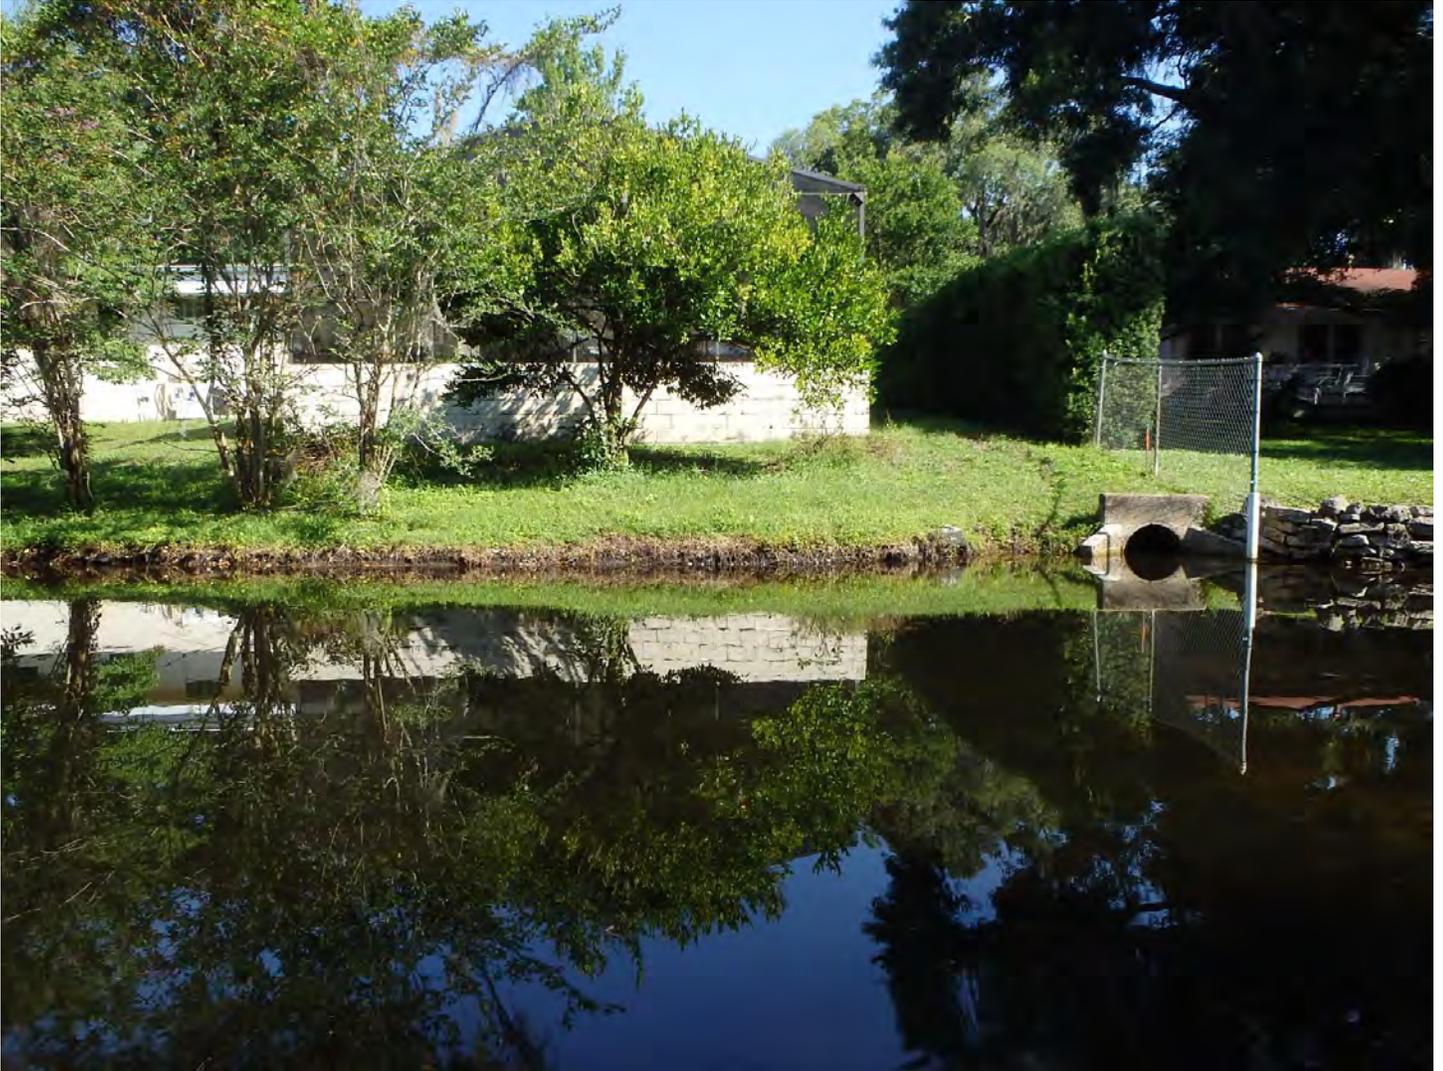
Water hyacinth has been reduced throughout the creek but was still present in small patches. Torpedo grass and alligatorweed also were found reduced. Torpedo grass has been reduced to the point that it is no longer the dominant shoreline species. Many shorelines are bare or have terrestrial grass to the waters edge. It is

Photo: Typical shoreline along Howell Creek.

recommended that native emergent species (such as duck potato, pickerelweed, or soft rush) is planted along the shoreline. Native emergent vegetation along the shoreline can help reduce erosion and help buffer nutrients from yard runoff.

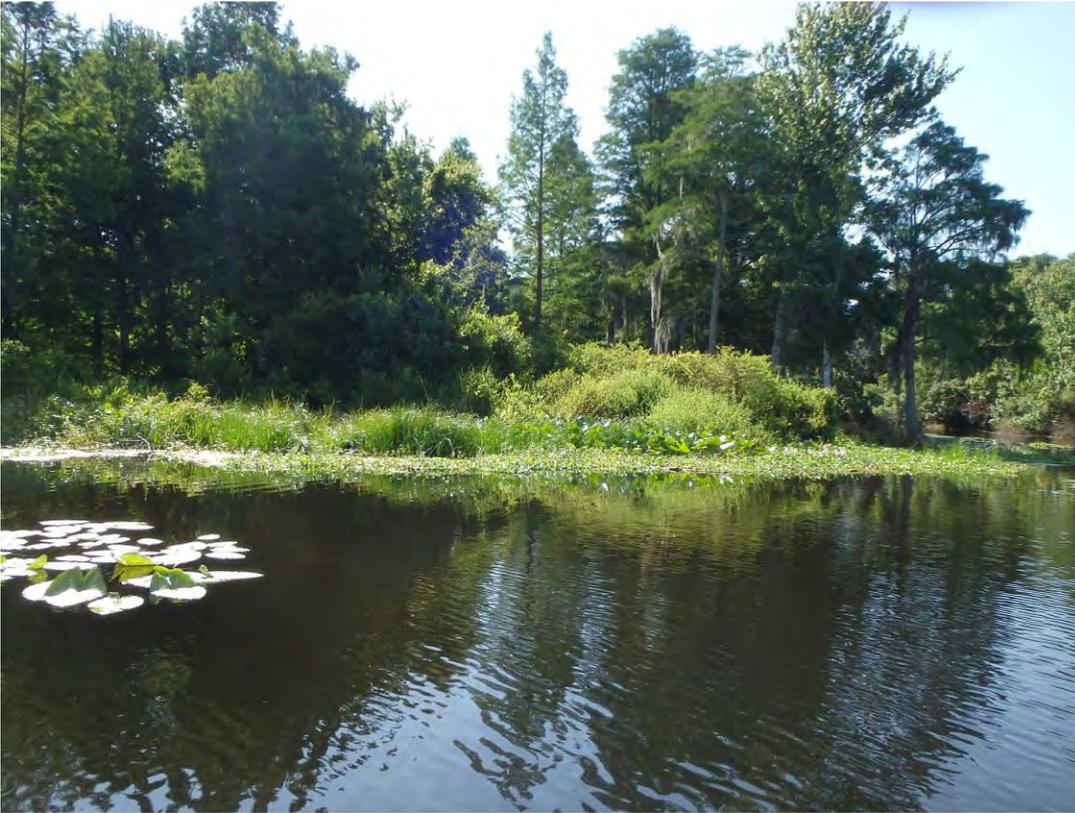
Lake Waumpi was also surveyed during this inspection. Lily pads are beginning to return to the lake. The rhizomes (root system) of the dead lily pads are still present in the creek. Most of Lake Waumpi's shoreline was dominated by invasive species including: burhead sedge, primrose willow, Carolina willow, cattails, alligator weed, and salvinia.

Photo: Bur-head sedge at the entrance to Lake Waumpi.

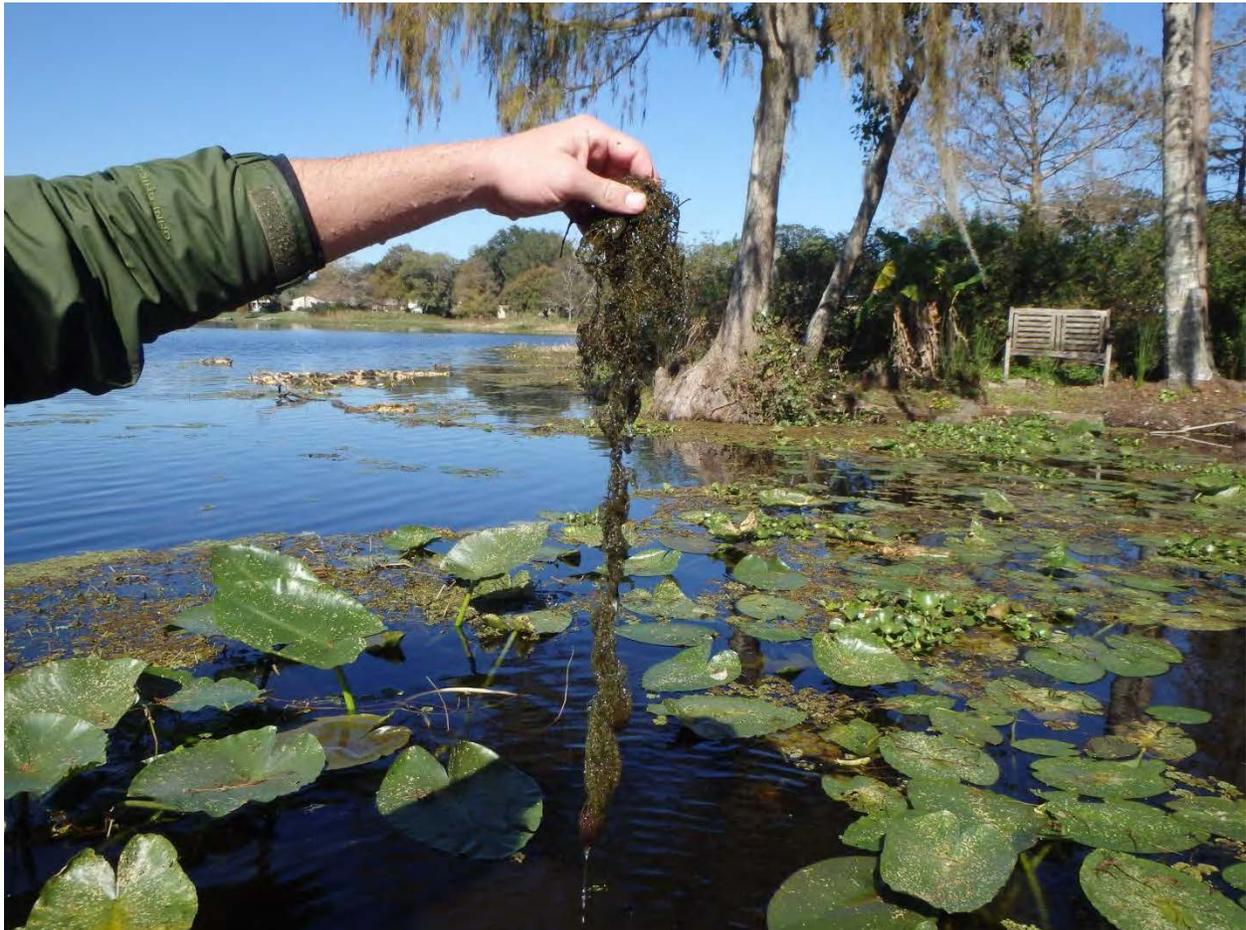
Five species of submersed aquatic vegetation (SAV) were found during the inspection. These SAV species included road grass, southern naiad, bladderwort, eelgrass, and hydrilla. The invasive species hydrilla was found in small springs only in a few regions of the creek. No treatment for hydrilla is needed at this time.

Photo: Bladderwort.

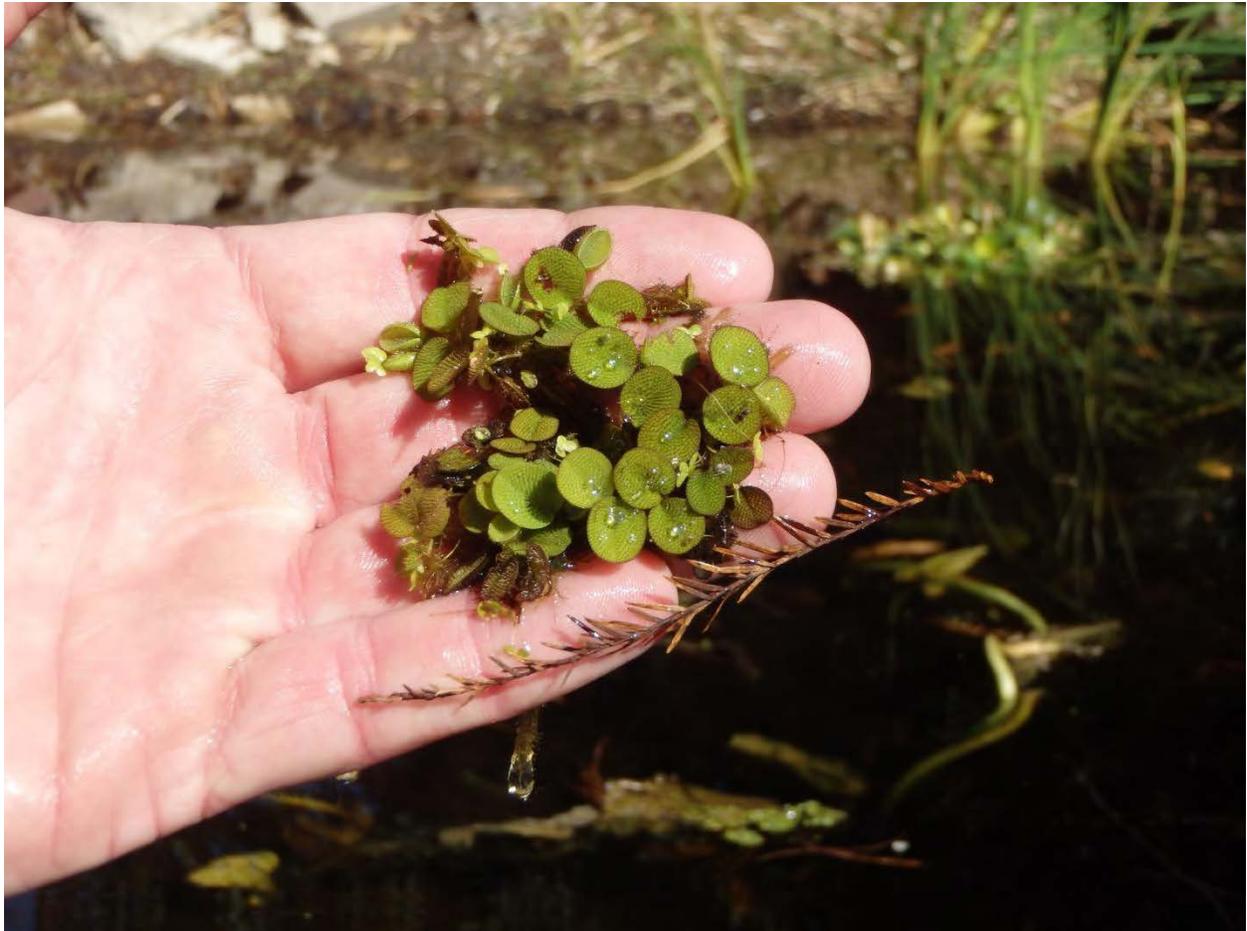
Invasive emergent vegetation found during the inspection included: alligator weed, elephant ear, and cattail. Water hyacinth, a floating invasive aquatic plant, has spread throughout the creek since the last inspection. There were several large mats of water hyacinth in the upstream portion of the creek and a few isolated water hyacinths downstream. Another floating invasive aquatic plant, salvinia, was seen in large quantities but has been impacted by the MSBU funded herbicide contractor.

Photo: Salvinia.

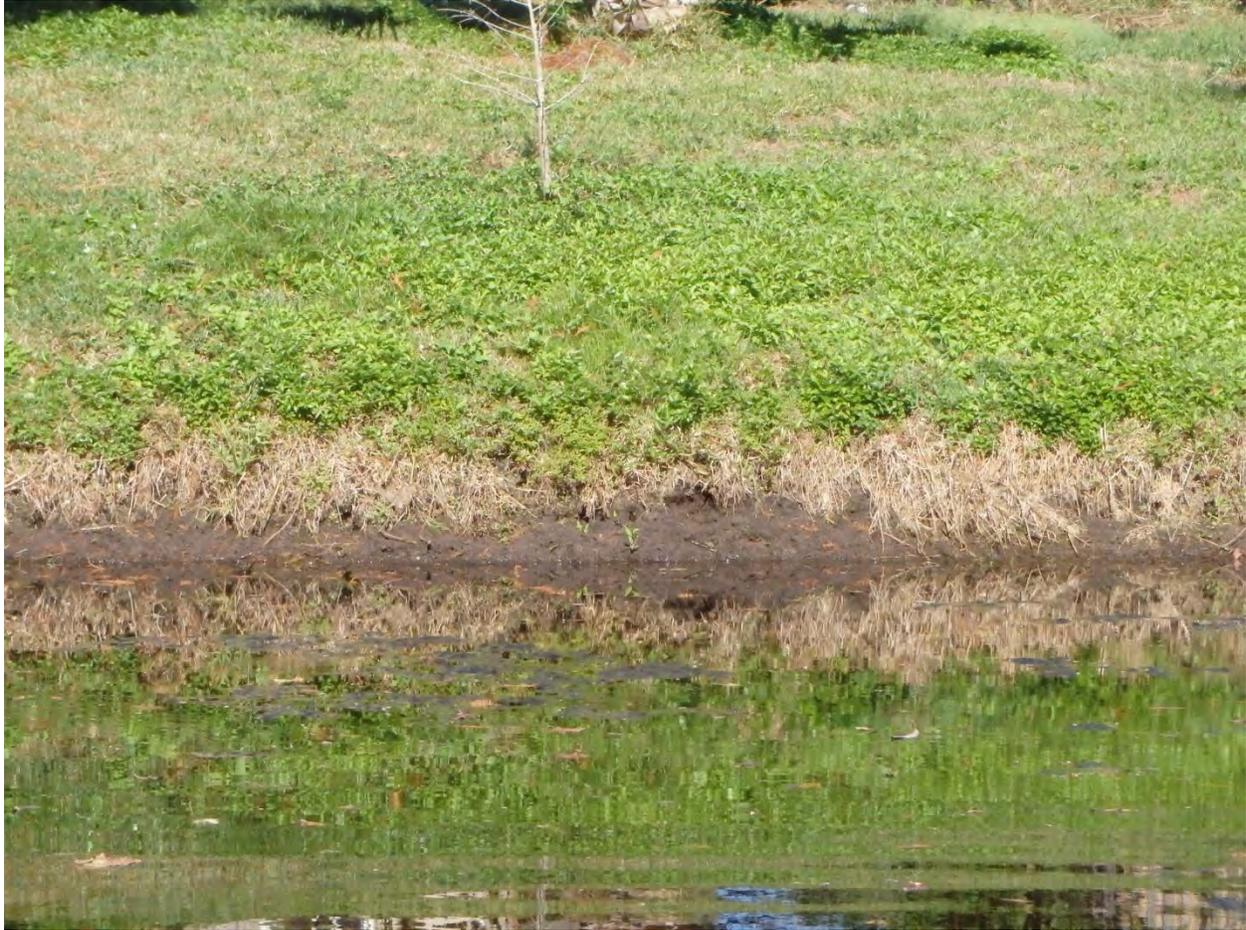
Photo: Bare shoreline is susceptible to erosion.

Now that the torpedo grass has been reduced, some of the shorelines along the north bank of the creek are bare and showing signs of erosion. It is recommended that native shoreline vegetation be planted to help reduce erosion, stabilize the shoreline, and prevent the return of torpedo grass. Recommended native species include, but are not limited to: pickerelweed (scientific name: *Pontederia cordata*), duck potato (*Sagittaria lancifolia*), golden canna (*Canna flacida*), fire flag (*Thalia geniculata*), and cord grass (*Spartina bakeri*). Native vegetation found during the inspection included yellow cow lily, pickerelweed, soft rush, and pennywort.

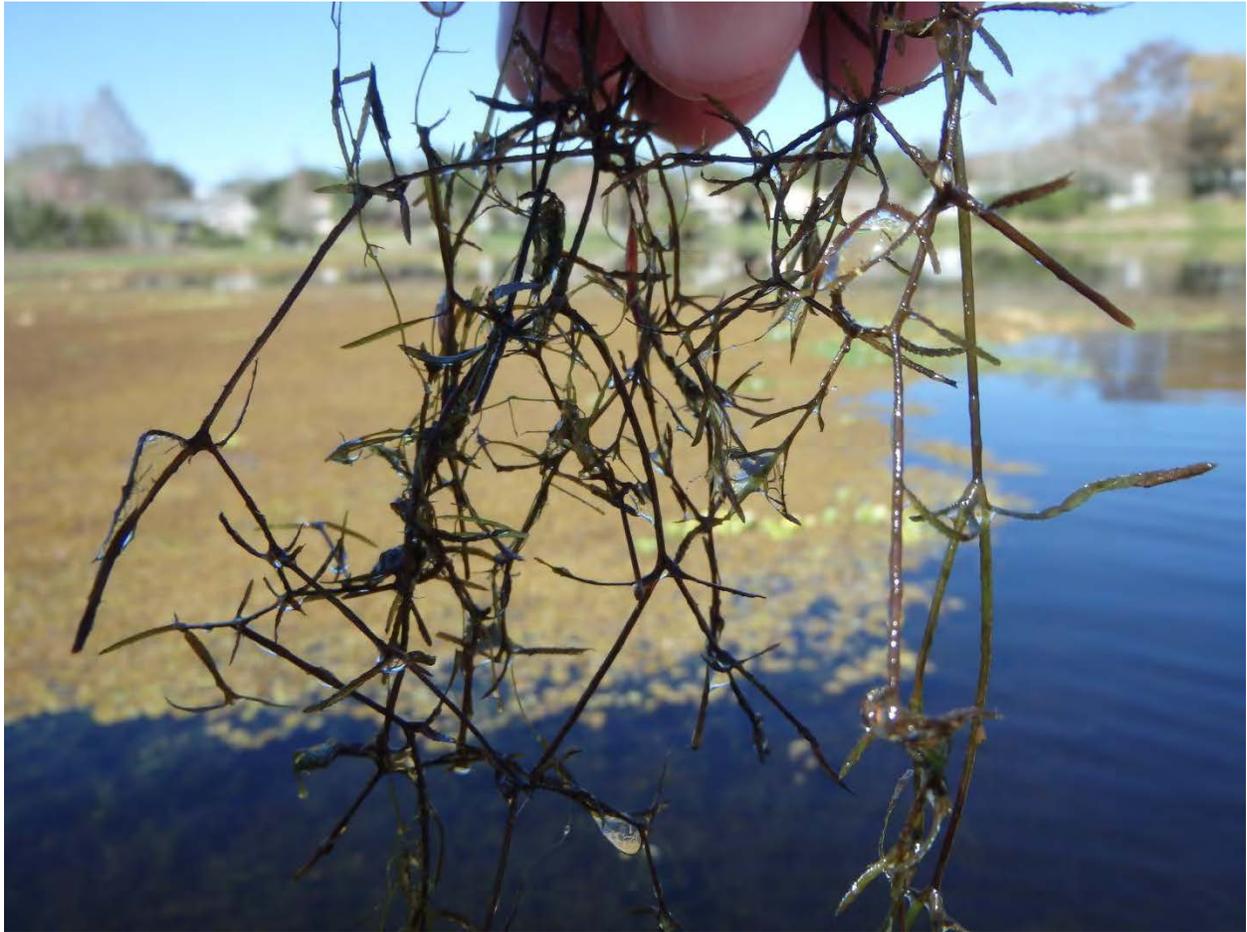
Five species of submersed aquatic vegetation (SAV) were found during the inspection. These SAV species included road grass, bladderwort, eelgrass, southern naiad and coontail. The invasive species hydrilla was not found during this inspection

Photo: Southern naiad.
