Greetings Howell Creek Residents!

Please find the latest bioassessment report for your creek below. Our next inspection date will be October 20th; weather permitting. Some of the key highlights from this report will include:

On **August 20th, 2014**, Thomas Calhoun (Seminole County Lake Management Program) and Joey Cordell (Seminole County Watershed Management Intern) surveyed the aquatic plants in **Howell Creek and Lake Waumpi**.

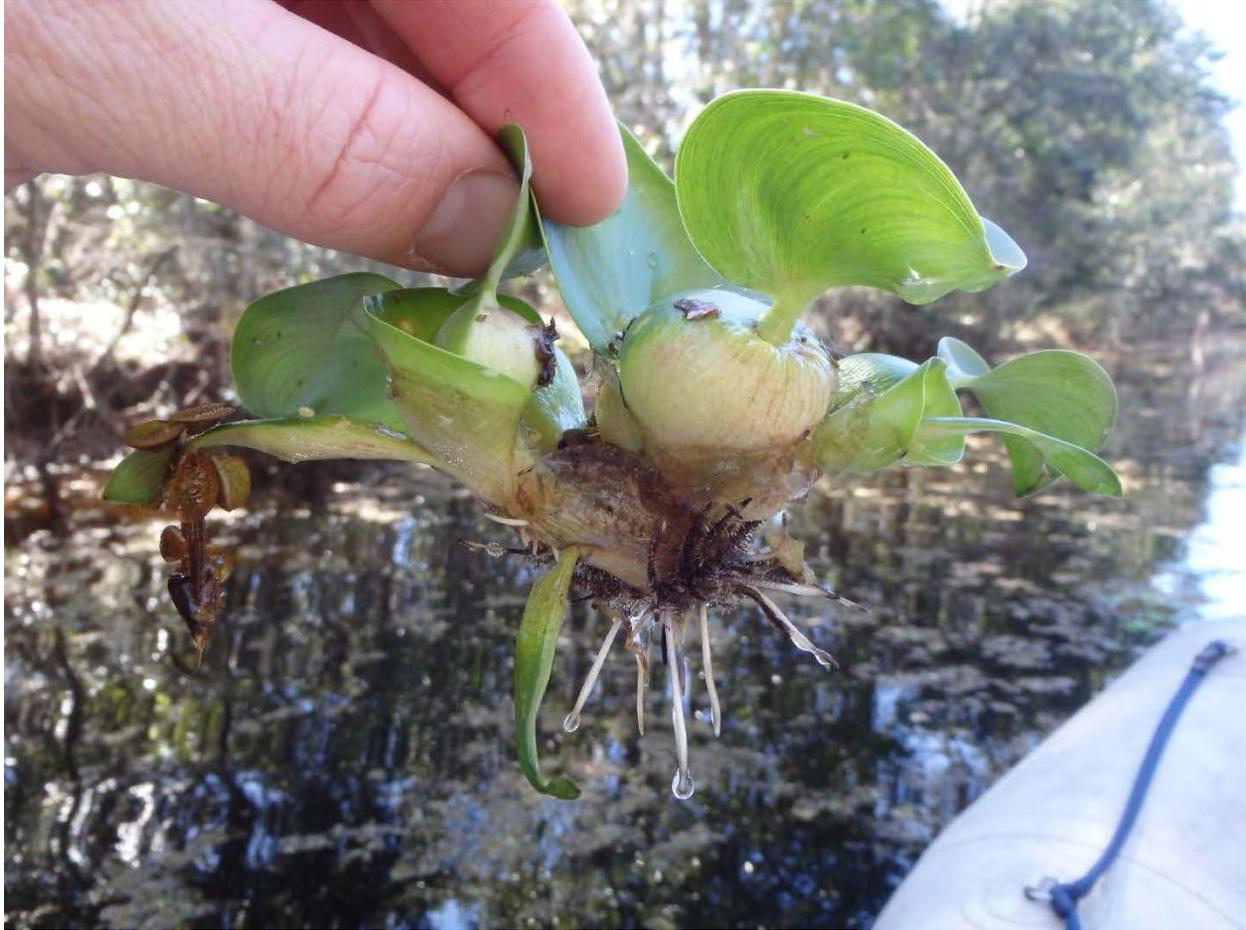
Invasive emergent vegetation found during the inspection included: alligator weed, elephant ear, and cattail. Water hyacinth was found throughout the creek. Salvinia is washing in from Lake Waumpi due to the recent rainfall. This is causing large pockets of salvinia to occur especially around the weir.

Photo: Water hyacinth.

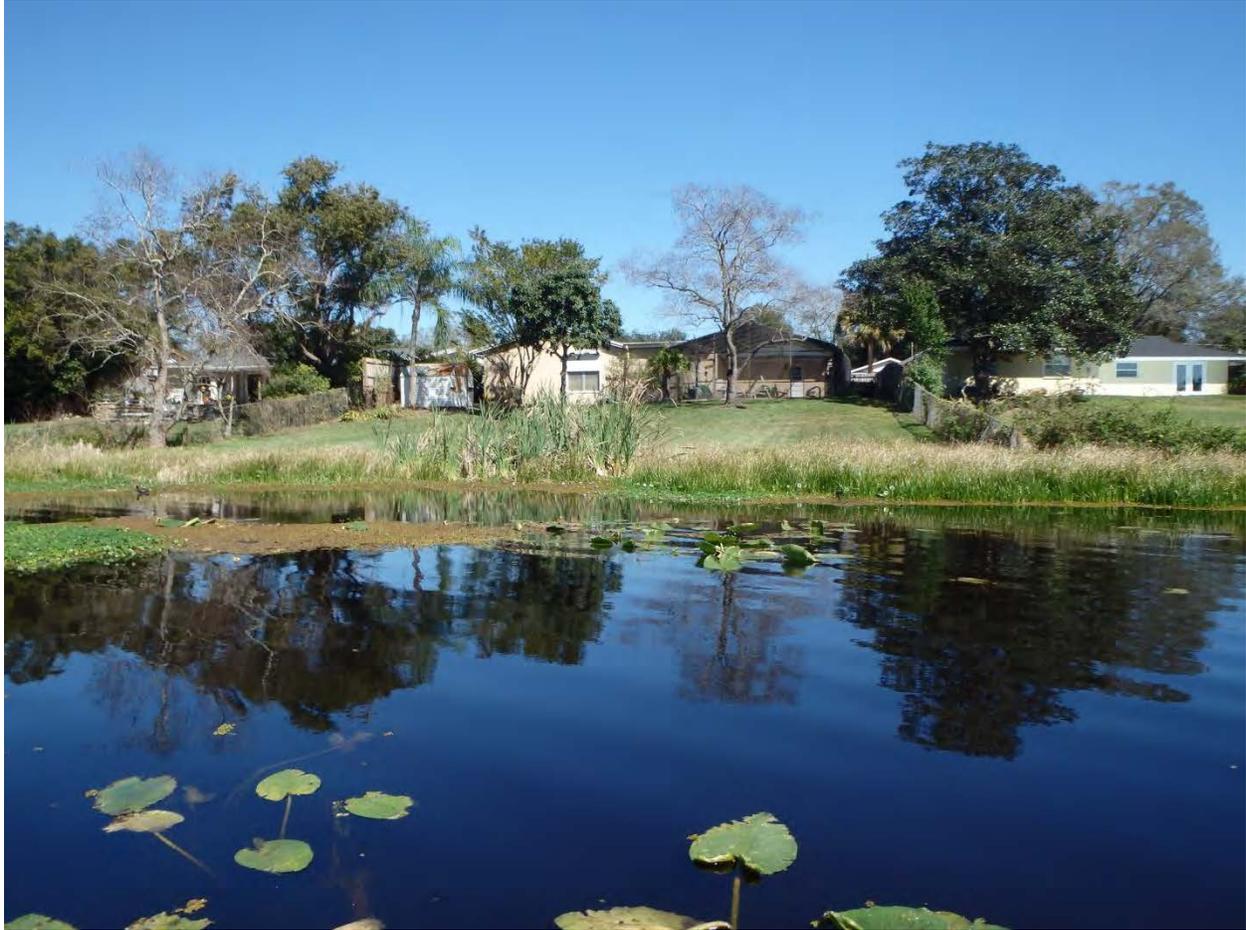
Lake Waumpi was also surveyed during this inspection. There were significantly less lily pads on Waumpi than in the previous inspection. Coontail and hydrilla were the only SAV found in the lake. Most of Lake Waumpi's shoreline was dominated by invasive species including: burhead sedge, primrose willow, Carolina willow, cattails, alligator weed, and salvinia. Some floating mats extending from the shoreline show signs of herbicide treatment. Salvinia was found in large quantities around Lake Waumpi's shoreline

Photo: Burhead sedge and cattails on Lake Waumpi's shoreline.

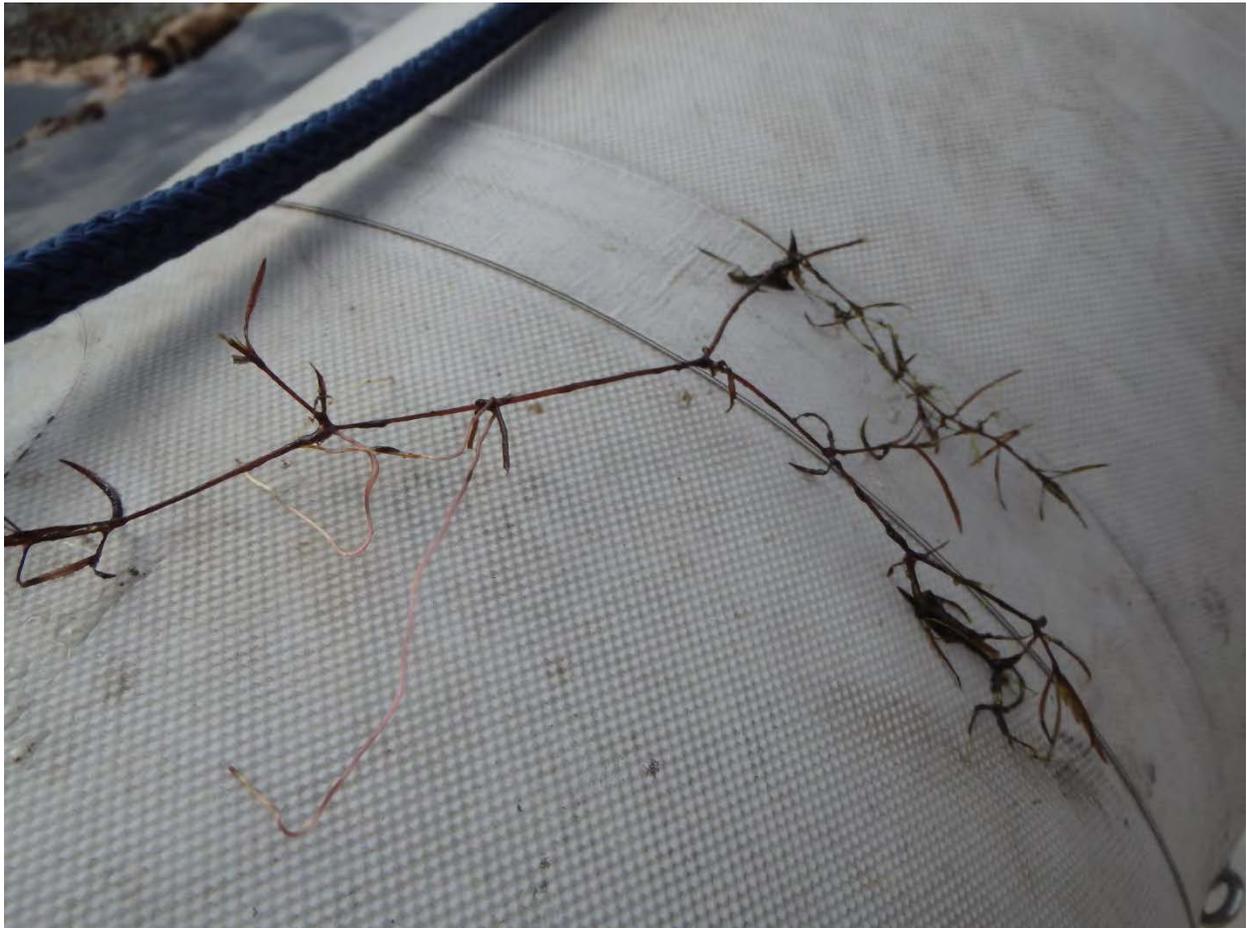
Four species of submersed aquatic vegetation (SAV) were observed during the inspection. These SAV species included road grass, southern naiad, coontail, and eelgrass. Hydrilla was not observed during this inspection. This was a reduction in hydrilla from the previous inspection in which only a few sprigs were found.

Photo: Southern naiad found in creek.

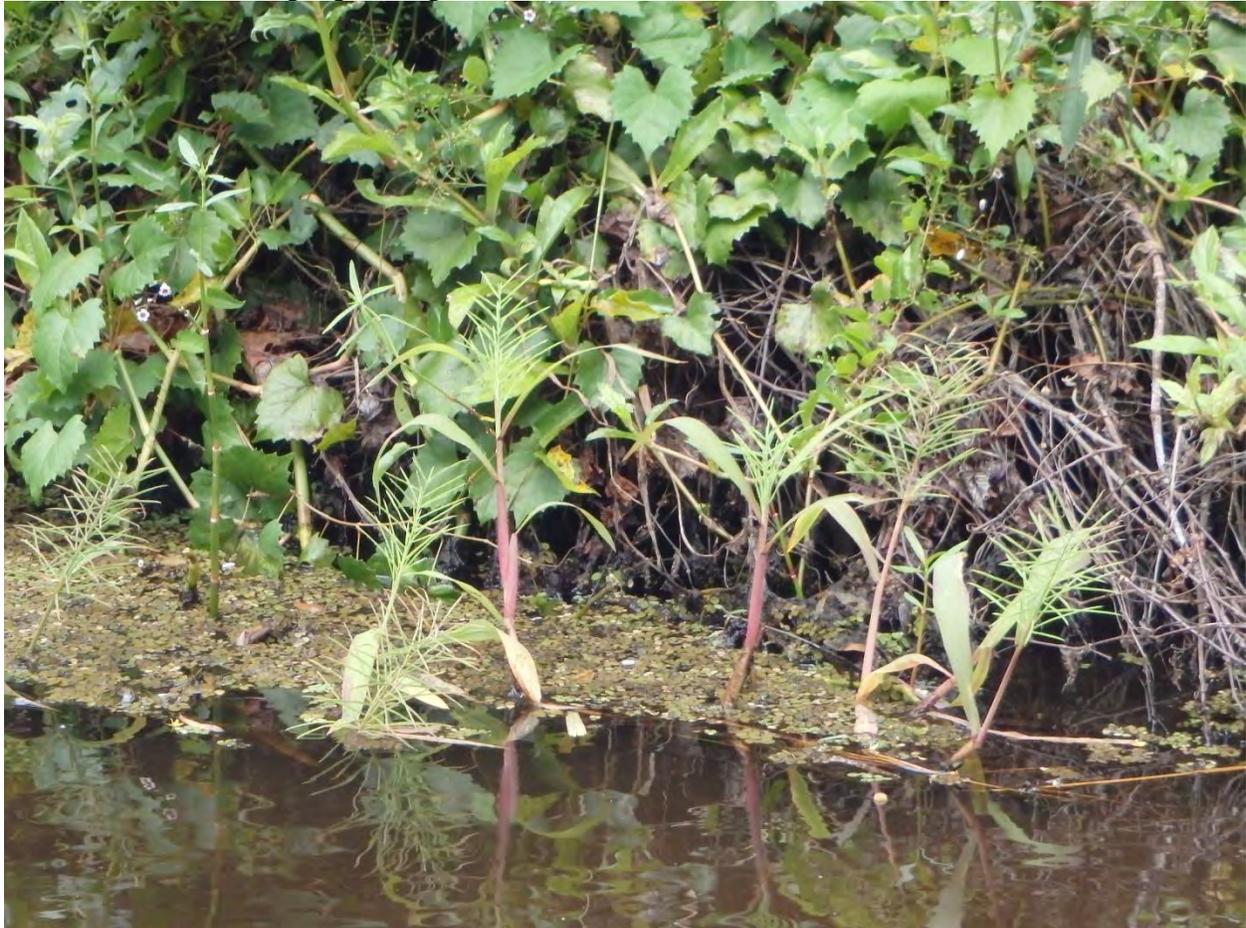
Native vegetation found during the inspection included: yellow cow lily, pennywort, and water paspalum. Some shorelines along the north bank of the creek had visible erosion issues. It is recommended that native shoreline vegetation be planted to help reduce erosion and stabilize this shoreline. Recommended native species include, but are not limited to: pickerelweed (scientific name: *Pontederia cordata*), duck potato (*Sagittaria lancifolia*), golden canna (*Canna flacida*), fire flag (*Thalia geniculata*), and cord grass (*Spartina bakeri*).

Photo: Native water paspalum plant found in Howell Creek.

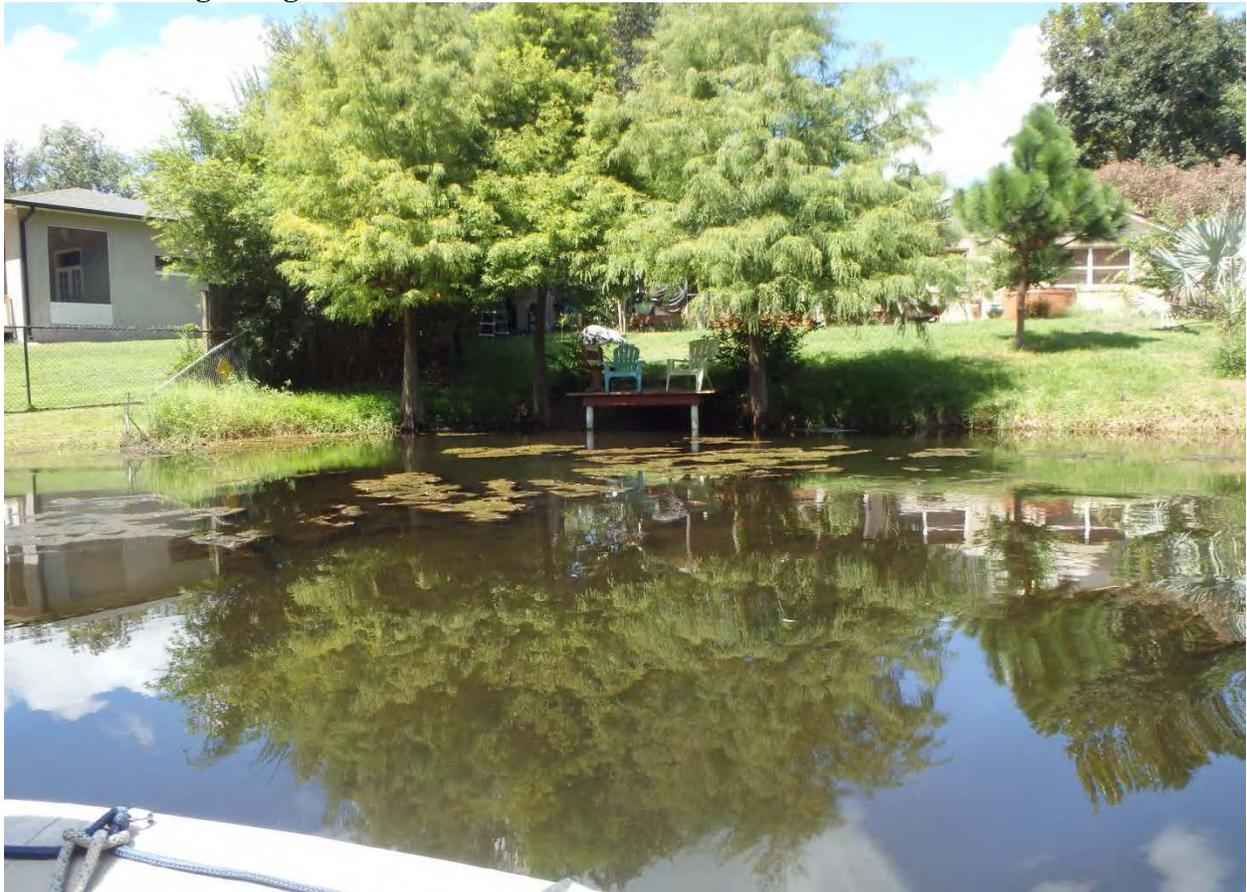
Five species of native submerged aquatic vegetation (SAV) were observed during the inspection. These SAV species included: coontail, roadgrass, southern naiad, bladderwort, and eelgrass. The eelgrass had grown enough to top out (reach the surface) in 2 feet of water close to Lake Waumpi. Several floating mats of roadgrass had formed just downstream from the canopied bend of Howell Creek. The carp had continued to eat the hydrilla and only one sprig was found in the creek.

Photo: Floating roadgrass mats.

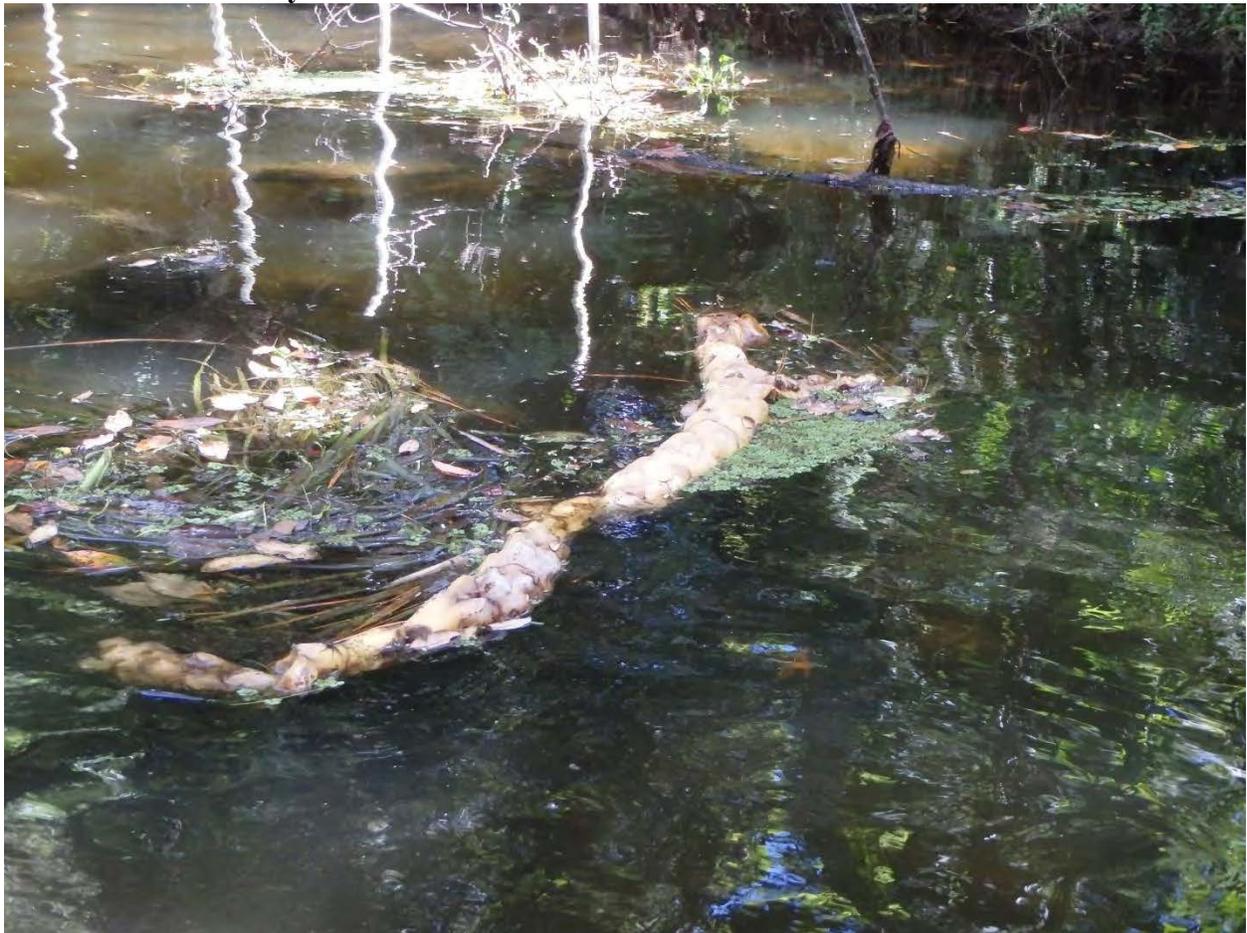
The inspection resulted in the identification of four invasive emergent vegetation species in Howell Creek: alligator weed, elephant ear, torpedo grass, and cattail. The alligator weed expanded since the previous inspection. Invasive species observed in the creek also included two floating species: water hyacinth and salvinia. A few large clusters of water hyacinth had formed along the shoreline of the creek near the lake. After last month's herbicide treatment of lilies, the plants' large rhizomes had floated to the surface.

Photo: Yellow cow lily rhizome.

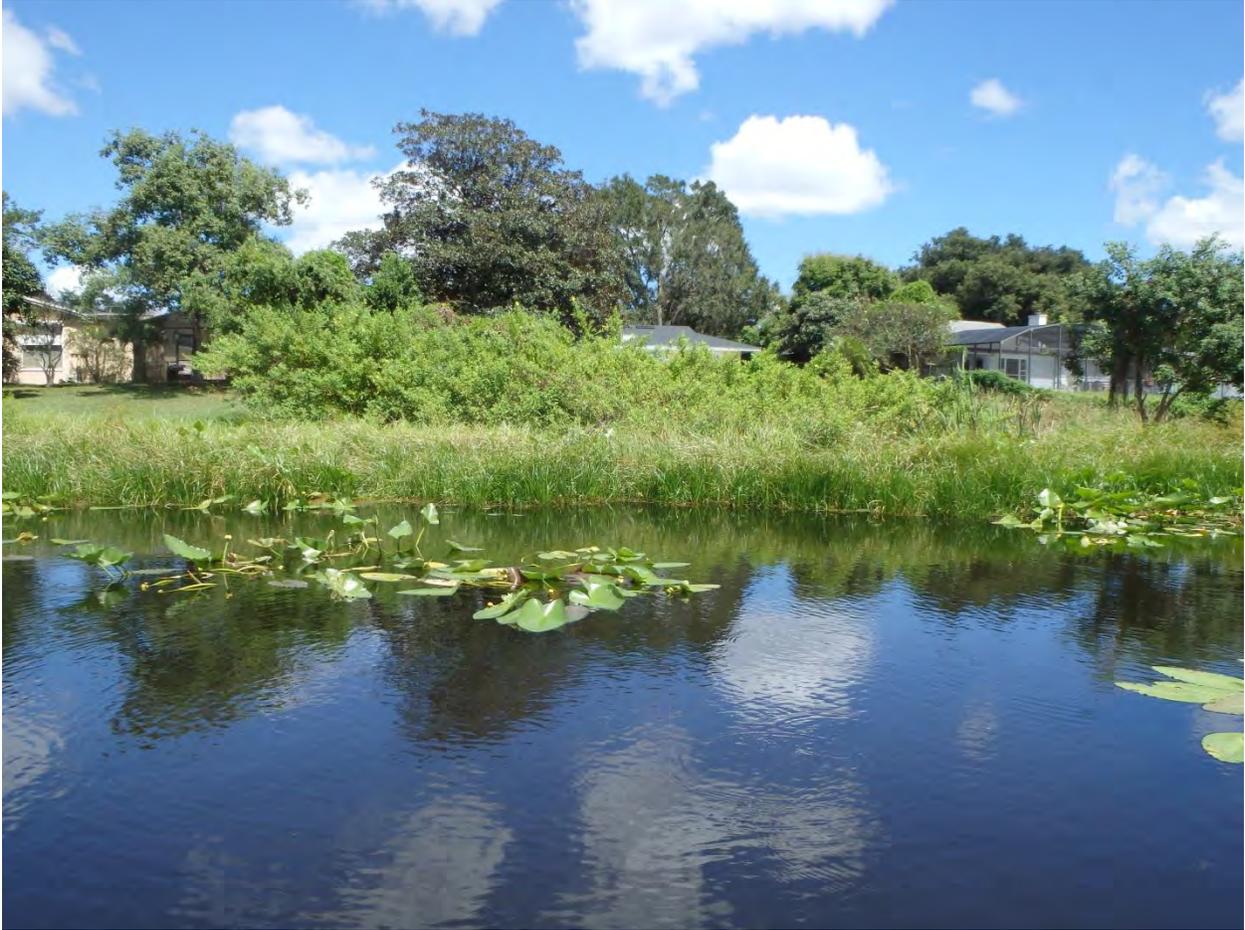
Lake Waumpi had many invasive species around its perimeter. These species included: Carolina willow, Mexican primrose, burhead sedge, cattail, alligator weed, and salvinia. Large floating mats along the shoreline were reducing the area of the lake. No submerged vegetation was found in Lake Waumpi.

Photo: Floating mat on Lake Waumpi

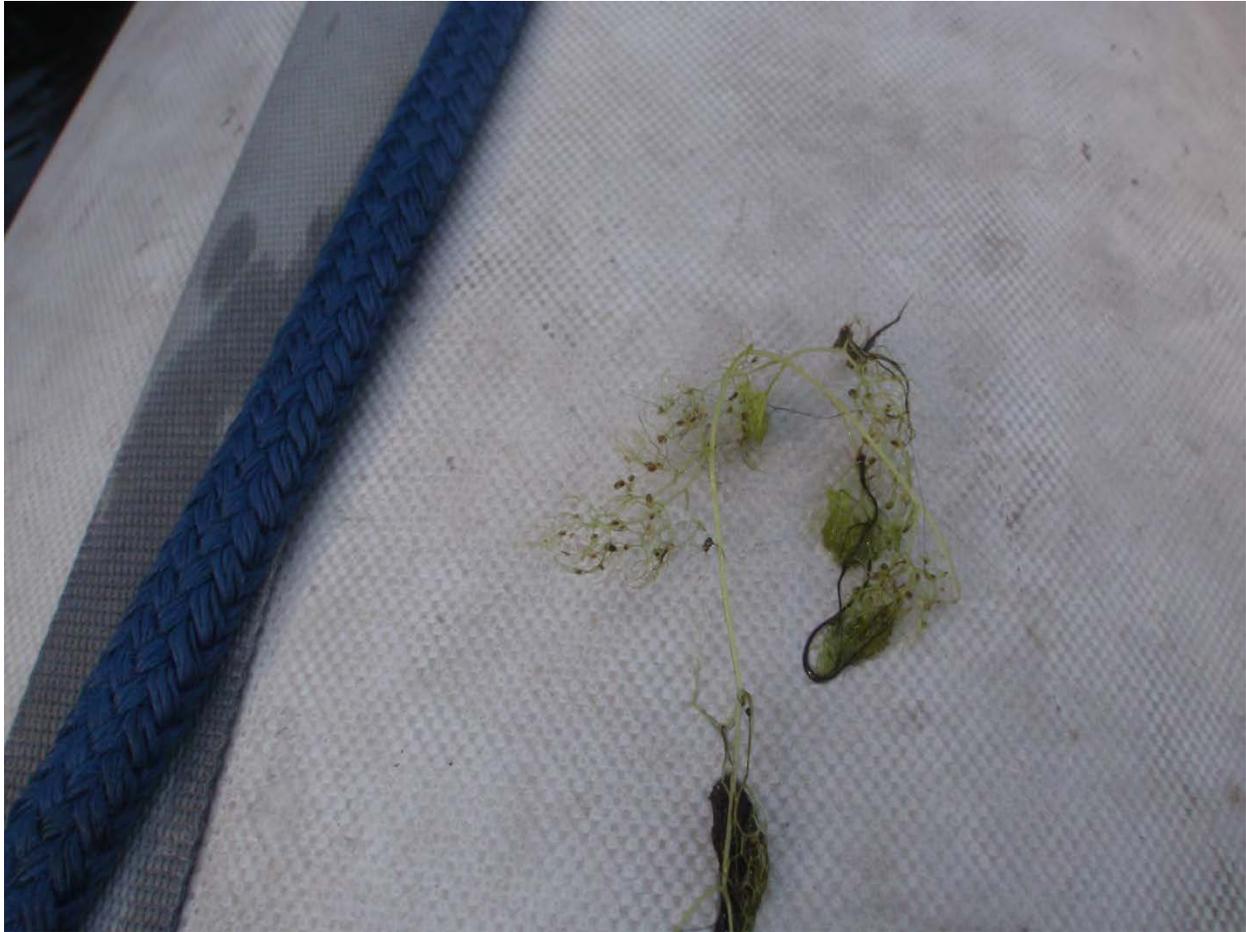
Four species of native submerged aquatic vegetation (SAV) were observed during this inspection. These species included: coontail, bladderwort, eelgrass, and roadgrass, each to a depth of 2 feet. One patch of hydrilla was found, but it was evident that grass carp had been eating it.

Photo: Bladderwort.

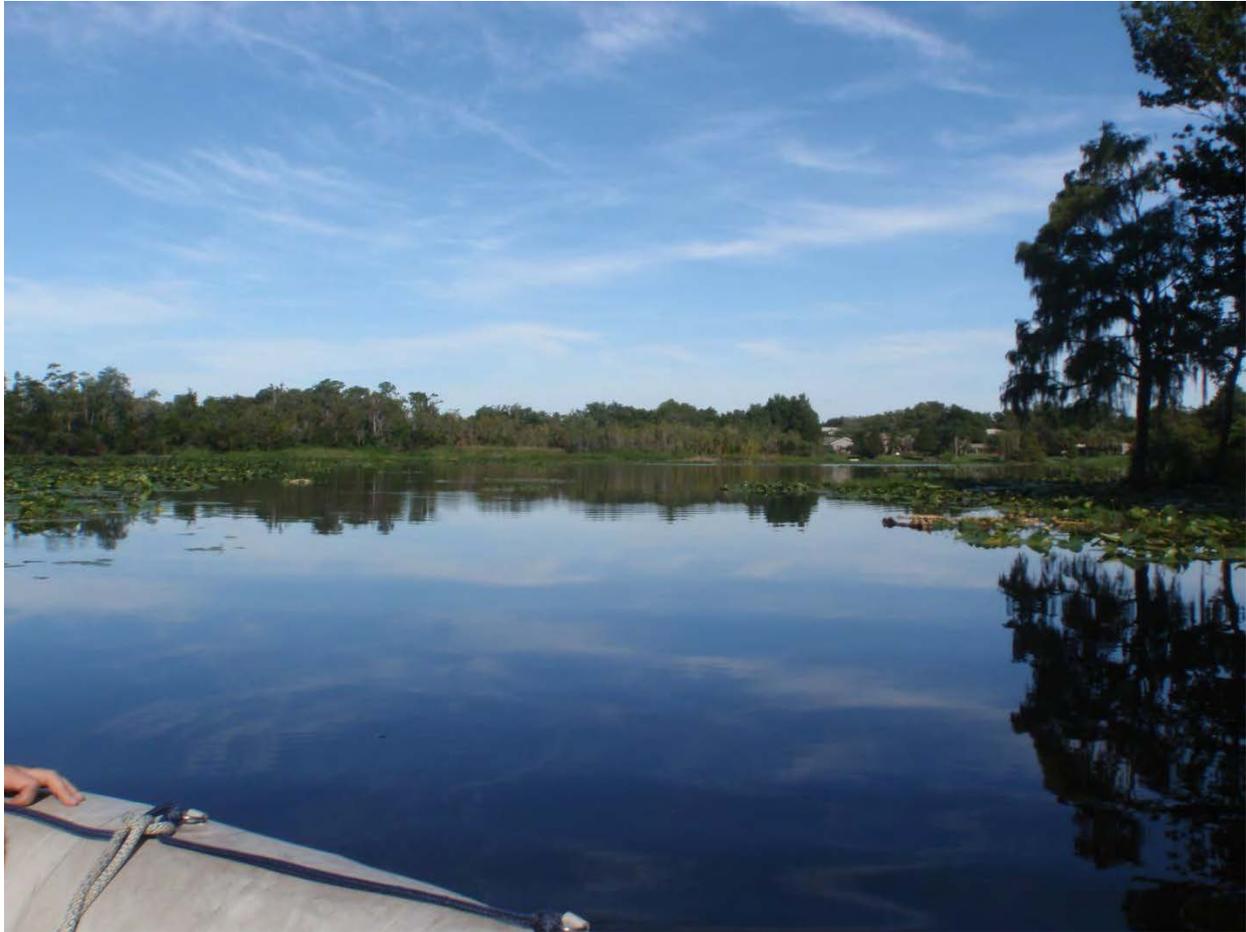
Photo: View of Lake Waumpi from Howell Creek.

Entry into Lake Waumpi from Howell Creek was easier during the last inspection because of a reduction in yellow cow lilies. Vegetation in the middle of the lake had been reduced, but the invasive plants on the shoreline were still prominent. The most prominent species were: burhead sedge, primrose willow, Carolina willow, cattails, alligator weed, and salvinia. These invasive species reduce the size of the lake as they grow out away from the shoreline as floating mats. No submerged vegetation was found in Lake Waumpi.

- 1 Work together with other lakefront owners. Have *at least* one annual waterbody association meeting, invite guest speakers (such as county or state biologists) and discuss lake specific issues, especially nutrients/lake management recommendations. Seminole County Lake Management Program staff would be glad to present our findings from this and other surveys. Continue to increase native aquatic plantings along the shoreline (such as pickerelweed, duck potato, and canna).
