Greetings Residents of The Bear Chain of Lakes!

On **October 3rd, 2013**, Seminole County Lake Management and Water Quality Program staff (Thomas Calhoun, Gloria Eby, and Marianne Pluchino) surveyed the aquatic plants in **Bear Lake**.

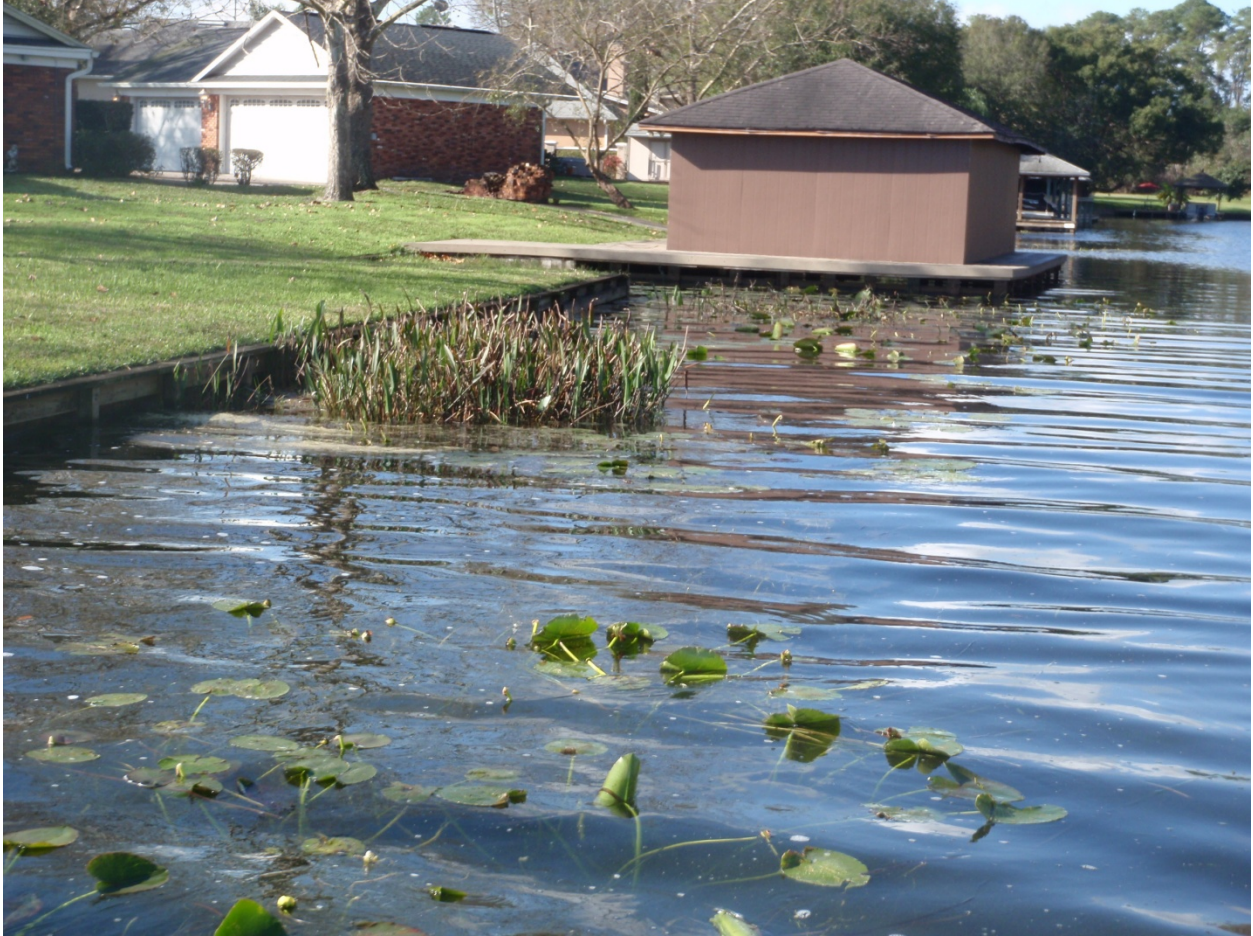
A small amount of water hyacinths were observed in the canal off of Linneal Beach Drive. Residents of the canal have done a great job of managing this exotic plant!

Photo: Linneal Beach Drive Canal.

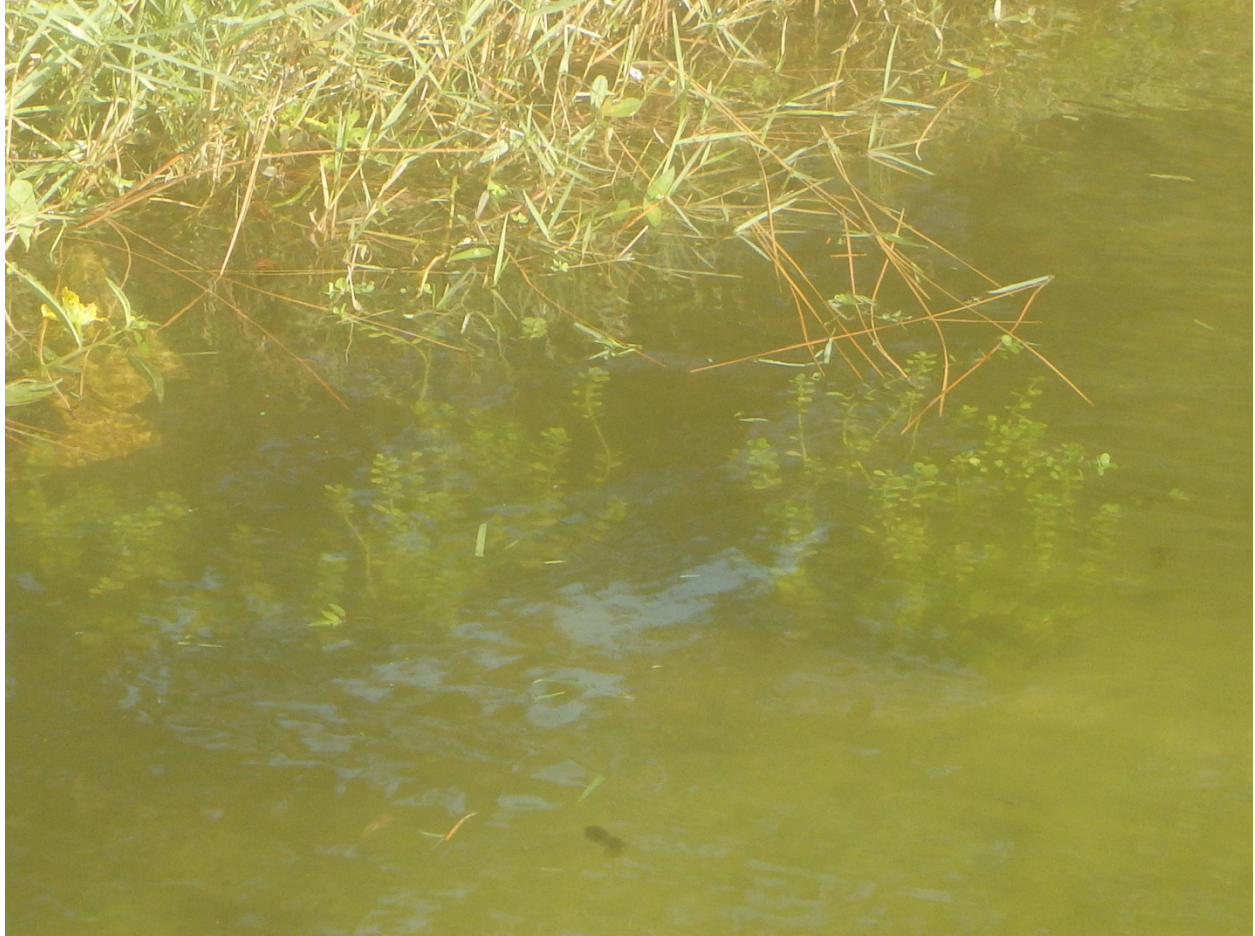
Submersed aquatic vegetation (SAV) found in Little Bear Lake during this inspection included road grass to a depth of 2 feet and smooth water hyssop to a depth of 1 foot. Filamentous algae was also present during the inspection.

Photo: Submersed aquatic vegetation- smooth water hyssop.

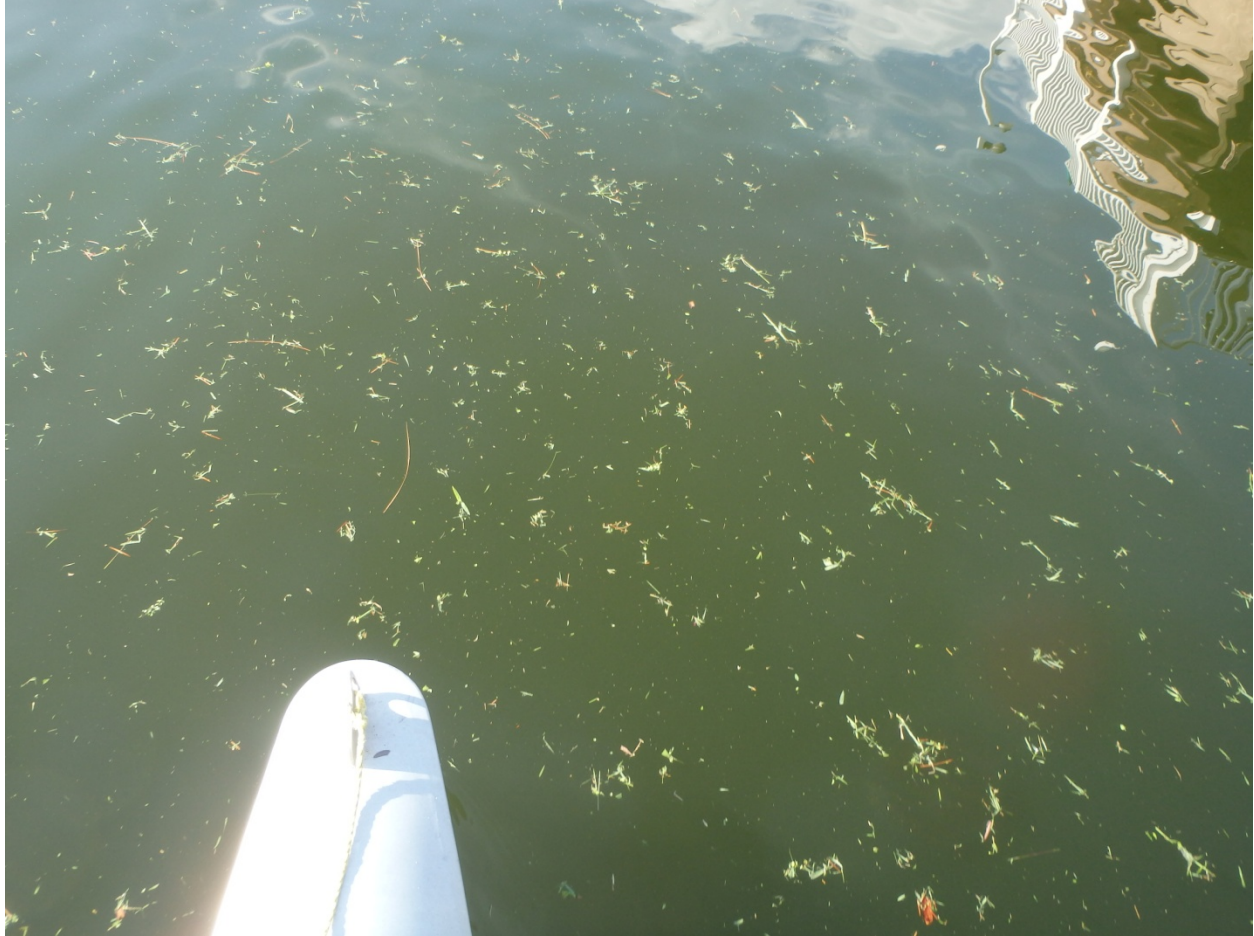
At the time of inspection a large amount of fresh grass clippings were found floating in Little Bear Lake. Grass clippings can add nutrients to the lake which will cause algae blooms. Instead of blowing clippings into the lake, blow them back into your lawn, which will provide nutrients for your lawn.

Photo: Grass clippings in Little Bear Lake.

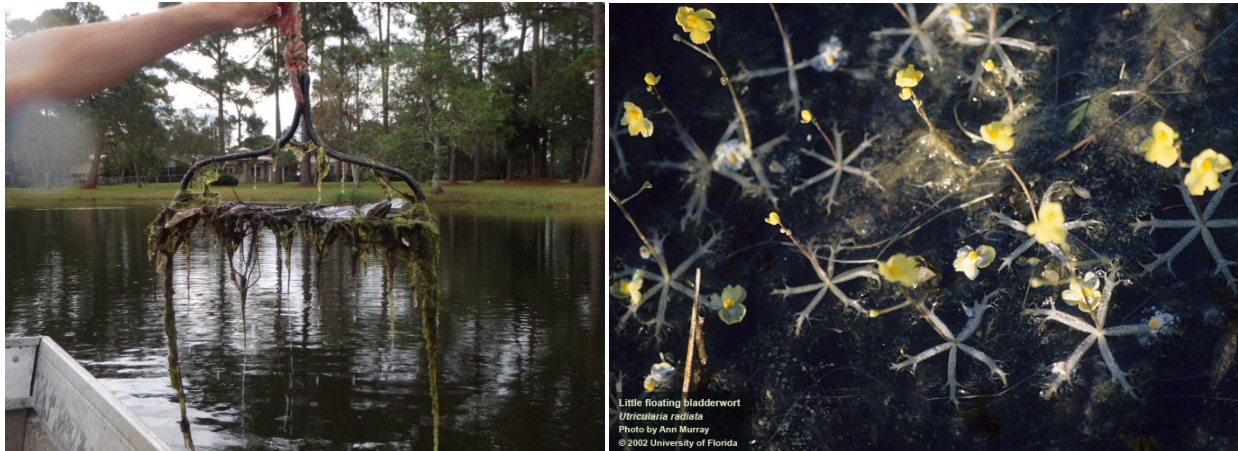
A healthy diversity of native submersed aquatic vegetation (SAV) was observed during the inspection. These species included: lemon bacopa to a depth of 4 feet, road grass to 2 feet, stonewort to 6 feet, musk grass to 3 feet, bladderwort to 6 feet, and eelgrass to 8 feet. Bladderwort was the dominant species of SAV found in Cub Lake. Filamentous algae was also found during the inspection.

Photo: Bladderwort found in Cub Lake.

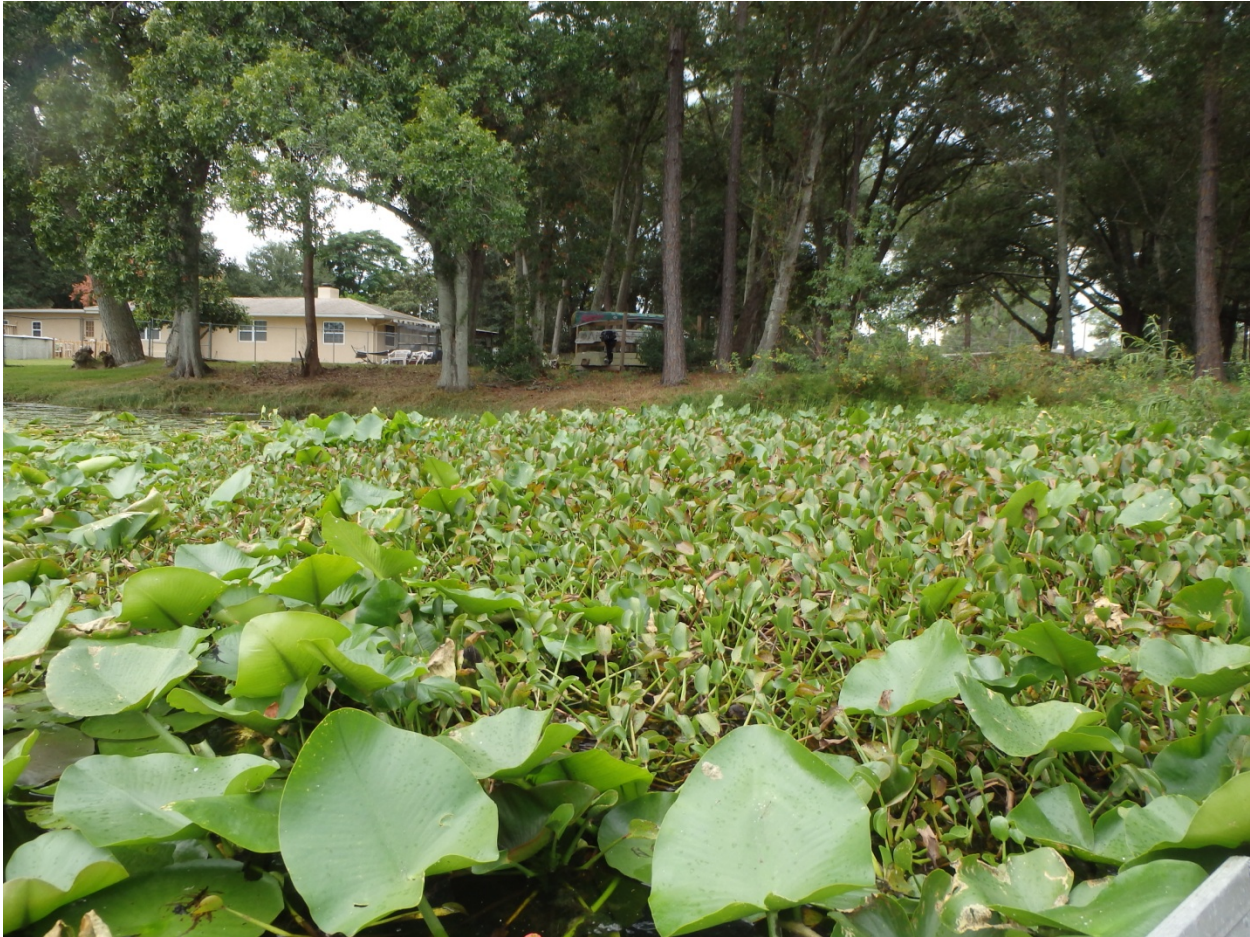
Invasive exotic species found during the inspection included: torpedo grass, alligator weed, wild taro, primrose willow, and dwarf papyrus. These continue to be the most abundant emergent aquatic plants and were present throughout the lake. A large size patch of water hyacinth was also found at the Cub Lake inflow canal. We highly recommend removing these plants by physical means or by treating with herbicides. If using herbicides, please be sure to obtain your free aquatic plant management permit from FWC prior to treating.

Photo: Water hyacinth found at Cub Lake inflow canal.

4. Control of aquatic and wetland plants could require a Florida Fish and Wildlife Conservation Commission (FWC) aquatic plant control permit (such as the lilies in Cub). Contact Alicia Knecht at (321) 246-0682 or Alicia.knecht@myfwc.com for a permit and recommendations.

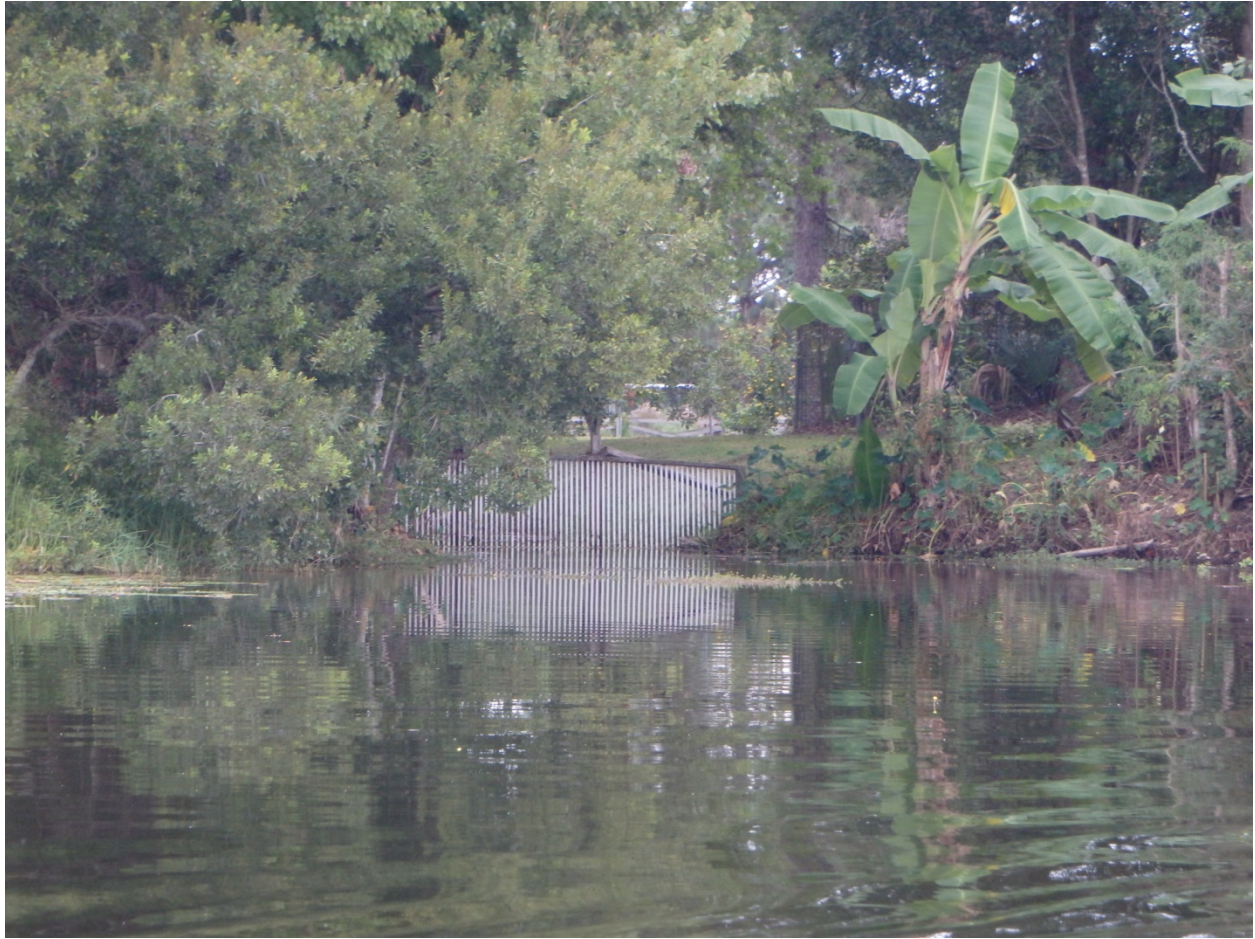
Photo: Grass carp fence.

The Secchi (water clarity) was 6.9 feet in a depth of 10.9 feet. The grass carp barrier was free from debris and operational.
