Greetings Howell Creek Residents!

On **March 11th, 2015**, Thomas Calhoun (Seminole County Lake Management Program) and Sophia Pengra (Seminole County Watershed Management Intern) surveyed the aquatic plants in **Howell Creek** and **Lake Waumpi**.

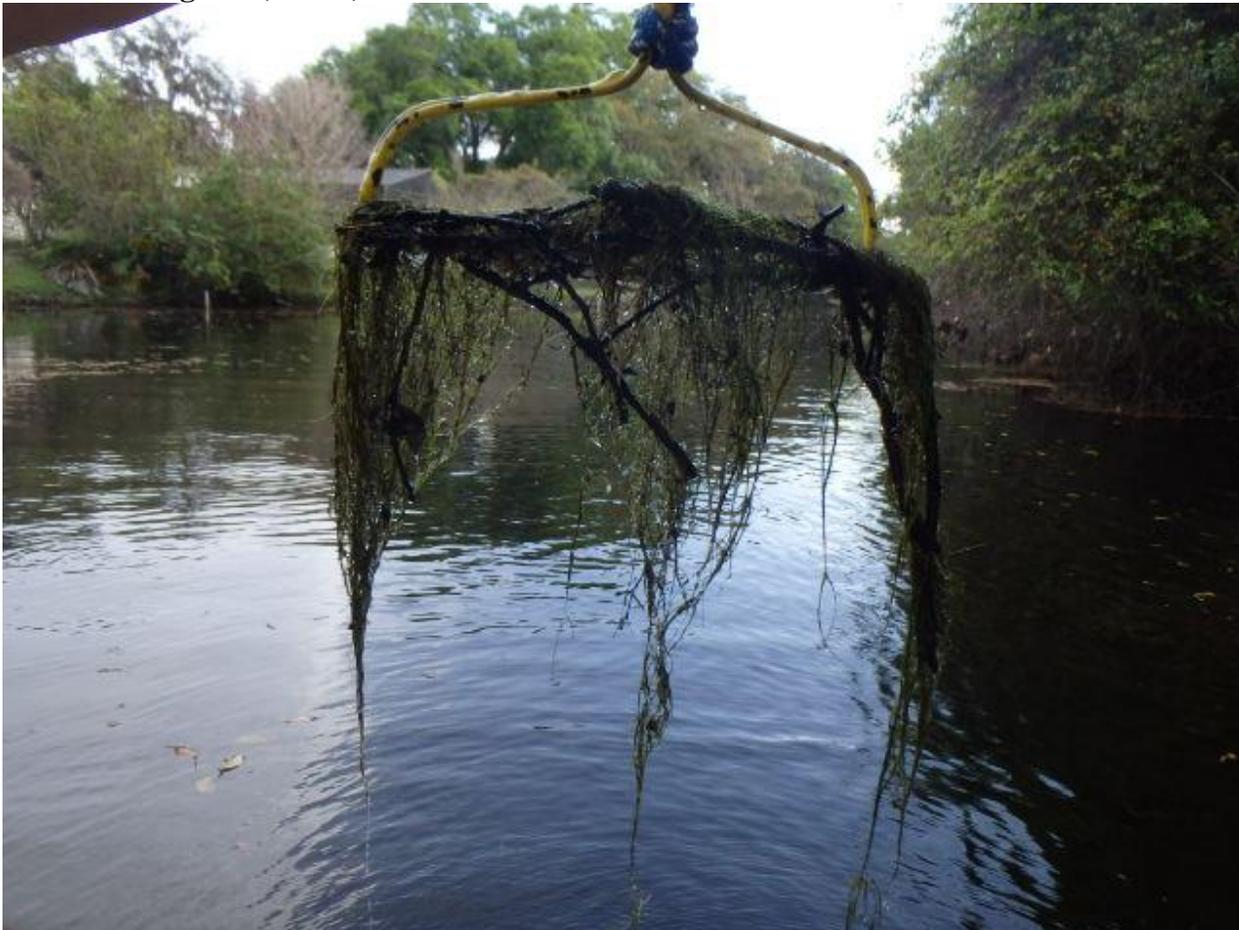
Native submersed aquatic vegetation (SAV) species found during the inspection included road-grass and eelgrass, with road-grass being identified as the dominant SAV species. One sprig of invasive hydrilla was observed. A bottom filamentous algal bloom was observed.

Photo: Road-grass (native).

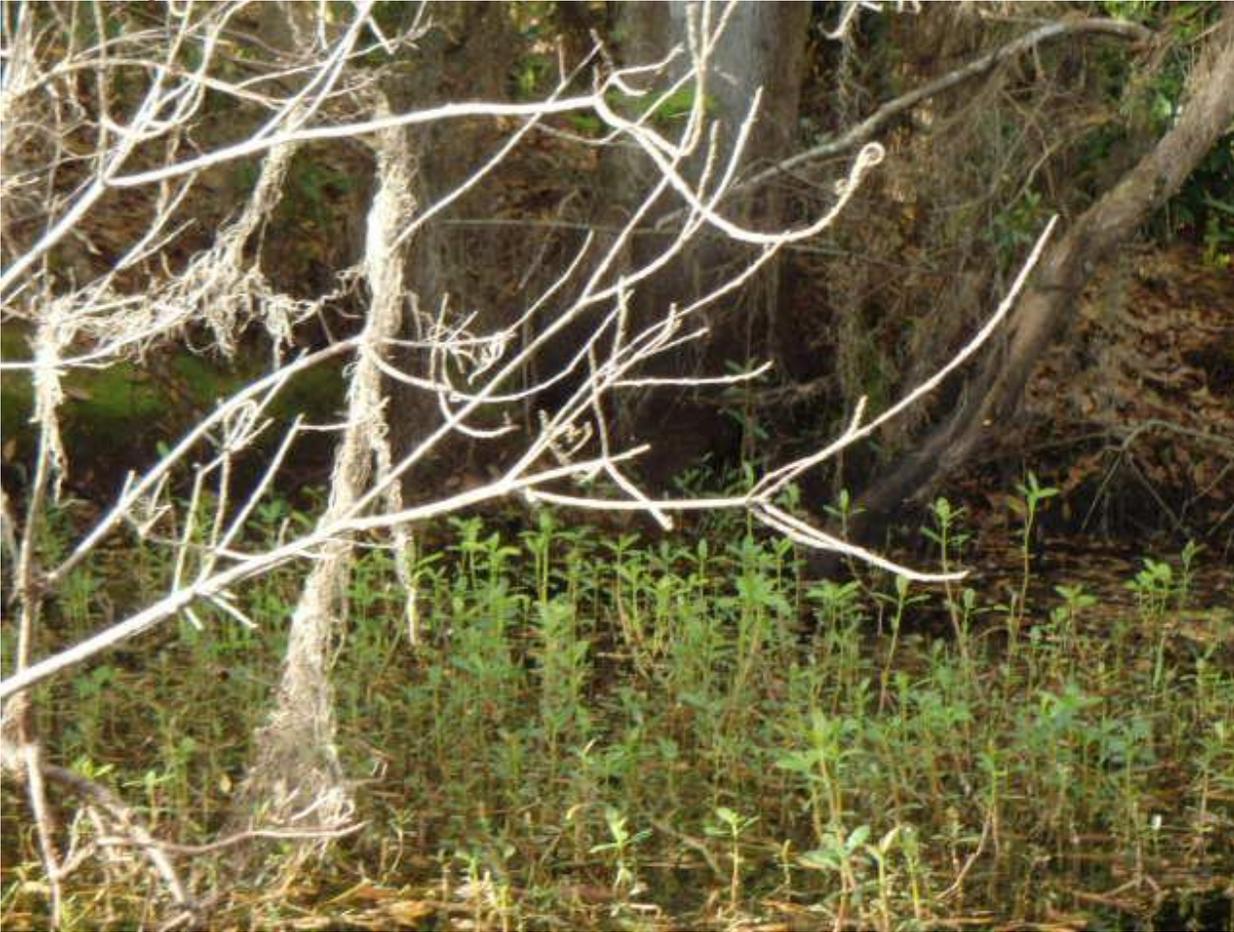
Invasive emergent vegetation observed during the inspection included: alligatorweed, wild taro, wedelia, torpedo grass, and water hyacinth. Torpedo grass and alligatorweed growth have increased in comparison to the

last survey in December. Only two water hyacinth plants were observed during this survey, which was a reduction from the last survey.

Photo: Alligatorweed (invasive)

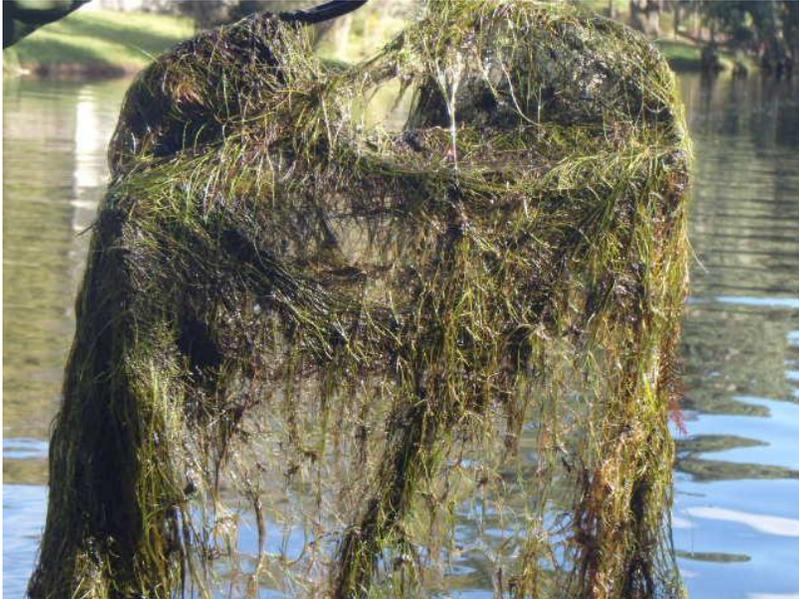
Six species of submersed aquatic vegetation (SAV) were found during the inspection. These SAV species included eelgrass, coontail, southern naiad, bladderwort, baby's tears, and hydrilla. There was an increase in southern naiad from the previous inspection.

Photo: Southern naiad (native).

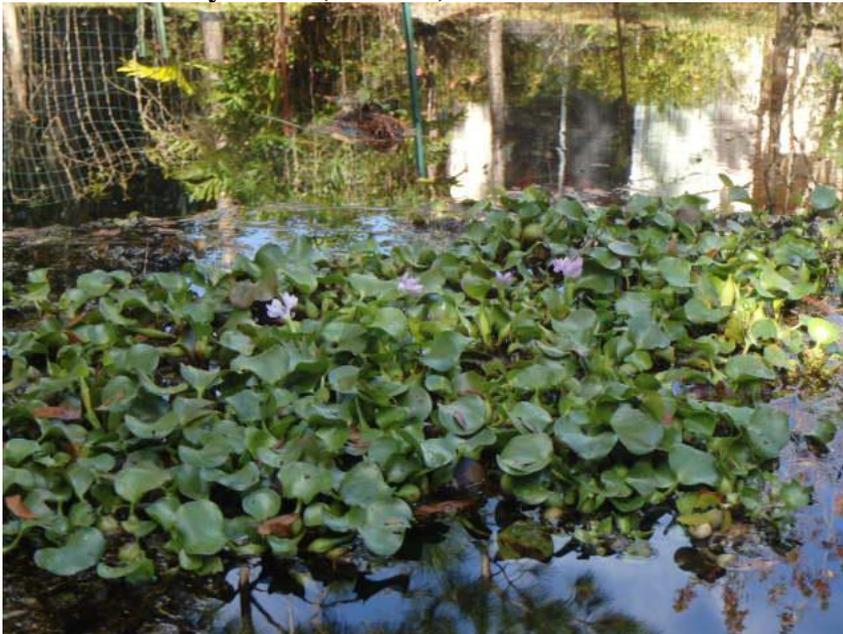
Invasive emergent vegetation observed during the inspection included: alligatorweed, wild taro, salvinia, and water hyacinth. Mats of water hyacinth, alligator weed and burhead sedge have floated down the creek from Lake Waumpi. Torpedo grass was not present in the creek at time of inspection.

Photo: Water hyacinth (invasive)

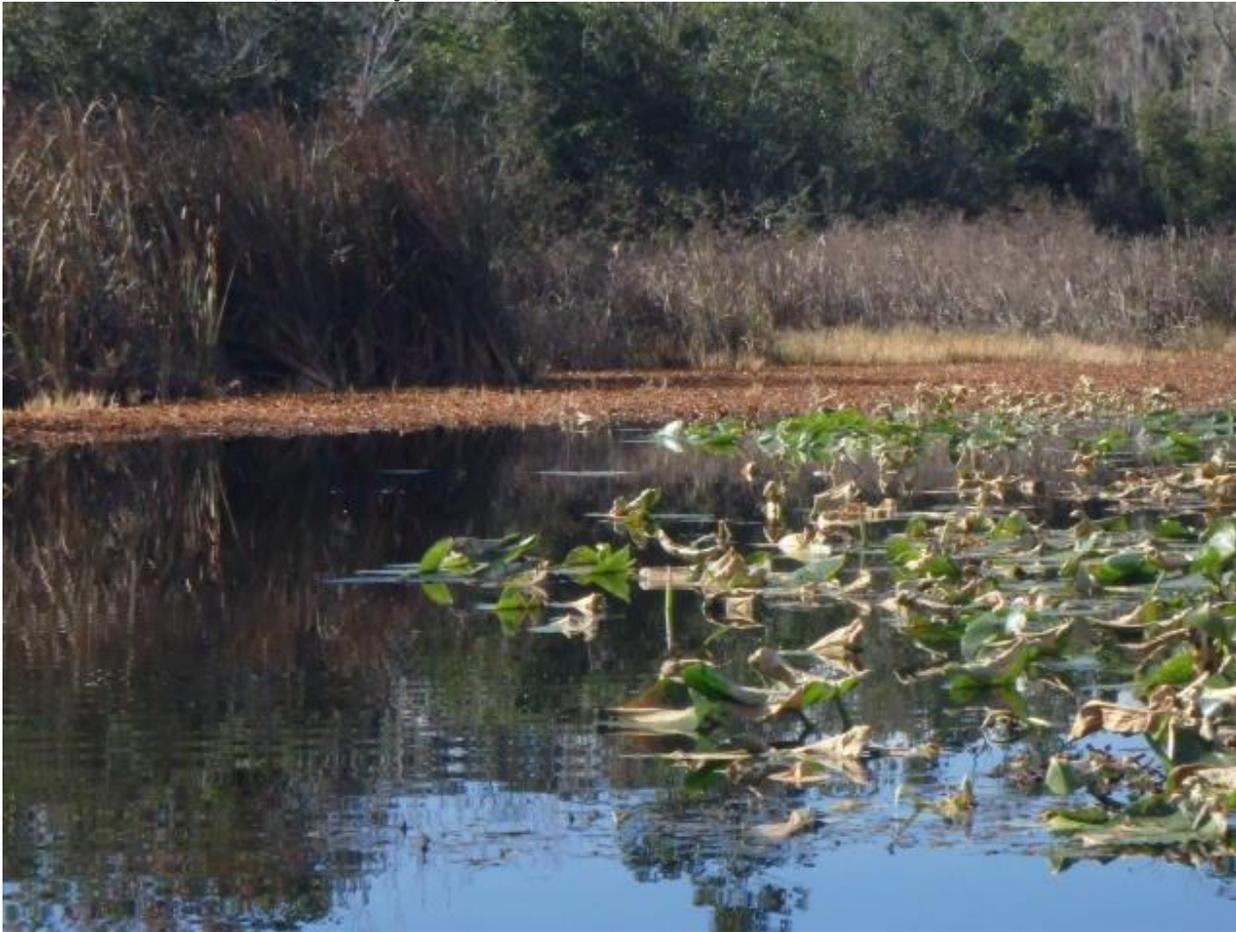
Lake Waumpi was also surveyed during this inspection. There was an abundance of SAV which included coontail, bladderwort, and southern naiad. The lake was recently treated for lily pads and water hyacinth. Emergent species found on Lake Waumpi include: cattail, burhead sedge, yellow cow lily, water hyacinth, and primrose willow.

Photo: Treated lilies, water hyacinth, and cattail.

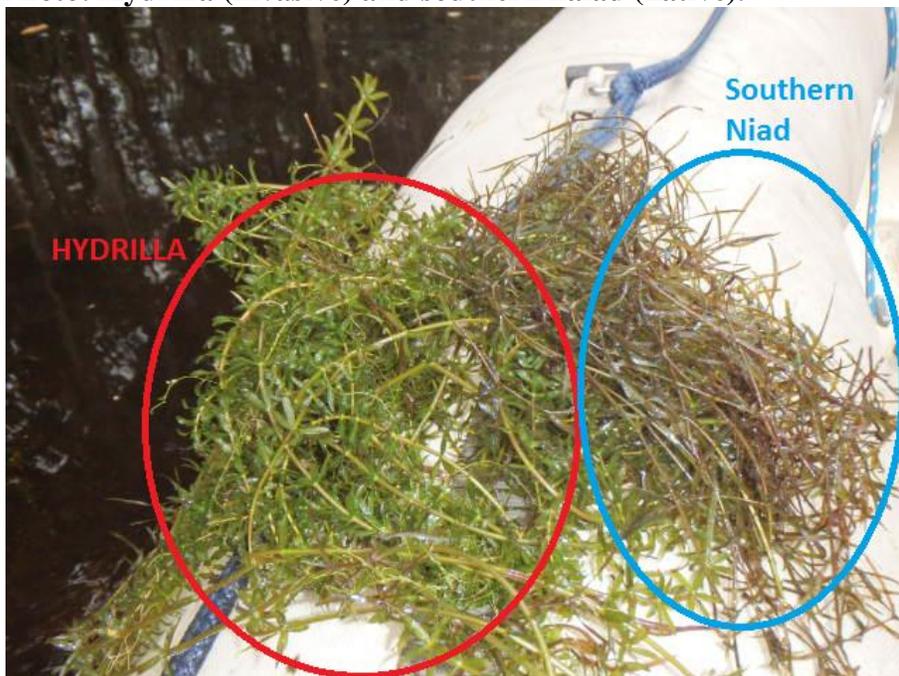
Seven species of submersed aquatic vegetation (SAV) were found during the inspection. These SAV species included road grass, eelgrass, coontail, southern naiad, 2 species of bladderwort, and hydrilla. Because of low water levels, eelgrass and bladderwort are topping out in portions of the creek. Southern naiad and hydrilla have expanded since the last inspection. Spot treatments and grass carp fish are both being considered as means to control the hydrilla.

Photo: Hydrilla (invasive) and southern naiad (native).

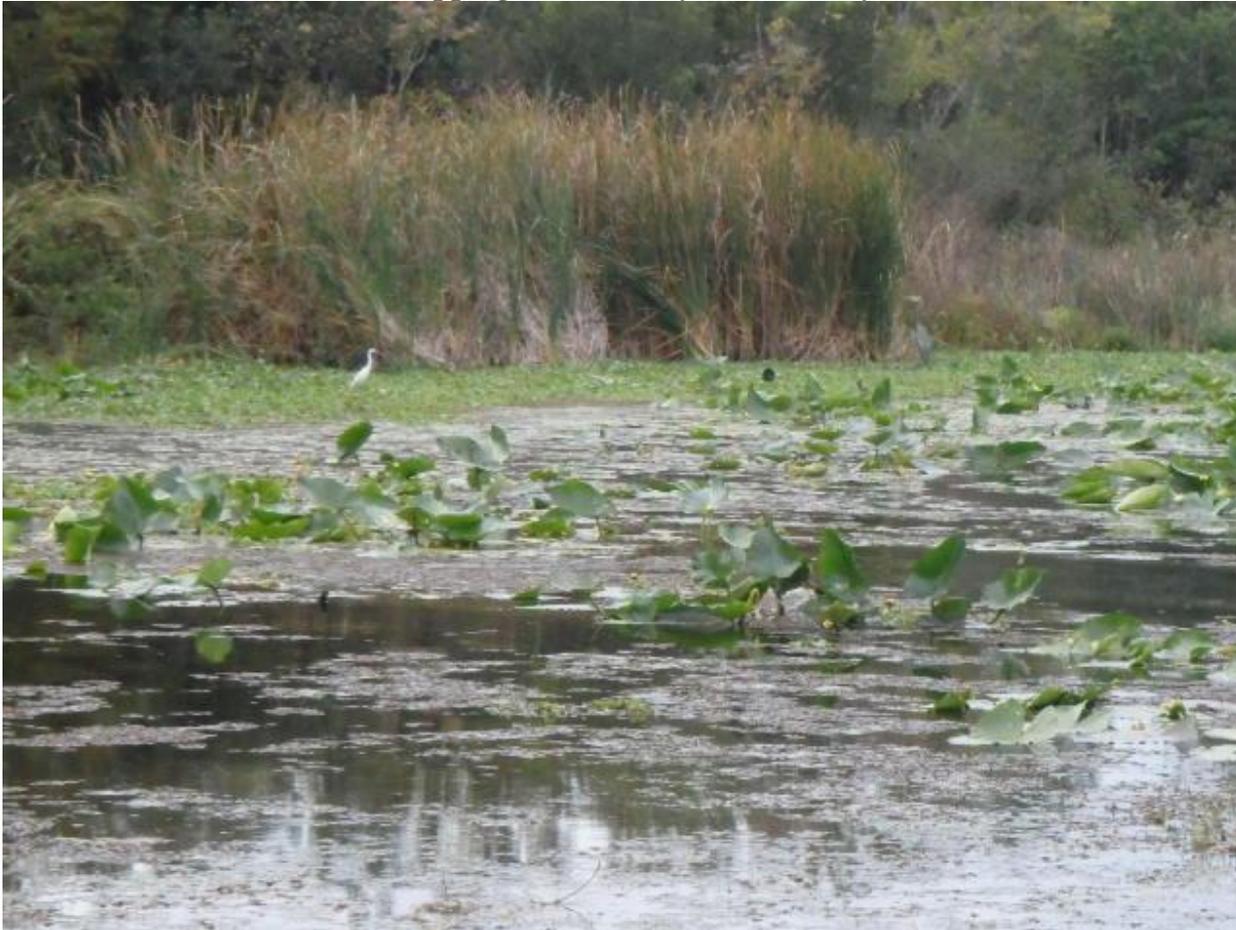
Lake Waumpi was also surveyed during this inspection. The lake has an abundance of SAV. Three quarters of the lake is topped out with southern naiad and bladderwort. Emergent species found on Lake Waumpi include: cattail, burhead sedge, yellow cow lily, water hyacinth, and primrose willow.

Photo: Southern naiad (SAV) topping out around yellow cow lily
