Greetings Howell Creek Residents!

On **July 17th, 2013**, Thomas Calhoun (Seminole County Lake Management Program) and Joey Cordell (Seminole County Watershed Management Intern) surveyed the aquatic plants in **Howell Creek and Lake Waumpi**.

On **May 15th, 2013**, Thomas Calhoun (Seminole County Lake Management Program) and Joey Cordell (Seminole County Watershed Management Intern) surveyed the aquatic plants in **Howell Creek and Lake Waumpi**.

On **March 26th, 2103** Thomas Calhoun (Seminole County Lake Management Program) and Devin Whitney (Seminole County Watershed Management Intern) surveyed the aquatic plants of **Howell Creek and Lake Waumpi**.

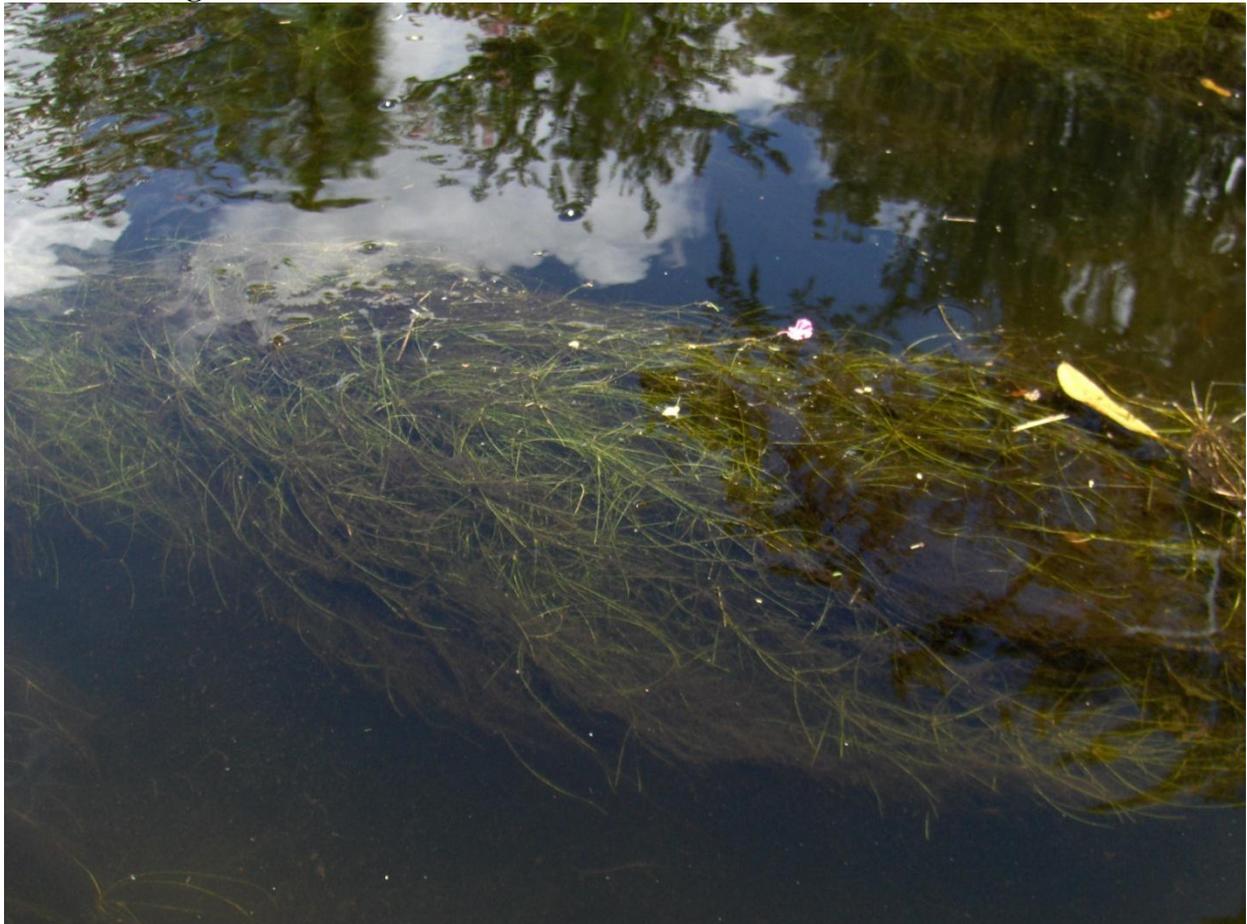
Four species of submersed aquatic vegetation (SAV) were found during the inspection. These SAV species included road grass, bladderwort, and eelgrass each to a depth of 2 feet. A few sprigs of hydrilla were observed during this inspection. We will continue to monitor the hydrilla to see if any further action will be necessary.

Photo: Road grass found in creek.

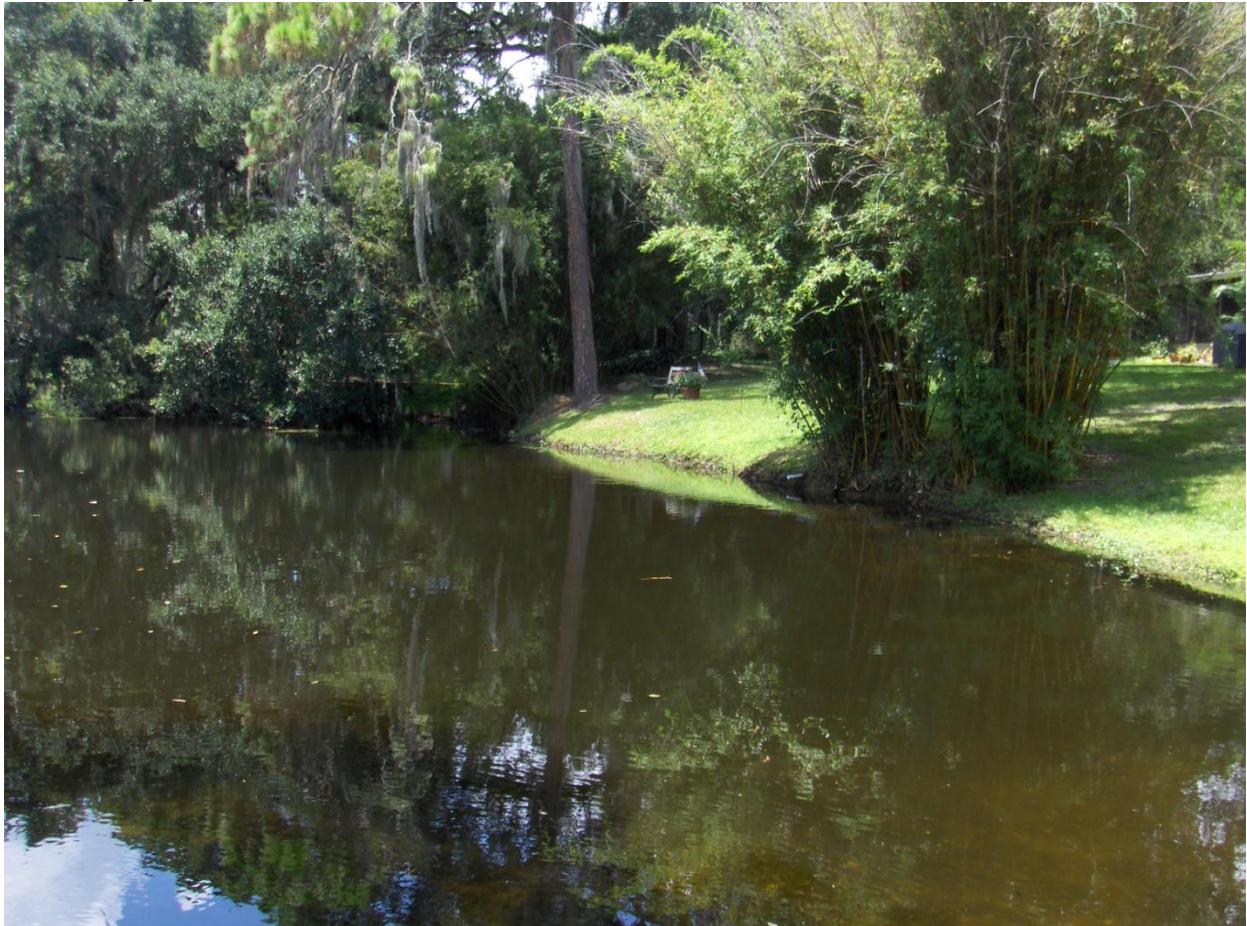
Invasive emergent vegetation found during the inspection included: elephant ear, alligator weed, and torpedo grass. A small amount of water hyacinth, an invasive floating aquatic plant, was observed during inspection. Torpedo grass was found in a very small amount. The MSBU funded herbicide contractor continues to do a good job eradicating torpedo grass within the MSBU boundary of Howell Creek. Native vegetation found during the inspection included: canna lily, pickerelweed, yellow cow lily, and pennywort. Some shorelines along the north bank of the creek had visible erosion issues. It is recommended that native shoreline vegetation be planted to help reduce erosion and stabilize this shoreline. Recommended native species include, but are not limited to: pickerelweed (scientific name: *Pontederia cordata*), duck potato (*Sagittaria lancifolia*), golden canna (*Canna flacida*), fire flag (*Thalia geniculata*), and cord grass (*Spartina bakeri*).

Photo: Typical shoreline found on Howell Creek.

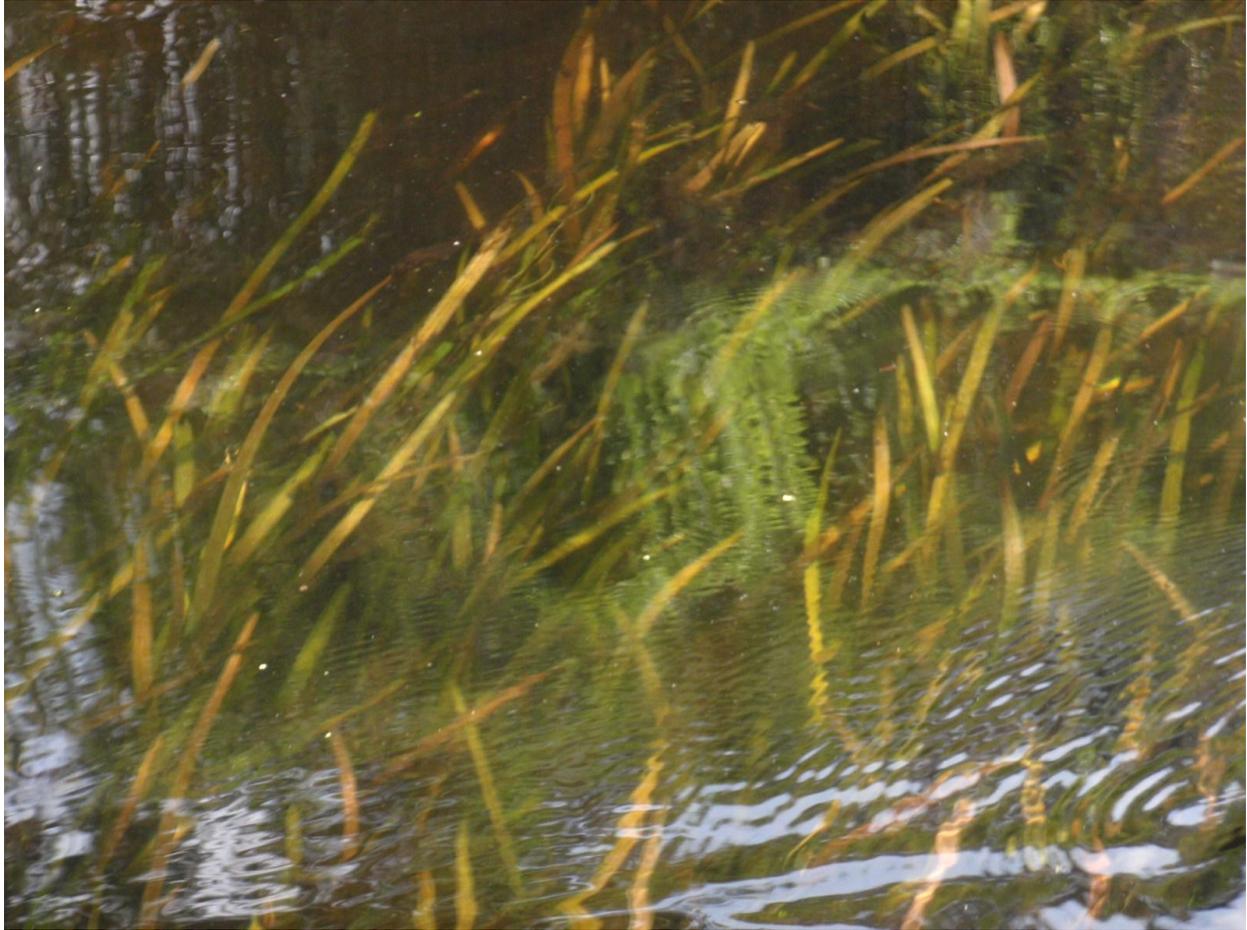
Only two species of submersed aquatic vegetation (SAV) were found during the inspection. These SAV species included roadgrass and eelgrass both to a depth of 2 feet. Hydrilla was not observed during this inspection.

Photo: Eelgrass found in creek.

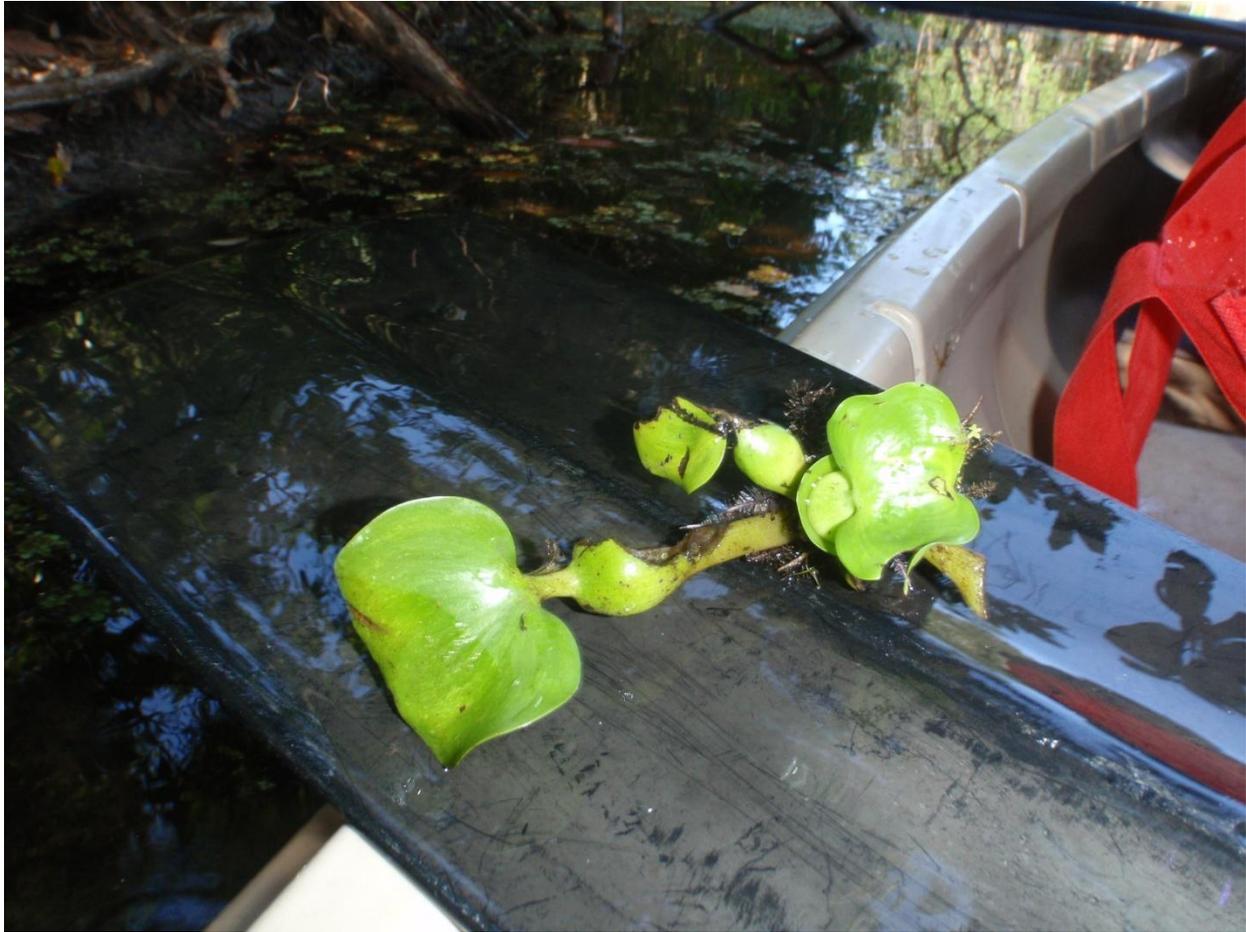
Invasive emergent vegetation found during the inspection included: elephant ear, alligator weed, and torpedo grass. A small amount of water hyacinth, an invasive floating aquatic plant, was observed during inspection. Native vegetation found during the inspection included: canna lily, pickerelweed, yellow cow lily, and pennywort. The entrance to Lake Waumpi is beginning to be filled by yellow cow lily and pennywort impeding access however this area is not within the MSBU assessment boundary of Howell Creek.

Photo: Water hyacinth found during inspection.

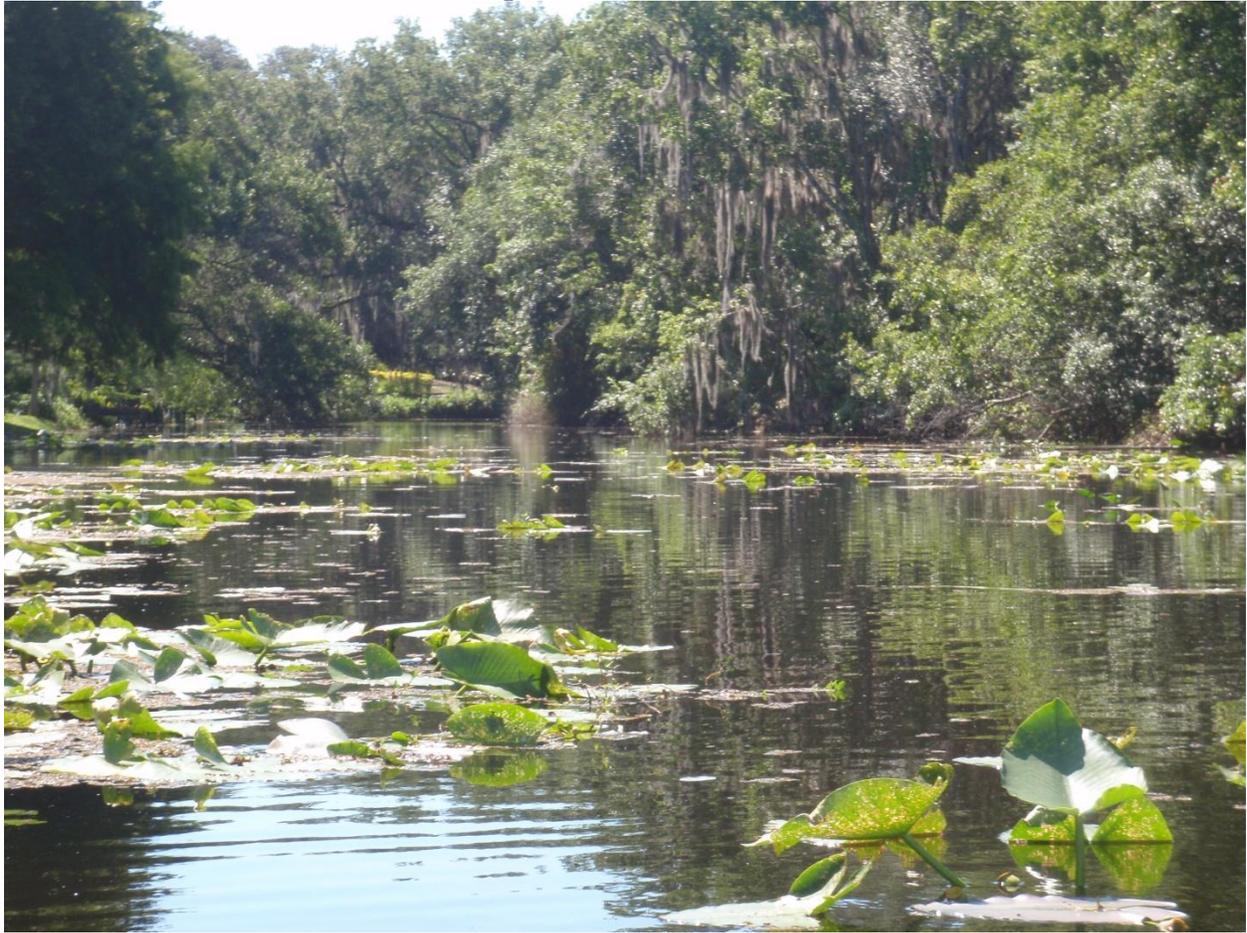
Photo: Howell Creek at Lake Waumpi.

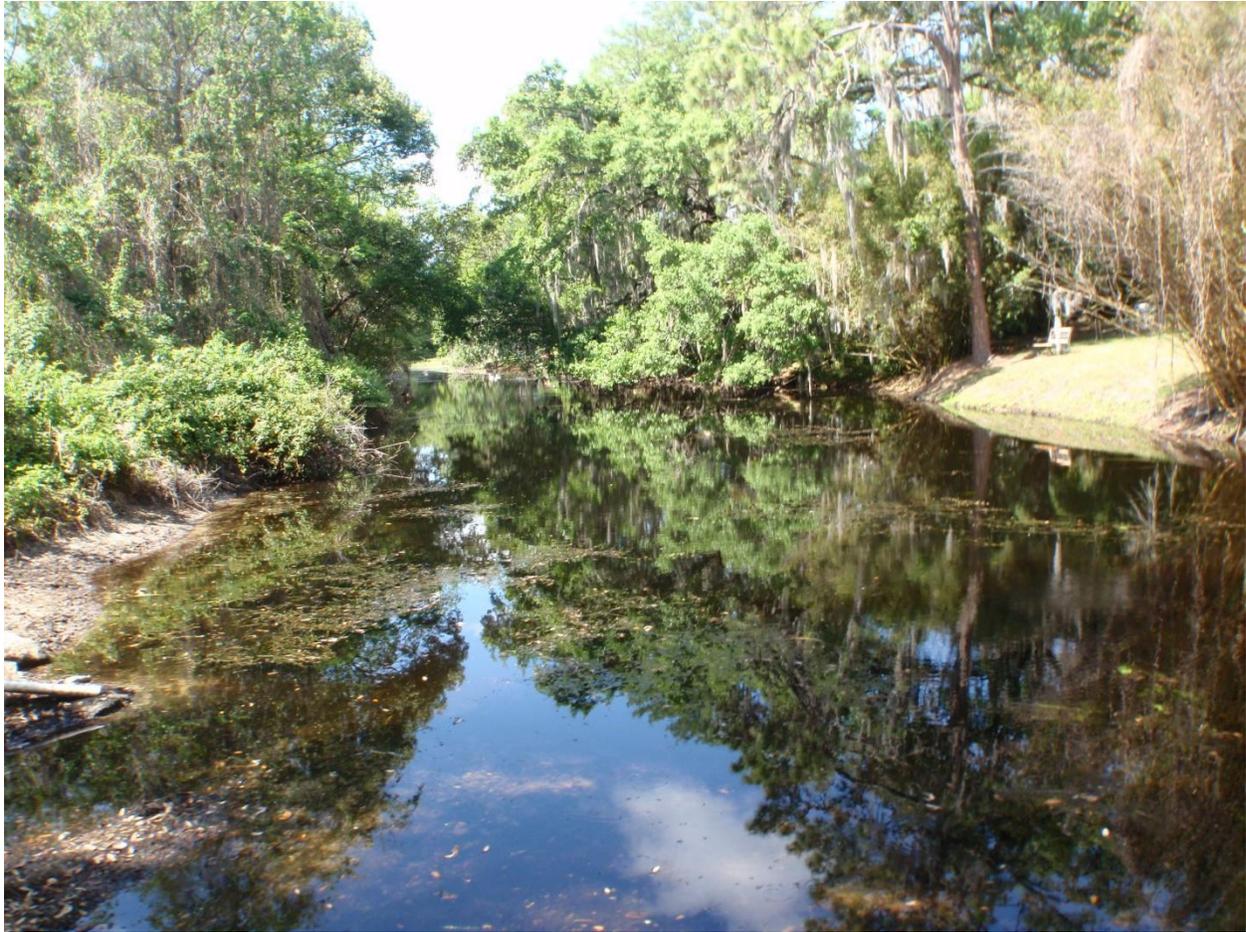
Four species of submersed aquatic vegetation (SAV) were found during the inspection. These SAV species included: roadgrass, eelgrass, baby's tears, and hydrilla. Hydrilla was observed in as few/sparse sprigs.

Photo: Roadgrass topped out along the banks of the creek.

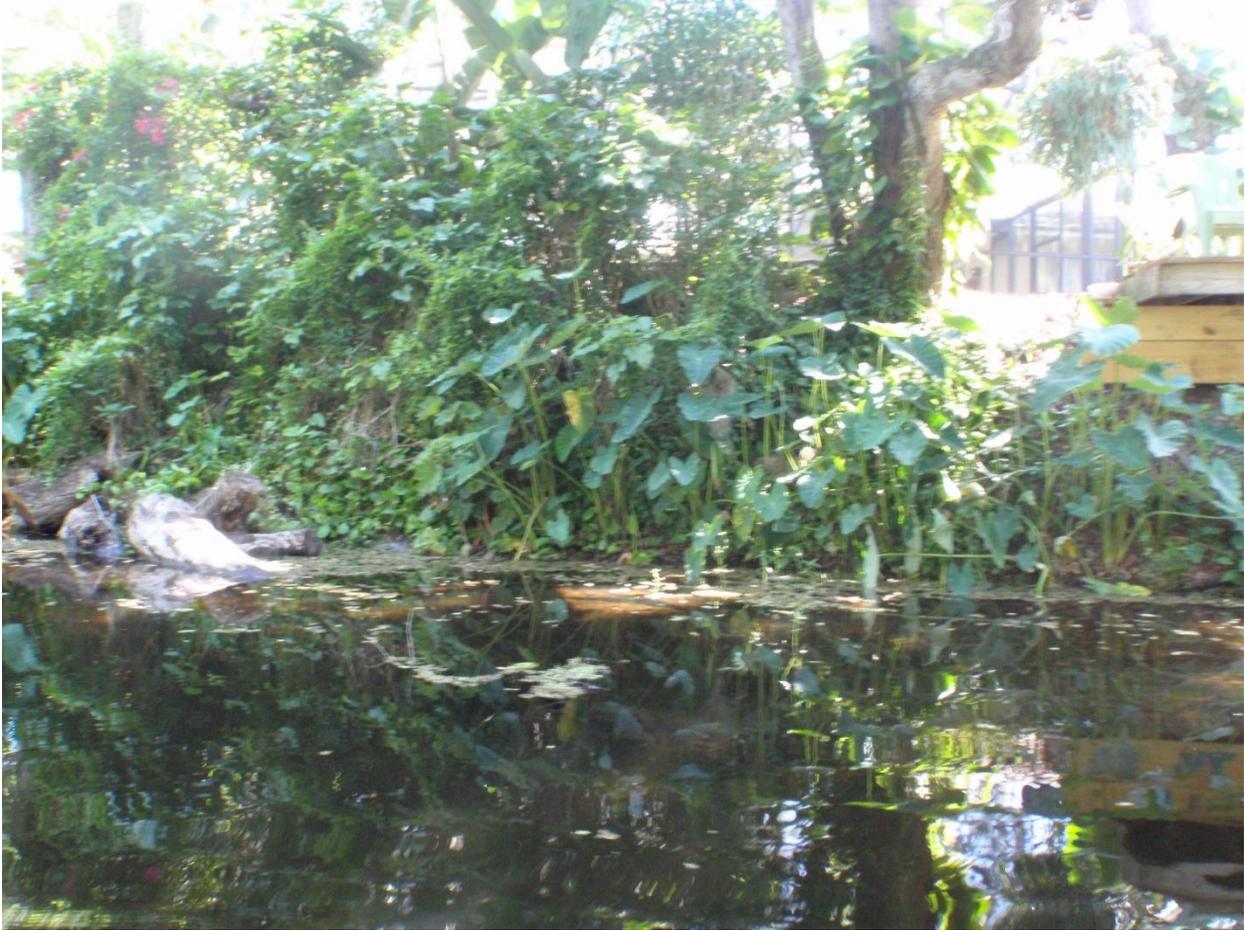
Invasive emergent vegetation found during the inspection included: elephant ear, alligator weed, and torpedo grass. Both torpedo grass and alligator weed were found in small amounts. Elephant ear is currently not being treated because it is stabilizing the bank in several areas along the creek. A small amount of water hyacinth was observed during this inspection. Native vegetation observed included: canna lily, pickerelweed, yellow cow lily, and pennywort. It is recommended to expand emergent native species within the creek such as canna lily, pickerelweed, and duck potato.

Photo: Exotic elephant ear assisting in stabilizing the bank.

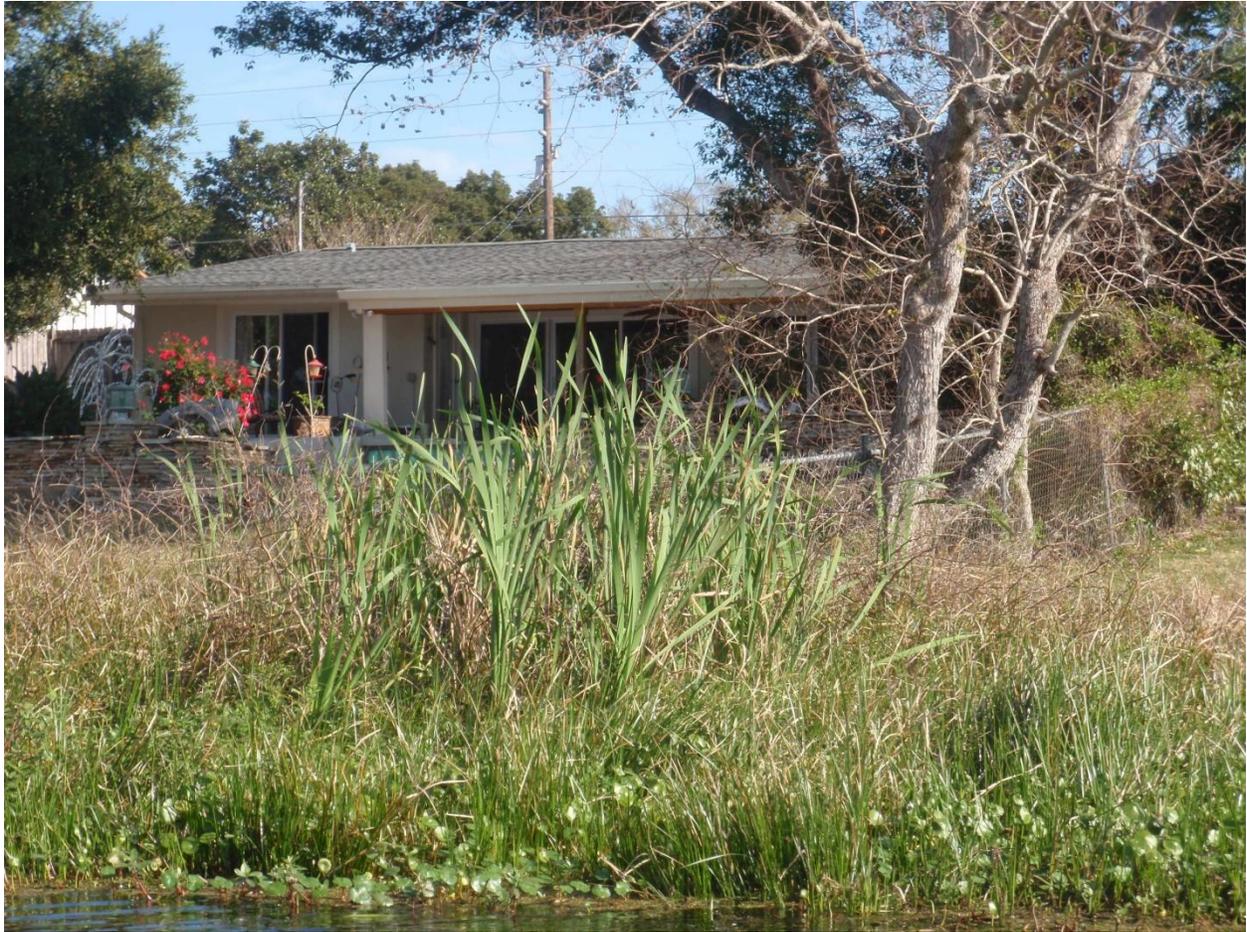
Lake Waumpi was also surveyed during this inspection. No SAV was found in Lake Waumpi; only detritus (organic sediment) along the lake bottom. Most of Lake Waumpi's shoreline was dominated by invasive species including: burhead sedge, primrose willow, Carolina willow, cattails, alligator weed, and salvinia. Many of these invasives were beginning to form large floating mats. Without management, these mats will eventually sprawl into the open waters of the lake. Secchi (water clarity) was not taken during this inspection.

Photo: Burhead sedge mat in Lake Waumpi

1 Work together with other lakefront owners. Have *at least* one annual waterbody association meeting, invite guest speakers (such as county or state biologists) and discuss lake specific issues, especially nutrients/lake management recommendations. Seminole County Lake Management Program staff would be glad to present our findings from this and other surveys. Continue to increase native aquatic plantings along shoreline (such as pickerelweed, duck potato, and canna).
