Below please find the latest assessment updated for lakes Jesup, Monroe, and Harney.

On **February 29th, 2012**, Seminole County Lake Management Program (SCLMP) personnel, Gloria Eby and Thomas Calhoun, surveyed the aquatic plants in **Lake Jesup**.

On **February 29, 2012**, Seminole County Lake Management Program (SCLMP) personnel, Gloria Eby and Thomas Calhoun, surveyed the aquatic plants in **Lake Monroe**.

On **March 12, 2012**, SCLMP personnel, Thomas Calhoun and Marie Lackey, surveyed the aquatic plants in **Lake Harney**.

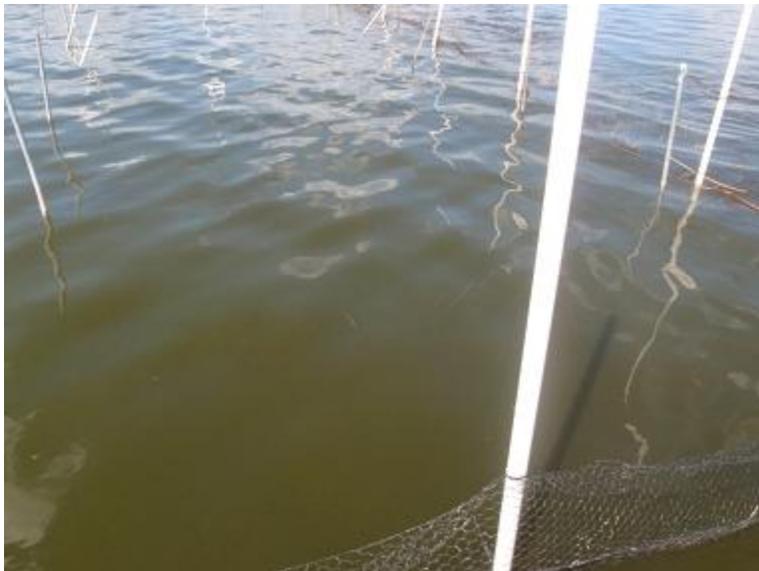
Submersed aquatic vegetation (SAV) found during the inspection included coontail, hydrilla, and eelgrass. Hydrilla and coontail were found at the Sanford avenue boat ramp canal and eelgrass was observed within all but one of the FWC enclosures. Less than an acre of both floating exotics, water hyacinth and water lettuce were present in the lake. Access, via airboat, from the ramp is impeded by sediments and suggestion for navigational improvements will be submitted to county's Leisure Services Department.

Photo: FWC eelgrass enclosures (blooms present).

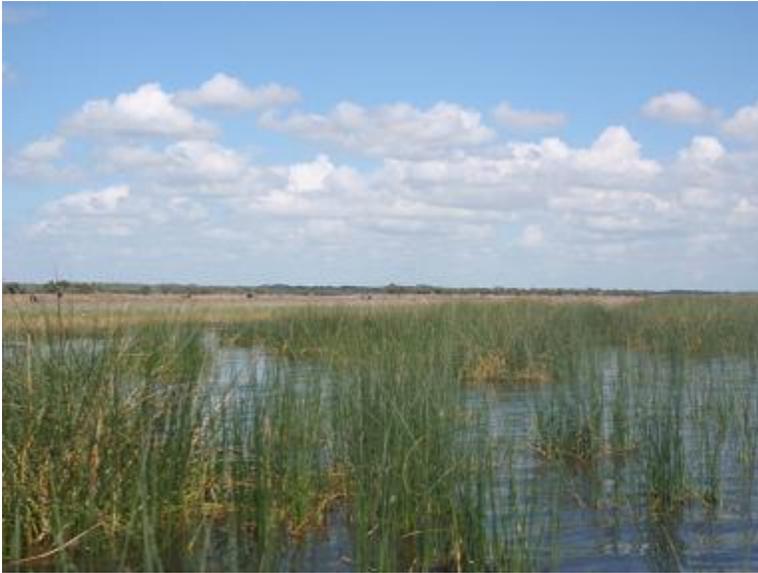
The FWC-AHRES and Seminole County Cooperative Restoration Project continues to expand very well. This project is located along the north shore centered by the SR417 bridge. Bulrush, pickerelweed, and thalia are expanding exceptionally well within this area, although cattails and phragmites are invading portions of the restoration area west of the SR417 bridge.

Photo: Bulrush expanding in restoration area.

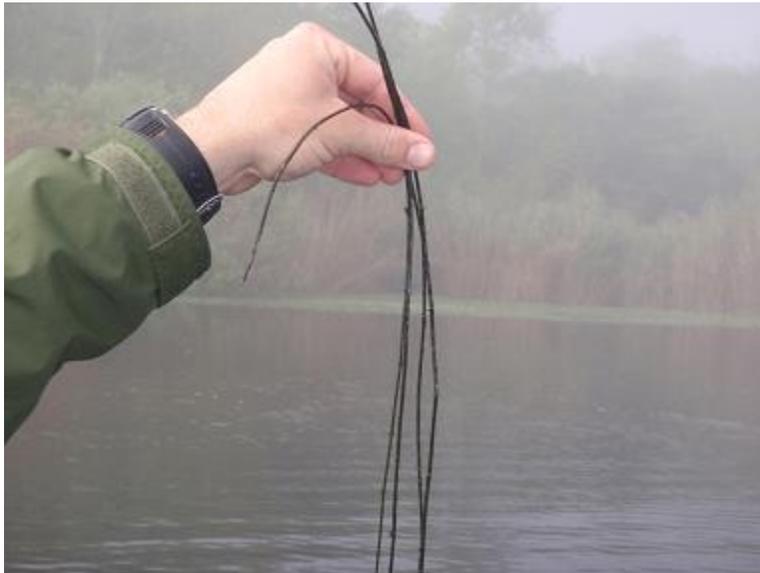
Native submerged aquatic vegetation (SAV) observed included: coontail to a depth of 3 feet, eelgrass to 3 feet, and bladderwort (*Utricularia foliosa*) to a depth of 3 feet. One exotic SAV, hydrilla, was found to a depth of 6 feet. SAV was found at more shallow depths than in previous inspections due to lower water conditions. Currently, eelgrass is the dominant SAV throughout the lake and found topped out along the perimeter. Hydrilla had been found to be more abundant in the previous inspection than during this inspection. There were many coots observed foraging upon SAV over nearly the entire perimeter of the lake, more so than in previous inspections, with most foraging noted on the hydrilla as the majority of the plants were without leaves.

Photo: Hydrilla, without leaves, found along perimeter of the lake.

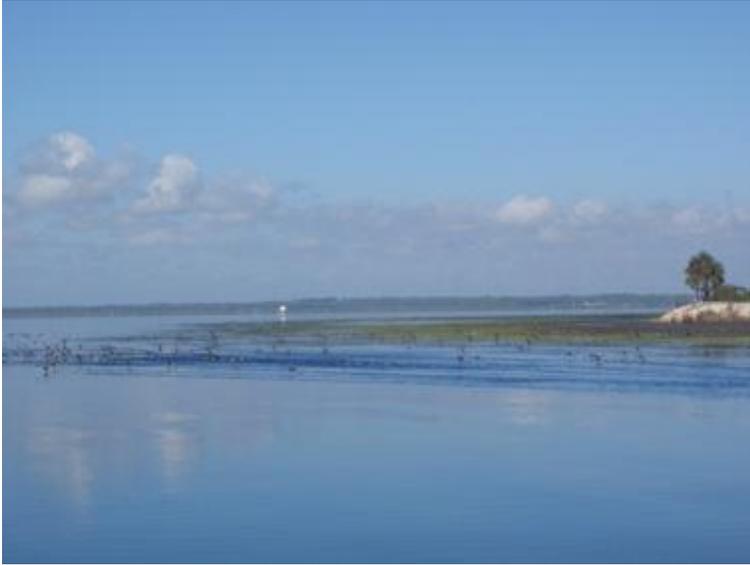
Photo: Topped out eelgrass around Stone Island.

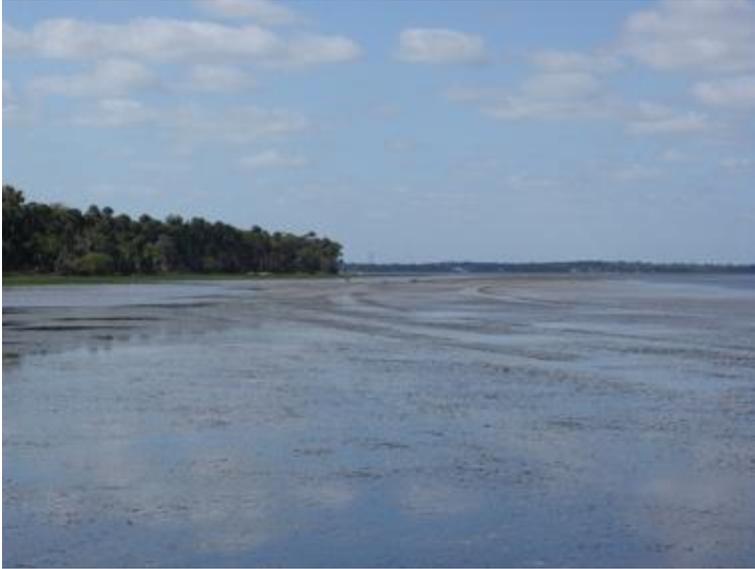
SAV included: eelgrass to 2 feet, coontail to 2 feet, and hydrilla to 1 foot. Eelgrass was the dominant SAV and has expanded around the entire perimeter of the lake with the leaf blades topped out in 2 feet of water. Hydrilla was found to be sparse and was intermixed within the eelgrass only on the west side of the lake, in less than 1 foot of water. Coontail was found only in the canals along the east side of the lake.

Photo: Eelgrass topped out in the shallow regions of the lake.

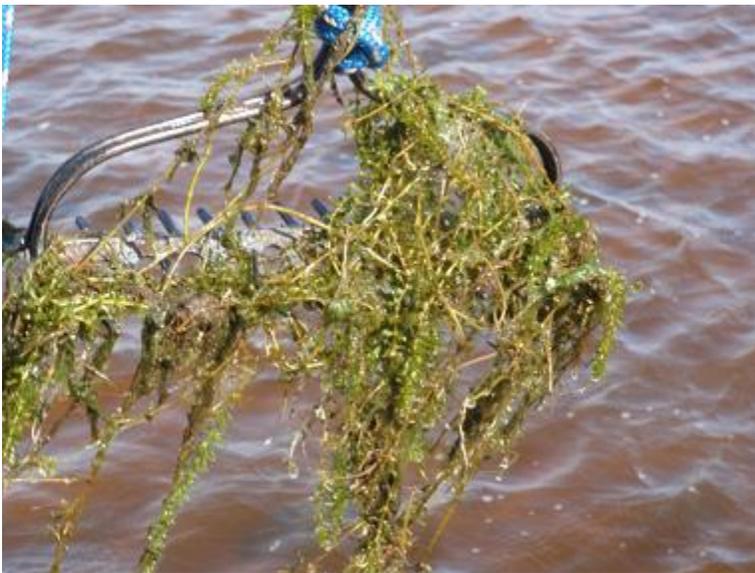
Photo: Hydrilla found along the western shoreline.
