Greetings Lake Howell!

The lab results are in from the **April 2nd** sampling and inspection event. Concentration of herbicide product in Lake Howell is still above the precautionary advisory level of 10 ppb therefore the precautionary irrigation advisory **is still in effect until further notice**.

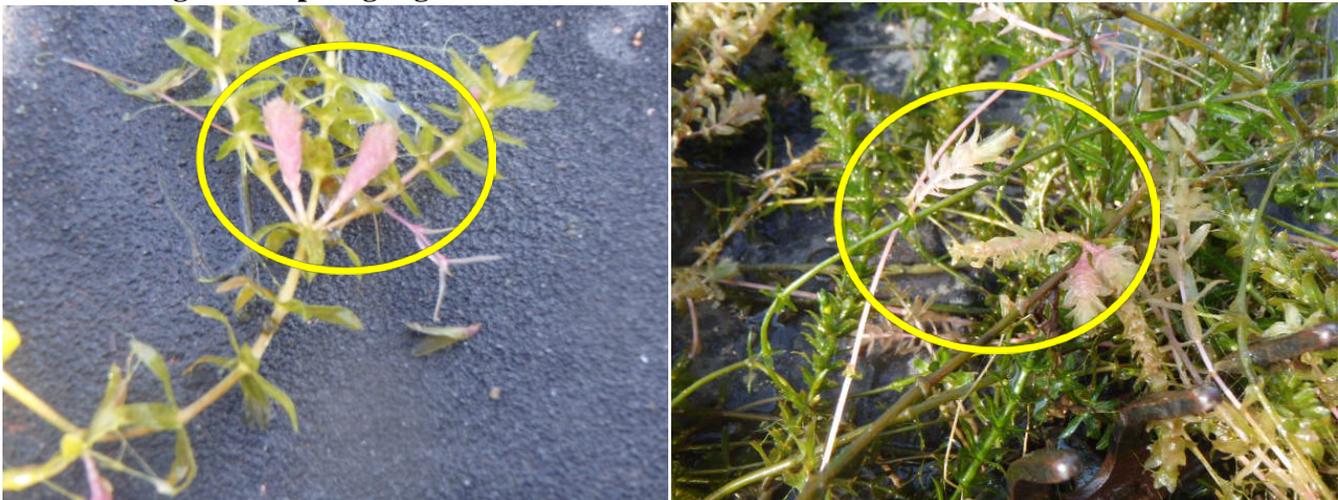
During our inspection, chlorosis was important to observe. **No new growth was observed to be green** (this would indicate that the plant was growing in presence of the product).

Photo: New growth tips highlighted.

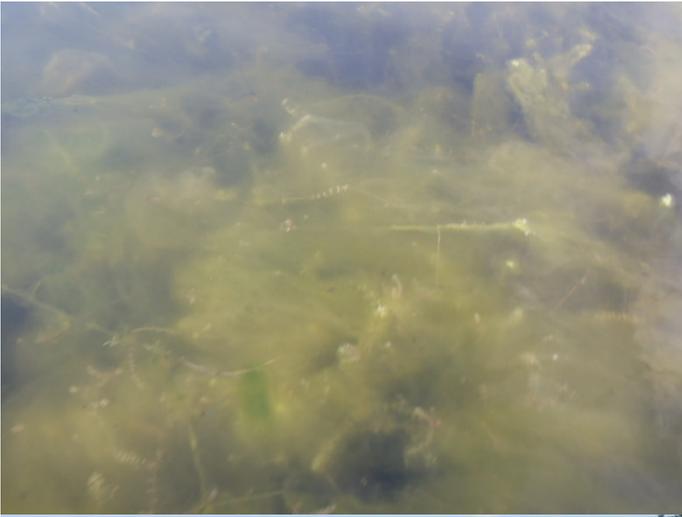
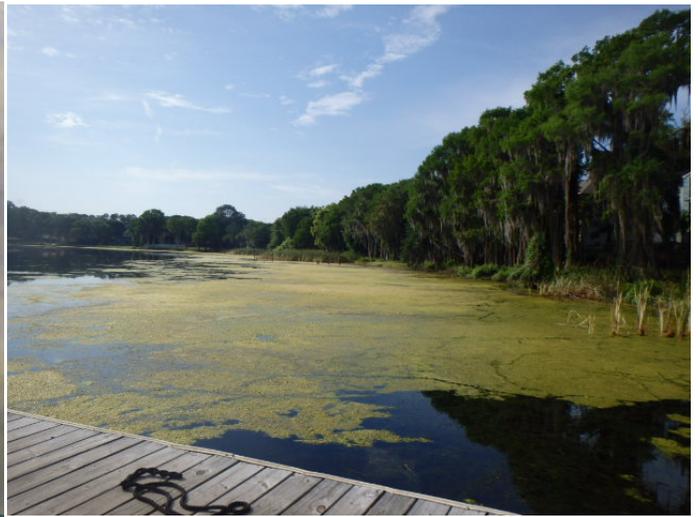
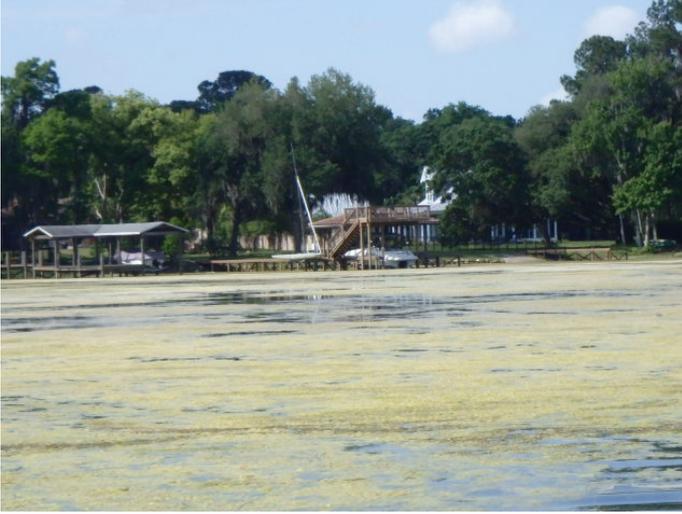
Algae are present in large portions of the lake due to the die-back of the plant. This is to be expected. This process will continue until the hydrilla has fully decomposed. We estimate this will be in June.

Photos: Algae examples.

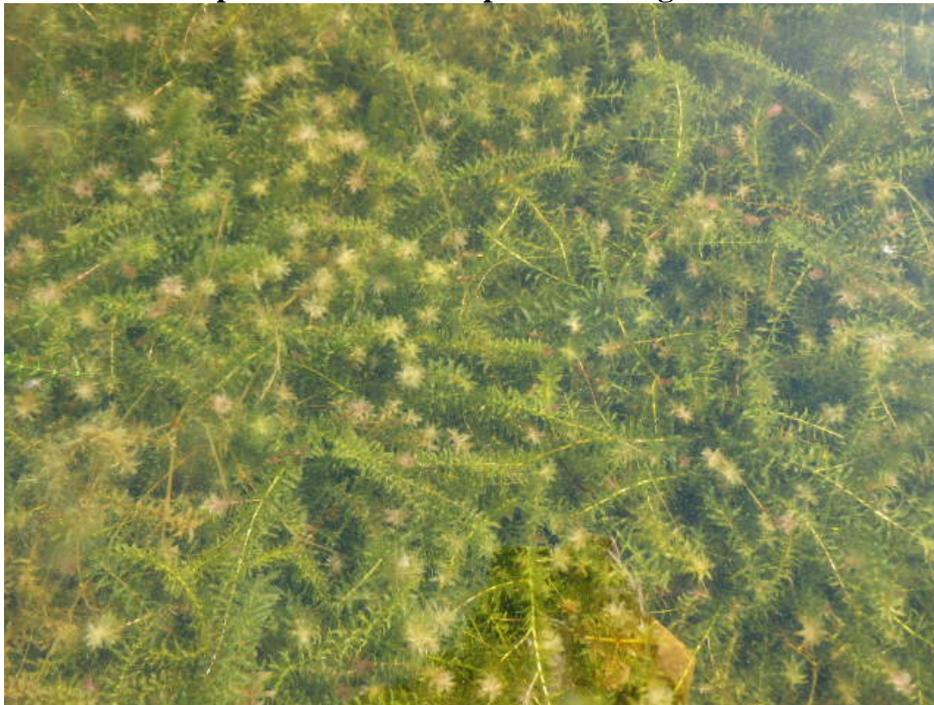
Photo: White tips off main stem of plant showing chlorosis.

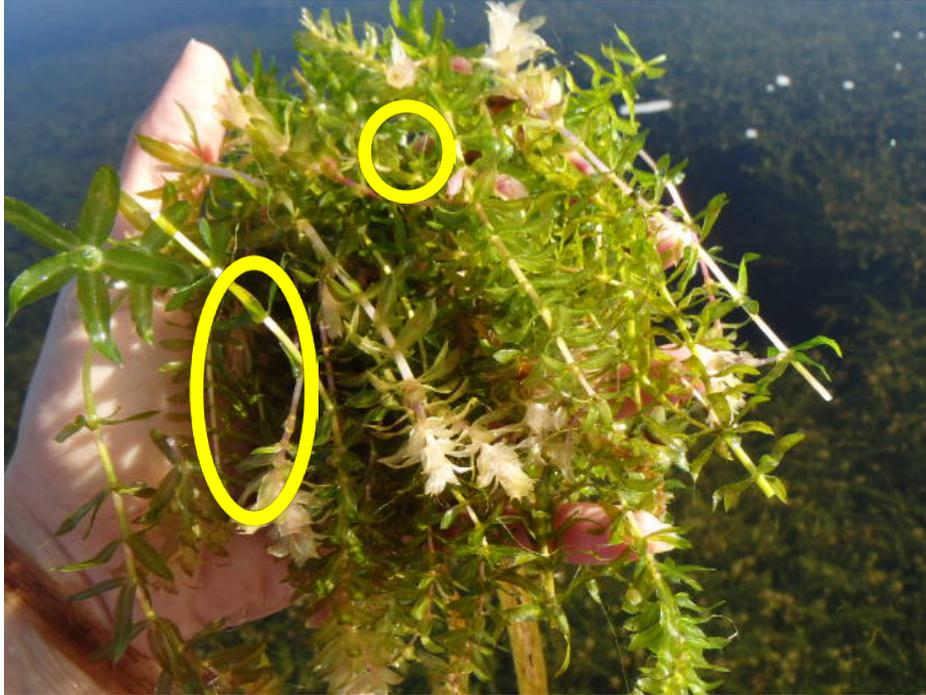
During our inspection, chlorosis was important to observe. No new growth was observed to be green (this would indicate that the plant was growing in presence of the product).

Photo: New growth tips highlighted.

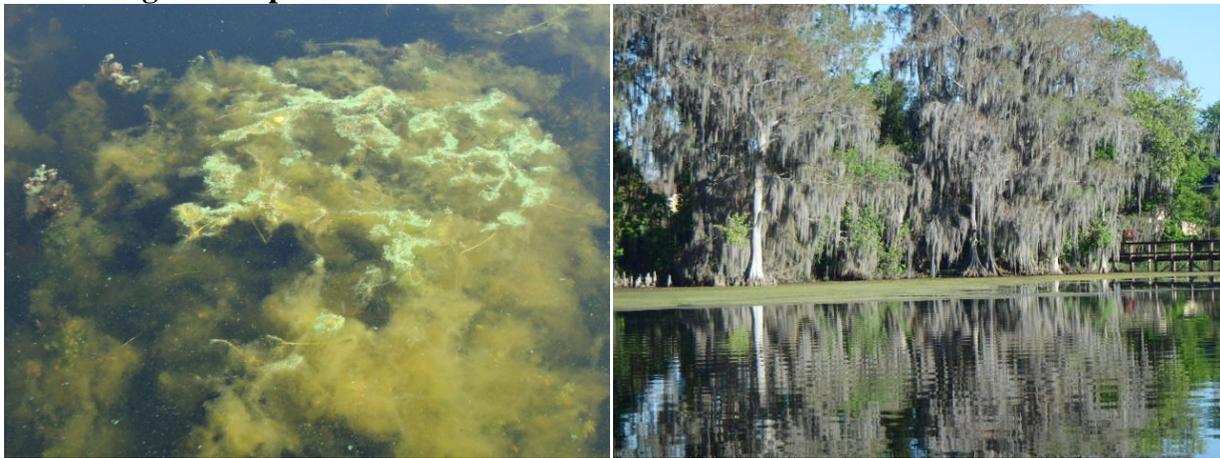
Algae are present in large portions of the lake due to the die-back of the plant as anticipated.

Photos: Algae examples.
