Greetings Spring Lake Residents!

Please find the latest bioassessment of your lake below. Key highlights of this update include:

**Bioassessments:**

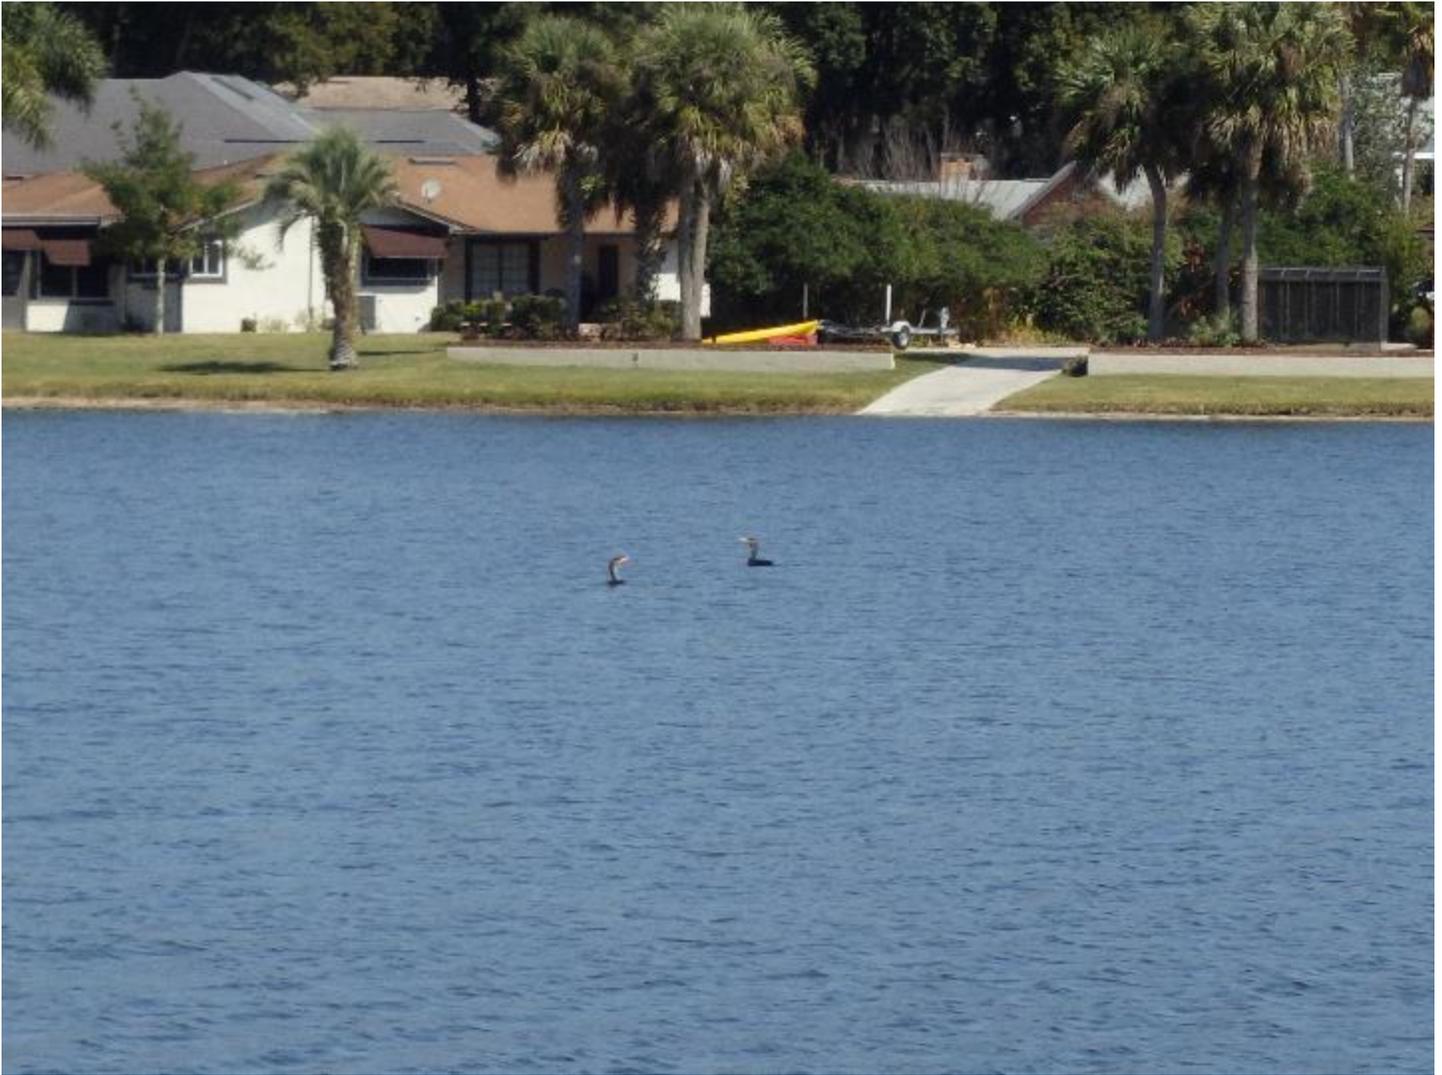
Native emergent vegetation found during the inspection included: pennywort, hempvine, yellow cow lily, fragrant water lily, pickerelweed, duck potato, bulrush, cordgrass, fireflag, cattail, and iris. Many of the shorelines in Spring Lake have little to no emergent aquatic vegetation. Emergent vegetation is important to lake systems as it acts as a filter for nutrient runoff from surrounding yards. Planting native vegetation is an easy and effective way to improve the water quality of the lake. It is also effective at reducing shoreline erosion.

**Photo: Example of shoreline without vegetation.**

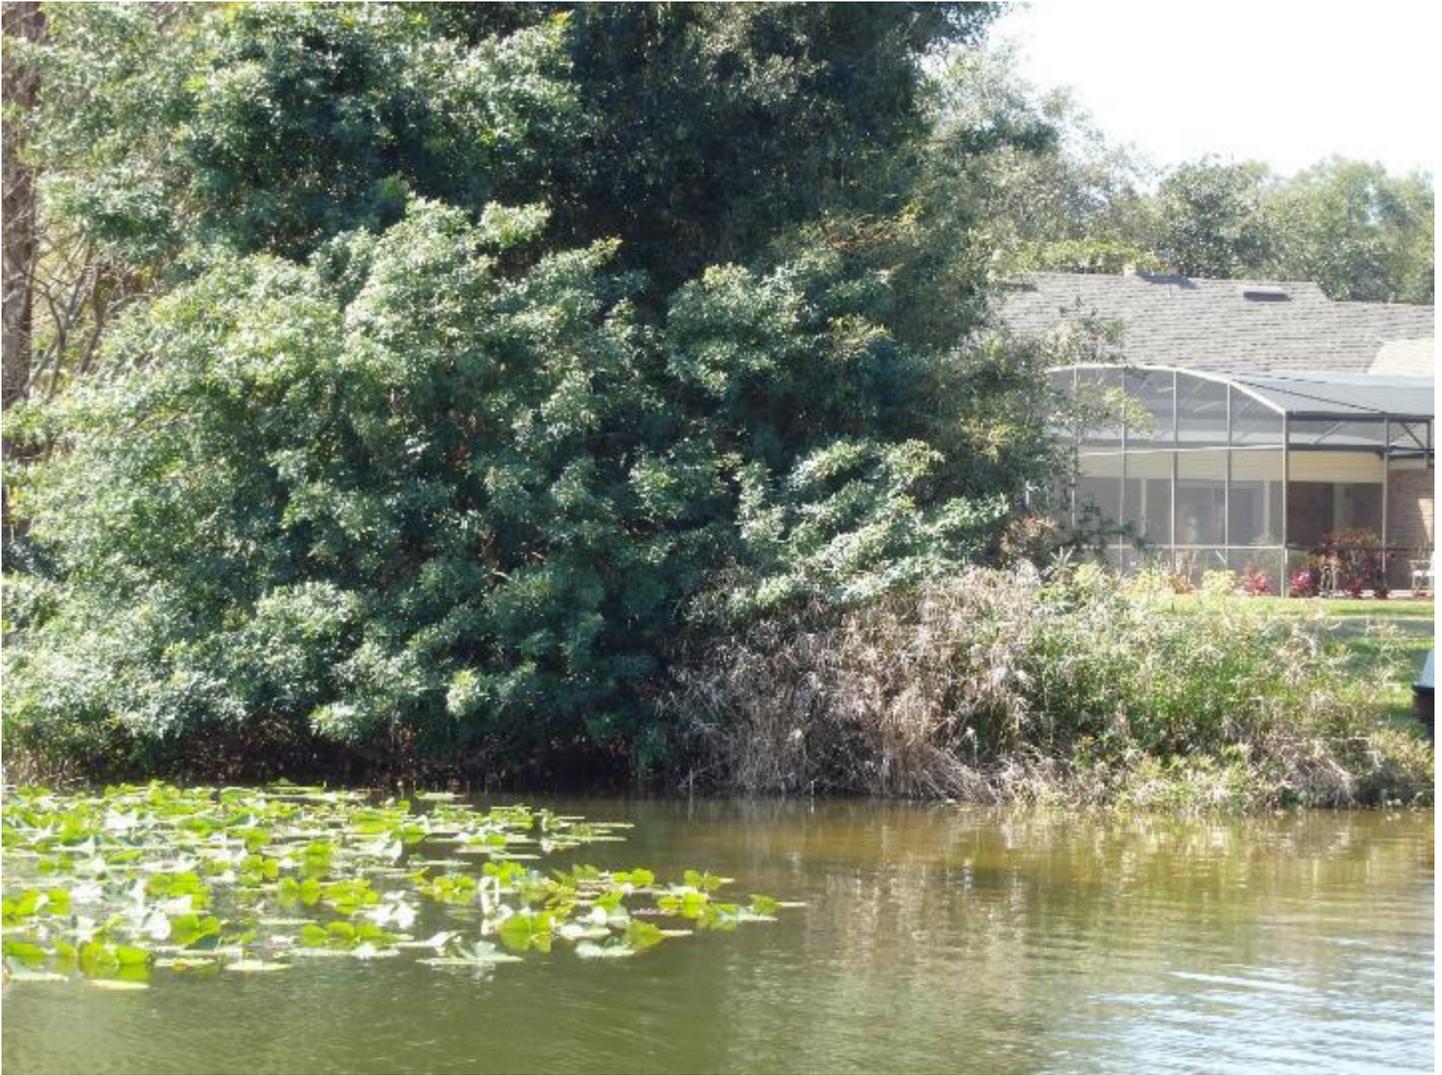
A minimal amount of invasive emergent vegetation was found during the inspection. Invasive emergent species observed during the inspection included: alligator weed, wild taro, primrose willow, Chinese tallow, Brazilian pepper tree, and creeping oxeye.

**Photo: The invasive Brazilian pepper tree.**

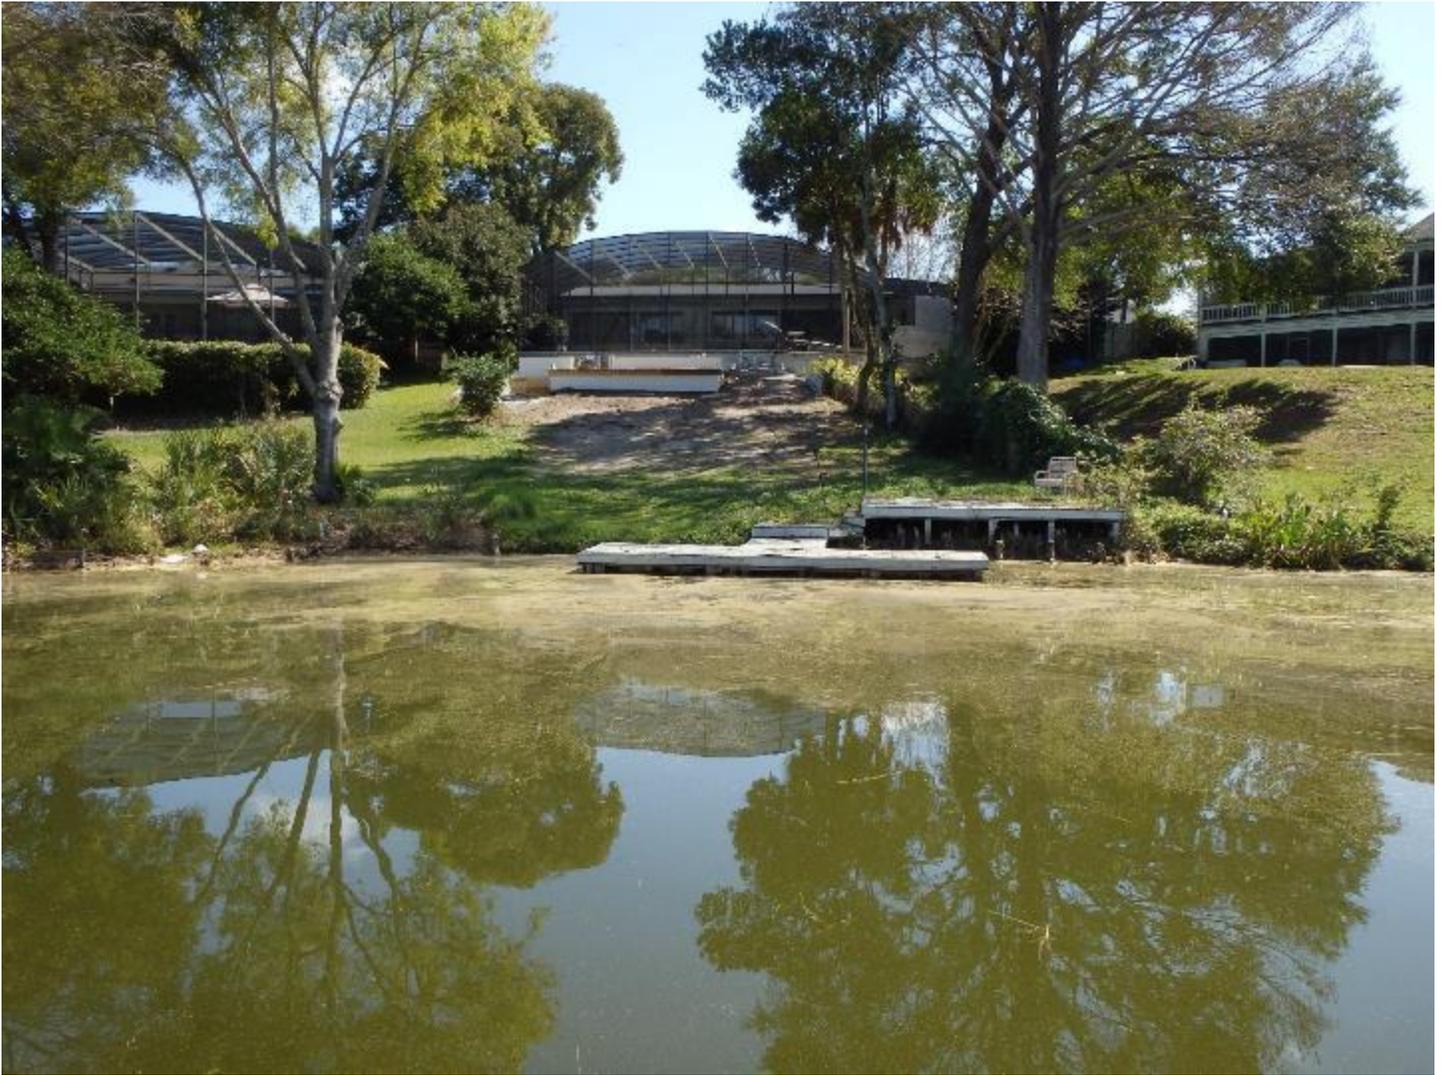
The water elevation at the time of the inspection was 63.07 feet above sea level. The secchi reading (measurement for water clarity) was 3.9 feet in a total depth of 12.0 feet. Two grass triploid (sterile) carp fish were observed during this inspection. An algae bloom was also present on the south east side of the lake.

**Photo: Algae bloom.**

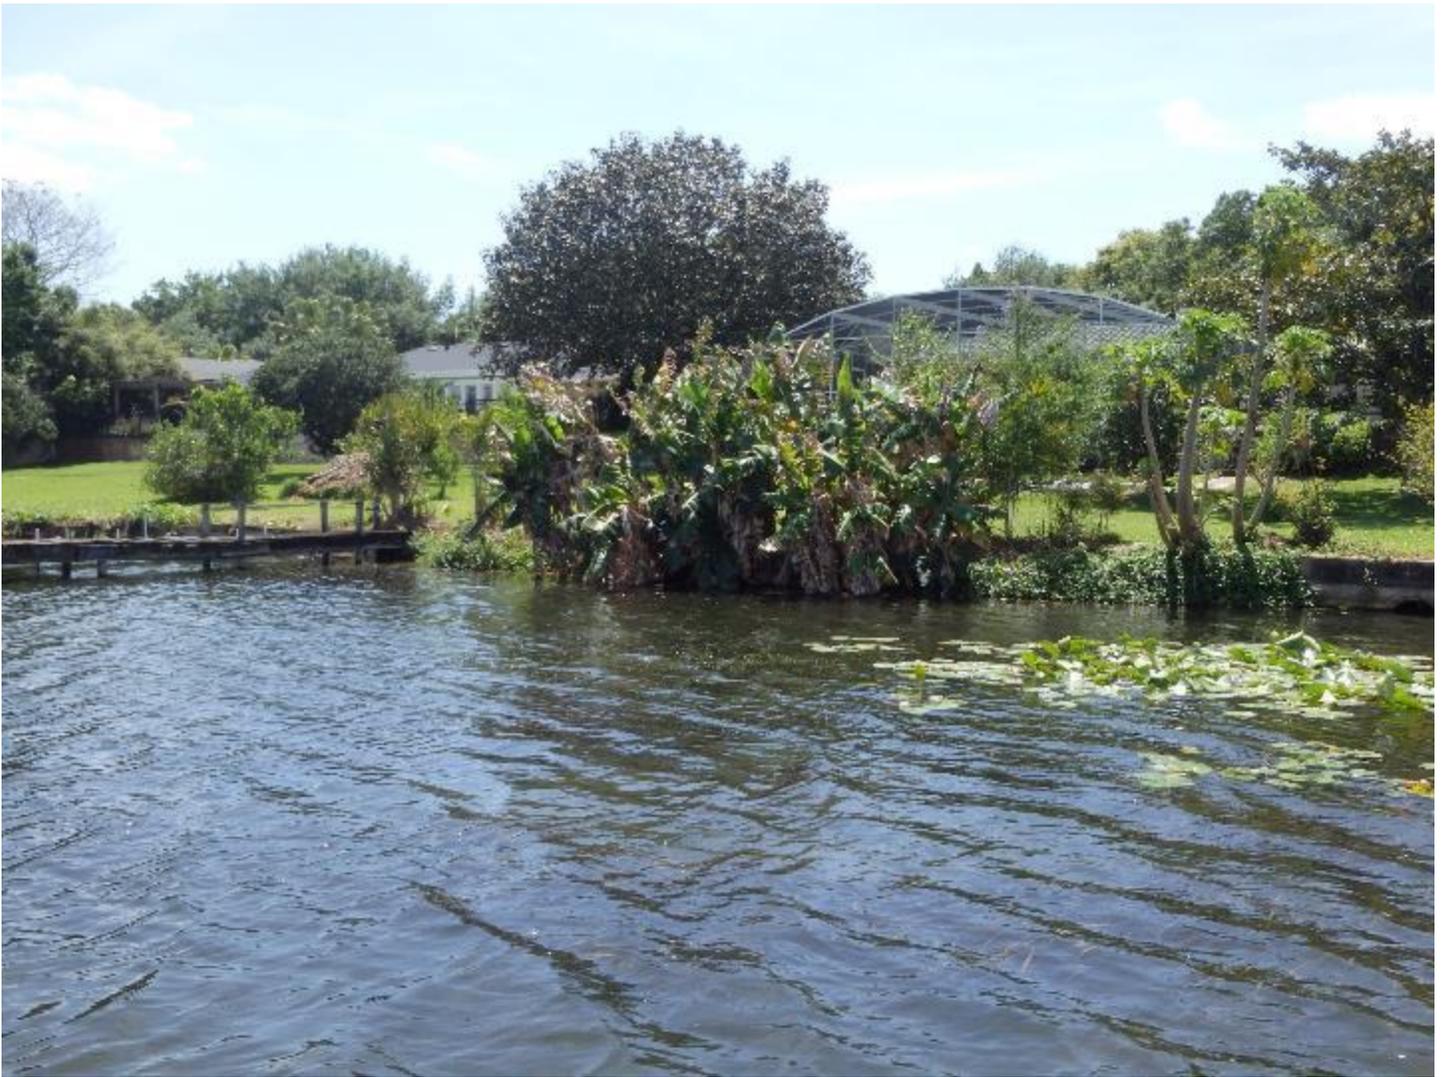
Eelgrass was the dominant SAV and was found to a maximum depth of 4.0 feet; this species was found “topping out” (reaching the surface) in depths less 1.5 feet. This was an increase in depth of 3.5 feet from the previous inspection. Southern naiad was not found during this inspection. Access corridors were open and in good shape. No hydrilla was observed during the inspection.

**Photo: Eelgrass “topping out” along the shoreline.**

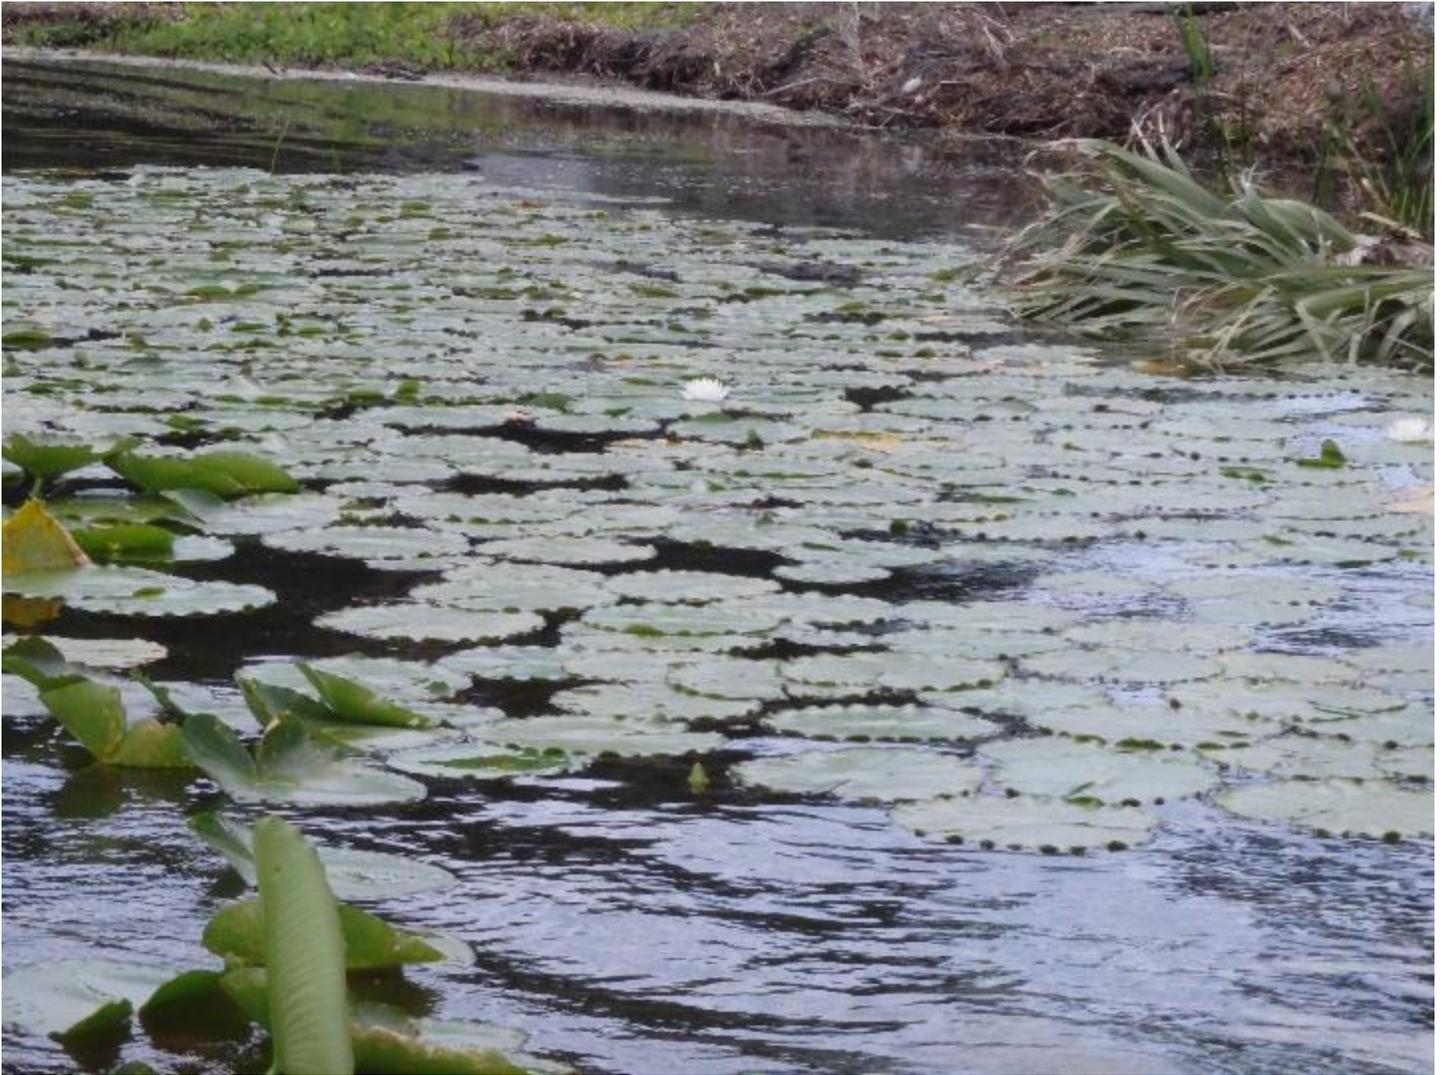
**Photo: Fragrant water lily.**

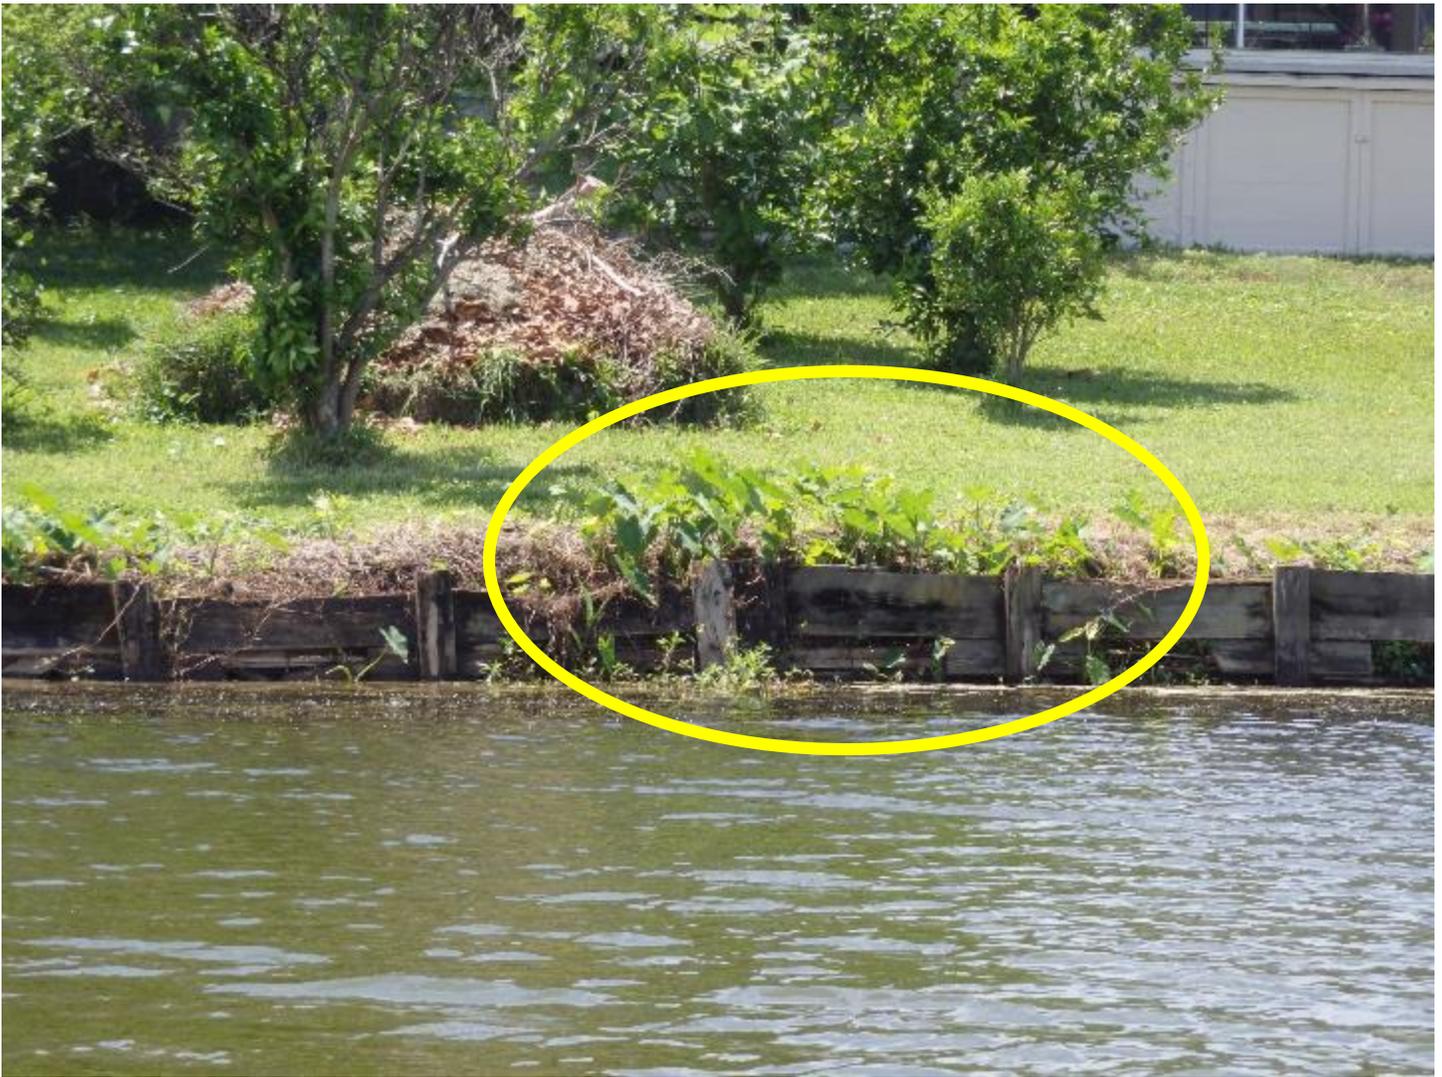
A minimal amount of invasive emergent vegetation was again found during this inspection; this was a positive effect of the MSBU-funded herbicide maintenance program. Invasive emergent vegetation observed during the inspection included: alligator weed, wild taro, primrose willow, torpedo grass, Chinese tallow, Brazilian pepper tree, and creeping oxeye.

**Photo: Invasive emergent vegetation wild taro.**

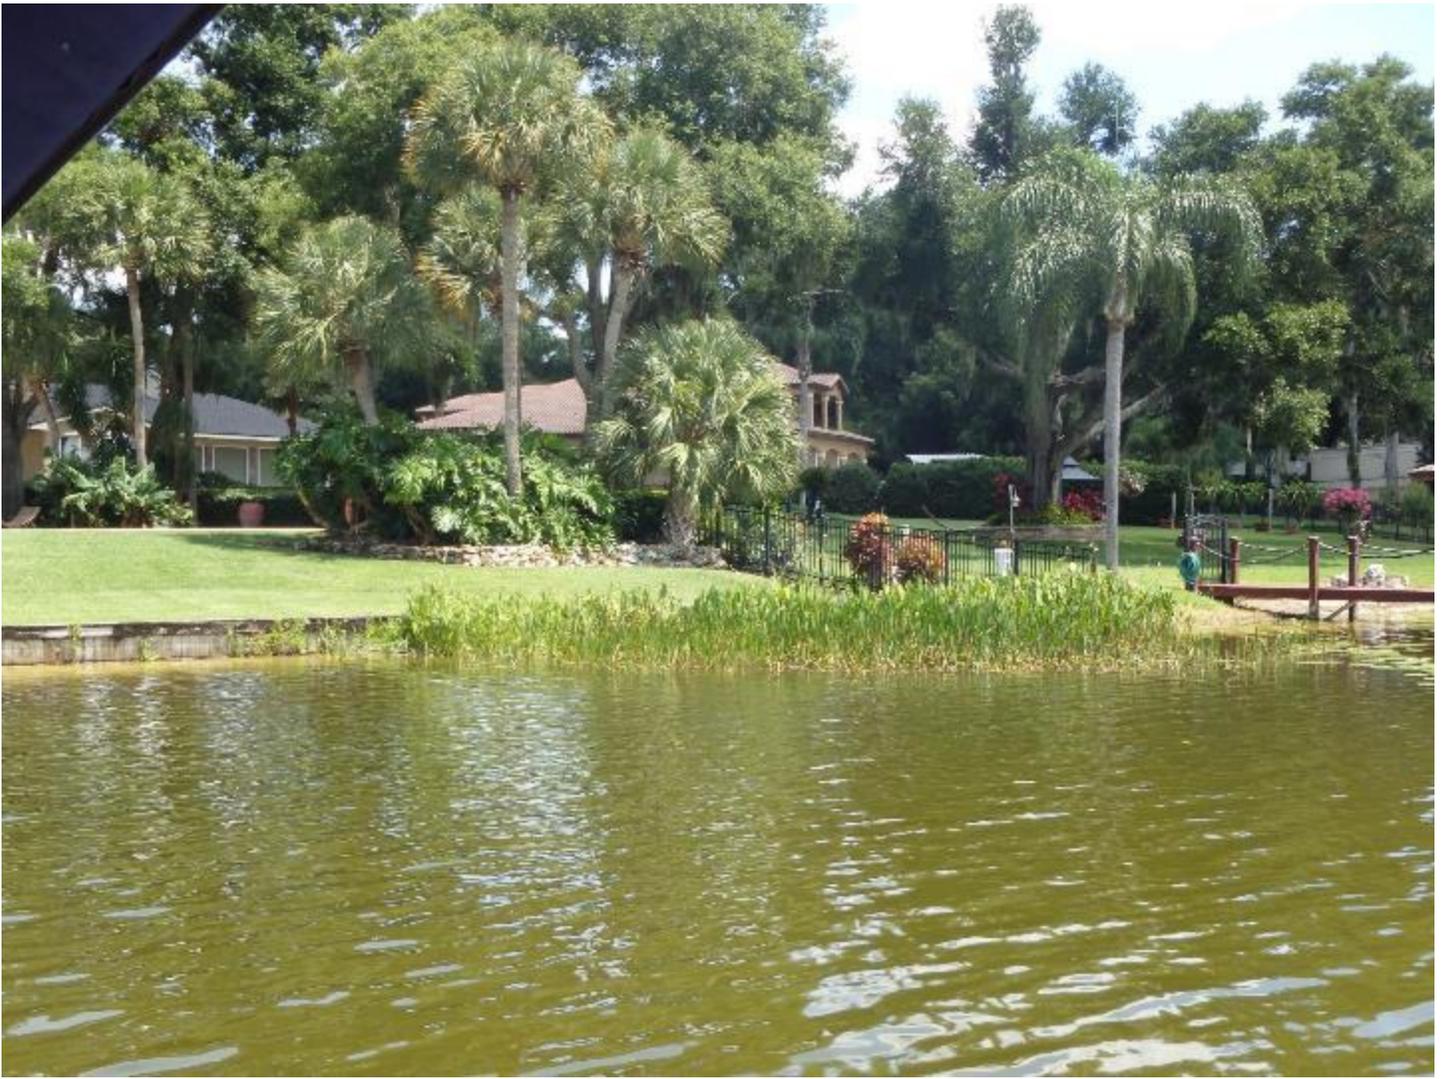
**Photo: Stand of native emergent duck potato and pickerel weed.**

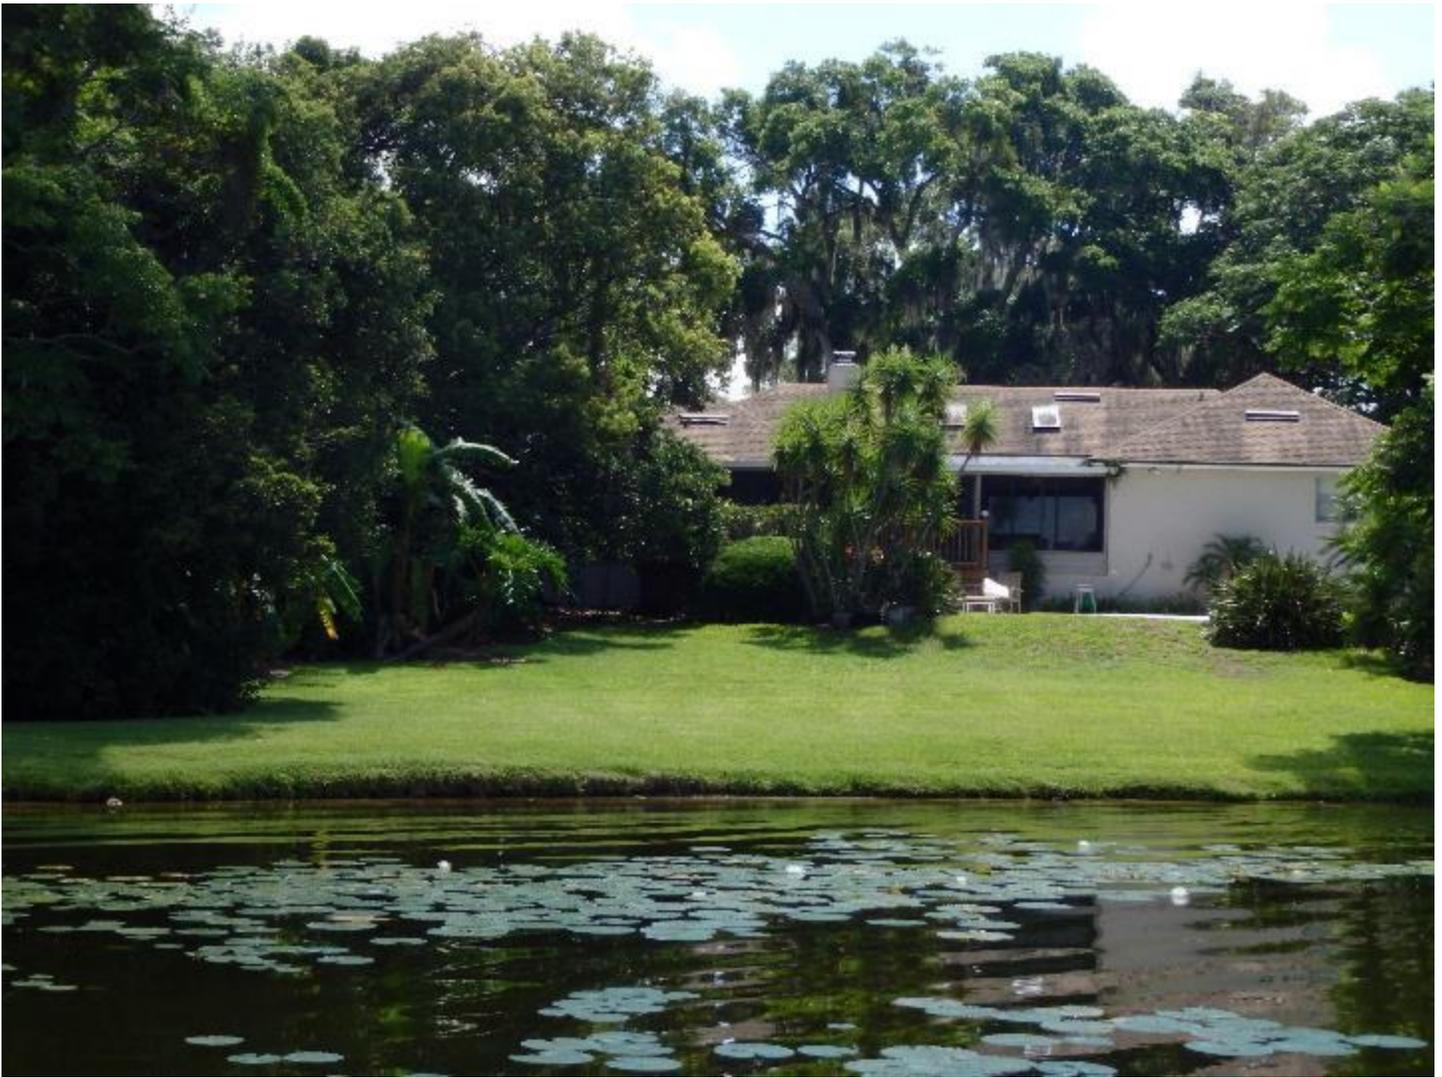
Native emergent vegetation found during the inspection included: pennywort, yellow cow lily, fragrant water lily, pickerelweed, duck potato, bulrush, cordgrass, fireflag, cattail, rush-fuirena and iris. Many of the shorelines in Spring Lake have little to no emergent aquatic vegetation. Emergent vegetation is important to lake systems as it acts as a filter for nutrient runoff from surrounding yards. Planting native vegetation is an easy and effective way to improve the water quality of the lake. It is also effective at reducing shoreline erosion.

**Photo: Example of shoreline without emergent vegetation.**

1. Work together with other lakefront owners. Have *at least* one annual lake association meeting, invite guest speakers (such as county or state biologists), and discuss lake specific issues, especially nutrients/lake management recommendations. SCLMP staff will be glad to present our findings from this and other surveys. Continue to increase native aquatic plantings along shorelines (such as pickerelweed, duck potato, and canna).
