Mirror Lake 8-21-2012

On **August 2nd, 2012** Seminole County Lake Management Program (SCLMP) personnel, Thomas Calhoun, surveyed the aquatic plants of **Mirror Lake**.

Mirror Lake 8-2-2012

Mirror Lake 3-20-2012

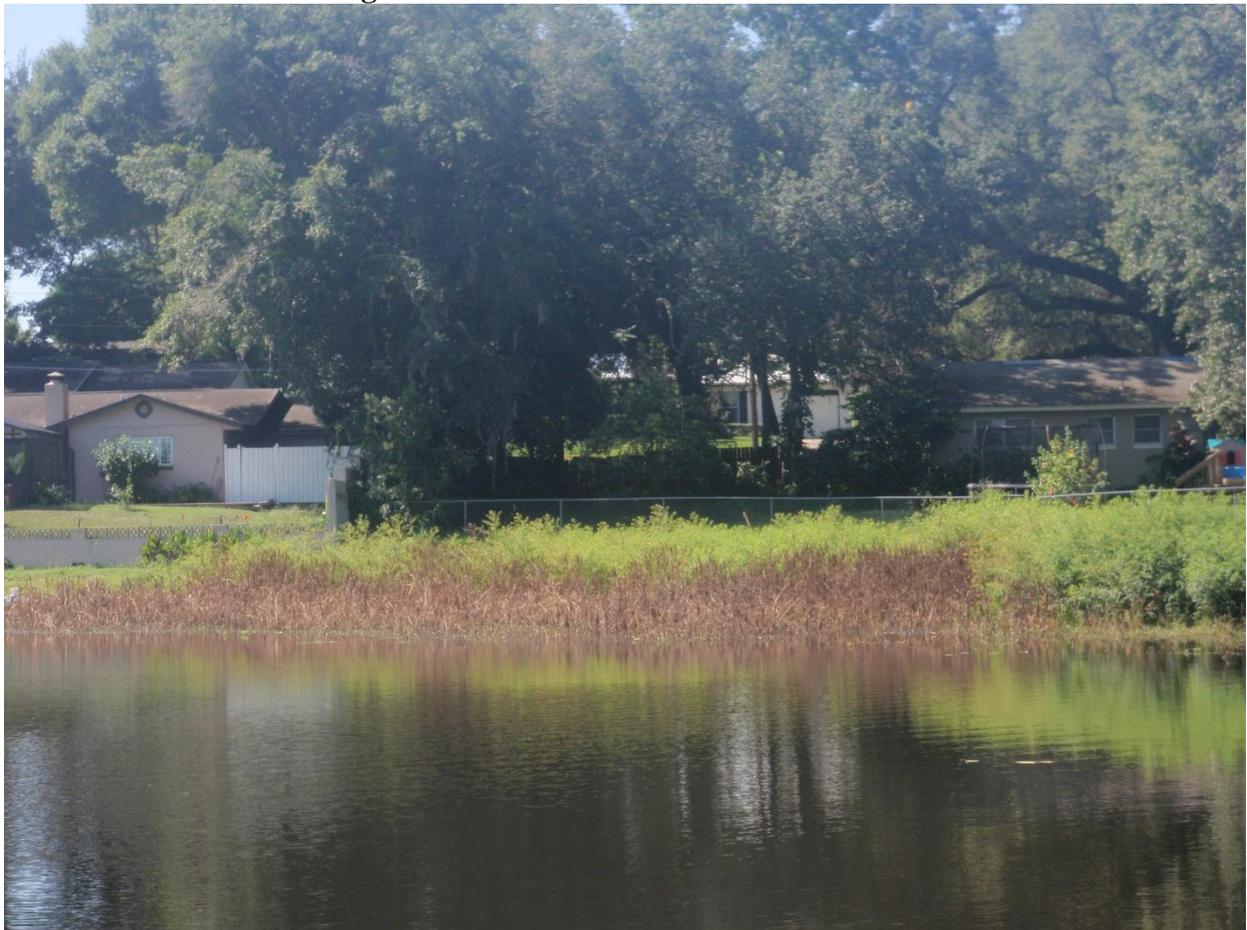
Although the water elevation is rising, it still remains extremely low in Mirror Lake. Many areas along the shoreline that have been exposed or previously dry are experiencing a lot of growth from invasives such as; barnyard grass, torpedo grass, primrose willow, and dog fennel. These areas will be treated by the MSBU funded herbicide contractor as the water elevation rises. It is recommended that these areas be mowed (if possible) especially under dry land conditions.

Photo: Treated areas along the southern shoreline.

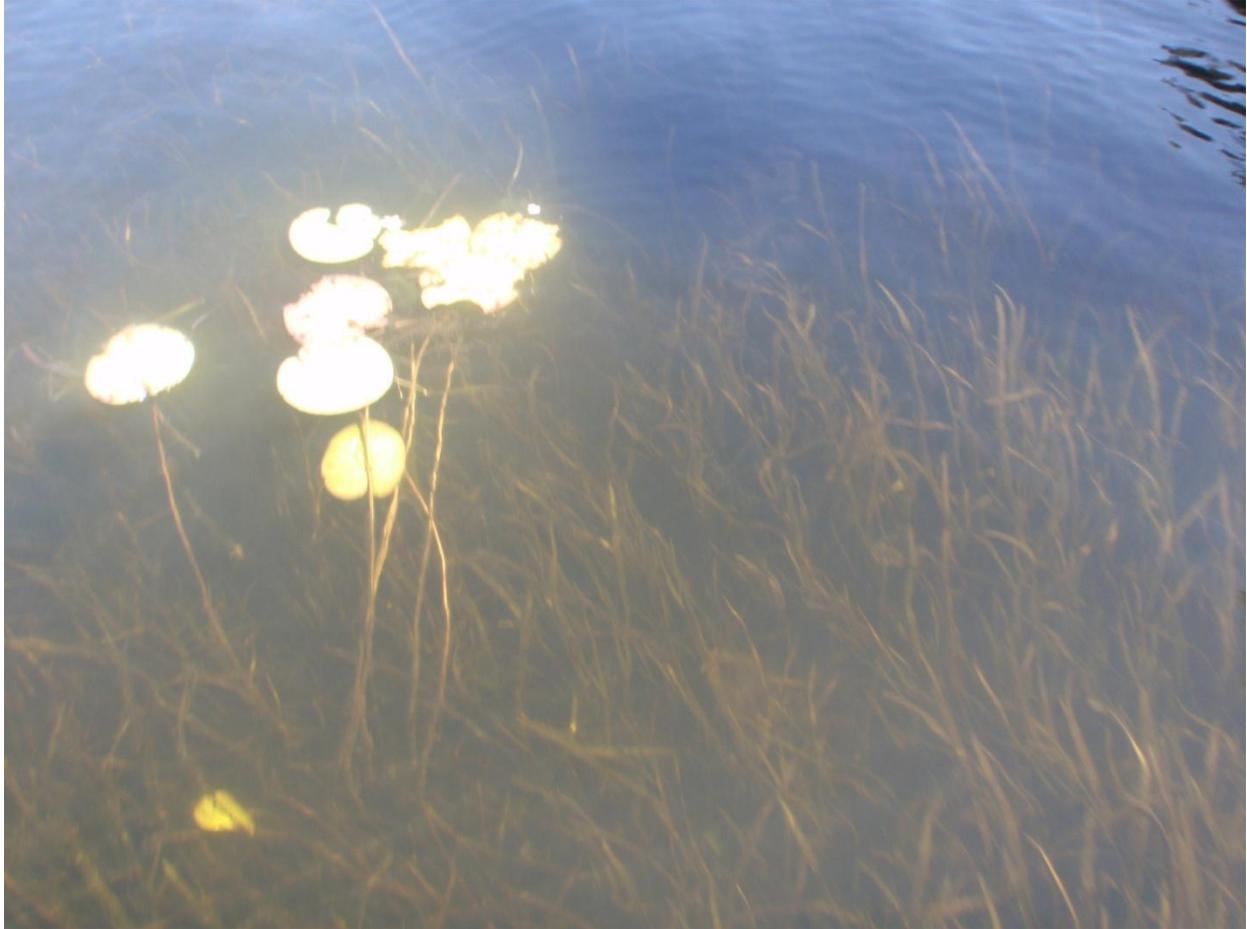
Mirror Lake has a diverse and healthy amount of native submersed aquatic vegetation (SAV). This vegetation plays an important role in competing for space with hydrilla as well as providing habitat for wildlife and up taking nutrients within the system. This contributes to improving the overall health and water quality of the lake. The native SAV found during this inspection included; lemon bacopa to a depth of 1 ft, coontail to a depth of 5 ft, musk grass to a depth of 5 ft, southern naiad to a depth of 5 ft, stonewort to a depth of 2 ft, bladderwort to a depth of 5 ft, baby's tears to a depth of 1 ft, and eelgrass to a depth of 3 ft.

Photo: Eelgrass found during inspection.

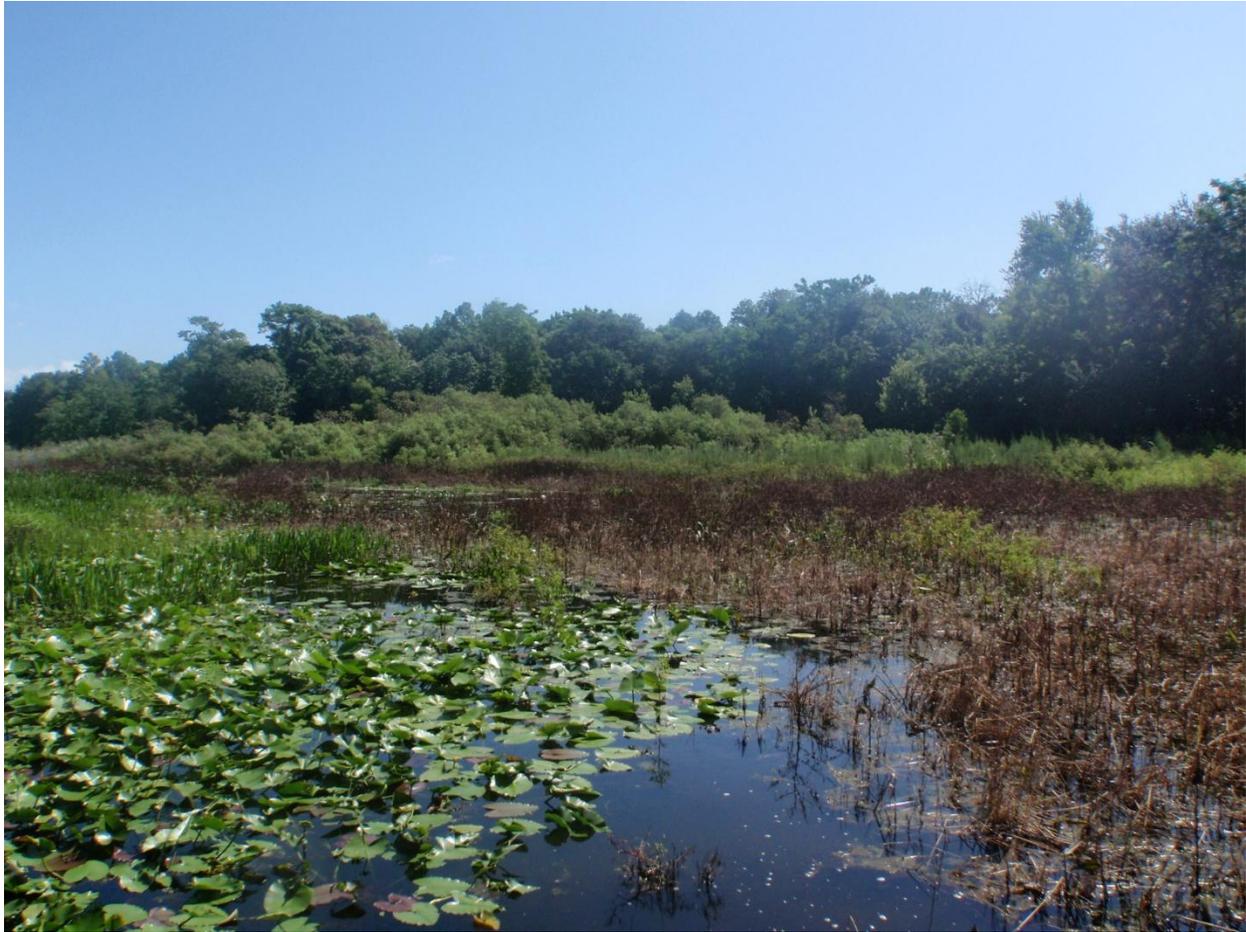
Photo: Low water conditions on Mirror Lake.

The water elevation at the time of inspection was 56.91 ft above sea level. Two grass carp fish were observed during this inspection.

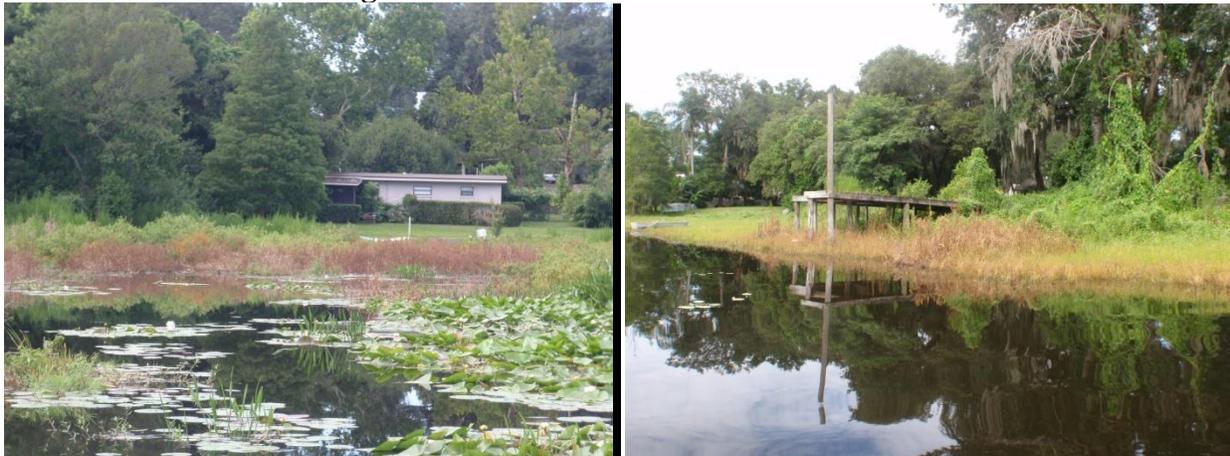
Although the water elevation is coming up, it still remains extremely low in Mirror Lake exposing several areas of the natural lake bottom. Many areas along the shoreline that are exposed are experiencing a lot of growth from invasives such as; barnyard grass, torpedo grass, primrose willow, and dog fennel. These areas will be treated by the Seminole County herbicide contractor as the water elevation rises. It is recommended that these areas be mowed if possible. Burhead sedge and water lilies will continue to be treated upon next service date.

Photo: Treated areas along the southern shoreline.

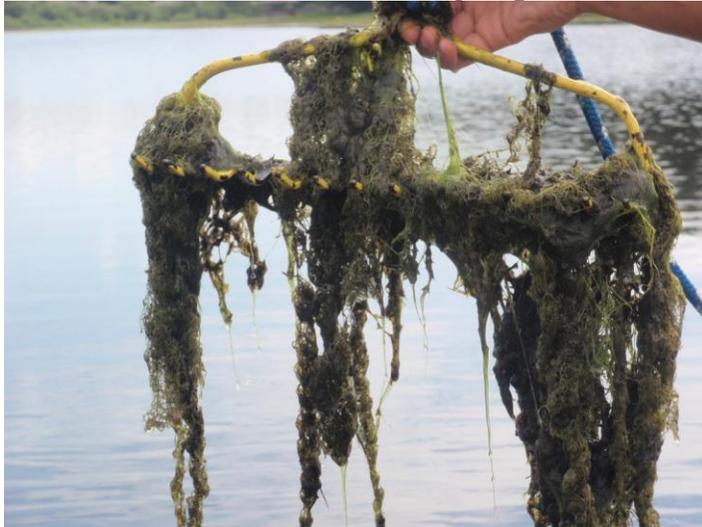
Mirror Lake has a large and healthy amount of native submersed aquatic vegetation (SAV). This vegetation plays an important role in competing for space with hydrilla as well as providing habitat for wildlife and up taking nutrients within the system. The native SAVs found during this inspection included; lemon bacopa to a depth of 1 ft, coontail to a depth of 5 ft, musk grass to a depth of 5 ft, southern naiad to a depth of 5 ft, stonewort to a depth of 2 ft, bladderwort to a depth of 5 ft, baby's tears to a depth of 1 ft, and eelgrass to a depth of 3 ft.

Photo: Bladderwort found during inspection.

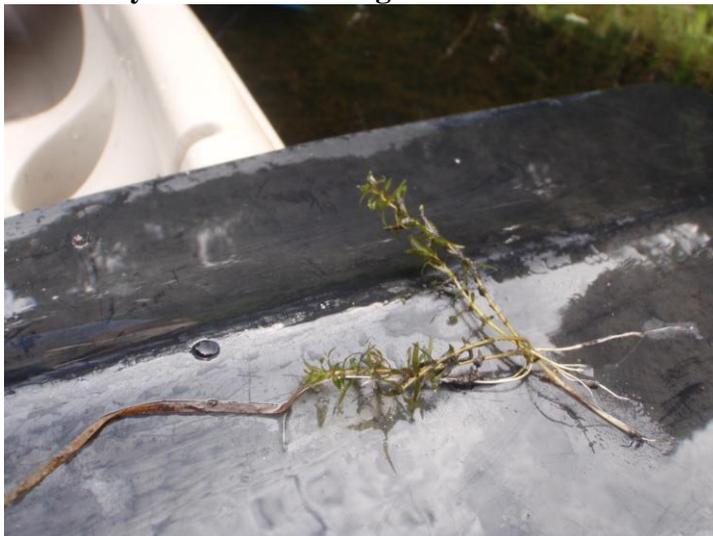
Hydrilla was found along the shoreline in shallow water but found very sparse and intermixed with the native SAV. Many large grass carp fish were seen in shallow water, possibly feeding on the hydrilla. We will keep monitoring the amount of hydrilla within the lake to see if any further action will be necessary.

Photo: Hydrilla found along the inshore area.

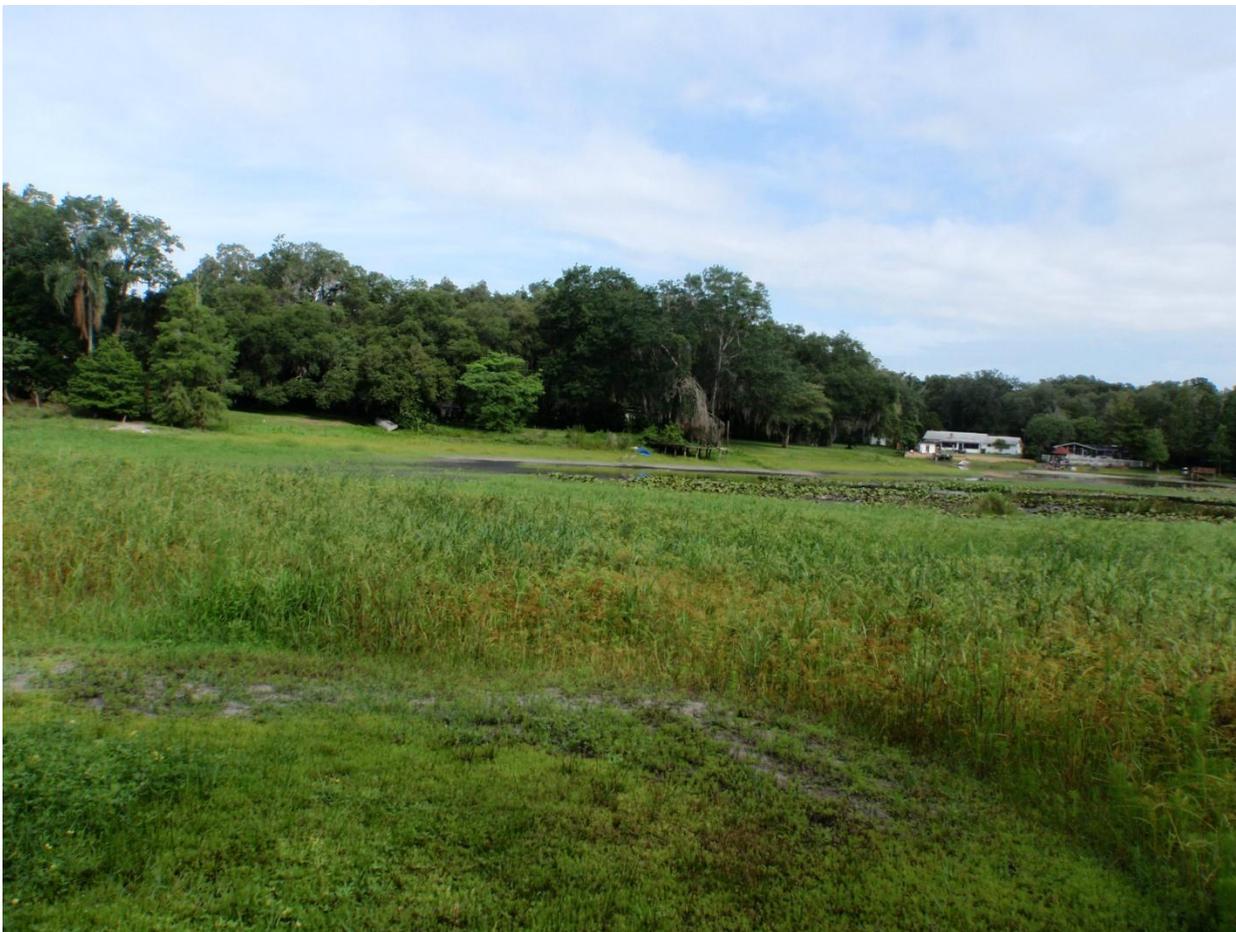
Water elevations are extremely low in Mirror Lake exposing several areas of the lake bottom. Many areas along the shoreline that are now exposed are experiencing accelerated growth from invasive plants such as barnyard grass, torpedo grass, and dog fennel. These areas are unable to be treated by the County's MSBU funded herbicide contractor until the water elevation raises allowing airboat access to these plants. SCLMP recommends that these areas be mowed (if possible) during the drought phase. Once water is at adequate level for the airboat to access, any existing invasives will be treated.

Photo: Area recommended to be mowed along the south side of the lake containing invasives.

- 1 Mow areas containing invasive plants during periods of extreme drought.
- 2 Work together with other lakefront owners. Have *at least* one annual lake association meeting, invite guest speakers (such as county or state biologists) and discuss lake specific issues, especially nutrients/lake management recommendations. SCLMP staff would be glad to present our findings from this and other surveys. Continue to increase native aquatic plantings along shoreline (such as pickerelweed, duck potato and canna).

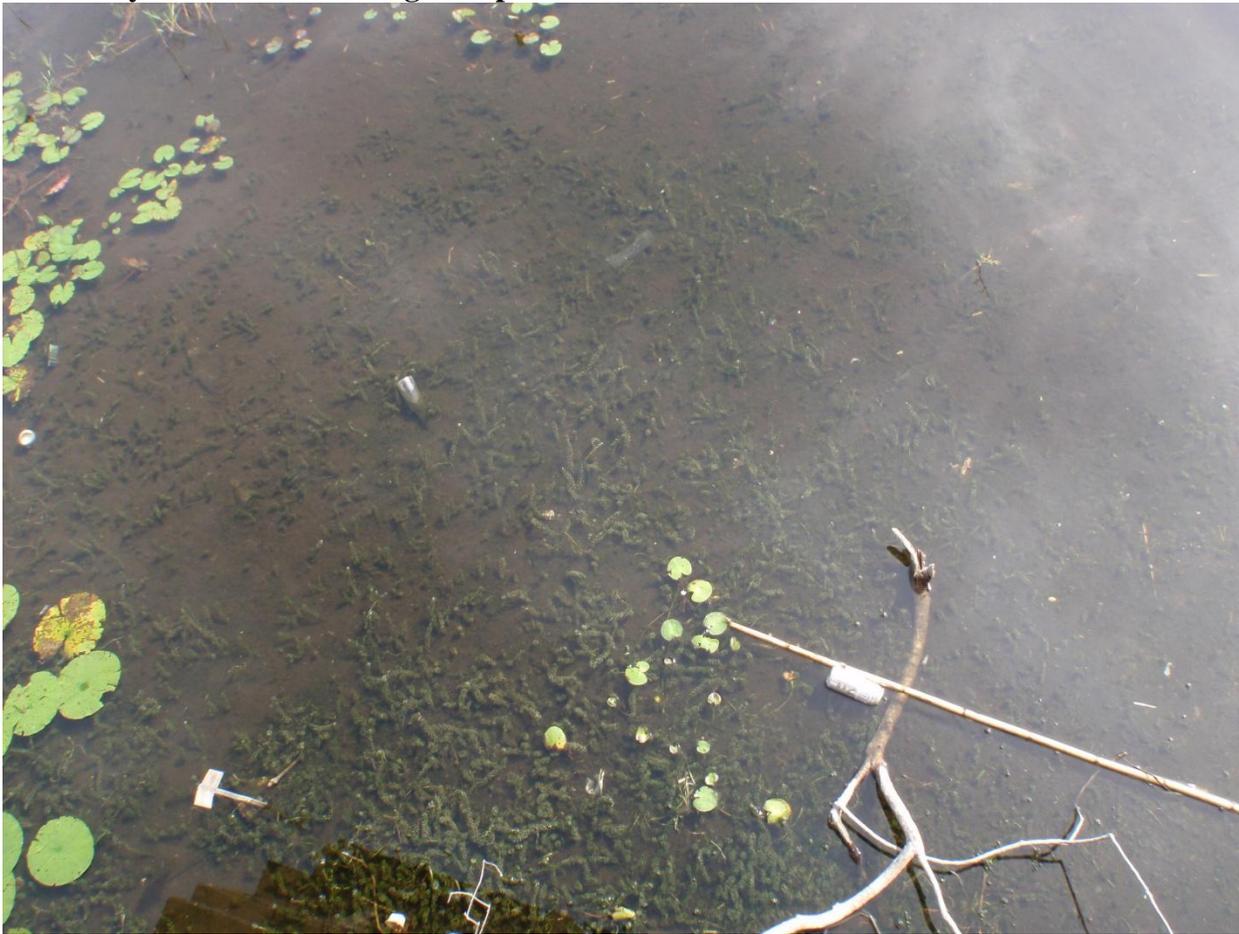
Hydrilla was found along the shoreline in two areas but found very sparse and intermixed with the native SAV. The only large monoculture of hydrilla found during the inspection was around the dock at Barrington Apartments but in a smaller amount than previous inspections. The low water elevation has helped eliminate the hydrilla inshore by exposing it in many places. We will keep monitoring the amount of hydrilla within the

lake to see if any further action will be necessary. The only other SAV found during the inspection included eelgrass, bladderwort, and lemon bacopa.

Photo: Hydrilla at the Barrington Apartment dock.

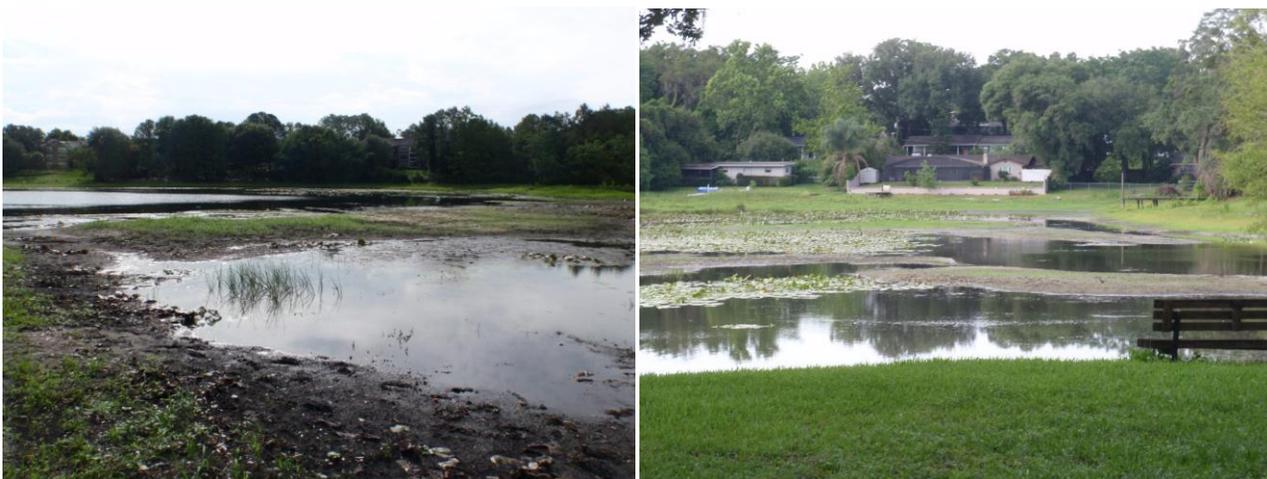
Photo: Low water conditions exposing lake bottom on Mirror Lake.

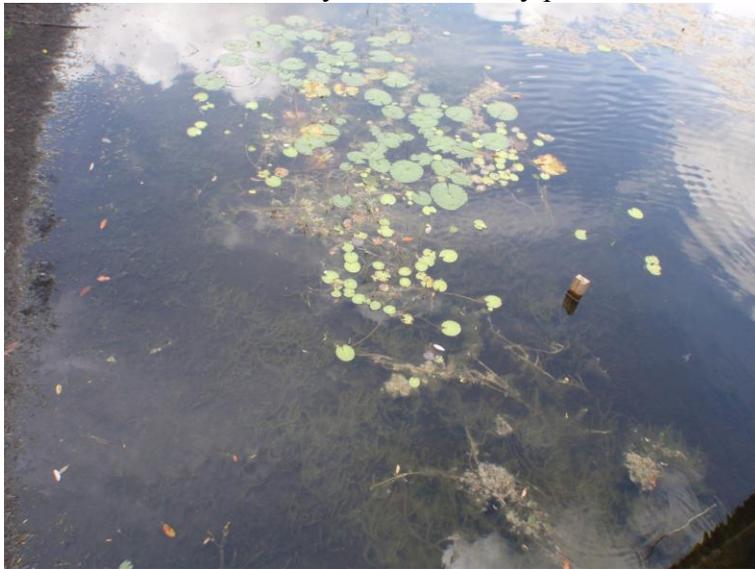
Hydrilla was found along the shoreline in all areas that was inspected. The hydrilla was found in monocultures (single crop) as well as intermixed with the native SAVs. This is an expansion of hydrilla since the previous inspection. It is expected that when the water elevation raises the present grass carp population will be able to start consuming this plant. We will keep monitoring the amount of hydrilla within the lake to see if any further action will be necessary.

Photo: Monoculture of hydrilla under lily pads.

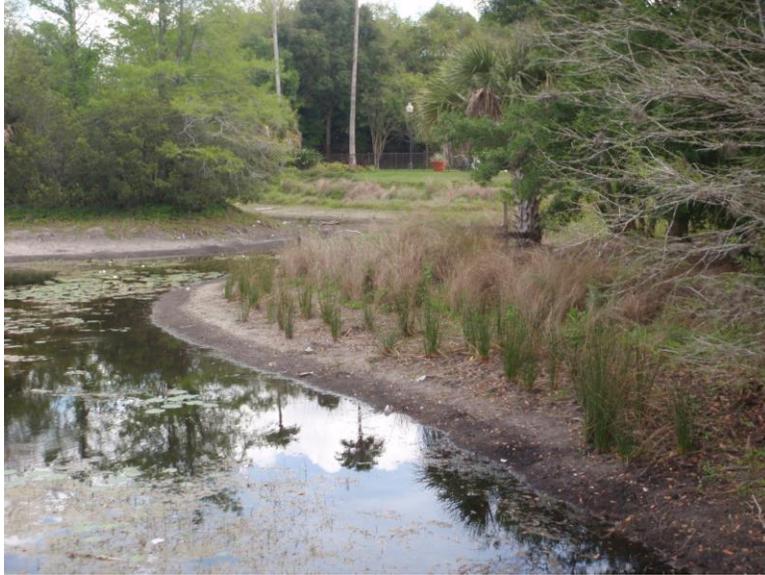
After break for the months of January and February, as cost savings efforts, the Seminole County MSBU funded herbicide contractor has resumed treating the exotic species in Mirror Lake this month. Torpedo grass has been treated to the point that it is no longer the dominant species within the lake. Lily pads will be targeted in the upcoming treatments. Native vegetation is returning from its winter state and is doing very well. Now would be a great time to target and

Photo: Soft rush and cord grass at The Barrington Apartments.

remove the dead torpedo grass around the lake due to low water level. This would encourage the expansion of the planted native vegetation.

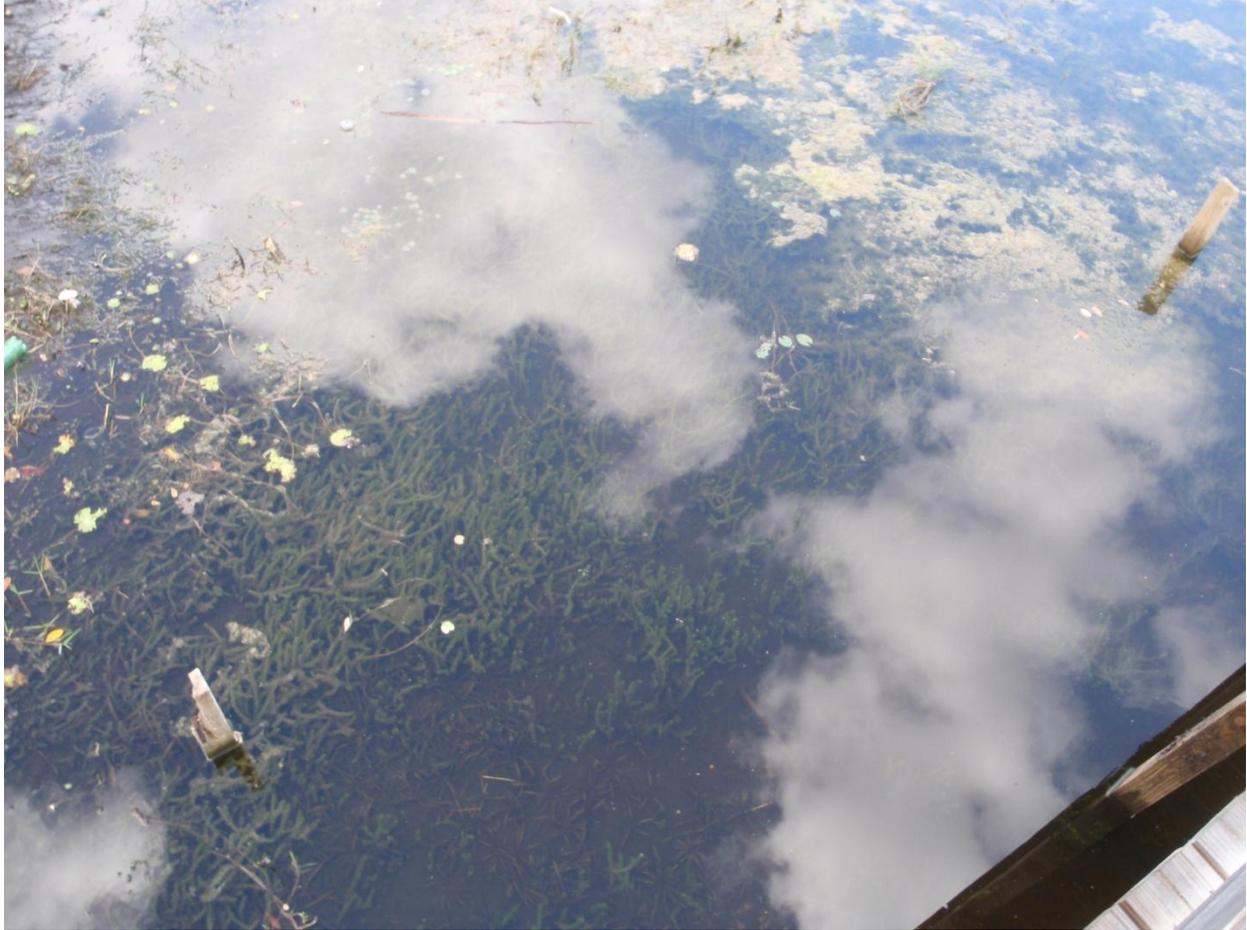
Hydrilla was found along the shoreline in all areas that was inspected but found very sparse and intermixed with the native SAV. The only large monoculture (single crop) of hydrilla found during the inspection was around the dock at Barrington Apartments. It is expected that when the water elevation increases, the present grass carp fish population will be able to start consuming this plant. We will keep monitoring the amount of hydrilla within the lake to see if any further action will be necessary (such as herbicide treatments).

Photo: Monoculture of hydrilla under lily pads.

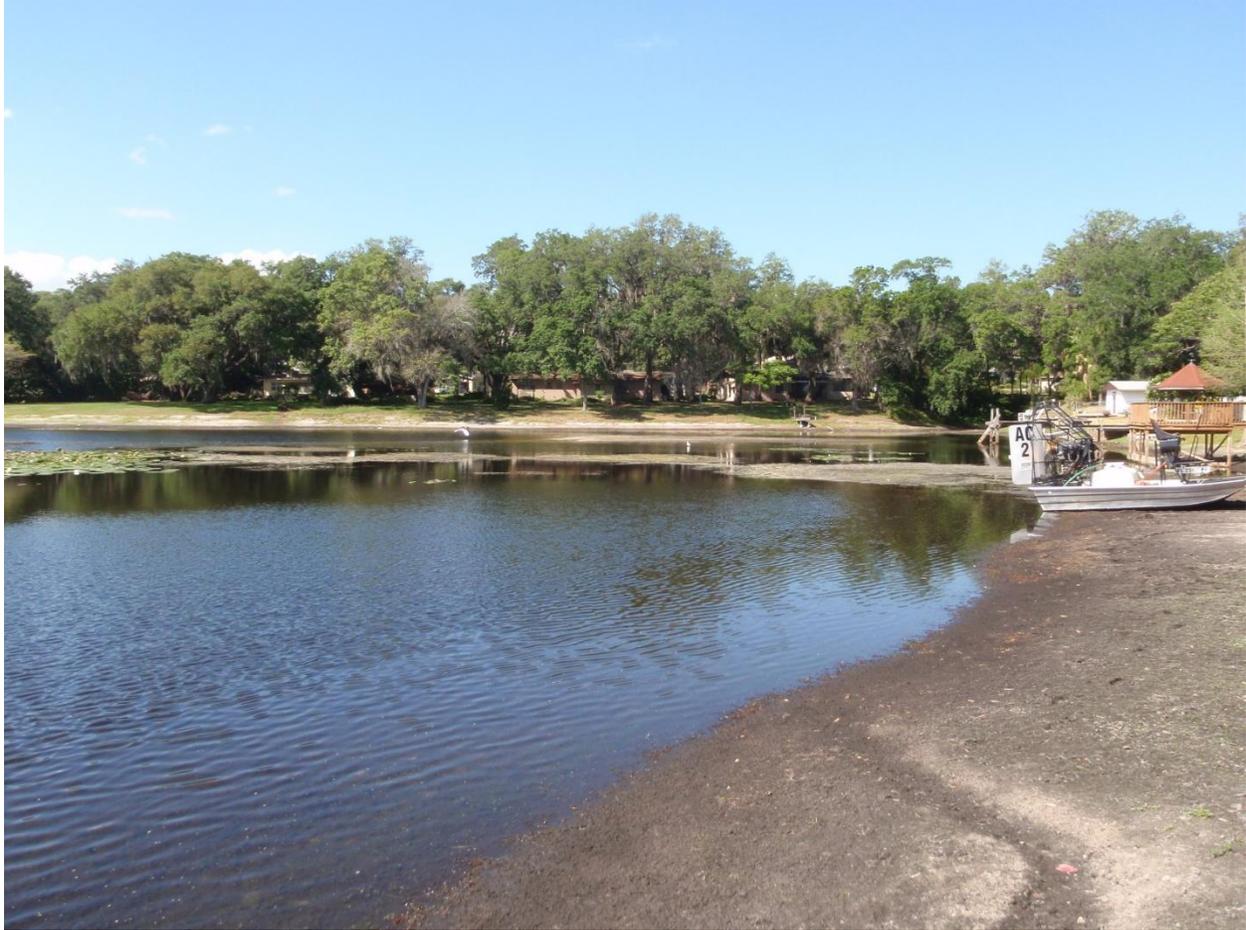
Photo: Low water conditions on Mirror Lake.

The secchi (water clarity) was not taken due to low water conditions and no grass carp were observed during the inspection.

It is still a great time to target and remove the dead torpedo grass around the lake due to the low water level. This would encourage the expansion of the planted native vegetation.

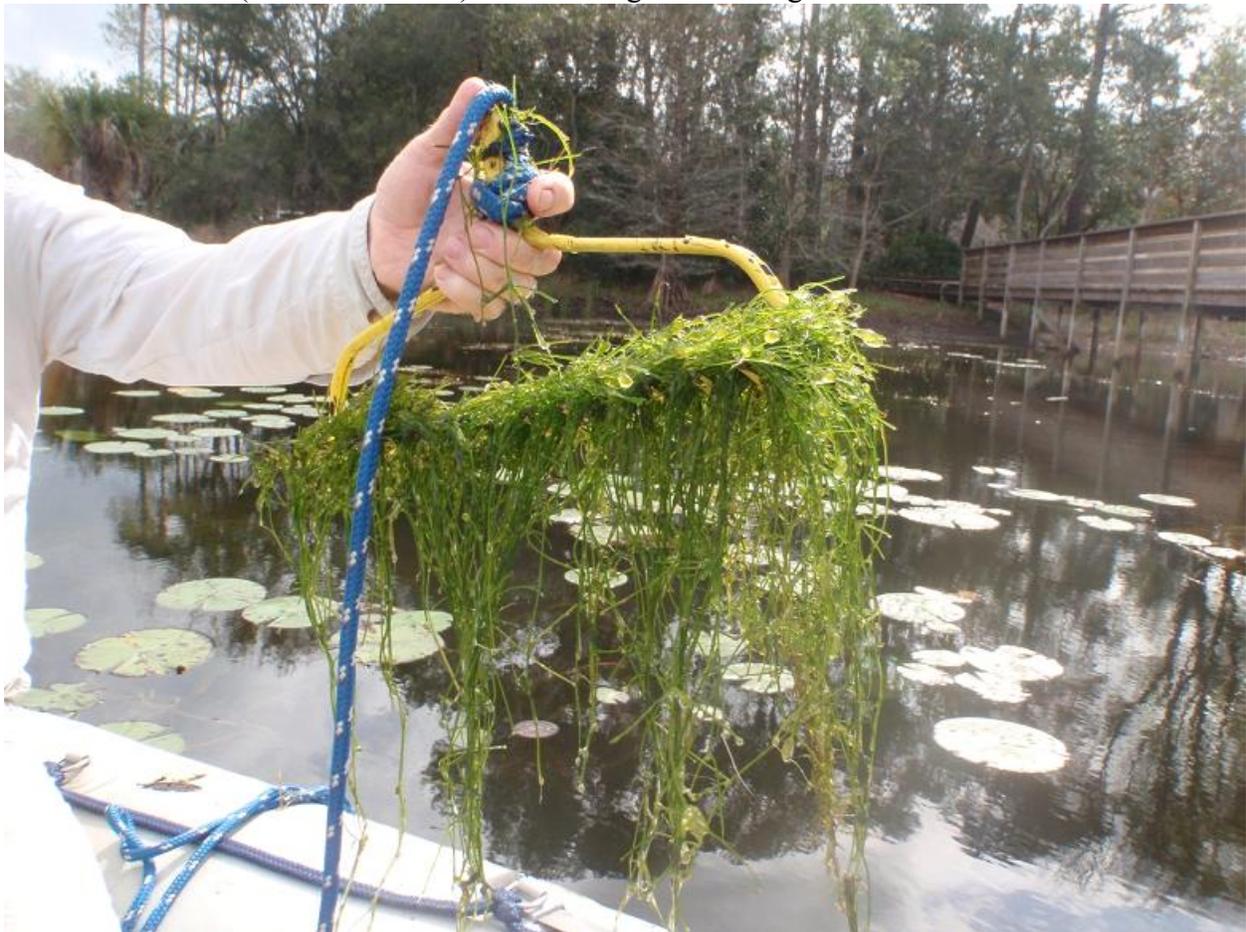
Nine different submersed aquatic vegetation (SAV) species were observed; 8 native and one exotic: lemon bacopa to a depth of 3 feet, musk grass to 3 feet, road grass to 3 feet, filamentous algae to 3 feet, southern naiad to 3 feet, stonewort to 4 feet, bladderwort (*Utricularia foliosa*) to 6 feet, and eelgrass to 2 feet. Overall, the native SAV present was very healthy and is expanding around the lake.

Photo: Stonewort (beneficial native) found in large mats along the north east side of the lake.

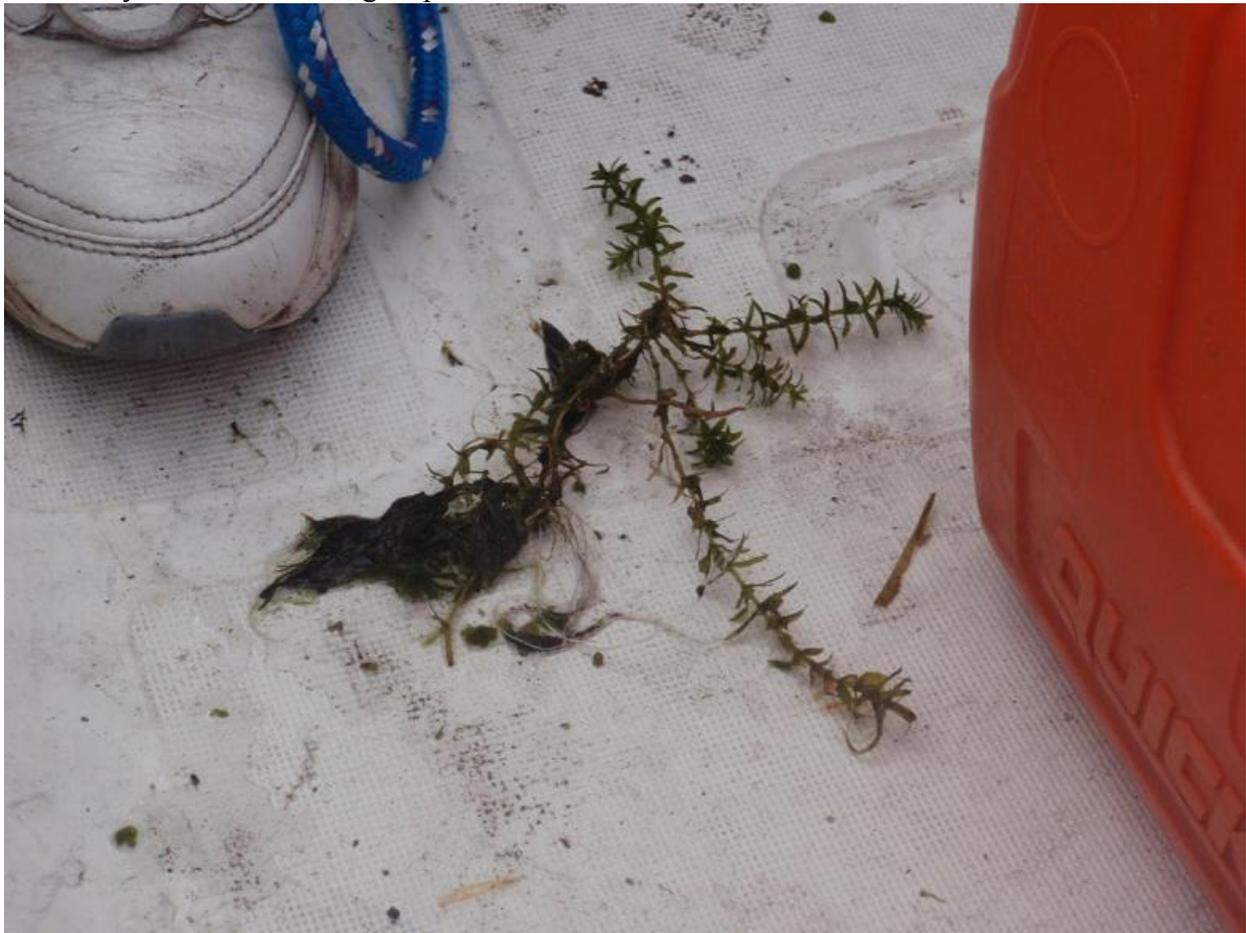
The invasive exotic hydrilla was found to a depth of 6 feet intermixed with the native vegetation. Hydrilla has not expanded much beyond and is found mostly adjacent to the shore (in shallow water) as a monoculture (single crop). When the water elevation rises, the present grass carp population is expected to be able to consume this plant given adequate depth. We will keep monitoring this monoculture and evaluating the need for future intervention with herbicides and/or grass carp fish.

Photo: Hydrilla found during inspection.

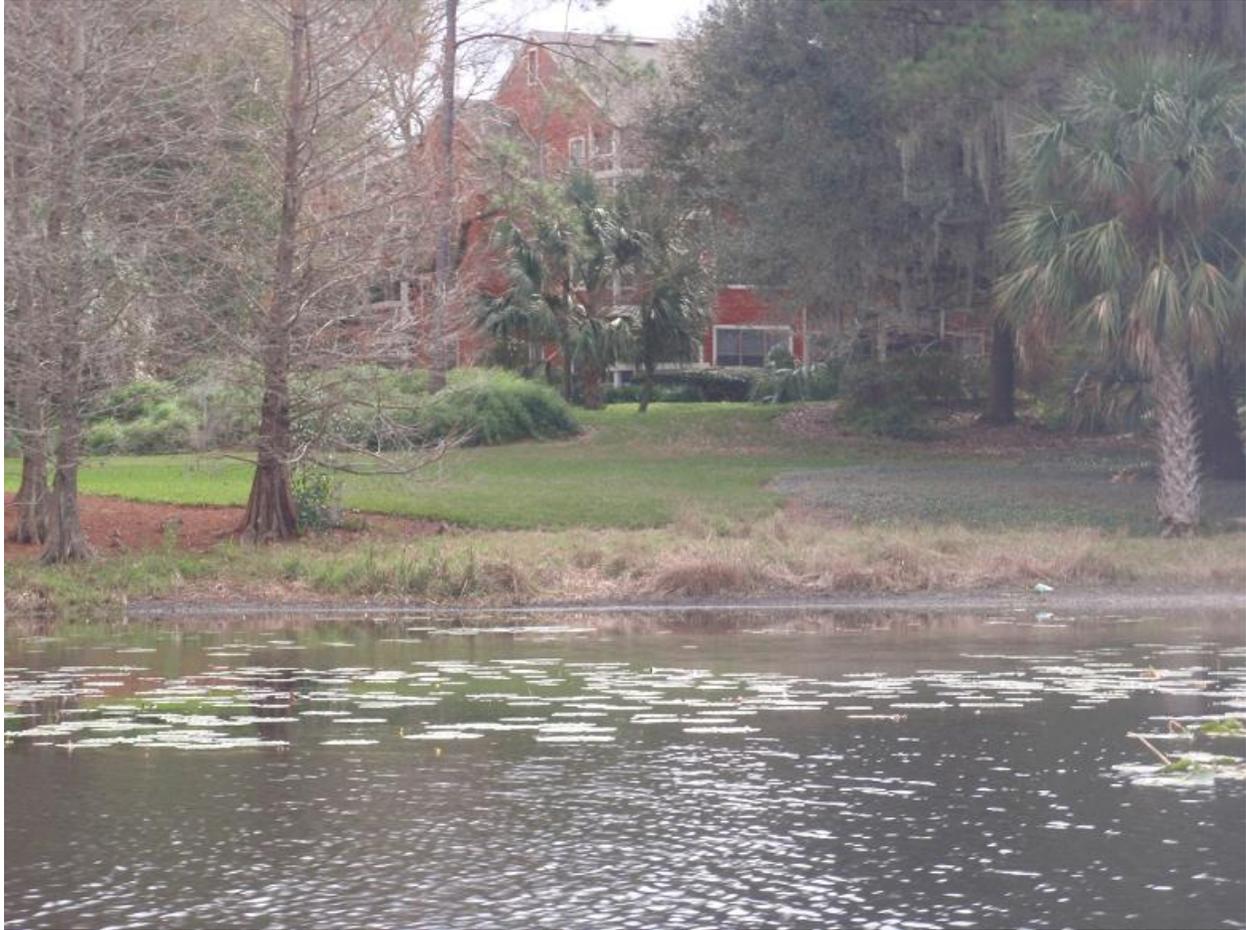
Lake wide, the Seminole County herbicide contractor has continued to treat invasive plants and the lily pads in isolated areas that are creating a nuisance as permitted by FWC. This coupled with some winter die back has the shoreline and emergent vegetation looking very brown. This vegetation will come back with the return of spring. With the current low water elevation of the lake, now would be a great time to target and remove the dead torpedo grass. This would encourage the expansion of the planted native vegetation come spring time.

Photo: Pickerelweed mixed in with dead torpedo grass.

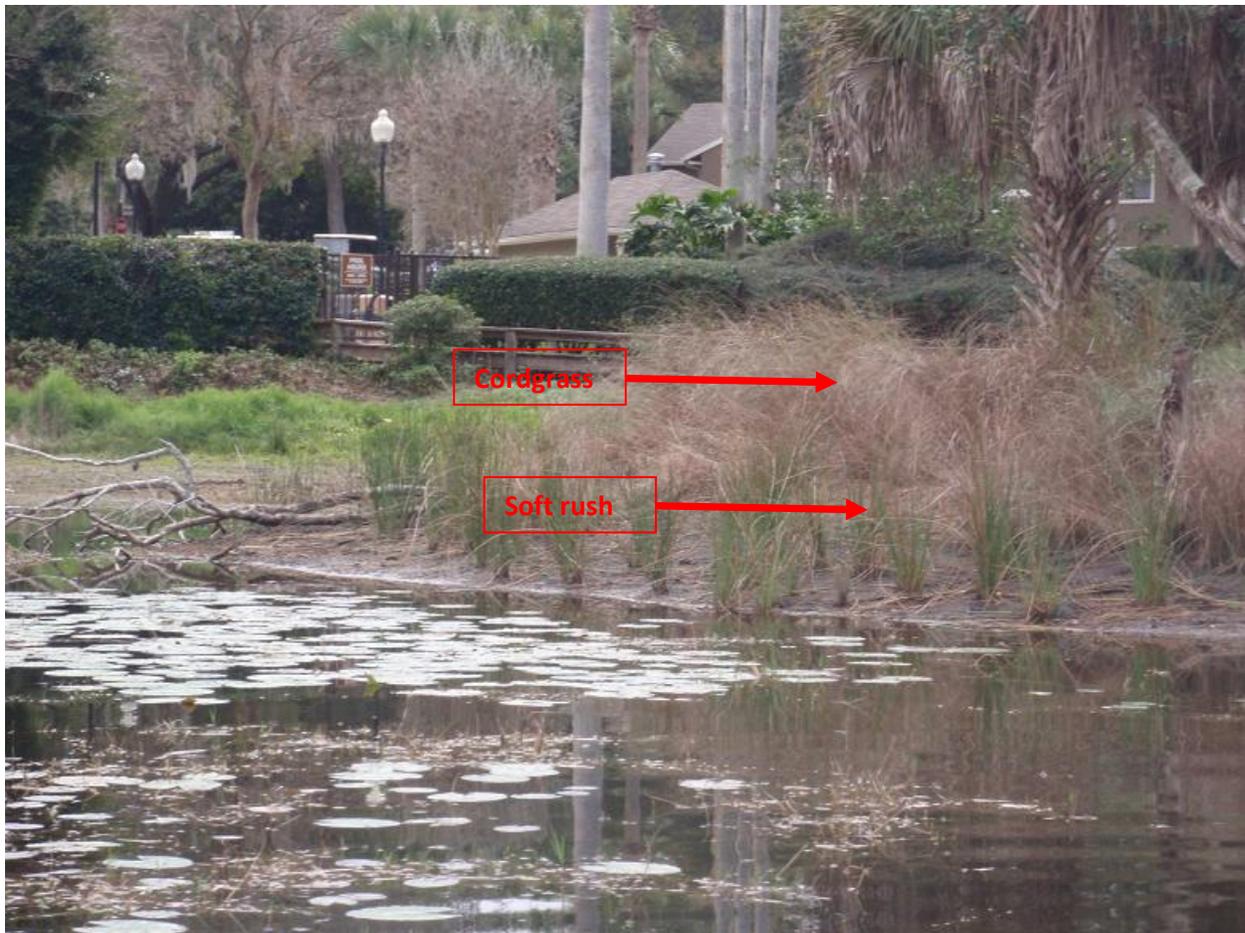
The plantings from the October 22nd, 2011 restoration event at The Barrington Apartments are doing extremely well over this winter. We continue to encourage such native plantings along the shoreline.

Photo: Soft rush (newly planted in October, 2011) and cord grass at The Barrington Apartments.

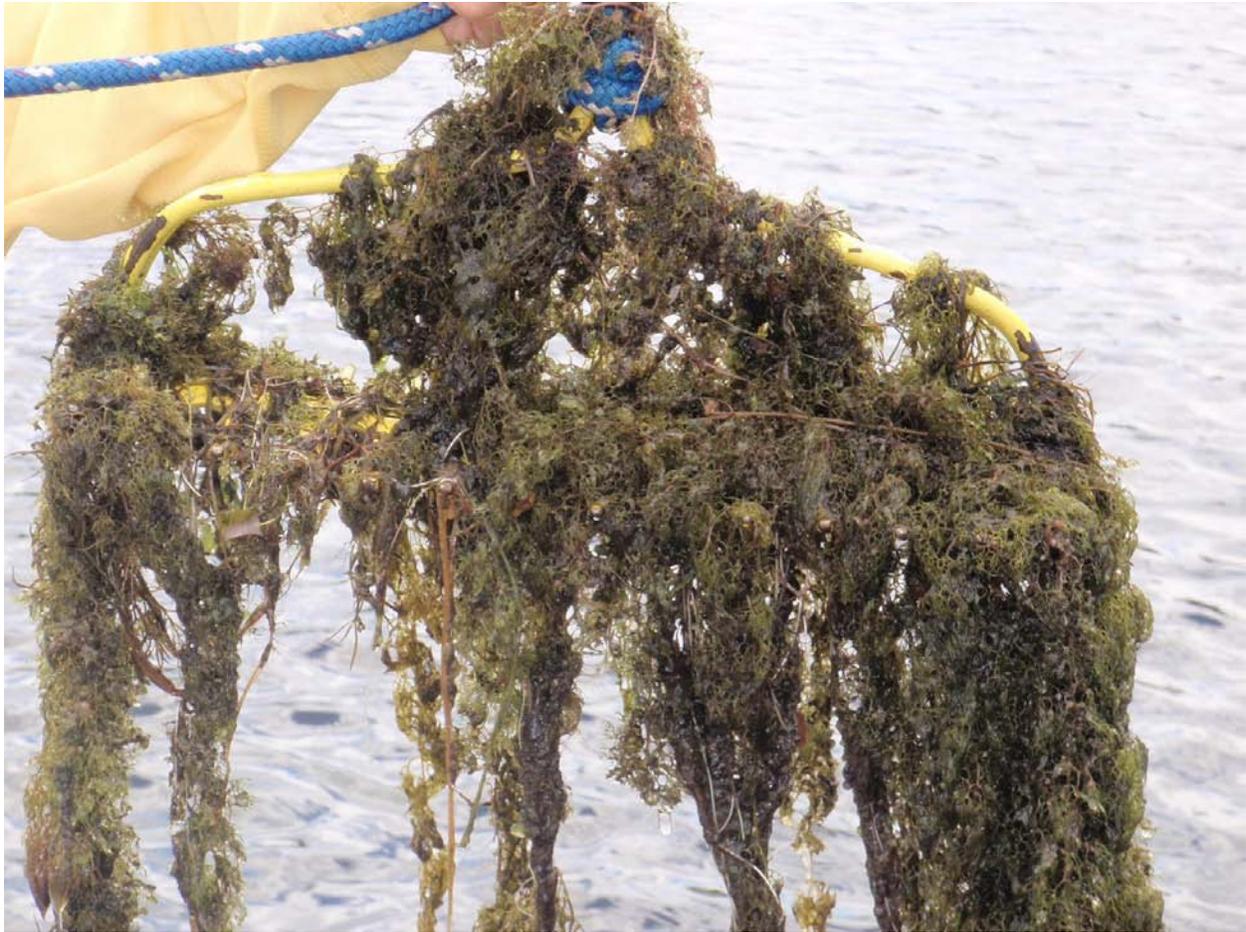
Nine submersed aquatic vegetation (SAV) were observed, 8 native and one exotic: lemon bacopa to a depth of 3 feet, musk grass to 5 feet, road grass to 5 feet, filamentous algae to 7 feet, the invasive exotic hydrilla to 7 feet, southern naiad to 7 feet, stonewort to 3 feet, bladderwort (*Utricularia inflata*) to 7 feet and eelgrass to 4.5 feet. All plants were observed at greater depths than the previous inspection. This is likely due to the previous storm events.

Photo: Bladderwort found during inspection.

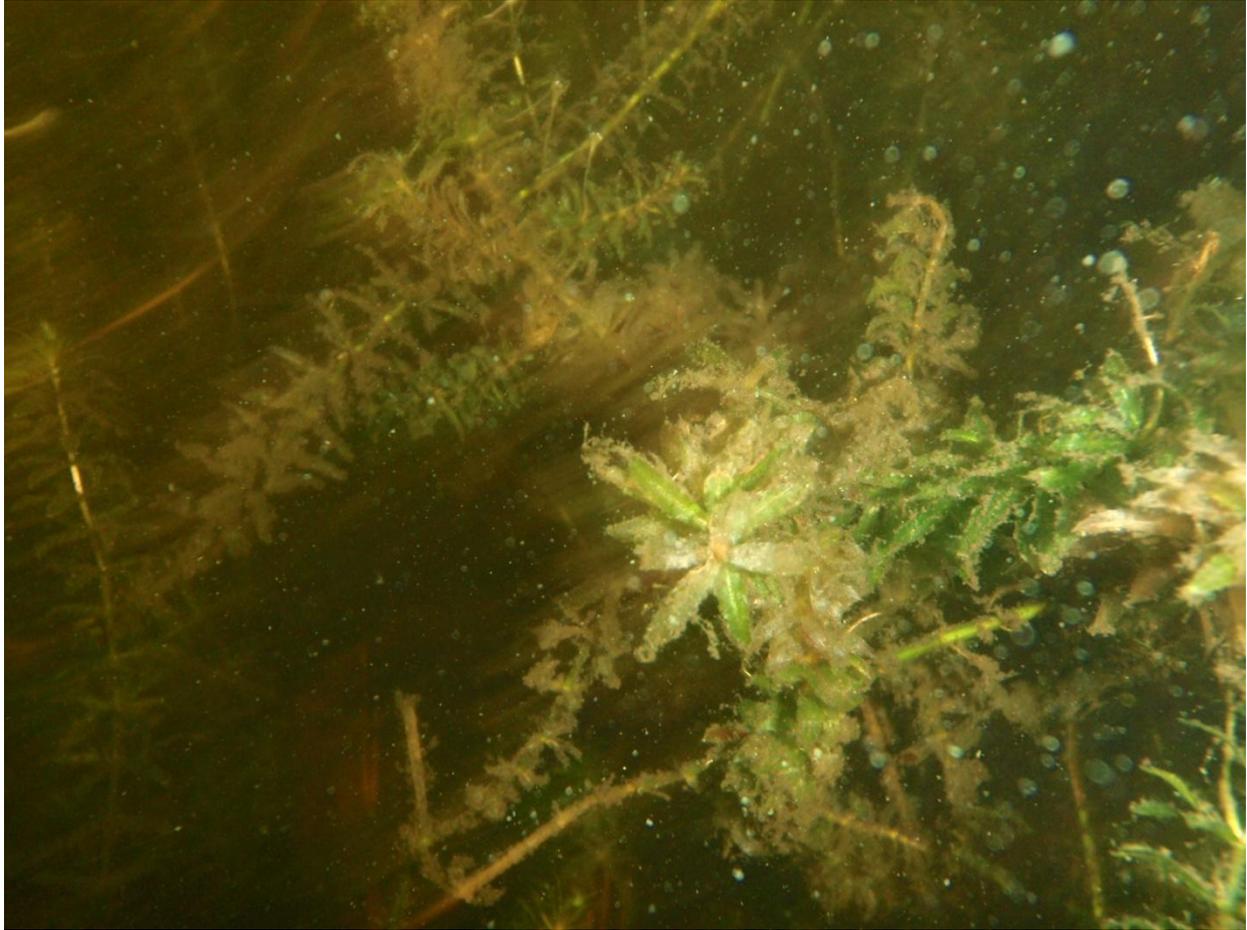
Hydrilla was stressed, dominantly in the treated plots along the west central shoreline. Outside of the treatment areas hydrilla continues to expand nearshore and offshore. New treatment plots will be scheduled for future treatment. Eelgrass population continues to expand, being observed at new sites, but still in relatively shallow water (4.5 feet or less).

Photo: Hydrilla underwater
