On **September 17th, 2014**, Seminole County Lake Management and Water Quality Program staff (Gloria Eby, Marianne Pluchino, and Thomas Calhoun) surveyed the aquatic plants in **Buck Lake** and conducted a Lake Vegetation Index (LVI).

Greetings Buck Lake Residents! Please find the latest bioassessment for your lake below.

On **September 18th, 2013**, Seminole County Lake Management Program (SCLMP) staff (Thomas Calhoun, Gloria Eby, and Marianne Pluchino) surveyed the aquatic plants and conducted a Lake Vegetation Assessment (LVI) in **Buck Lake**.

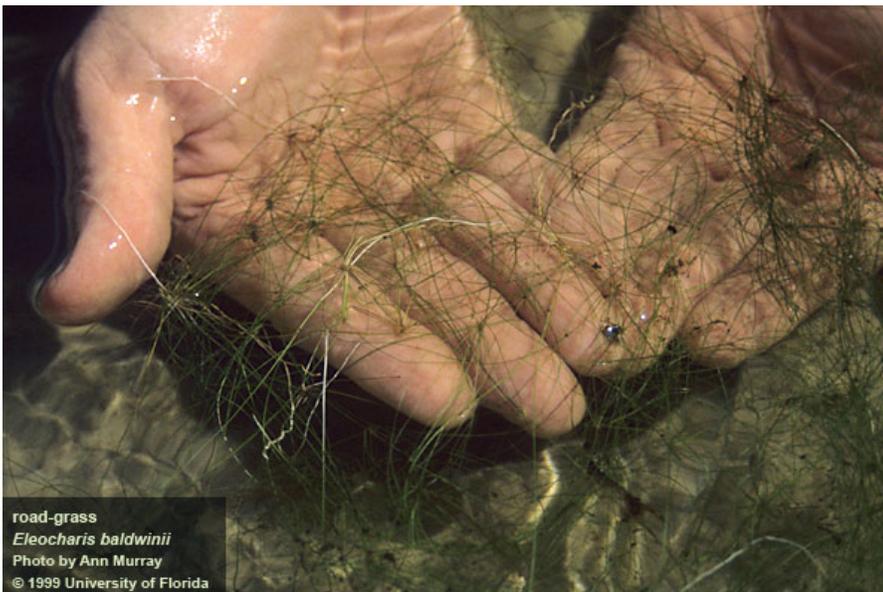
Six native submersed aquatic vegetation (SAV) were observed during this inspection which included road grass to a depth 4 feet, stonewort (*Nitella spp.*) to 3 feet, and three bladderwort species to 3 feet.

Photo: Road-grass.

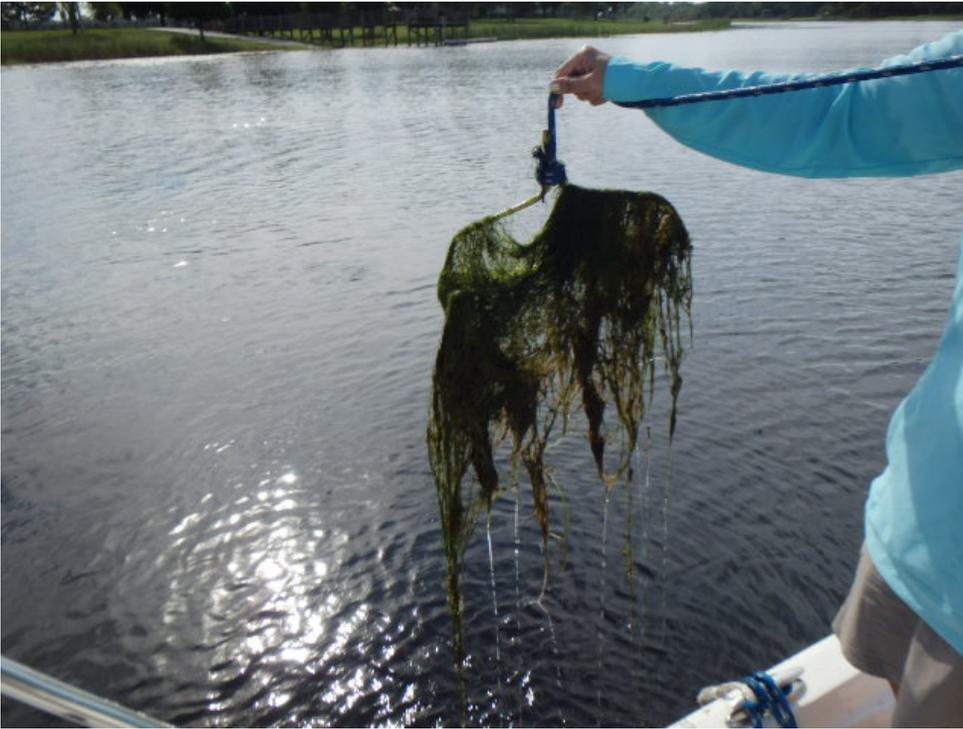
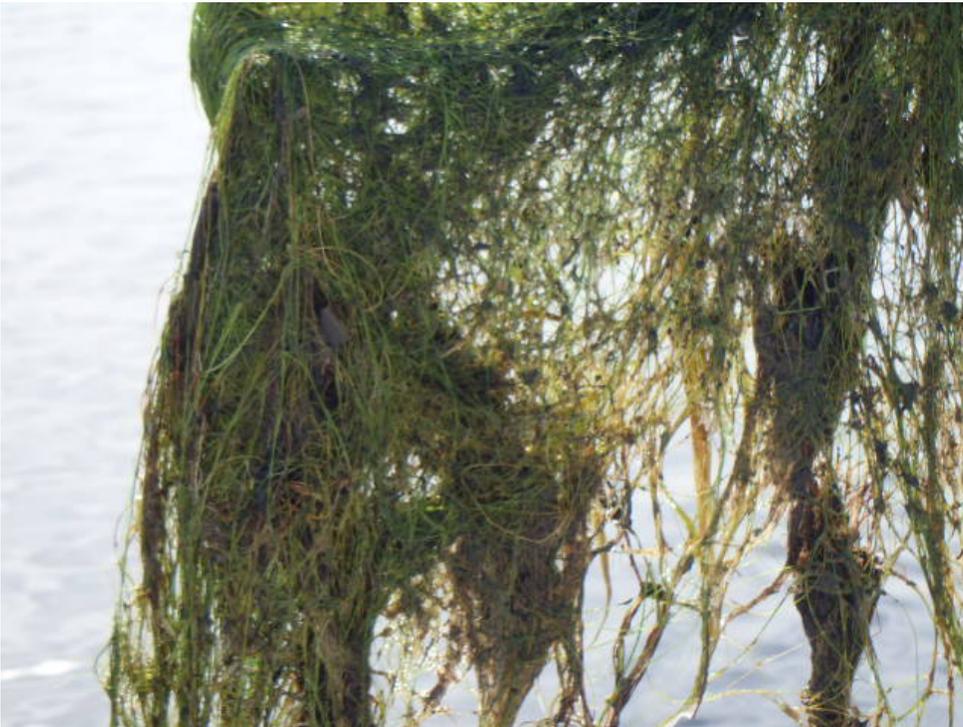
Photo: Native SAV observed in Buck Lake (mainly road grass).

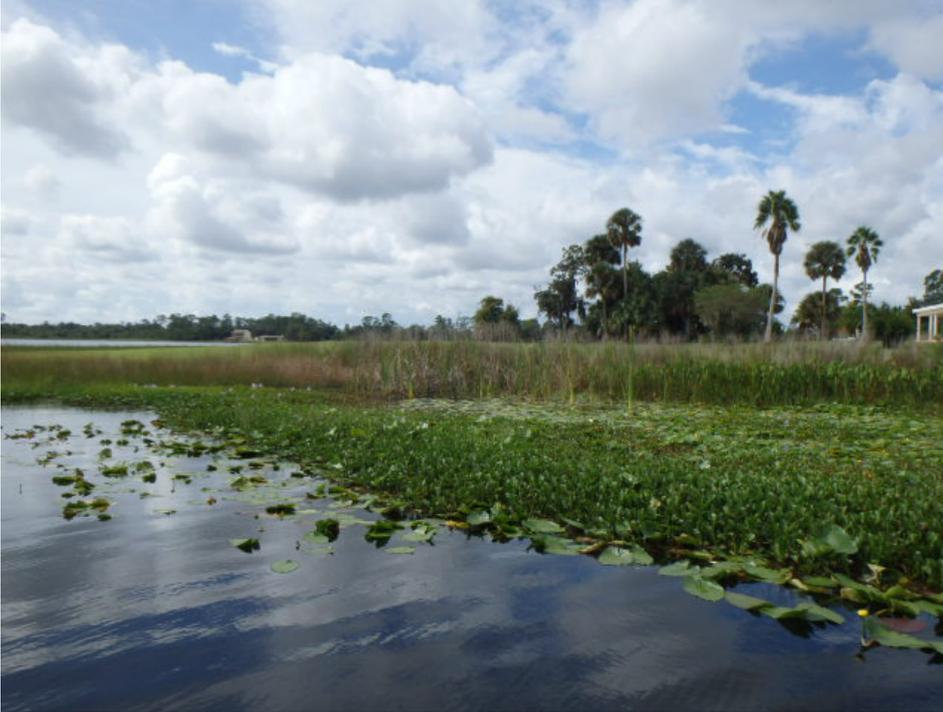
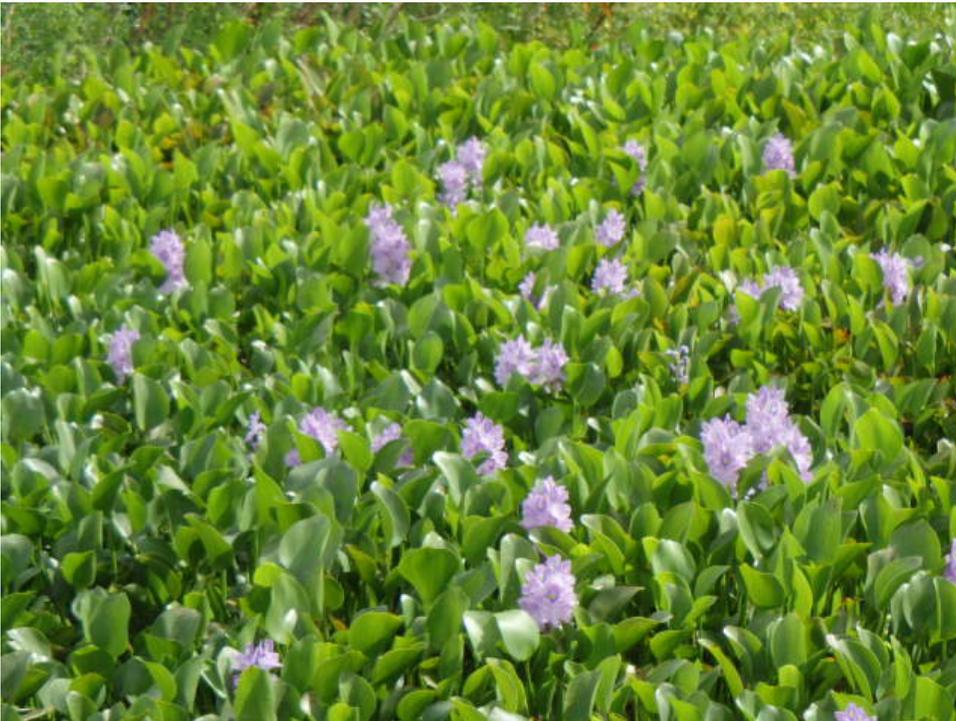
Water hyacinth, a floating invasive-exotic aquatic plant continues to expand in the northern portion of the lake, now consisting of over 60% of the shoreline (photo attached). Water hyacinth is now coined one of the worst floating weeds in Florida. A new publication on this plant can be found at: <http://edis.ifas.ufl.edu/pdffiles/AG/AG38500.pdf>.

Five invasive plants and trees were observed during this inspection which included: water hyacinth (*Eichornia crassipes*), bur-head sedge (*Scirpus cubensis*), torpedo grass (*Panicum repens*), Chinese tallow tree (*Sapium sebiferum*), and creeping oxeye (*Wedelia trilobata*). With a little effort, most of these invasives could be controlled, especially the water hyacinth.

Photo: Water hyacinth images taken during inspection.

2 Treat invasives (water hyacinth, torpedo grass, and bur-head sedge): Either do it yourself and establish a spray program or hire a contracted aquatic herbicide application company (we can provide a list of companies). Control of aquatic and wetland plants could require a free Florida Fish and Wildlife Conservation Commission (FWC) aquatic plant control permit. Contact FWC at (407) 858-6170 for a permit.

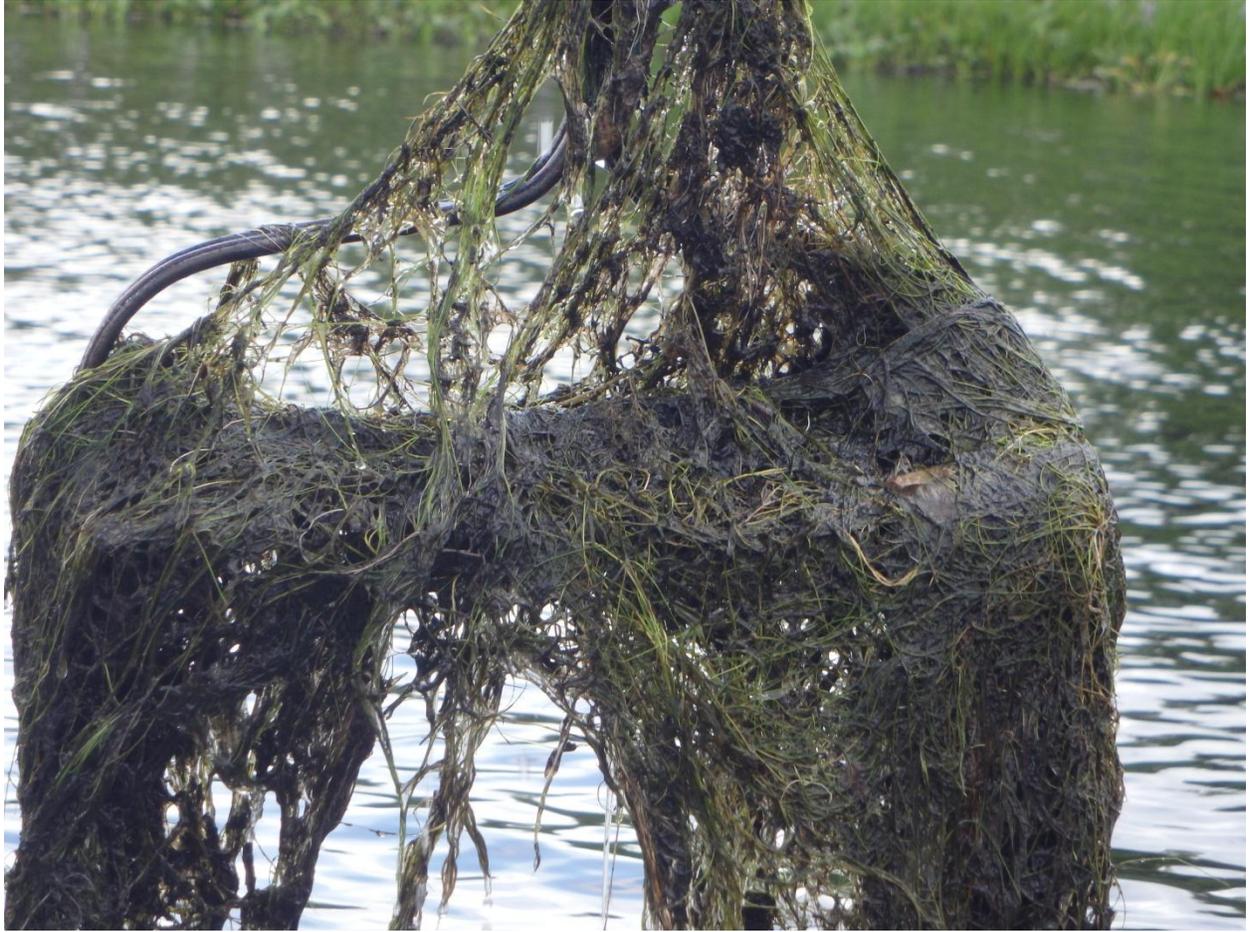
The native submersed aquatic vegetation (SAV) observed during this inspection included: road grass to a depth 4.5 feet, stone wort to a depth of 4.0 feet, eelgrass to a depth of 4.5 feet, and 2 types of bladderwort found to a depth of 2.5 feet. This is an increase in both diversity and biomass. Native SAV plays an important role in the aquatic ecosystem by providing habitat and reducing nutrients within the lake.

Photo: Road grass found during the inspection.

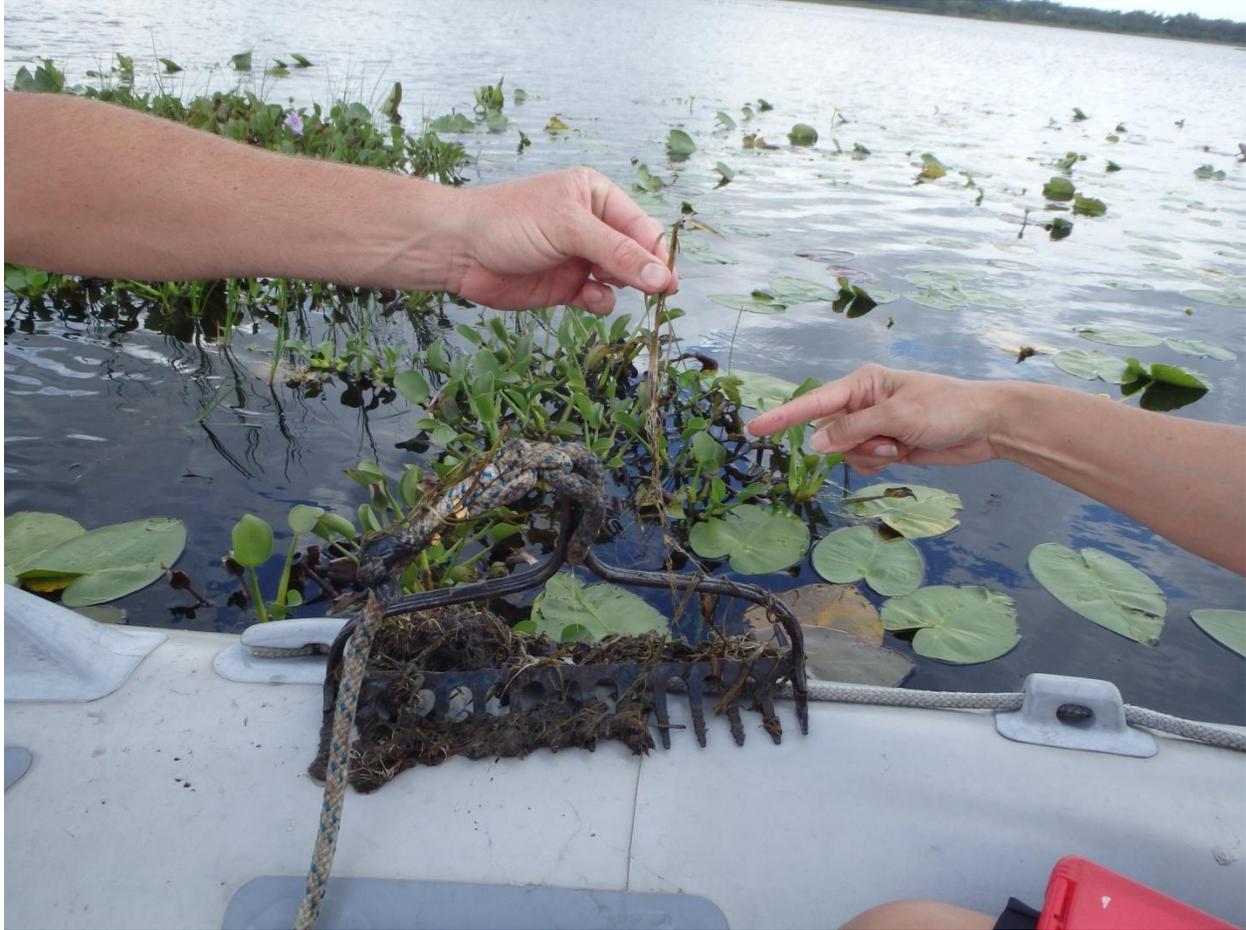
Photo: Eelgrass found during the inspection.

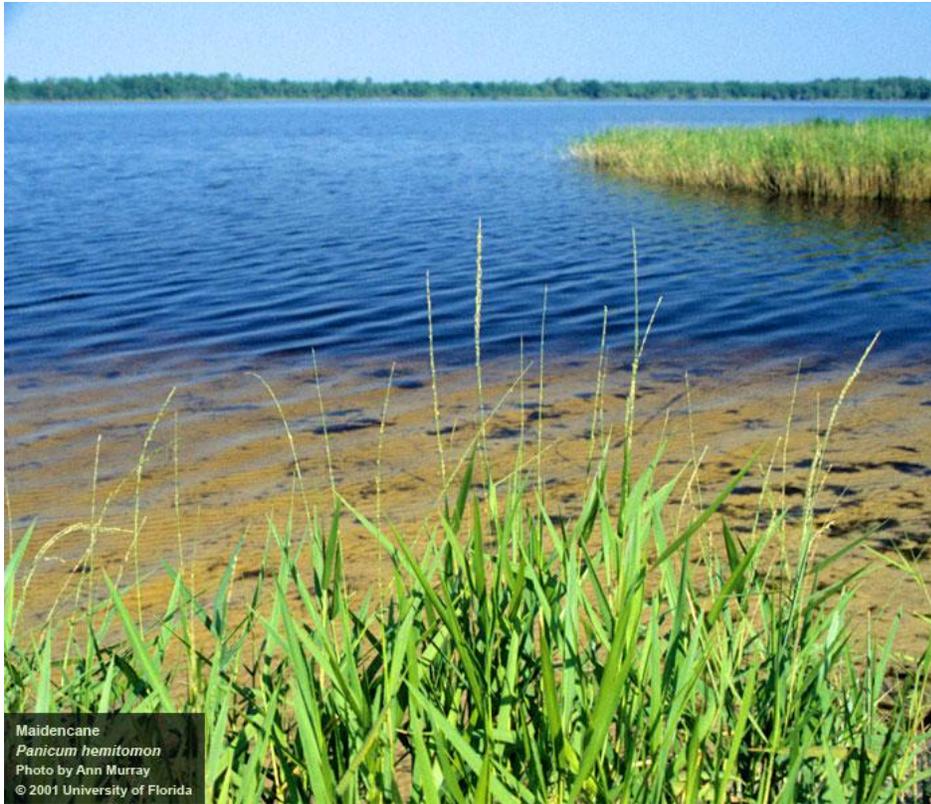
A good diversity of native emergent shoreline vegetation was observed during the inspection. Native species included: pickerelweed, saw grass, soft rush, rush fuirena, button bush, and maidencane.

Photo: Example of maidencane.

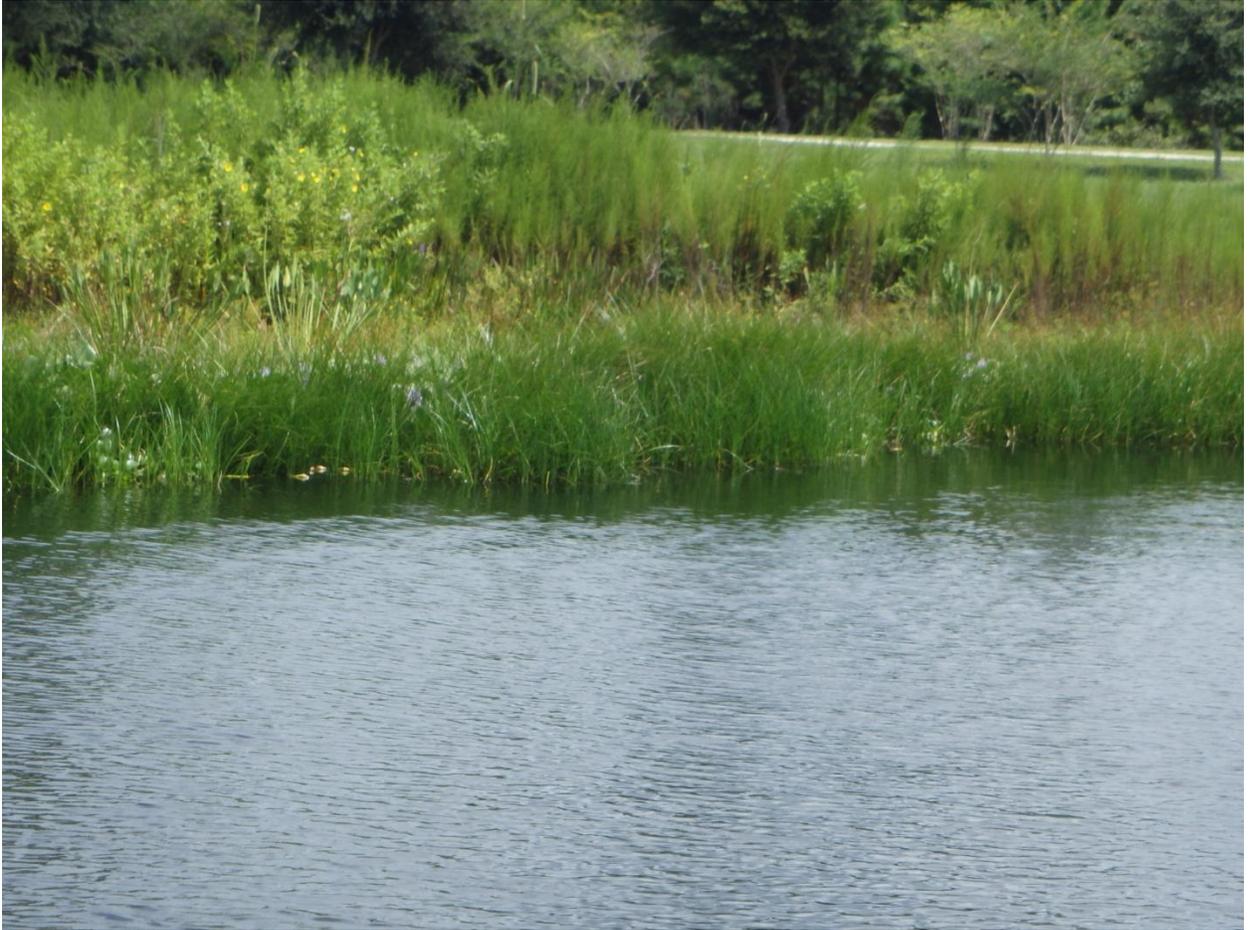
The invasive plant species observed during this inspection included: water hyacinth, bur-head sedge, and primrose willow. Bur-head sedge has expanded along many of the shorelines of the lake. This species of sedge can grow into a large floating mat that can out-compete neighboring plants by shading them, and can creep further into the lake thereby reducing the acreage of open navigable water. The invasive water hyacinth has also increased in extent since the previous inspection in most areas of the lake. It is recommended that both of these species are treated by a licensed herbicide applicator and permitted by FWC.

Photo: Bur-head sedge along shoreline.

2 Treat invasives (water hyacinth, torpedo grass, and bur-head sedge) along your waterfront. You can remove the plants by hand, obtain the necessary aquatic herbicide to treat them (we can provide information about herbicide sources), or hire a contracted aquatic herbicide company to do the application (we can provide a list of companies). Control of aquatic and wetland plants

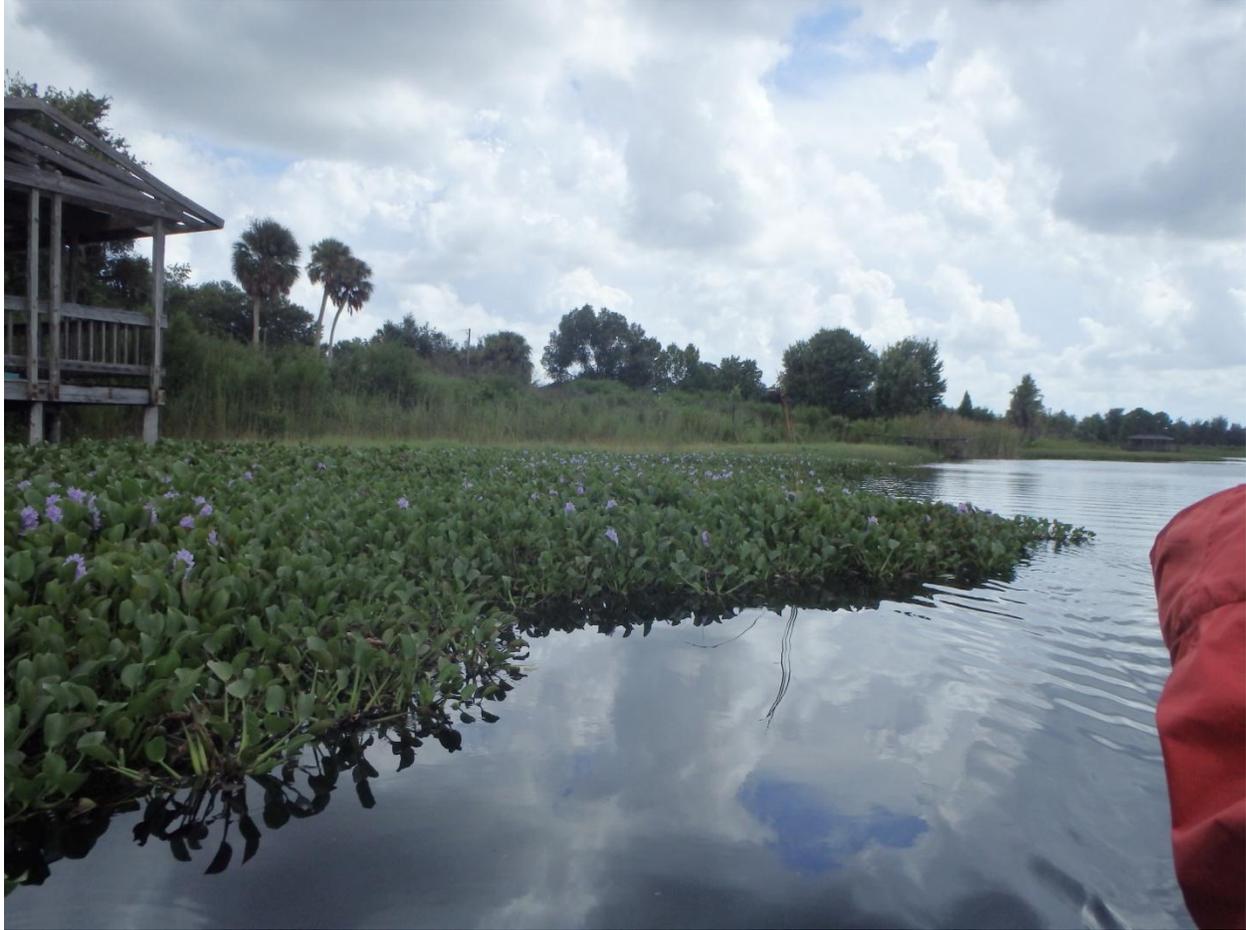
Photo: Water hyacinth along shoreline.
