LAKEWATCH

Dedicated to Sharing Information About Water Management and the Florida LAKEWATCH Program Volume 57 (2012)

Long-Term Weather Patterns, Drought and Lake Levels

Hydrilla Management in Florida Lakes

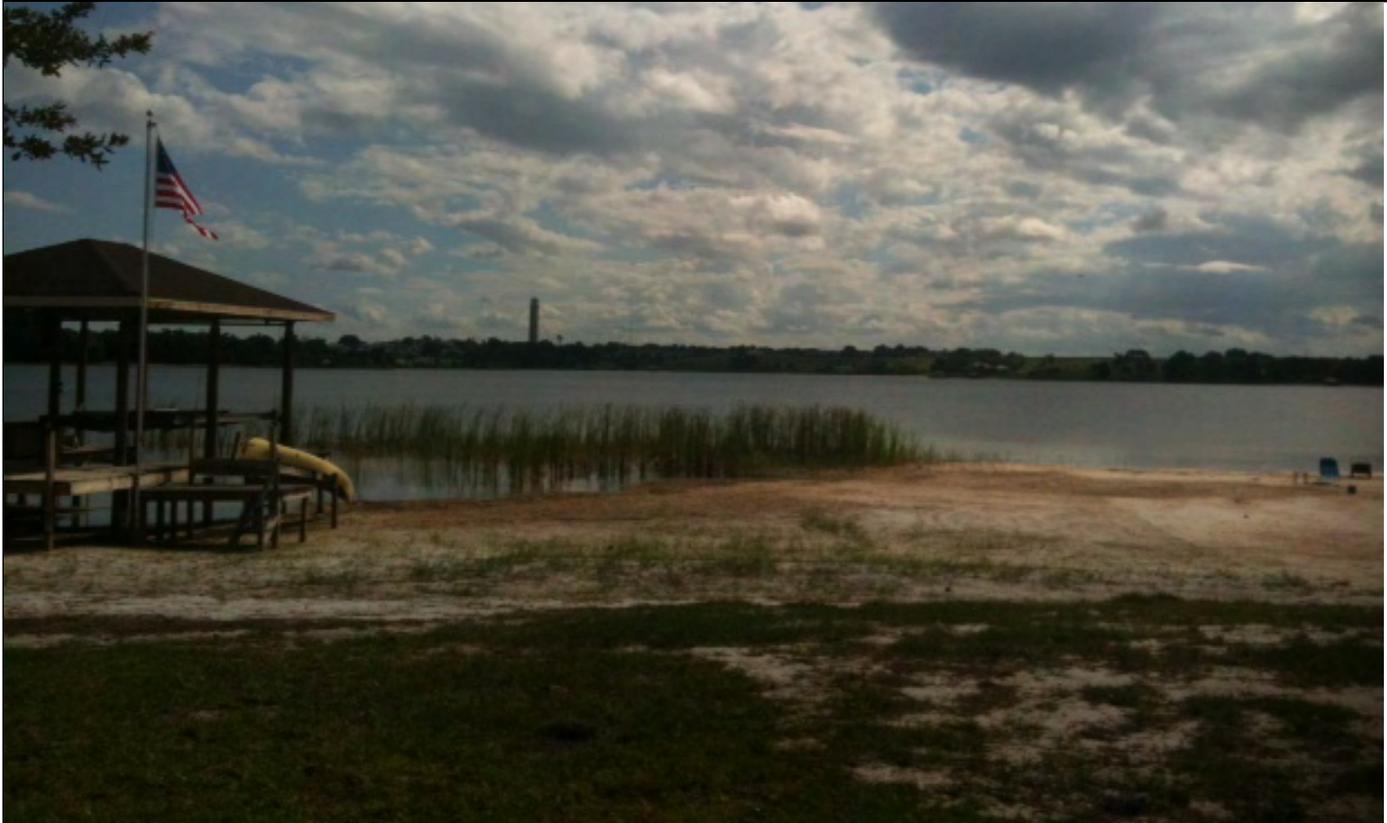
A dock out of water on Lake Clay in Highlands County.

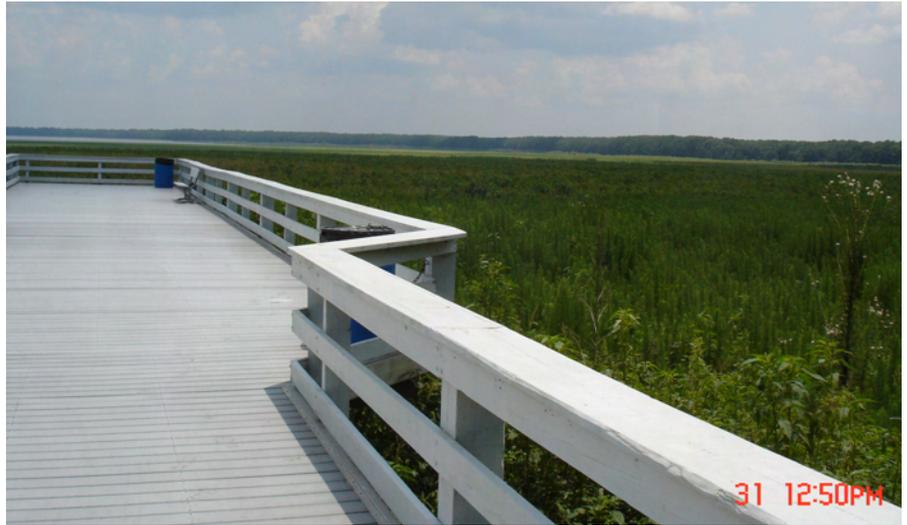
Newnans Lake in Alachua County in April 2012.

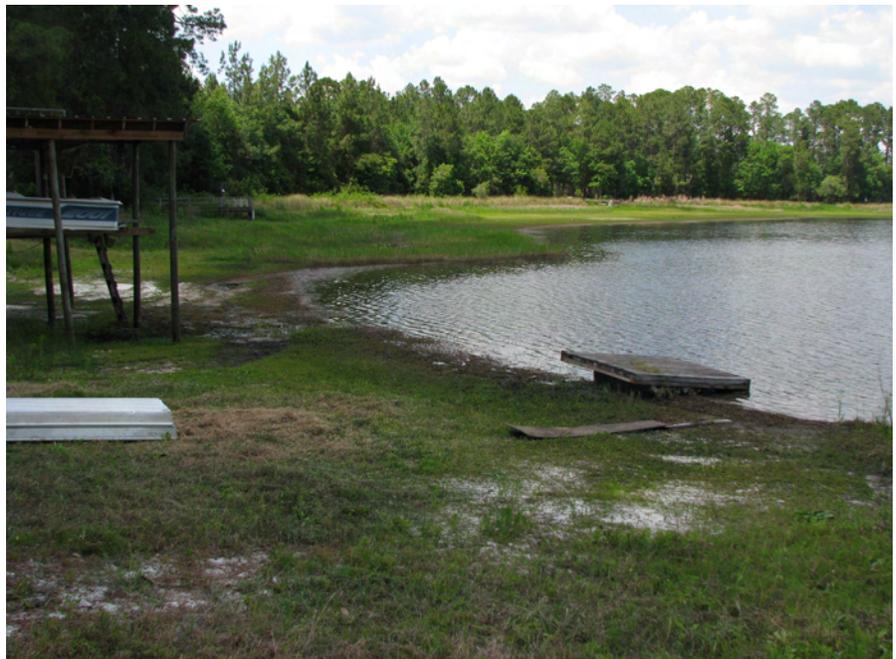
Lake Higgenbotham County in May 2012.

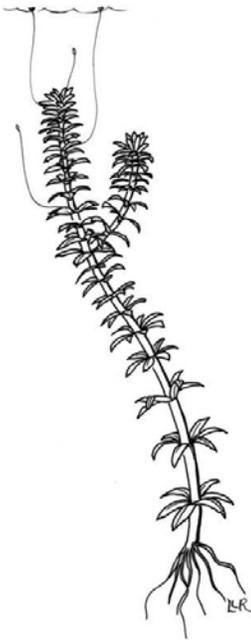
Figure 1. Hydrilla (*Hydrilla verticillata*) plant with flowers.

state. Erect stems can grow longer than 10.6 m (35 ft) when the plant grows in deep water (Figure 1). Branching is usually sparse, but when it grows near the water surface branching becomes profuse. Hydrilla's small leaves (2–4 mm [.08–.15 in] wide, 6–20 mm [.24–.79 in] long) are strap-like and pointed. They grow in whorls of four to eight (rarely three) around the stem. Leaf margins are coarsely saw-toothed, and one or more sharp teeth may be present along the length of the midrib on the underside of the leaf (Figure 2). Often a small bump appears where the tooth has aborted. Common waterweed (Brazilian elodea, *Egeria densa*) can be misidentified as hydrilla but is uncommon in Florida. When in doubt, an expert should be consulted for identification.

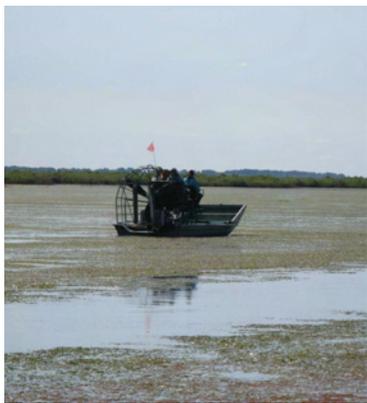
Figure 5. Hydrilla infestation on an 8–10 foot deep Lake Tohopekaliga in Central Florida.

Hydrilla causes serious environmental and economic impacts in Florida. It produces dense canopies that can cover the entire surface of a water body and have the potential to reduce plant diversity by shading out native submersed plants. The canopies also provide ideal breeding environments for mosquitoes; reduce aquatic life by lowering dissolved oxygen concentrations; and cause wide fluctuations in pH and surface water temperatures. Dense infestations can greatly impact water uses by restricting navigation and recreational activities such as boating, swimming, and fishing (Figure 5). Tourism, property values, native plant communities, water quality, fisheries, and flood control also can be impacted by hydrilla infestations.

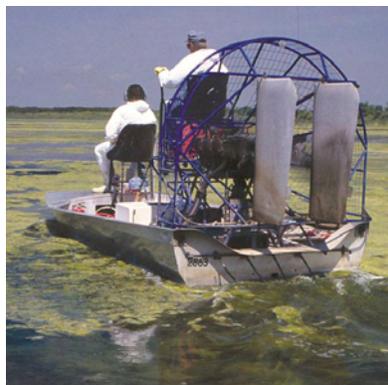
Figure 6. An application of aquatic herbicide using an airboat with trailing hoses for treating hydrilla. Note: Filamentous algae is on the water's surface and hydrilla is below.

Department of Agricultural and Consumer Services (FDACS) before they are used in Florida. Aquatic herbicides are a type of pesticide that has been approved by EPA to manage plant growth in aquatic systems. The label associated with each product is a legal document that describes the approved target plants, sites of application, application rates, and any restrictions on the use of water following treatment. Herbicide application techniques include helicopter, fixed-wing aircraft, boat, truck, or backpack sprayer, and they are selected based on various factors including the size of the target treatment (Figure 6).

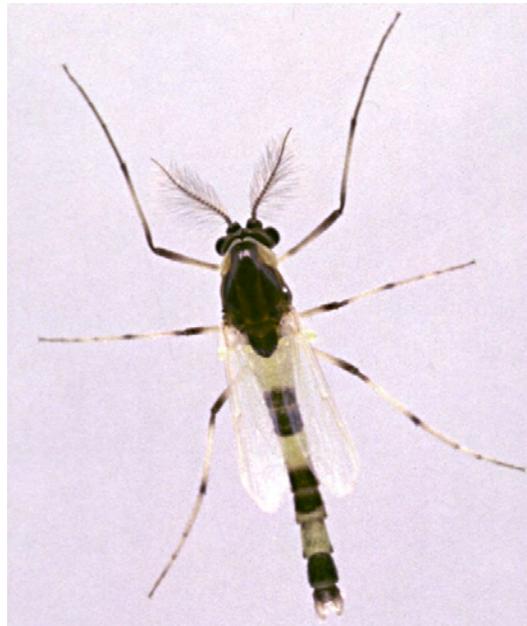
Figure 9. Adult male hydrilla miner, *Cricotopus lebetis*.

Cricotopus lebetis (Figure 9). Larvae of the hydrilla miner develop in the growing tips of hydrilla, which causes branching of the plants and stunts the growth of hydrilla (Figure 10). Studies are being conducted to investigate temperature tolerances and host range of the insect. Researchers are evaluating the compatibility of the hydrilla miner with the fungal pathogen

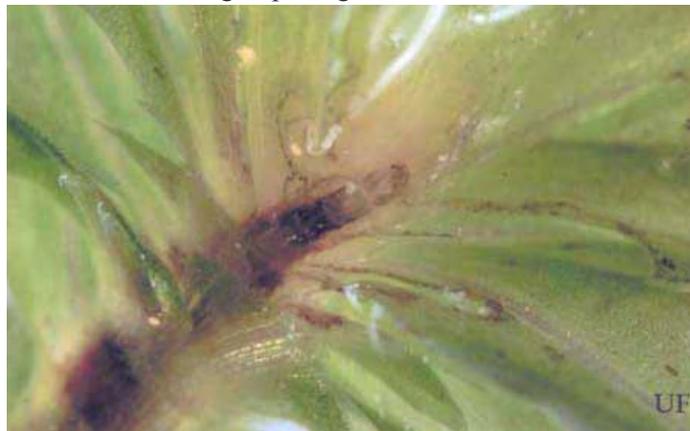
Figure 10. Damage to hydrilla tip from the larva of the hydrilla miner.
