Lake Harney 2-15-2011

On **15 February 2011**, Seminole County Lake Management Program (SCLMP) personnel Marie Lackey, Dean G Barber and Thomas Calhoun surveyed the aquatic plants of **Lake Harney**. The submersed aquatic vegetation (SAV) observed consisted of: coontail in shallow water, chara to a depth of 1.5 feet, road grass in shallow water, filamentous algae to 1.5 feet, hydrilla only in the boat ramp canal in Gopher Sough (0.1 acres) and eelgrass to 2 feet. As previously reported, eelgrass was the dominant SAV, however in previous reports it was mostly observed on the western shore, with dense monocultures out to a depth of 2 feet and no or little eelgrass on the southern, northern and eastern shore. During this survey all shores mostly consisted of new small plants with good densities (30-40 plants/square meter) out to 1.5 feet, then less dense to 2 feet. Only the western shore had larger plants, which were mostly in 0.5 to 1.5 feet. This can be expected, as this shoreline would have eelgrass when the others did not, thereby having the older plants. The southern shore had the most significant increase of SAV; from where 3 months previous there were almost no SAV, especially

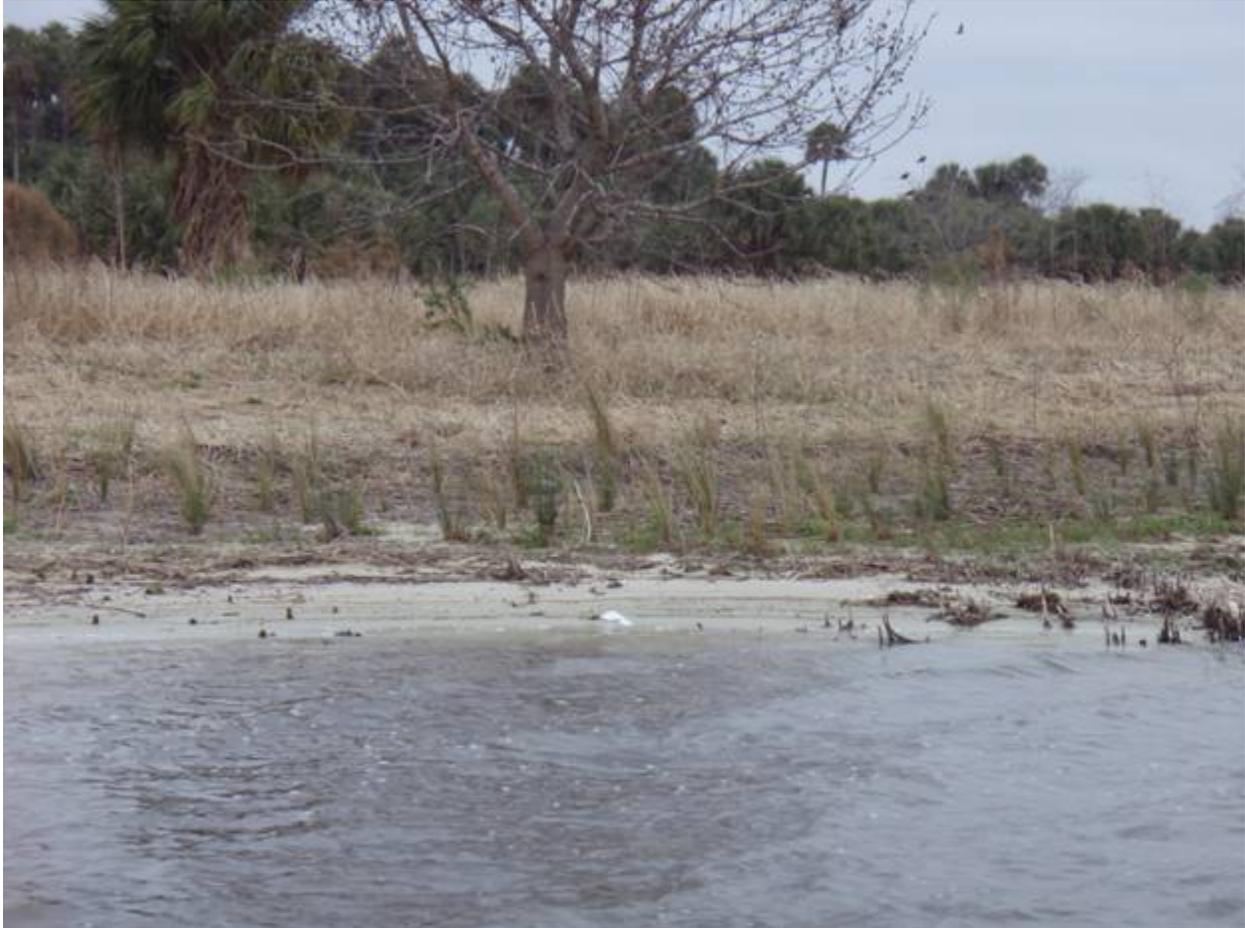
On **15 February 2011** SCLMP personnel Marie Lackey, Dean G Barber and Thomas Calhoun surveyed the aquatic plants of **Lake Jesup**. SAV observed consisted of: coontail in shallow water, road grass in shallow water, hydrilla with less than 0.1 acres of the invasive near to Black Hammock boat ramp and Overlook Park, southern naiad at Overlook Park and eelgrass to a depth of 1.5 feet within the FWC enclosures. Coontail was observed in small populations at Overlook Park with one small cluster of southern naiad and several small clusters of hydrilla. This is the first time that southern naiad has been documented in Lake Jesup in several years. Coontail, the dominant SAV, was again observed on the NW side of the lake, but in larger populations, sometimes as much as 0.1 acre. Two to three acres were observed, all adjacent to the phragmite shore. No hydrilla was observed at the south Sanford Avenue boat ramp, where hydrilla was previously reported. Eelgrass was observed only in the FWC enclosures. Five acres of water hyacinth and only 0.2 acres of water lettuce were present. Most of the hyacinth was in the NE, up against the phragmite. All were new plants coming off of surviving frost impacted plants. Re-vegetated aquatic plants within Site 1, both in the water and adjacent to the bank, are doing well. Most species that are in the water, mainly pickerelweed and bulrush, are 2 to 3 times their planted size. The trees, rush and cord grass are healthy and still not impacted by invasive species, like phragmite and para grass. Another month without significant freezes and they should have substantial growth. Overlook Park emergent plants, especially pickerelweed and duck potato have been reduced to a few populations. The cordgrass and

wetland trees are doing well. The only torpedo grass seen in the lake continues to be present at the South Sanford Avenue boat ramp. Fire flag has continued to expand, especially in Site 1 west of the Hwy 417 Bridge.

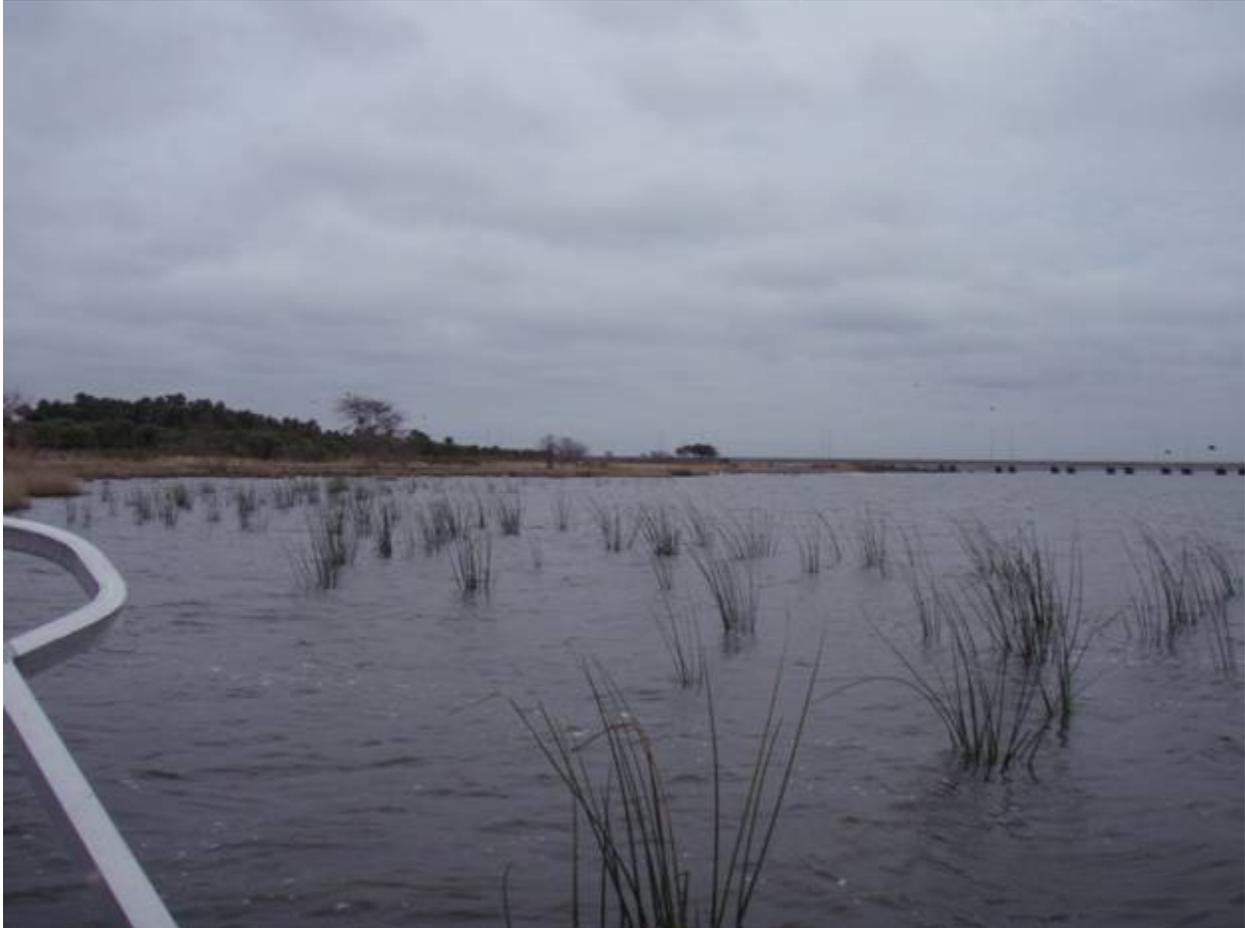
On **2 February 2011** Seminole County Lake Management Program (SCLMP) personnel Marie Lackey, Dean G Barber and Thomas Calhoun reviewed the status of the aquatic plant planting at **Lake Jesup** Site 1 (north shore either side of the Highway 417 Bridge) and Overlook Park. On Site 1, both the wetland trees and cordgrass (*Spartina bakeri*), all above water level, were impacted by winter weather, however showing some regrowth, especially the cordgrass. More time will tell. With the recent mowing done just upland of these planting and the herbicide treatment within these plants, these trees/plants are presently free to expand with minimal impact from other species. In the water ward area of Site 1 the plants, mainly pickerelweed (*Pontederia cordata*) and bulrush (*Scirpus californicus*), are present at over 90% of the original planting. In fact, most clusters are 2-3 times the original planting size. Other desirable native species that were previously on site, especially knotgrass (*Paspalidium geminatum*) and fire flag (*Thalia geniculata*) are also expanding. Phragmites (*Phragmites australis*) is still showing little regrowth. No hydrilla (*Hydrilla verticillata*) was observed. Eelgrass was observed only in the FWC enclosures.

At Overlook Park the wetland trees are stable, similar to Site 1. Within the next few months it will be more apparent as to their status. The cordgrass (*Spartina bakeri*) is well established,

thick and dominate both under the boardwalk and the previously open beach area. The original planted clusters have expanded into the adjacent clusters, appearing as a large cordgrass stand. Less than 20% of the in water or water's edge species, mainly pickerelweed (*Pontederia cordata*) and duck potato (*Sagittaria lancifolia*) are evident. Hopefully, with the spring these sites should be more apparent. Although hydrilla was present at several sites within Overlook Park on the previous survey, none was observed during this inspection.

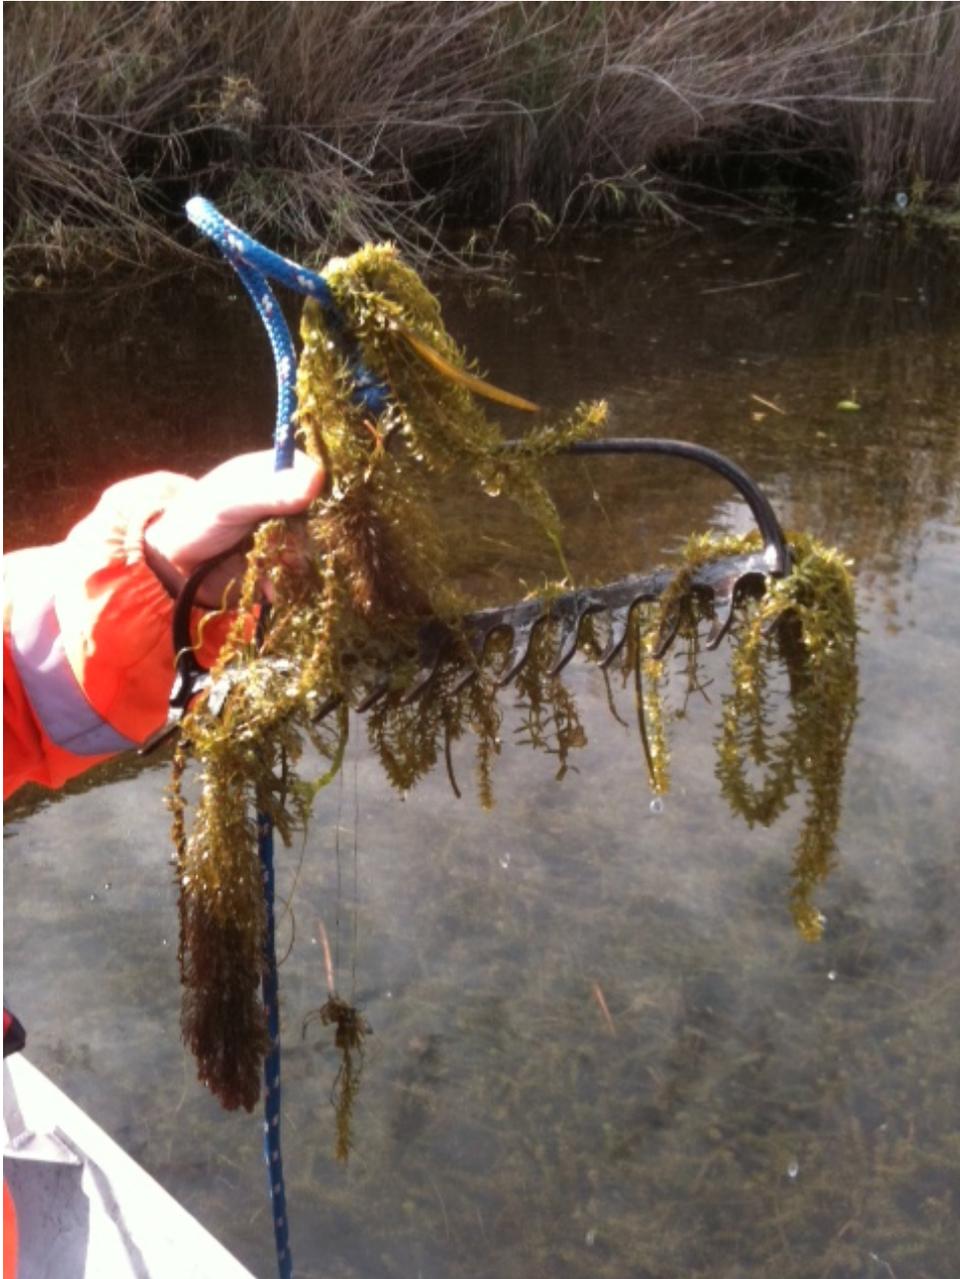
Hydrilla found on South West shore:

Eelgrass is the dominant SAV throughout the lake but Hydrilla has expanded to almost the same abundance. Along the SW shoreline, eelgrass and hydrilla has increased and was observed in dense populations reaching the surface from 2 feet. Hydrilla and eelgrass were present along the southern seawall extending out +1,000 ft. Along the southeast shore to the northeast (almost to the northern boat ramp) southern naiad and hydrilla was observed with hydrilla topping out in places around Stone Island. This east-northeast area was void of vegetation during the last survey. Along the north shore, from the boat ramp west, eelgrass is dominant followed by southern naiad and hydrilla; all to 2 feet. . The greatest population of SAV is along the western side, with thick populations extending out to the bulrush, with hydrilla being dominant, followed by coontail, then eelgrass. Filamentous algae is abundant inshore along most of the shoreline.

Water hyacinth and water lettuce were recently treated, with less than 5 acres of untreated hyacinth in the lake.

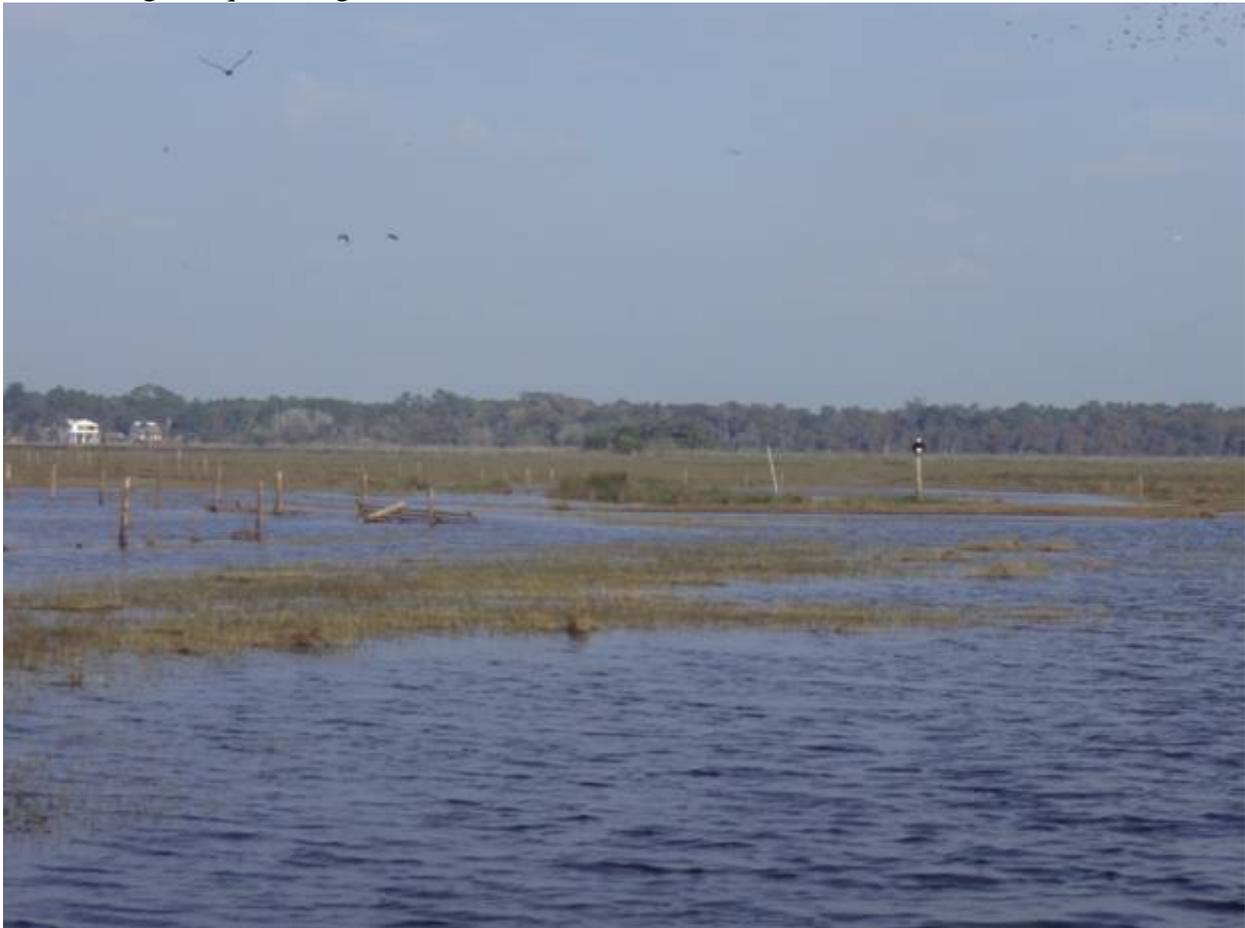
On **30 November 2010**, Seminole County Lake Management Program (SCLMP) personnel Marie Lackey, Dean G Barber and Thomas Calhoun surveyed the aquatic plants in **Lake Harney**. The only submersed aquatic vegetation (SAV) observed consisted of: filamentous algae to a depth of 1.5 feet, stonewort (*Nitella sp.*) to 1 foot, and eelgrass (*Vallisneria americana*) to 2 feet. There was very little stonewort observed. Eelgrass was the dominant SAV, mostly observed on the western shore, with dense monocultures out to a depth of 2 feet. Eelgrass was reaching the surface from depths up to 1.5 feet. There was no eelgrass observed along the northern and southern shore. The eastern shore had eelgrass out to 1.5 feet, but these populations were sparse and the plants were reduced in size. Overall the SAV populations were very similar to observations from previous survey (1 September 2010) where SAV populations were significantly reduced. Emergent aquatic plants populations also continue to be decreasing with three square (*Scirpus americanus/pungens*) being the dominant emergent plant followed by knot grass (*Paspalidium geminatum*) and cord grass (*Spartina bakeri*). With low water elevations, cord grass was doing well on the water's edge. There was approximately a tenth of an acre of water hyacinth and several tenth acres of water lettuce. No exotic island apple snails were observed, where previously the egg clusters were seen from the NW to the NE on the stems of the emergent aquatic vegetation.

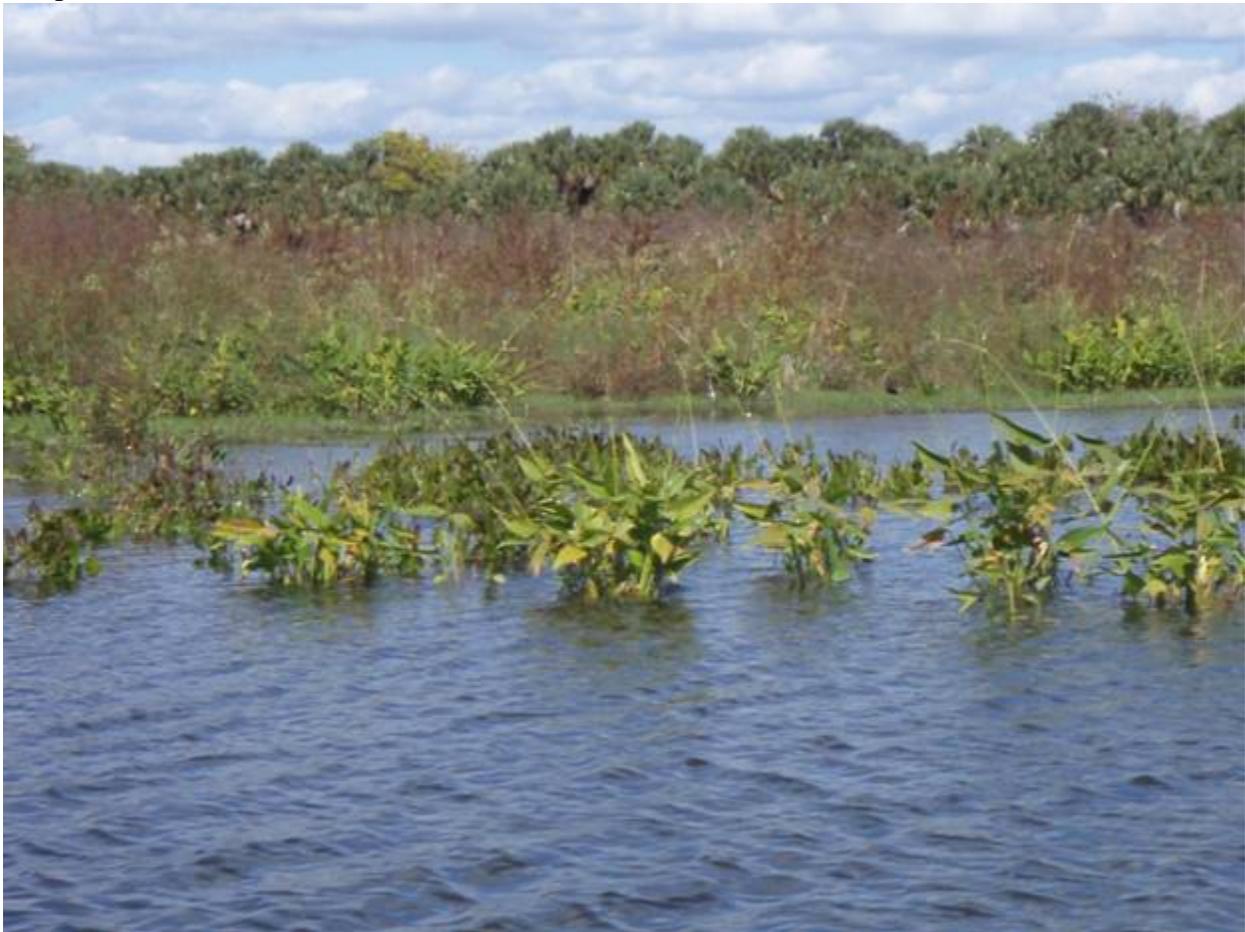
On **30 November 2010** SCLMP personnel Marie Lackey, Dean G Barber and Thomas Calhoun surveyed the aquatic plants in **Lake Jesup**. The only SAV observed was hydrilla, of which there was 0.1 acres of the invasive at both the Black Hammock canal and Overlook Park. The Overlook Park population had expanded from the previous survey. Healthy stands at each site were in shallow water less than a foot deep. Only two strands of hydrilla was seen in the area either side of the northern section of the Highway 417 Bridge, where FWC contractor had treated hydrilla recently. None was observed at the south Sanford Avenue boat ramp, where hydrilla was previously present. Coontail, which had been the previous dominant SAV, was not observed during this survey, where it had previously been present from the eastern side of the Highway 417 Bridge to the northern end of the lake at Highway 46. Eelgrass was observed only in the FWC enclosures. Ten acres of water hyacinth and over 20 acres of water lettuce were present, 15 of water lettuce were in and adjacent to Soldiers Creek. Although water hyacinth were in the planted area, mostly east of the northern section of the bridge, all of the plants were stranded on the shore, blown in by wind and wave action. The only torpedo grass seen continues to be present at the South Sanford Avenue boat ramp. Fire flag (*Thalia geniculata*) has increase significantly and established in new location within the lake, competing with phragmites for space.
