**Jesup 11/16/2013**

On **November 16<sup>th</sup>, 2013**, Seminole County Lake Management Program (SCLMP) personnel (Gloria Eby and Thomas Calhoun) surveyed the aquatic plants in **Lake Jesup**.

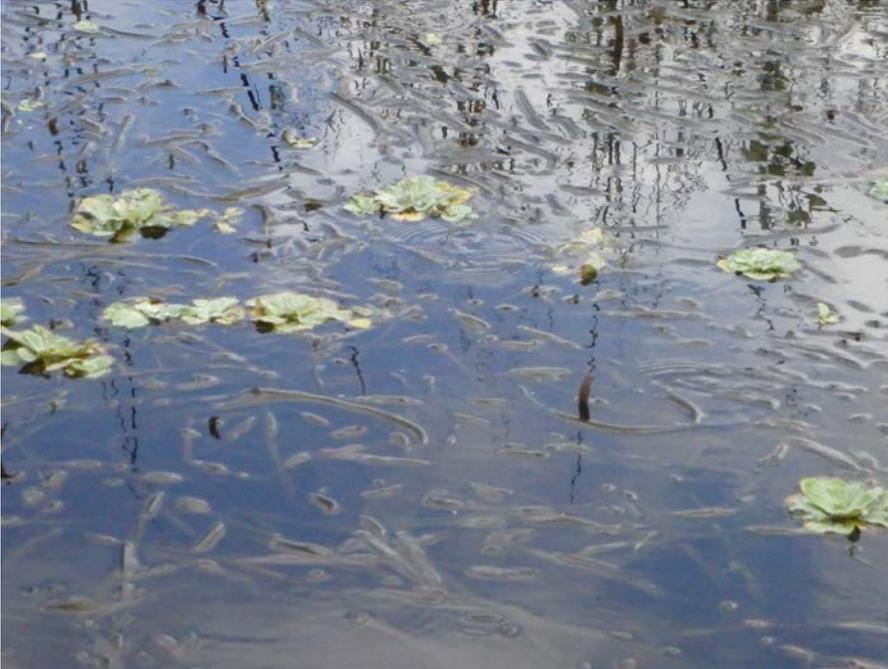
Submersed aquatic vegetation (SAV) found during the inspection included coontail, hydrilla, and eelgrass. Coontail and eelgrass was present at the Lake Jesup Park boat ramp. Hydrilla was found in the Overlook Park area.

**Photo: Eelgrass at Lake Jesup Park boat ramp.**

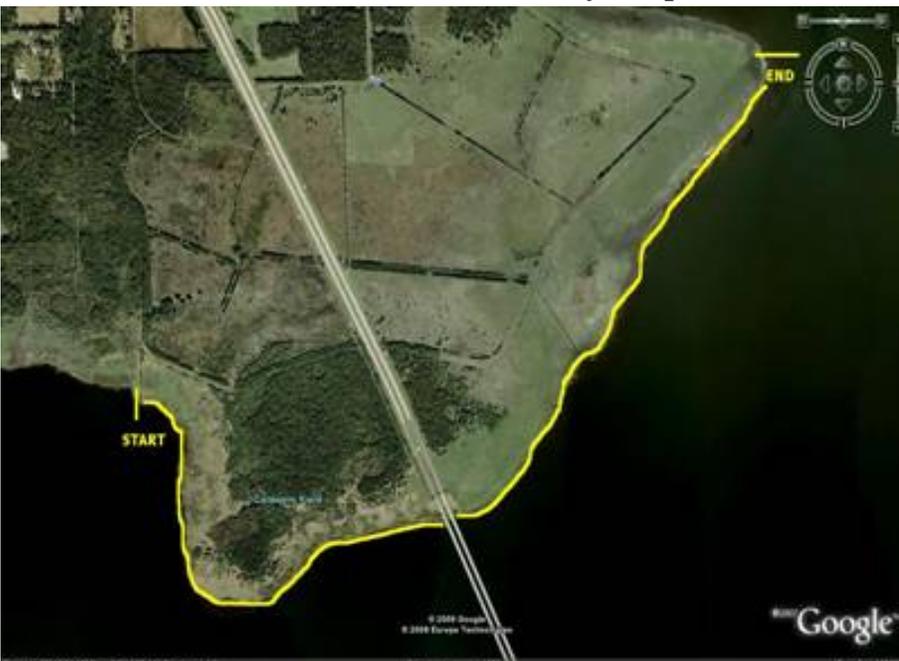
FWC-AHRES and Seminole County Cooperative Restoration Project that spans over 14,500 linear feet of shoreline continues to expand very well. Bulrush, pickerelweed, and thalia are growing exceptionally well in this area. American lotus was newly observed in the restoration area east of the boat ramp.

**Photos: FWC-AHRES and Seminole County Cooperative Restoration Project Area.**

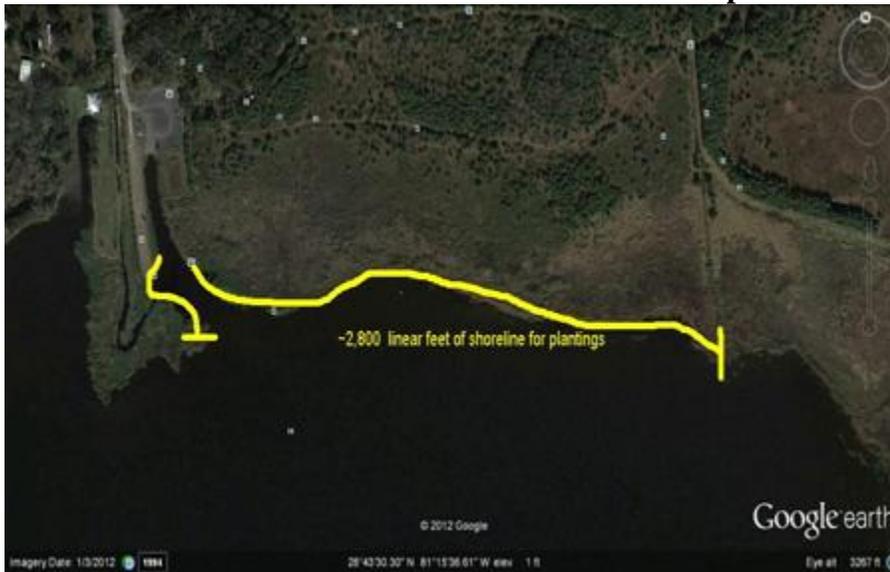
SCLMP was recently awarded funding for shoreline activities through the Florida Lake Management Society's "Love Your Lake" Program. This supplemental funding allowed SCLMP to conduct a restoration along the boat ramp of Lake Jesup Park. The restoration at Lake Jesup Park is expanding very nicely providing an aesthetically pleasing view to the lake patrons of Seminole County.

**Photo: Recent restoration conducted from Lake Jesup Park east to original project line.**

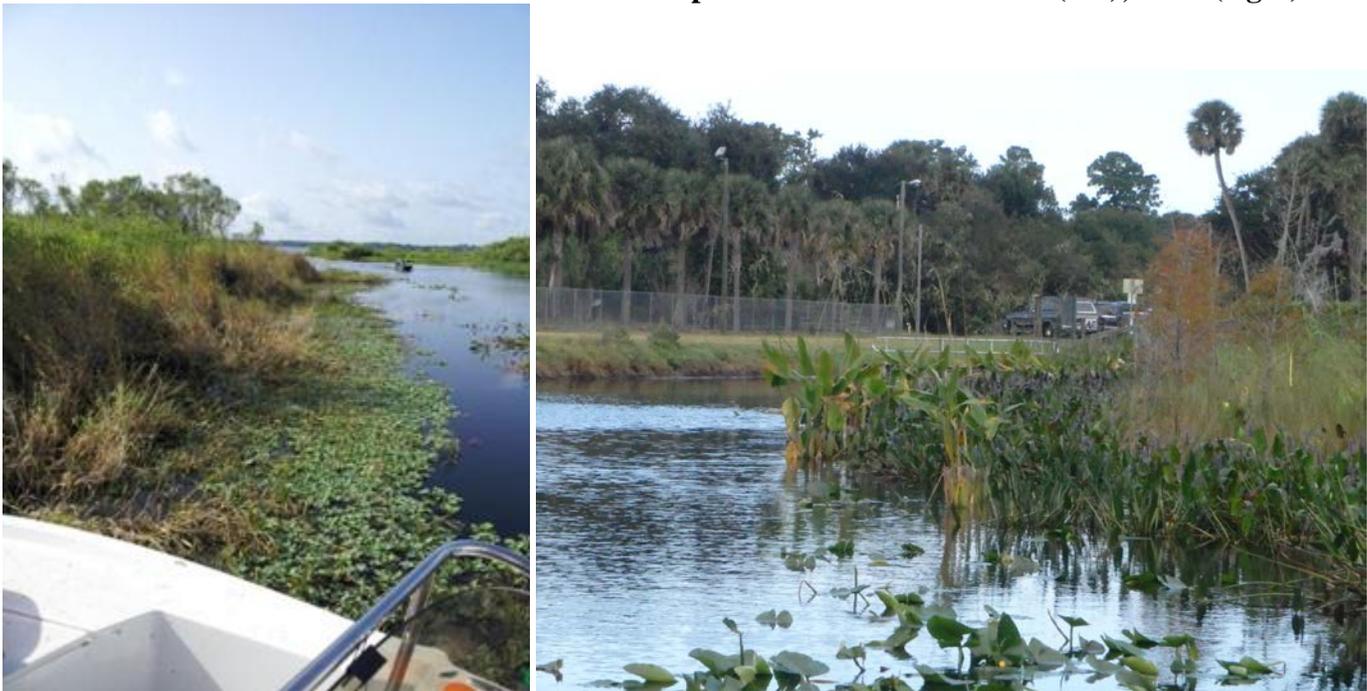
**Photo: Recent restoration conducted on Lake Jesup Park: before restoration (left); after (right).**

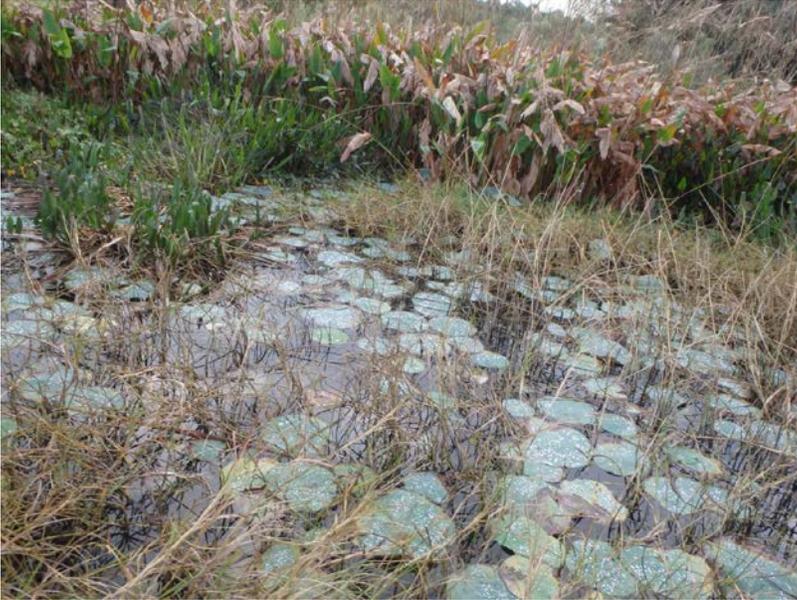
**Photo: American lotus established east of Lake Jesup Park.**

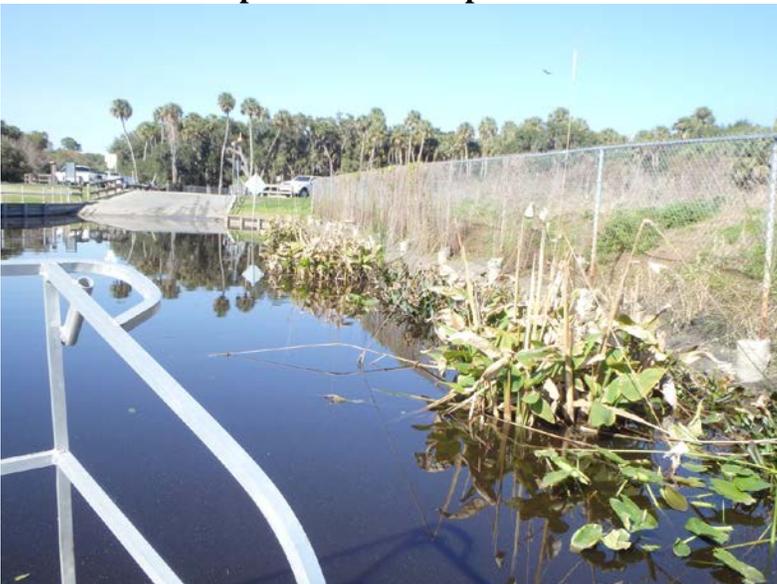
Invasive emergent vegetation found included: alligatorweed, para grass, wild taro, water hyacinth, and water lettuce. Water lettuce and water hyacinth was found along the perimeter of the lake but with less biomass than the previous inspection. The entrance to Soldiers Creek has been treated and is now open and navigable. The phragmites previously established in the area of Soldiers Creek was also treated. This was prompted by concerns communicated by SCLMP to FWC about this native invasive plant creating a tussock within the area.

**Photo: Lake Jesup Park boat ramp.**

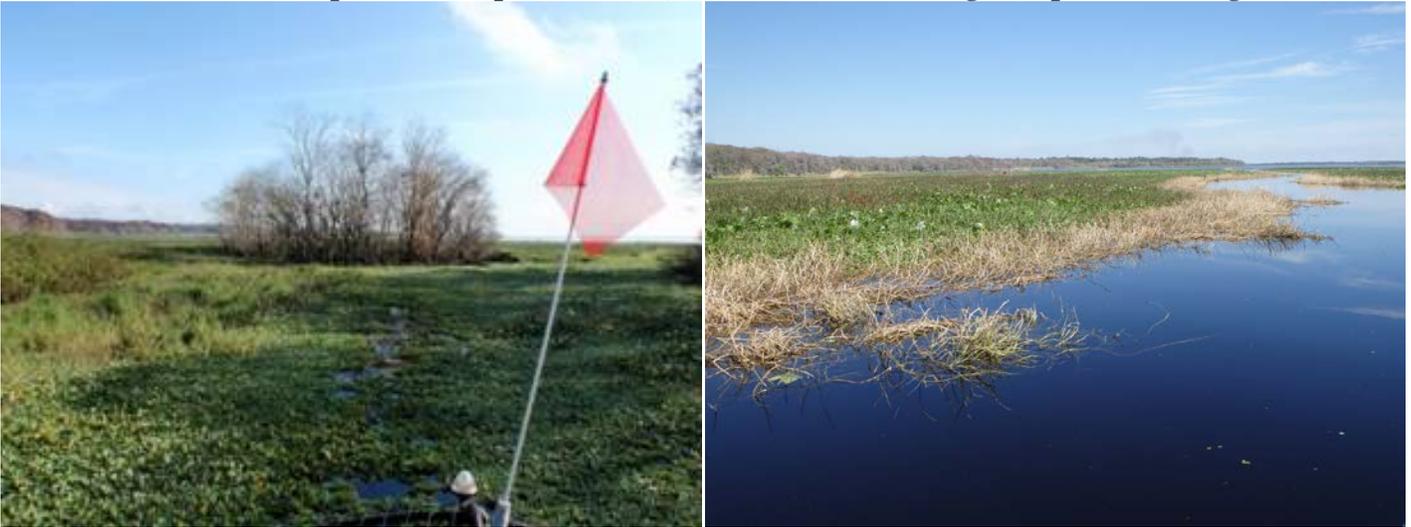
**Photo: Soldiers Creek: previous inspection (left); current condition (right), open and navigable.**

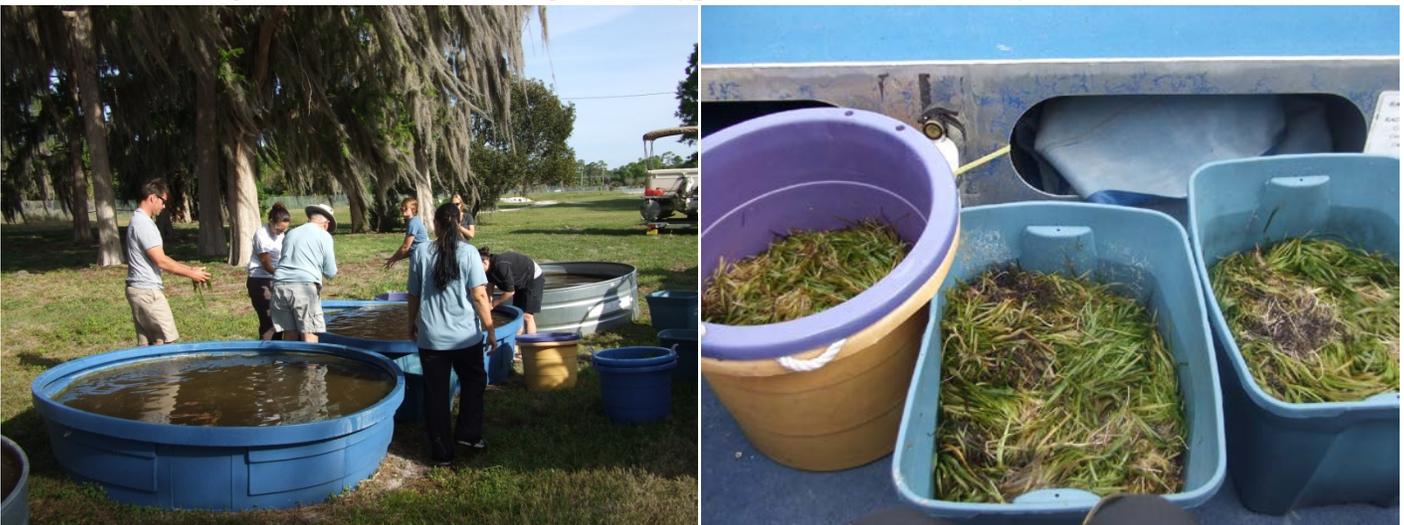
**Photo: Harvesting Suwannee narrow eelgrass biotype from SCLMP nursery tubs.**

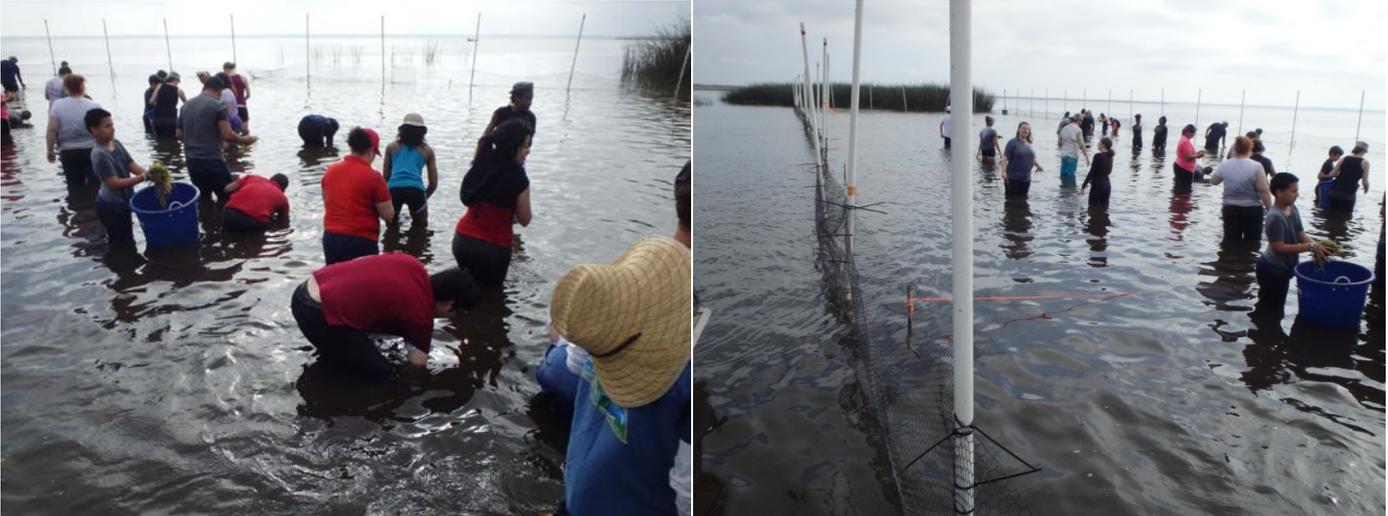
The Lake Jesup Restoration Event held on **April 5<sup>th</sup>, 2014** was a huge success in which 92+ volunteers helped us plant approximately 20,000 eelgrass plants in a 1-acre plot enclosure and rebuild another 1-acre enclosure located on the north shore of Lake Jesup. Assistance and transportation of the SERV volunteers via large multi-passenger airboats to the planting location was provided once again by Black Hammock Adventures. These restoration events could not be accomplished without their ongoing help and dedication.

**Photo: Volunteers planting eelgrass.**

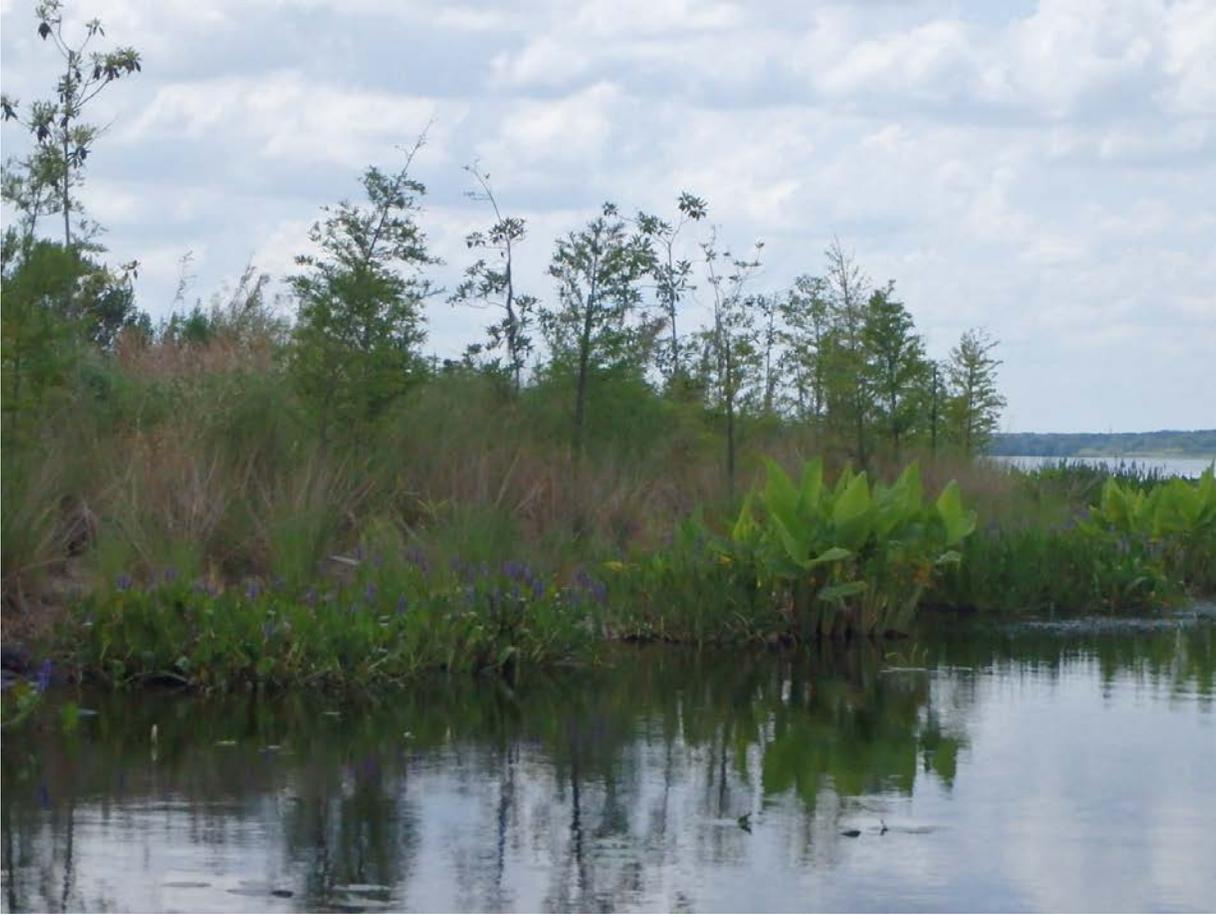
The SAV found during the inspection included hydrilla and eelgrass. Hydrilla was present at Overlook Park located on the south shore. Eelgrass was present at the Lake Jesup Park boat ramp and in the north shore restoration area. American lotus was observed in full bloom east of Lake Jesup Park ramp.

**Photo: Lake Jesup Park boat ramp restoration area.**

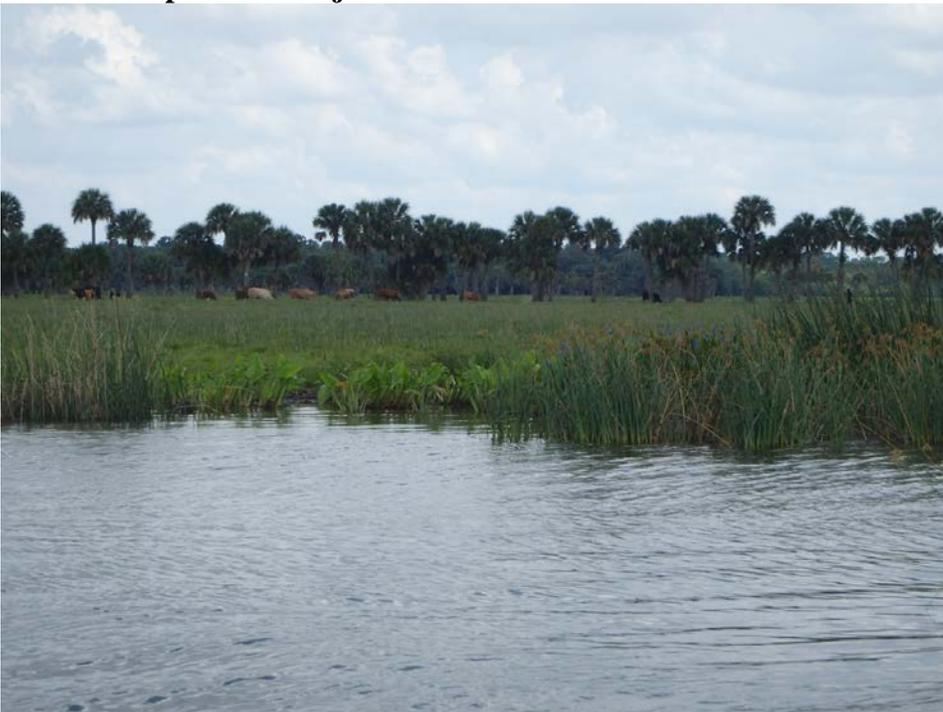
FWC-AHRES and Seminole County Cooperative Restoration Project continues to be very successful. Bulrush, pickerelweed and *Thalia* are expanding remarkably well in this area. Approximately 80% of the eelgrass planted during the April 7<sup>th</sup> restoration event was surviving and beginning to establish.

**Photo: Cooperative Project restoration area.**

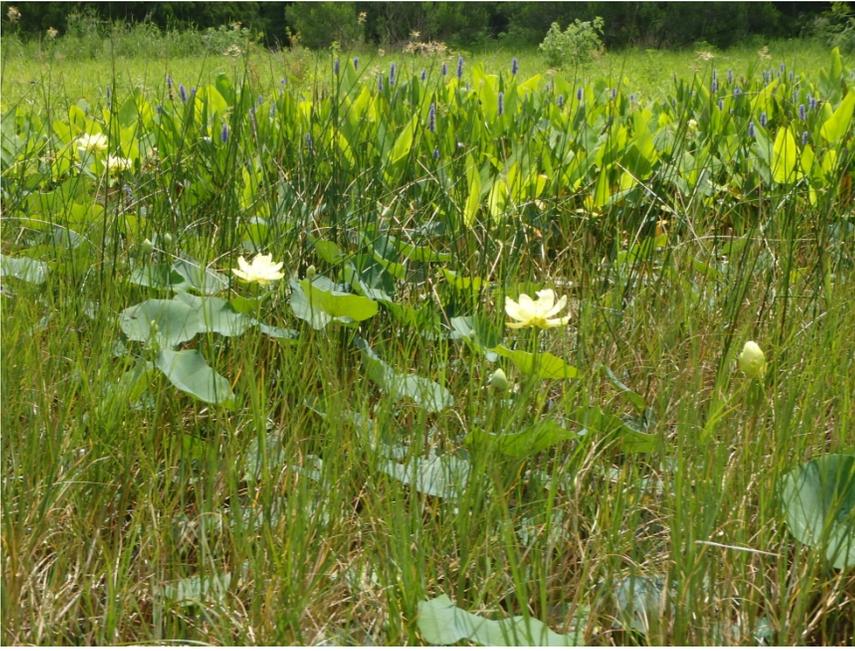
**Photo: American lotus blooming.**

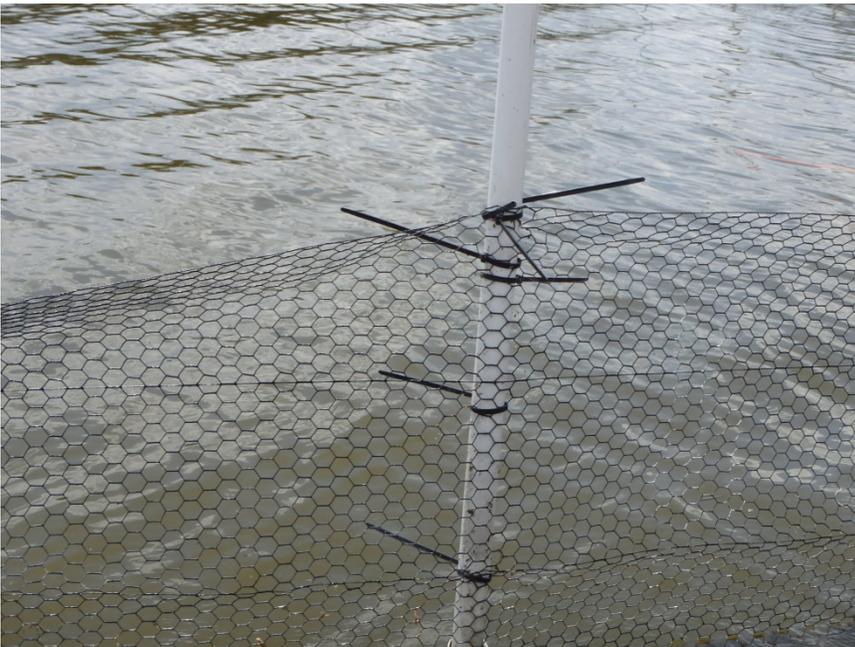
The exclusion cages containing eelgrass and fencing was inspected to see if repairs were needed. All fencing panels were found in good condition and the recently installed fence reinforcement design was performing well.

**Photo: Reinforcements holding fencing material in place.**

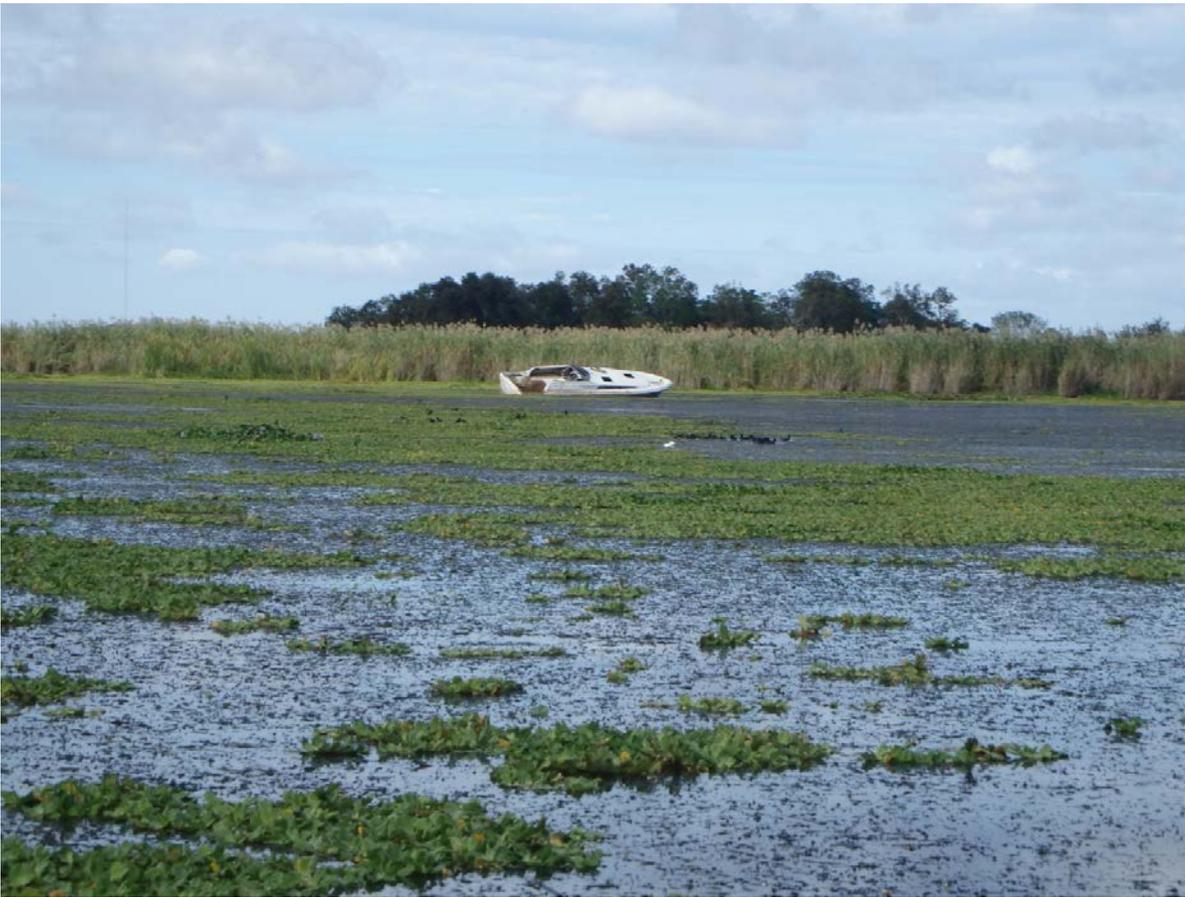
Hydrilla was observed to be more abundant than in the previous inspection and was found to a depth of 3.5 feet. Approximately 35 acres were found topped out mostly in the eastern region of the lake; however, hydrilla was found in all areas of the lake.

**Photo: Topped out hydrilla along the east side of the lake.**

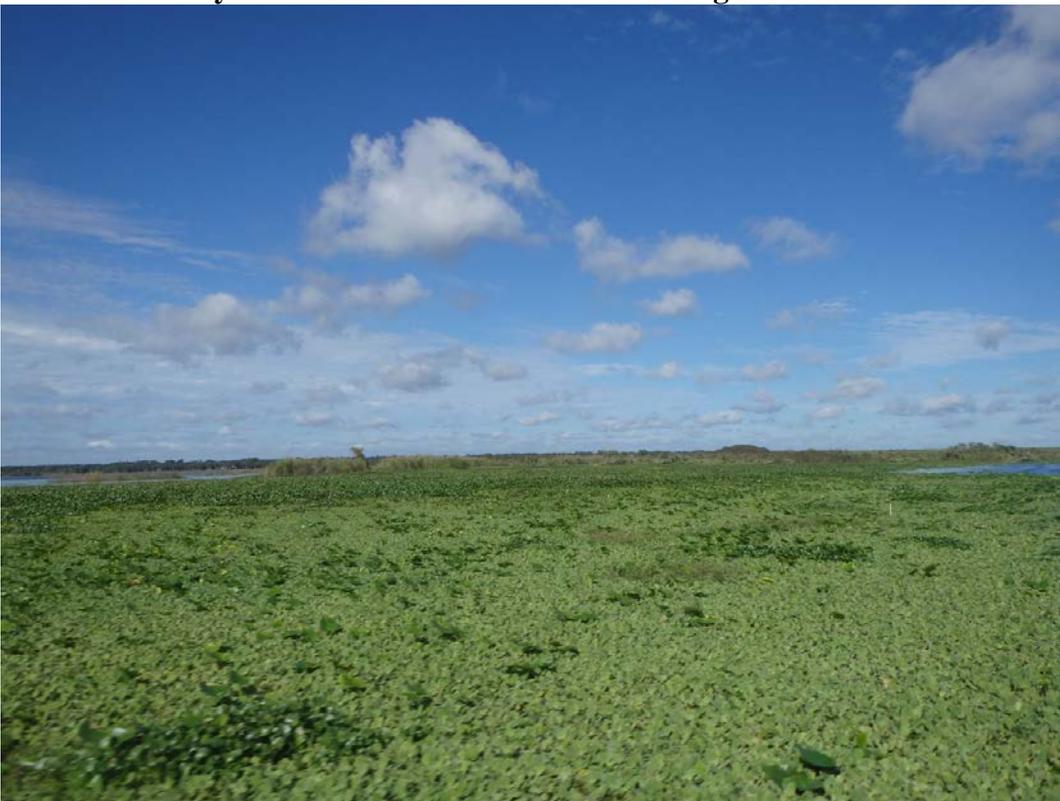
Invasive floating vegetation (water hyacinth and water lettuce) was found expanding along the eastern shoreline.

**Photo: Water hyacinth and water lettuce found along the eastern shoreline.**

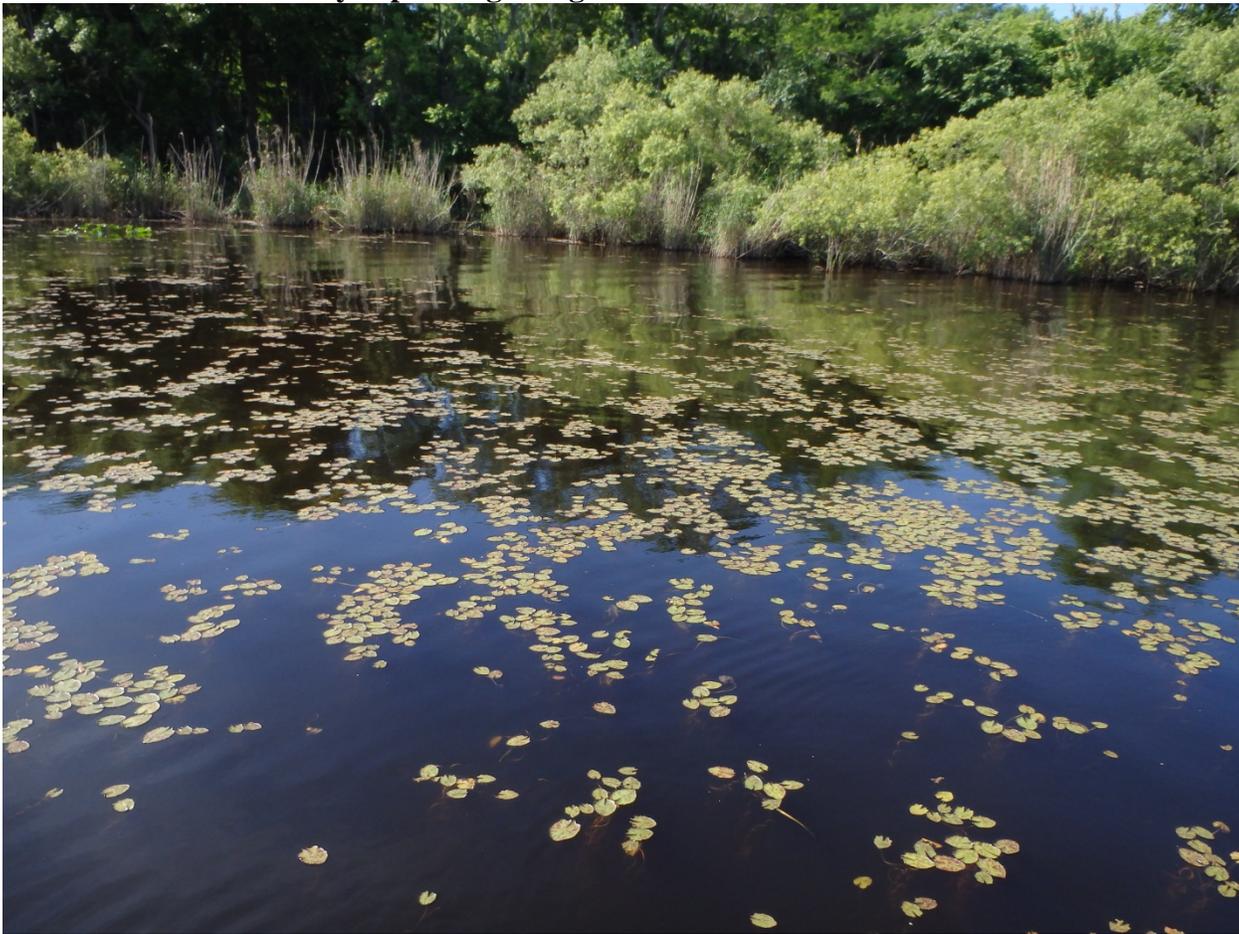
Native vegetation species that were noted to be expanding included: banana lily, bulrush, and knot grass.

**Photo: Native banana lily expanding along southern shore.**

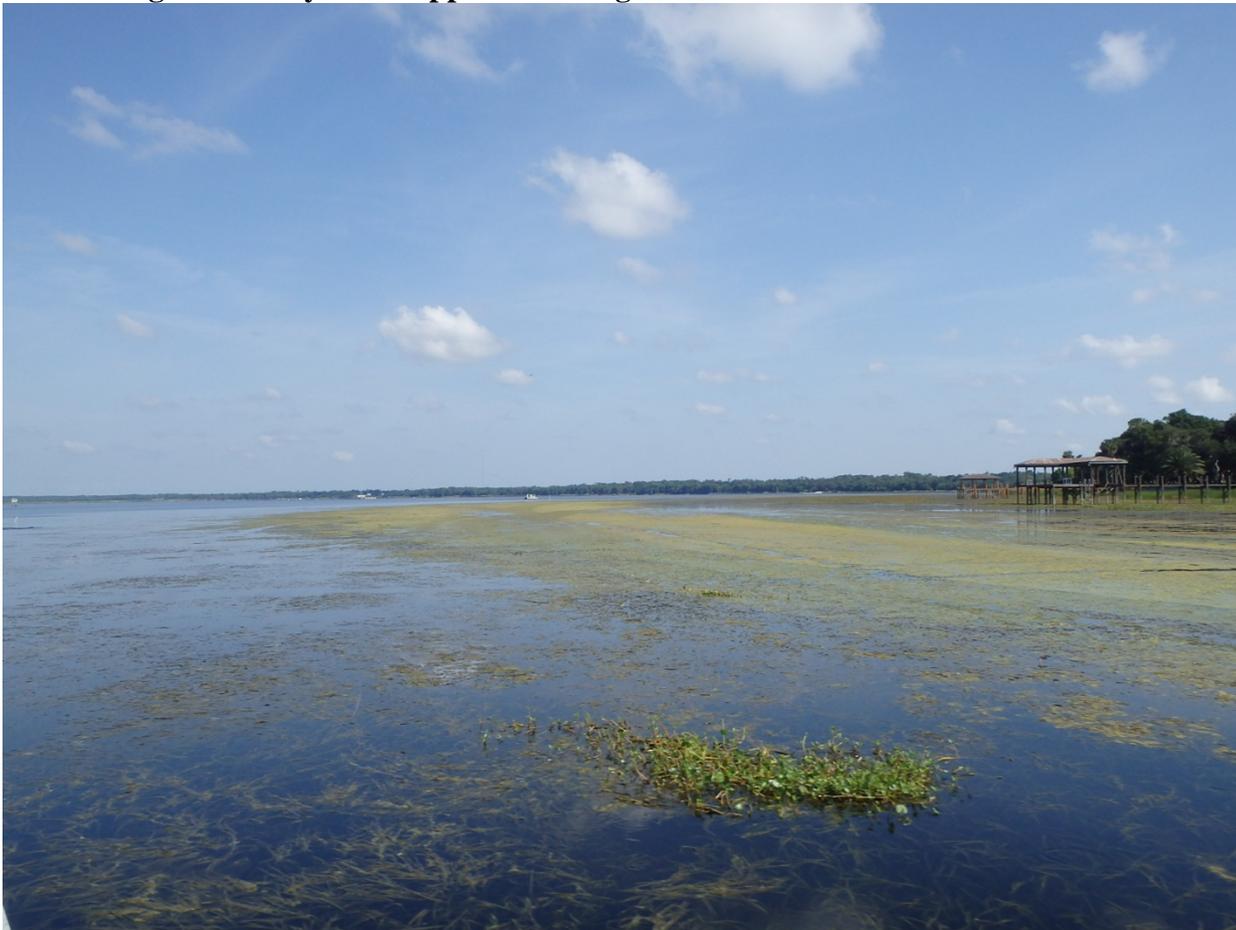
Hydrilla was found to a depth of 3.5 feet. The acreage has increased since the previous inspection, especially along the **southern east (southeastern?)** corner of the lake. Approximately 100 acres of hydrilla were found during the inspection.

**Photo: Eelgrass and hydrilla topped out along the eastern shore.**

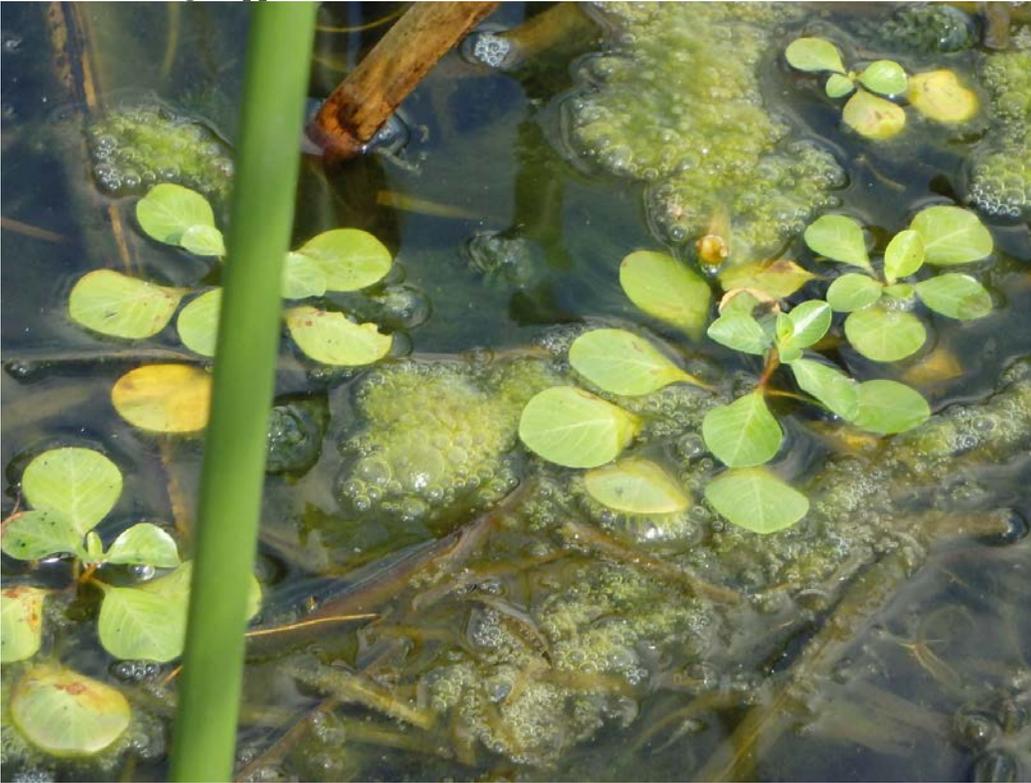
The two species of invasive floating vegetation, water hyacinth and water lettuce, were found expanding along the eastern shore. Additionally, a *Ludwigia spp.* was found along the northwest corner of the lake similar to that of Lake Harney's *Ludwigia peploides*; however, this specific species has not yet been verified in Lake Monroe.

**Photo: *Ludwigia* spp. found in northwest corner of lake.**

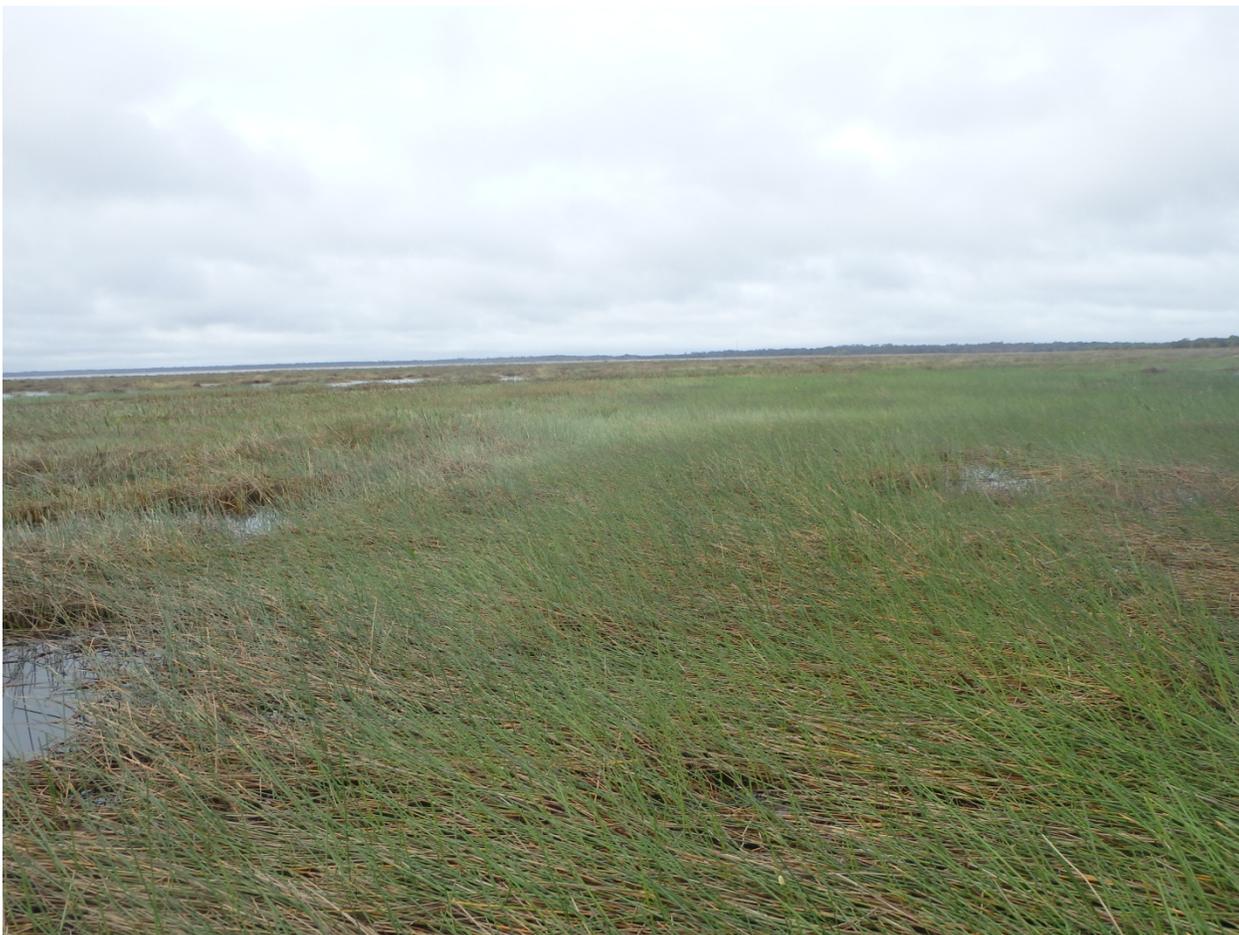
Emergent aquatic plants that were found included: bulrush, knot grass, pickerelweed, and spike rush. Spike rush and banana lily were found expanding along the northern shore of the lake.

**Photo: Spike rush expanding along the northern shore.**

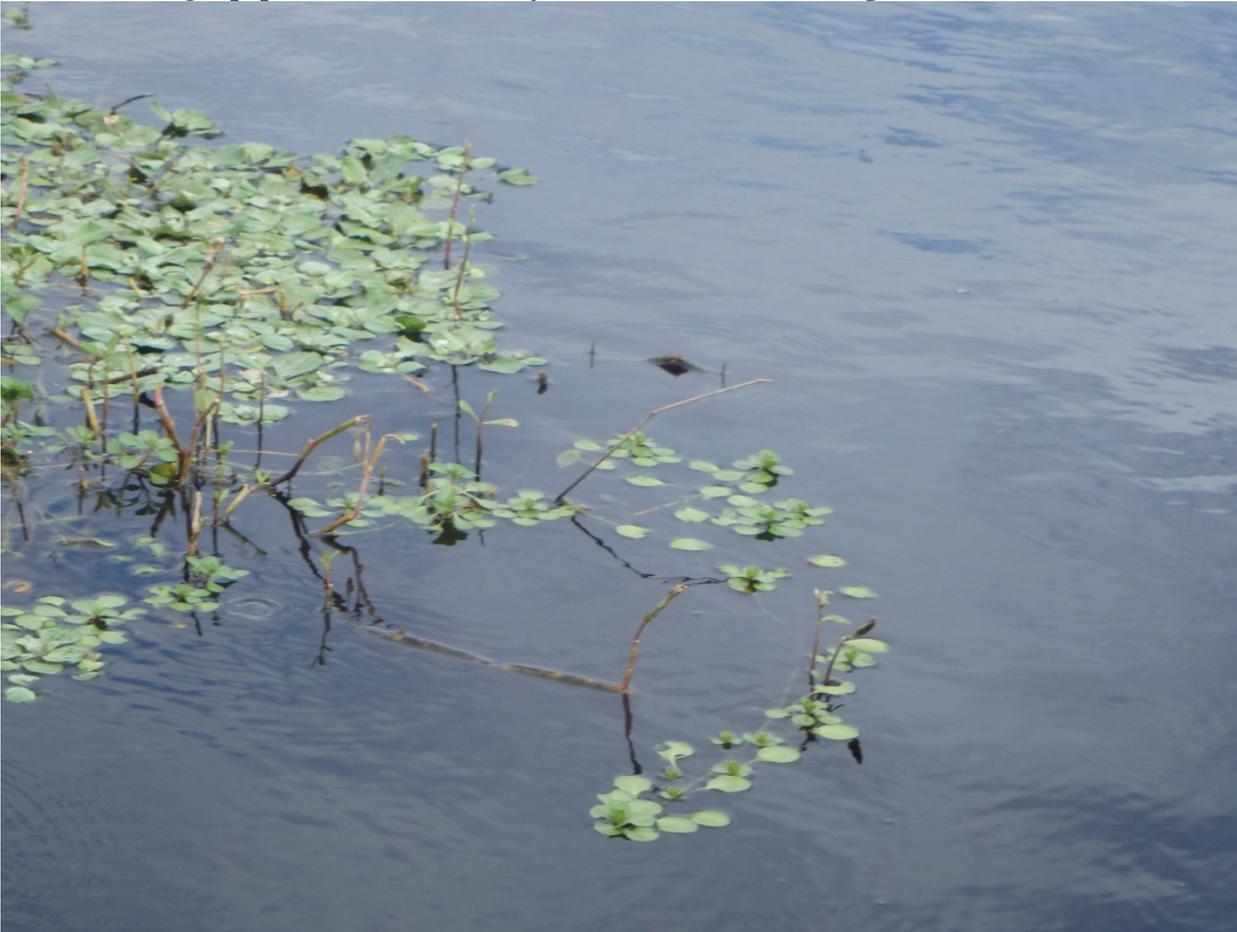
Invasive plants found include: torpedo grass, alligator weed, water hyacinth, and salvinia. Additionally, *Ludwigia peploides* was found along the southern shore of the lake, east of the river mouth.

**Photo: *Ludwigia peploides* (identified by John Tobe) found along the southern shoreline.**

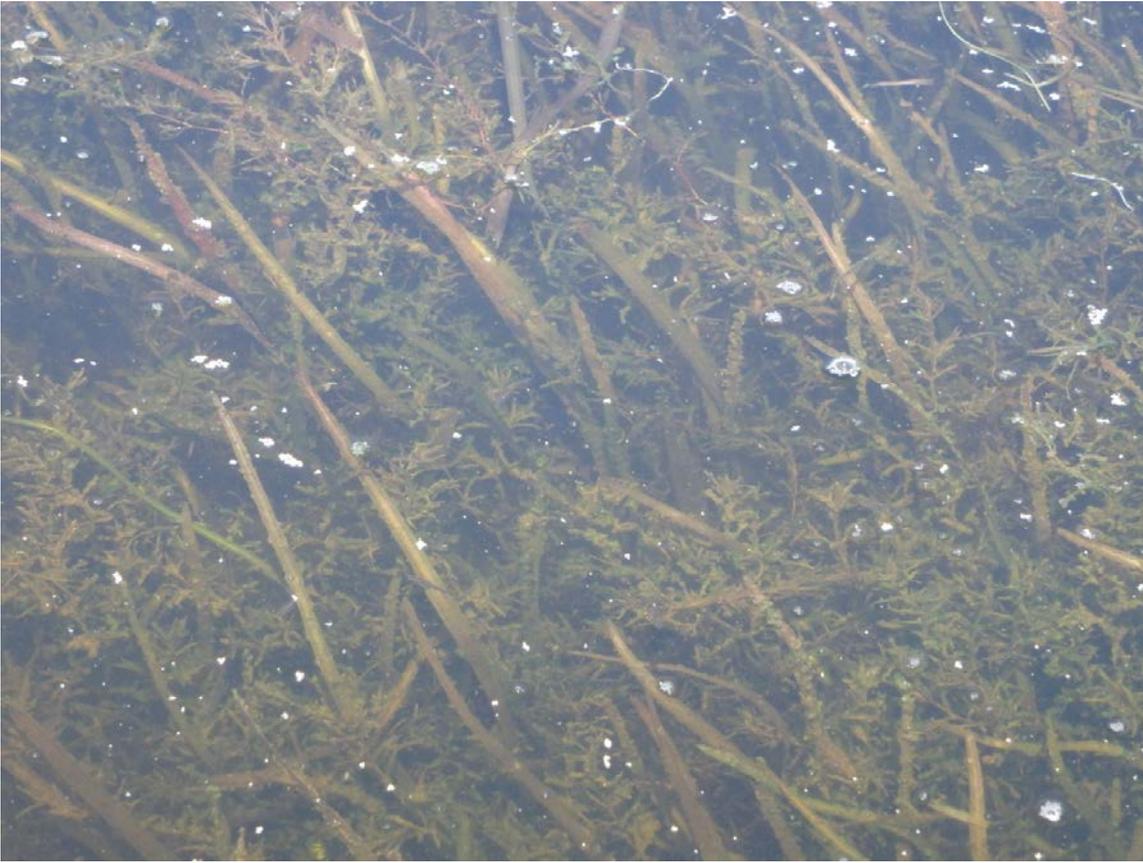
The native SAV observed included: eelgrass to 3 feet, coontail to 2 feet, southern naiad to 3 feet, bladderwort to 1 foot, road grass to 1 foot and hydrilla to 1 foot. Eelgrass was the dominant SAV found. Southern naiad was found expanding and intermixed within the eelgrass. Hydrilla was found sparse and in less amounts than the previous inspection. Approximately 20 acres of hydrilla was found.

**Photo: Southern naiad intermixed with eelgrass.**

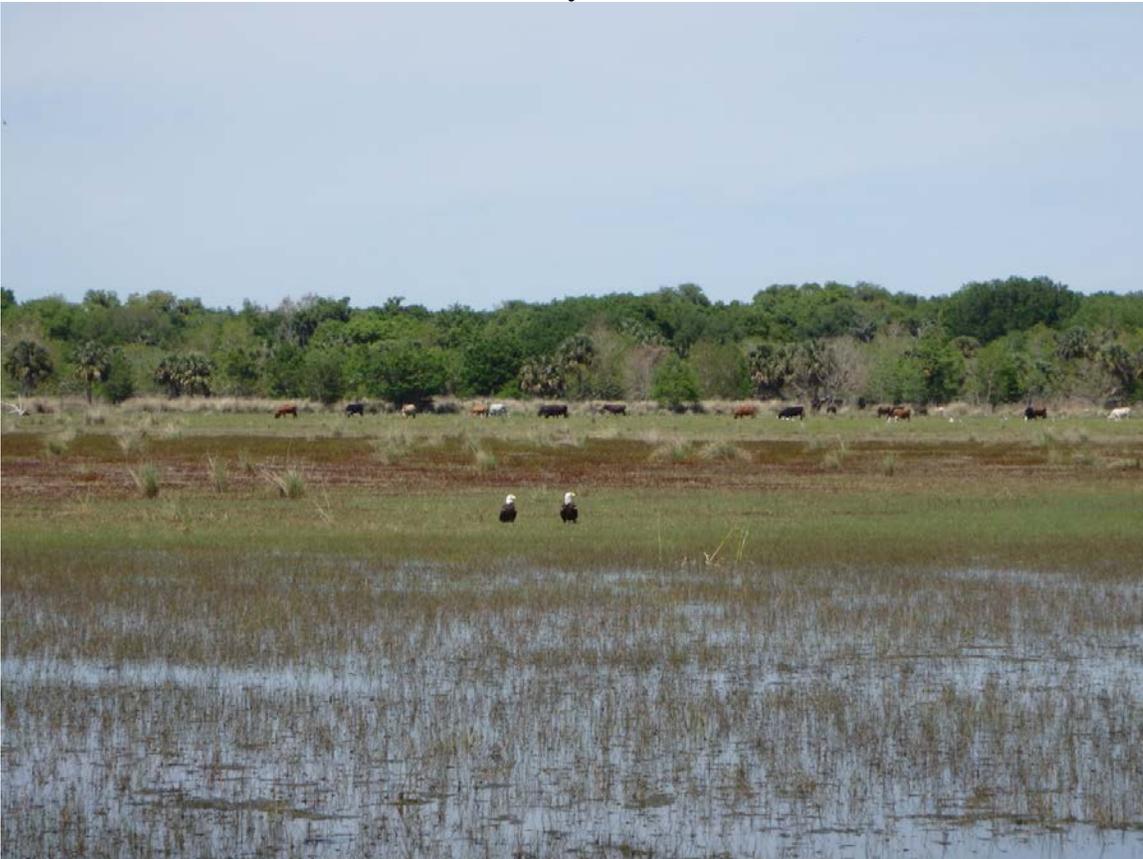
**Photo: Northern shoreline of Lake Harney.**

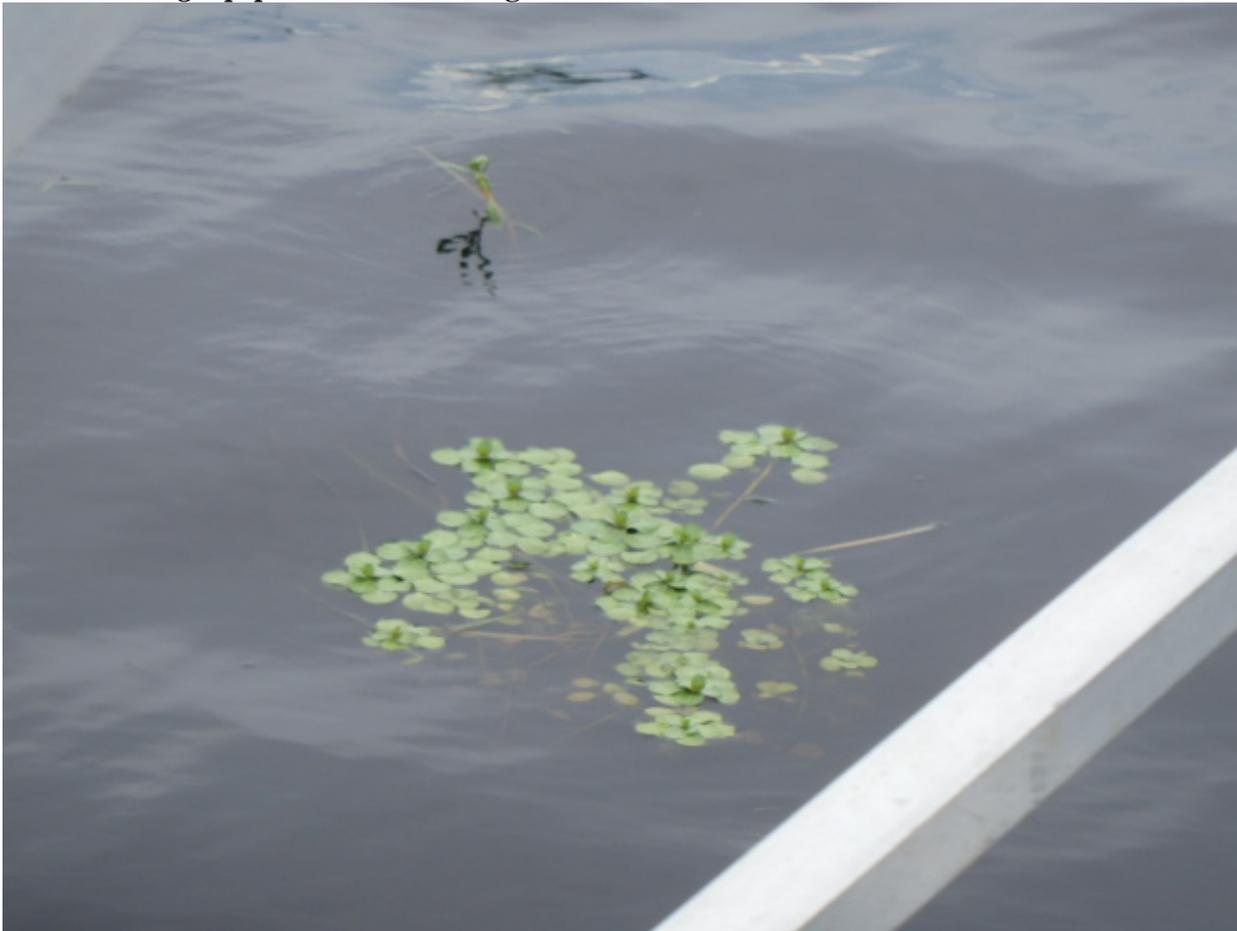
*Ludwigia peploides* was present along the southern shore of the lake and is also now present along the northern shore entering the St. John's River.

**Photo: *Ludwigia peploides* found along the northern shoreline.**
