Greetings Lake Tuskawilla residents!

Please find the latest bioassessment report for your lake below. Key highlights of this update include:

## 9-14-2014

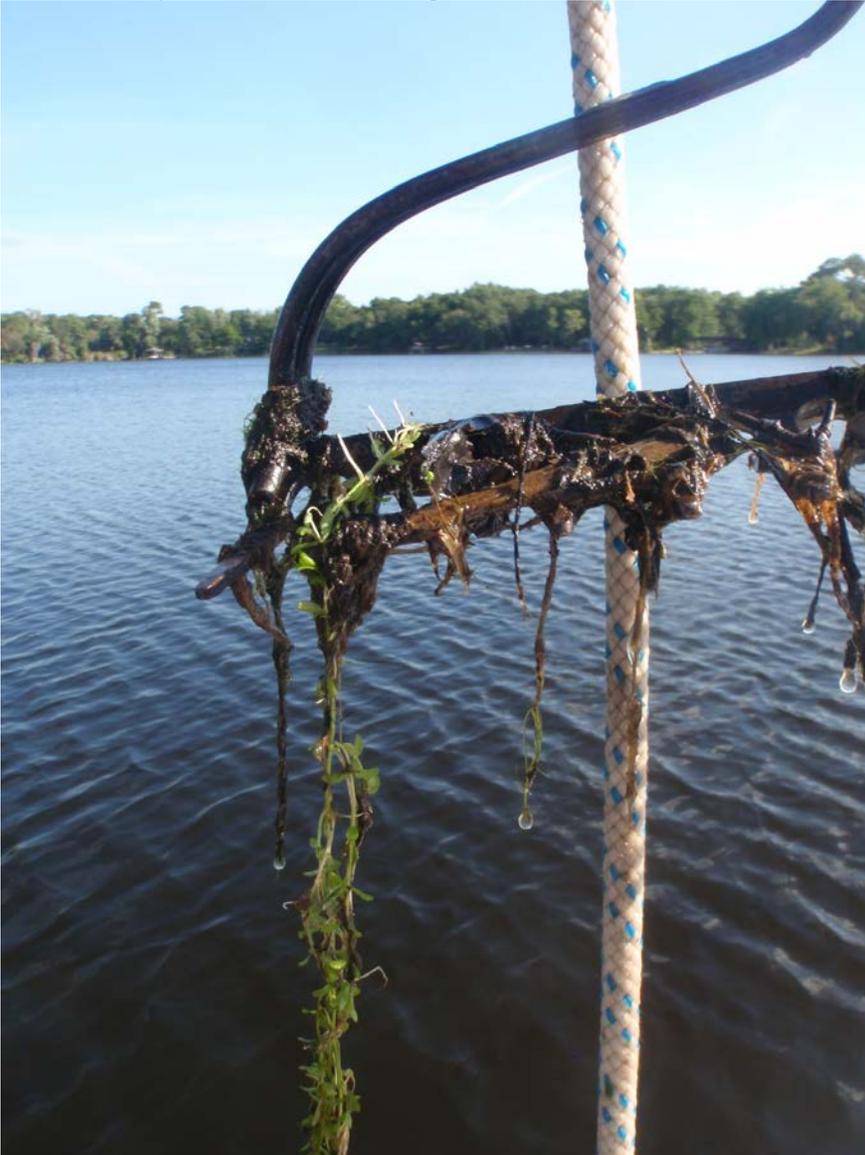
A total of 7 species of native submersed aquatic vegetation (SAV) were observed. These species included: baby tears to 3 feet, road grass to 3 feet, smooth water hyssop to 1 foot, southern naiad to 3 feet, stonewort to 3 feet, water thread pondweed to 7 feet, and eelgrass to 7 feet. The invasive exotic hydrilla was not observed during this survey.

**Photo: Baby's tears found along the bottom of Lake Tuskawilla.**

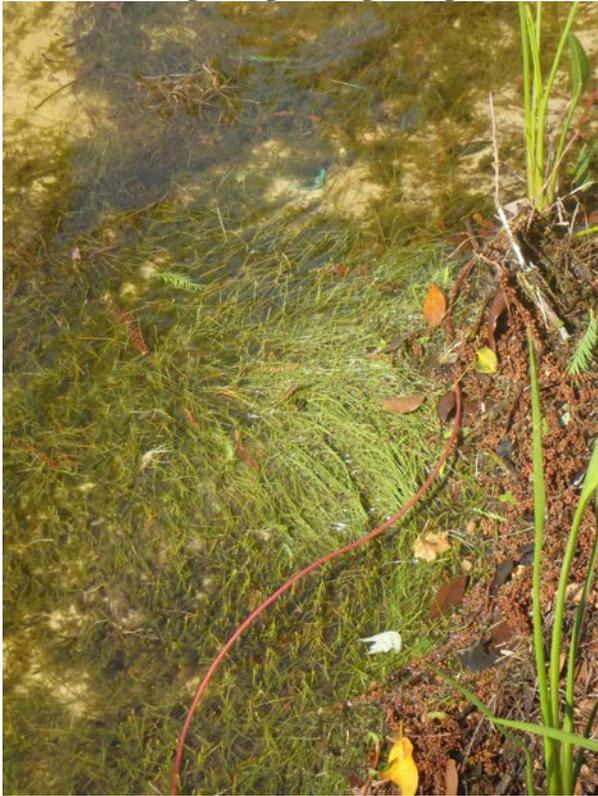
**Photo: Road grass growing along the shoreline.**

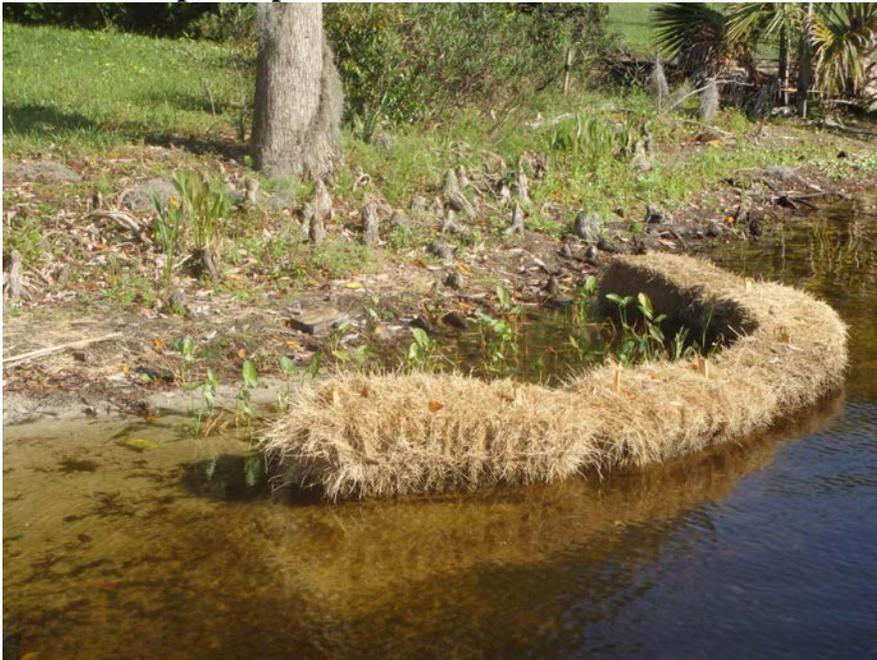
A wave action barrier was temporarily constructed using hay bales during this event to assist with reducing wave action while the plants root and stabilize. Wave action has contributed to the loss of plants in the past.

**Photo: Duck potato planted behind wave action barriers.**

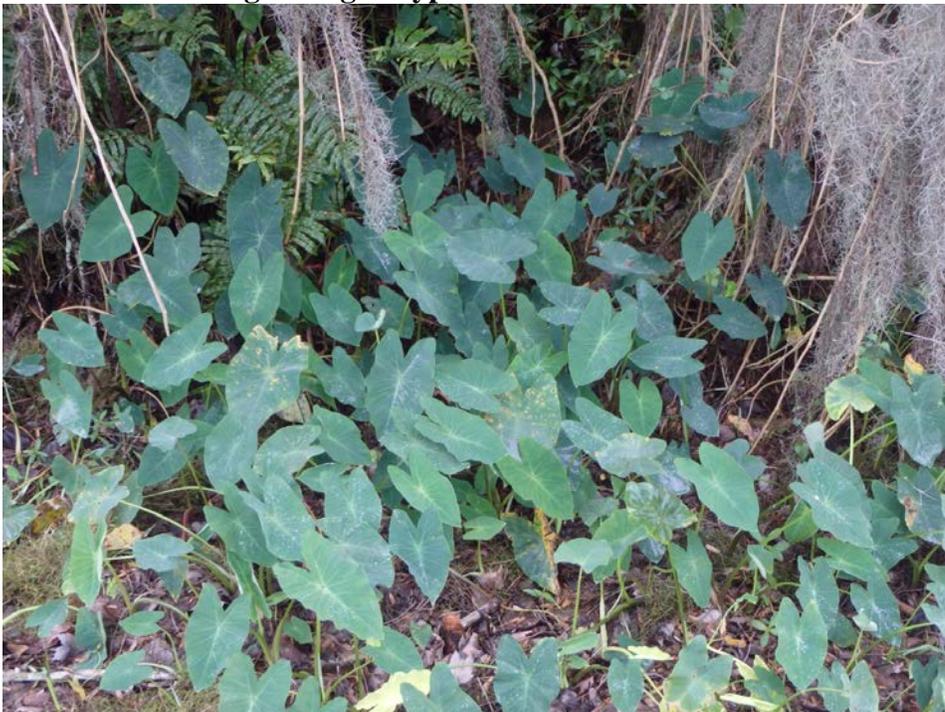
Invasive species of emergent vegetation included: alligatorweed, wild taro, and torpedo grass.

**Photo: Wild taro growing in cypress knees.**

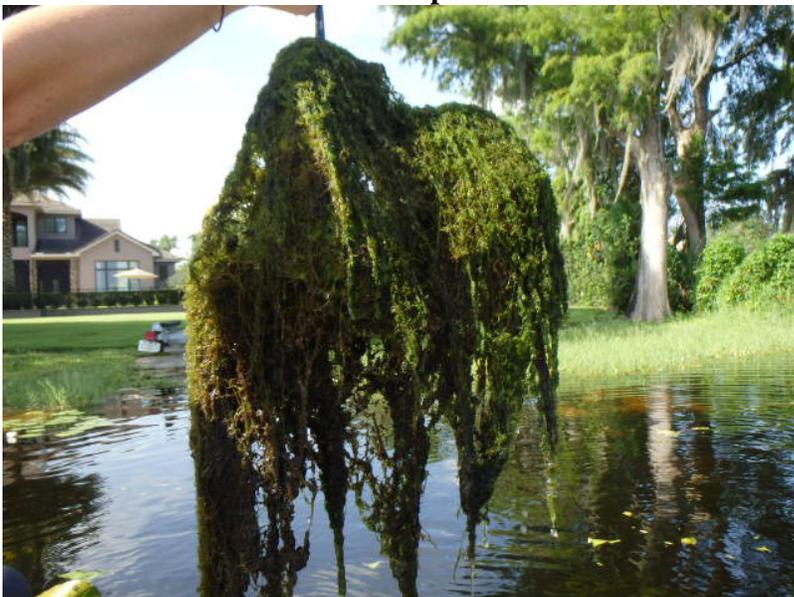
Lake Tuskawilla is 92 surface acres located in the Little Lake Howell watershed. Scores for Lake Tuskawilla have historically ranged from 38 to 61. LVI score for 2014 was 61 in the healthy range. The high score for this year is attributed to presence of the native SAV stonewort in all 4 of the sections surveyed! It was the dominant species in two of the 4 sections with yellow cow lily and cypress tree being dominant in the other two sections.

**Photo: Stonewort found to a depth of 7 feet.**

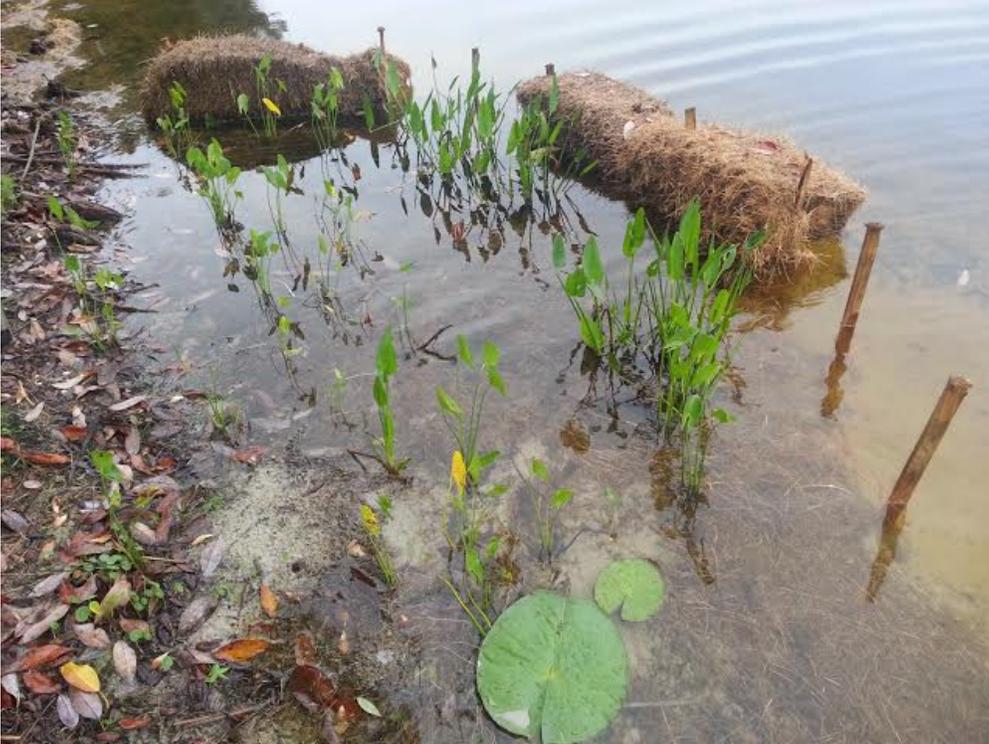
Several restoration event locations continue to expand nicely. The wave barrier provided some protection but months after installation, the grass carp fish began to eat the hay which caused it to dislodge. Other residents reported grass carp fish feeding on the new plantings which also lead to plant reduction as result.

**Photo: Barrier compromised.**

- 2 Continue to establish a beneficial native shoreline for your lake, especially in locations that are devoid of emergent aquatic plants. Given that some plants are stressed, or did not survive from the previous planting session, the planting of native species should continue until successful establishment is achieved.

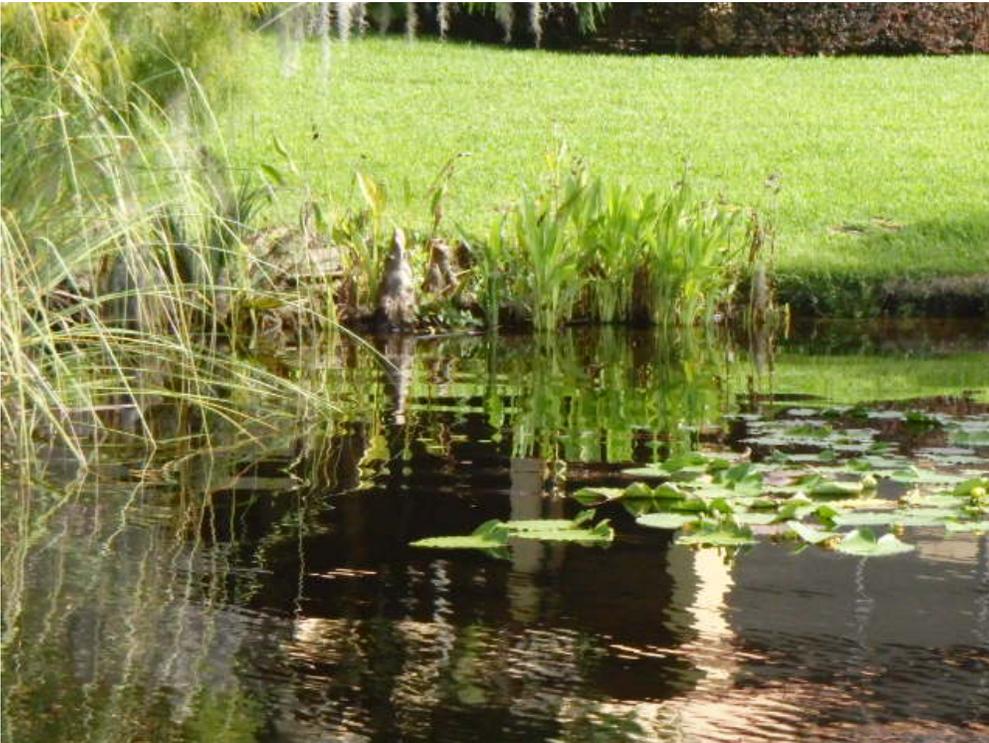
**Photo: Planted canna.**
