Greetings Mirror Lake!

On **28 June 2011**, Seminole County Lake Management Program (SCLMP) personnel Thomas Calhoun and Dean G Barber surveyed the aquatic plants of **Mirror Lake**.

On **23 August 2011**, Seminole County Lake Management Program (SCLMP) personnel Gloria Eby and Thomas Calhoun surveyed the aquatic plants of **Mirror Lake**.

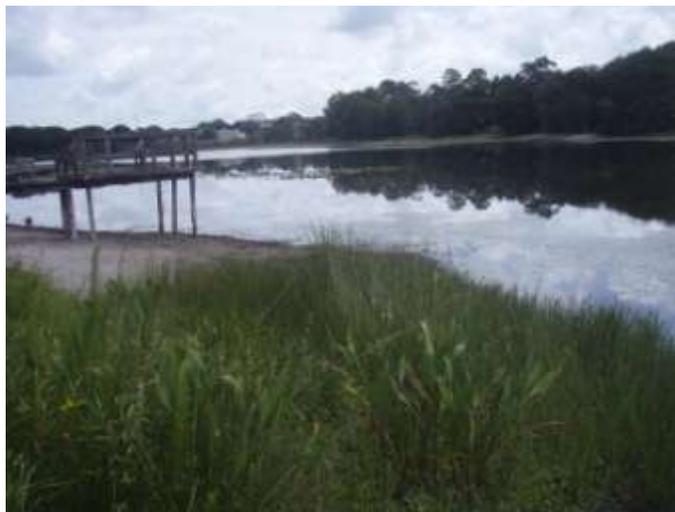
Ten submersed aquatic vegetation (SAV) were observed, 9 native and one exotic: lemon bacopa to a depth of 3 feet, coontail to 4 feet, musk grass to 5 feet, road grass to 5 feet, filamentous algae to 6 feet, the invasive exotic hydrilla to 4 feet, southern naiad to 6 feet, stonewort to 3 feet, bladderwort (*Utricularia inflata*) to 4 feet and eelgrass to 3 feet. Populations of both musk grass and southern naiad were thick and healthy, effectively covering the bottom from 2-6 feet. Musk grass continues to be the most dominant SAV, most prevalent in the area separating the north and south pool.

Photo: Native emergent plants with SAV topping out in nearshore areas.

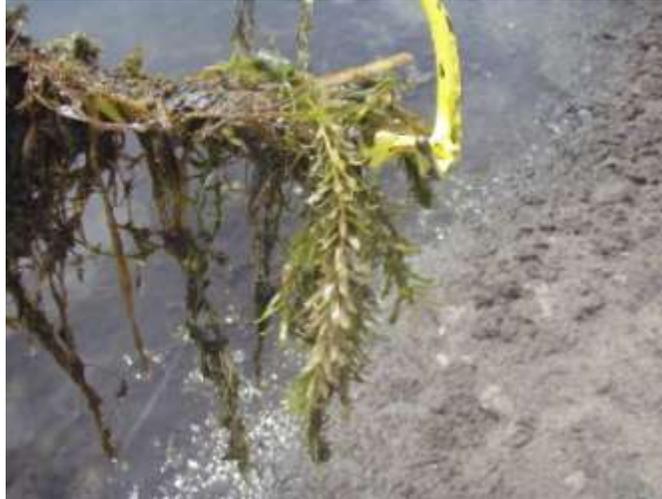
Hydrilla was significantly stressed, dominantly in the treated plots along the west shoreline. Most of the plant observed showed significant signs of herbicide impact, such that it will drop out soon. The treatment reduction of hydrilla will hopefully allow the native SAV to expand into the treatment sites. Eelgrass population continues to expand being observed at new sites in shallow water (3 feet or less). The plants are small, less than 1/3 of its potential size.

Photo: Impacted hydrilla

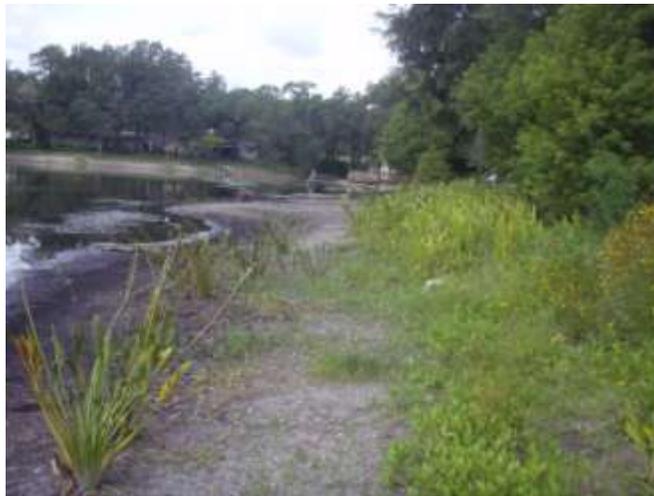
Overall the emergent native aquatic plants are doing well throughout the lake. However, torpedo grass continues to be a problem, especially in the cove in the NE corner of the lake. Torpedo grass, continues to be the dominant emergent aquatic plant, although, it has been treated throughout the lake. In the NE pool, because these torpedo grass plants have little leaf surface above the water to absorb the aquatic herbicide, it is difficult to get enough product on the plant for effective control. Most of the residential sites that were planted during the Seminole Education, Restoration & Volunteer (SERV) event have the planted natives, mostly pickerelweed, duck potato and canna expanding into thick stands. Sites like this make it difficult for invasive aquatic plants, especially torpedo grass to return. This is our objective. Some other sites need maintenance as the torpedo grass is trying to establish dominance and take over the site.

Photo: Low water level with expanding native emergent vegetation.

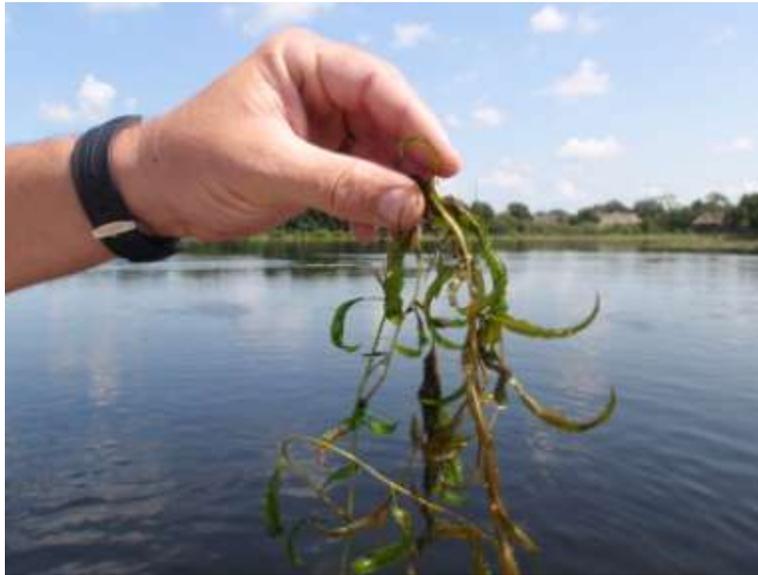
Eleven submersed aquatic vegetation (SAV) were observed, 10 native and 1 exotic: lemon bacopa to a depth of 3 feet, musk grass to 3 feet, road grass to 3 feet, filamentous algae to 6 feet, the invasive exotic hydrilla to 7 feet, southern naiad to 7 feet, stonewort to 4 feet, bladderwort (*Utricularia inflata & foliosa*) to 7 feet, eelgrass to 4 feet and recently observed is pondweed (*Potamogeton illinoensis*) to 4 feet.

Photo: Pondweed, a beneficial native aquatic plant, found in Mirror Lake.
