On **June 18<sup>th</sup>, 2013**, Seminole County Lake Management Program (SCLMP) personnel Thomas Calhoun and Watershed Management intern, Joey Cordell, surveyed the aquatic plants in **Mirror Lake**.

On **July 16<sup>th</sup>, 2013**, SCLMP personnel Thomas Calhoun and Watershed Management intern, Joey Cordell, surveyed the aquatic plants of **Mirror Lake**.

On **December 28<sup>th</sup>, 2012**, Seminole County Lake Management Program (SCLMP) personnel, Thomas Calhoun, and Water Quality intern, Devin Whitney, surveyed the aquatic plants of **Mirror Lake**.

On **October 23<sup>rd</sup>, 2012**, Seminole County Lake Management Program (SCLMP) personnel, Thomas Calhoun, and Water Quality staff, Marie Lackey, surveyed the aquatic plants of **Mirror Lake**.

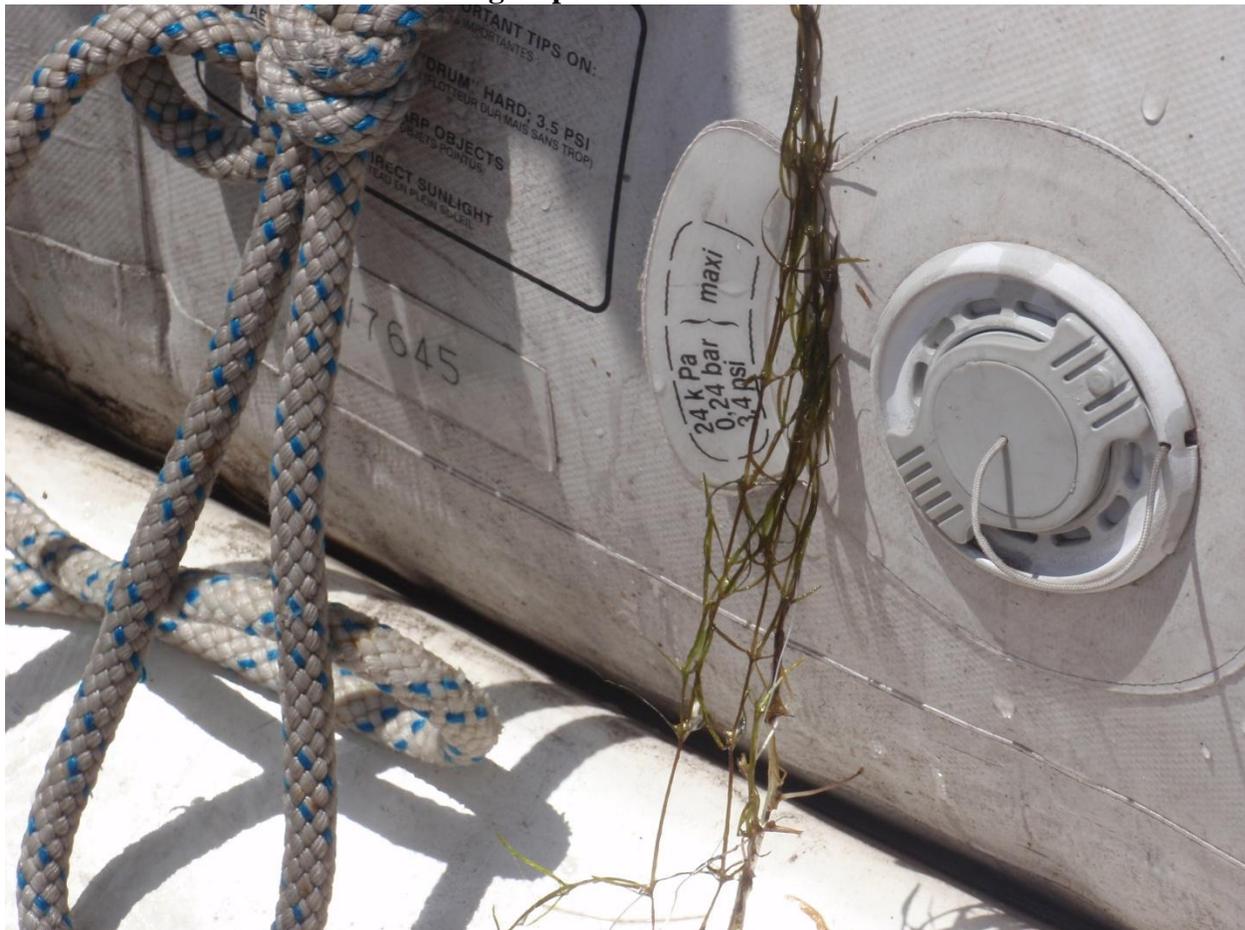
Ten species of submersed aquatic vegetation (SAV) were found during the inspection, nine of which were native species. These native species included: lemon bacopa to 3 feet, smooth water hyssop to 2 feet, musk grass to 4 feet, road grass to 8 feet, baby's tears to 2 feet, southern naiad to 8 feet, stonewort to 2 feet, 2 types of bladderwort to 7 feet, and eelgrass to 7 feet. Southern naiad has expanded significantly since the previous inspection. Mirror Lake continues to show excellent diversity of SAVs.

**Photo: Southern naiad found during inspection.**

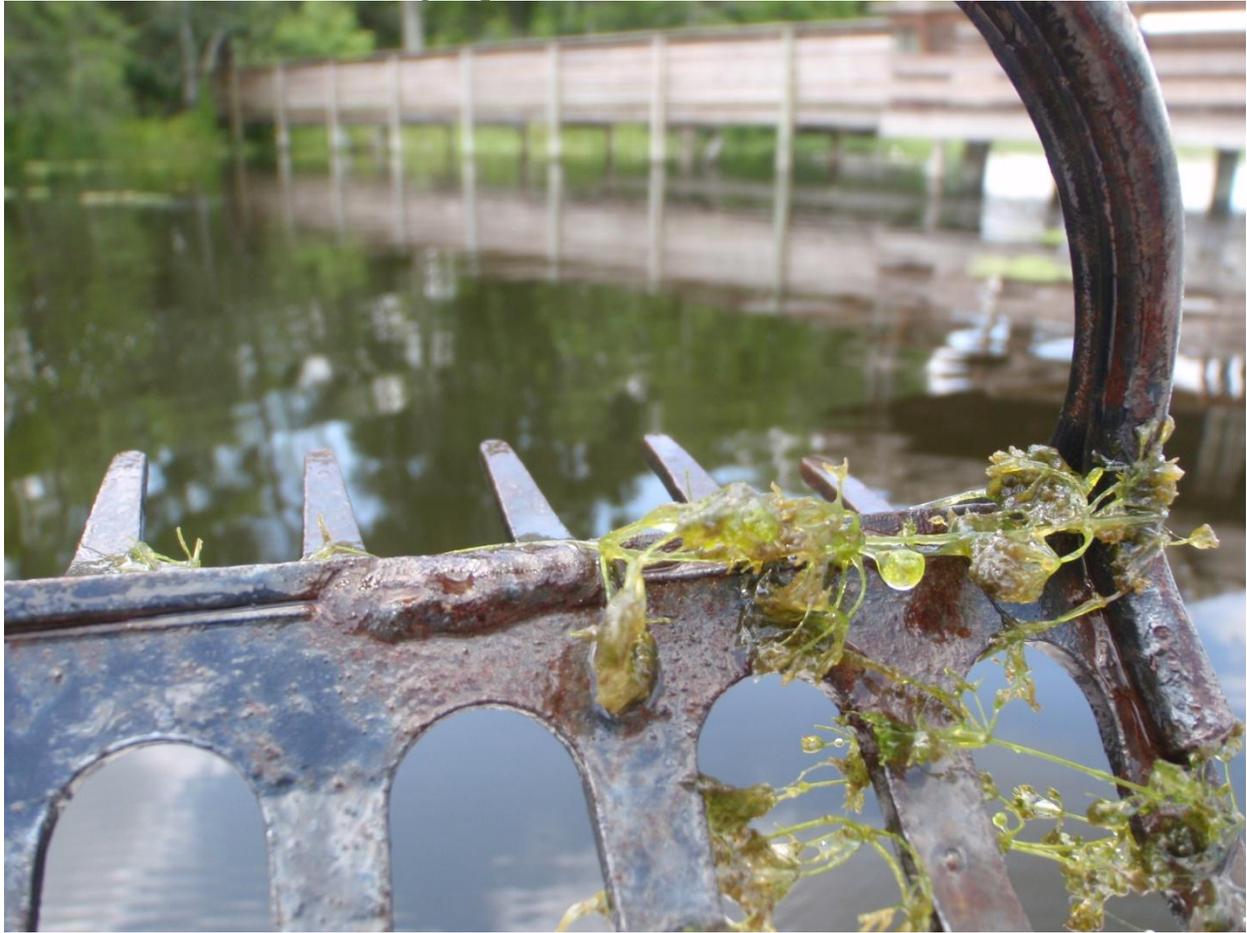
**Photo: Stonewort found during inspection.**

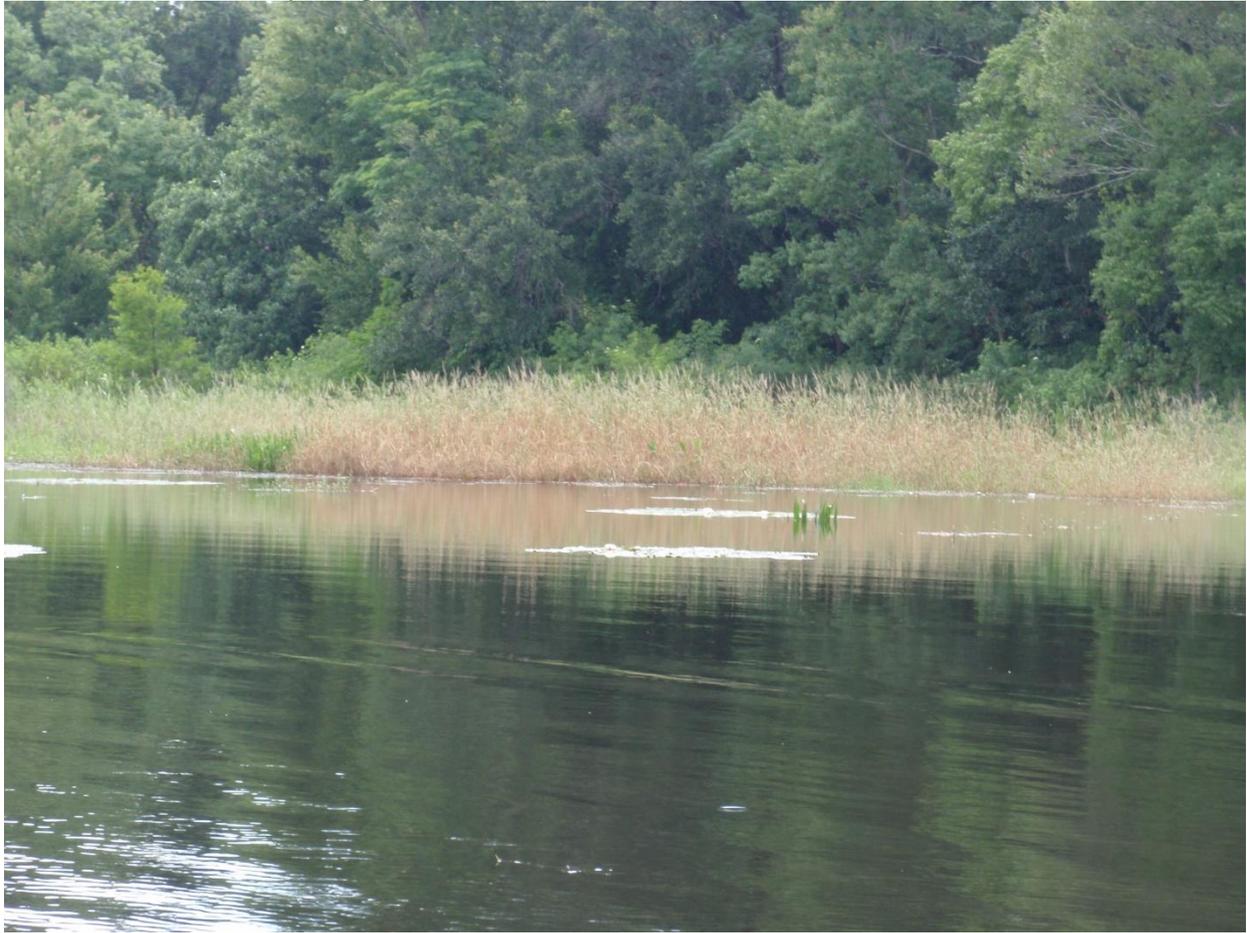
Barnyard grass and torpedo grass were showing signs of impact from the previous treatment. We observed that access corridors in the southern end of Mirror Lake were still open. The areas in the southern portion (especially the west and east corners) of the lake will be further treated as water levels allow. Water elevation plays a key role in how much the MSBU funded herbicide contractor can treat due to boat access. As water elevation rises, greater areas can be accessed and treated.

**Photo: Treated barnyard grass at the southern end of the lake.**

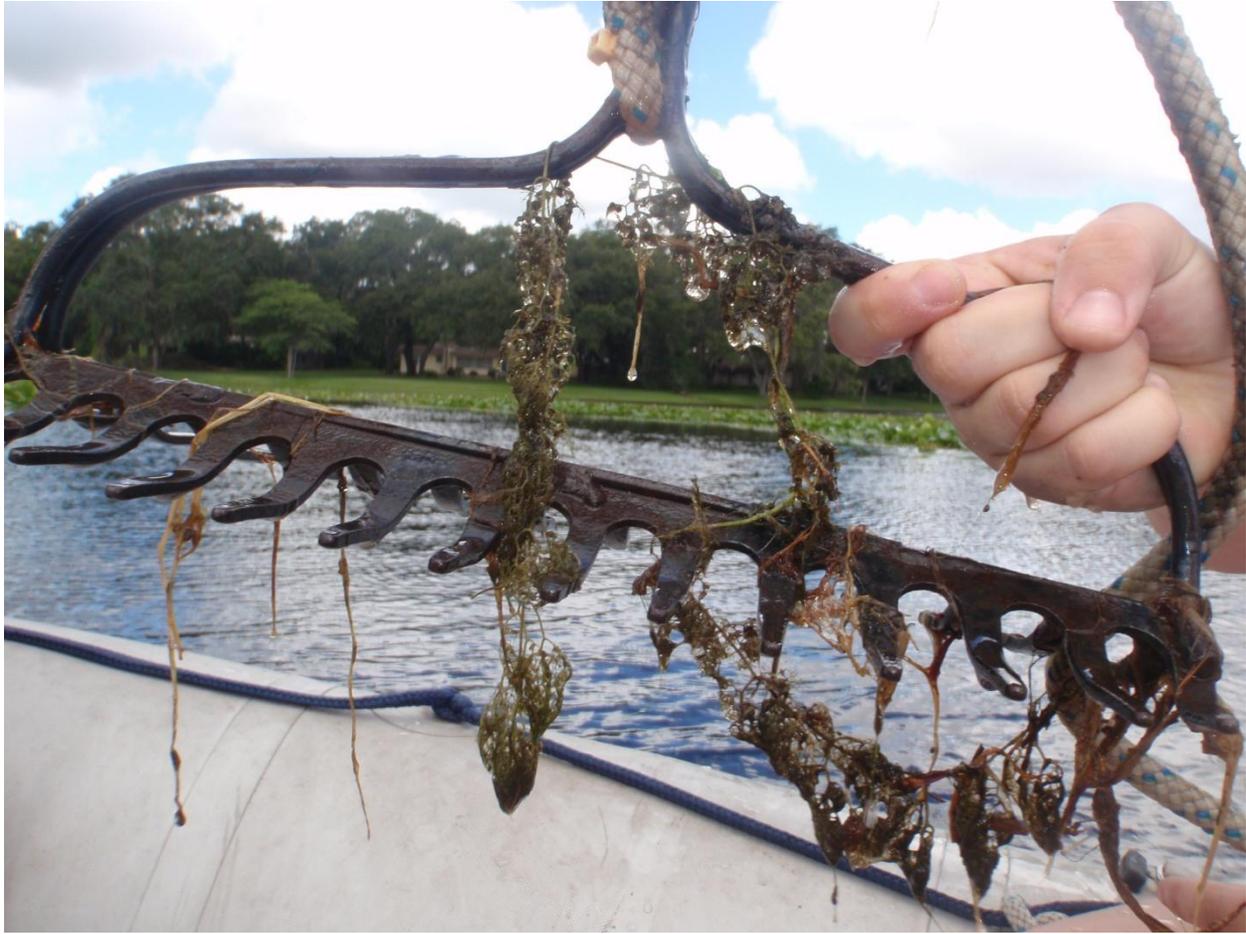
Ten species of submersed aquatic vegetation (SAV) were found during the inspection, nine of which were native species. These native species included: lemon bacopa to 3 feet, smooth water hyssop to 2 feet, musk grass to 4 feet, road grass to 8 feet, baby's tears to 3 feet, southern naiad to 7 feet, stonewort to 4 feet, 3 types of bladderwort to 7 feet, and eelgrass to 7 feet.

**Photo: Bladderwort found during the inspection.**

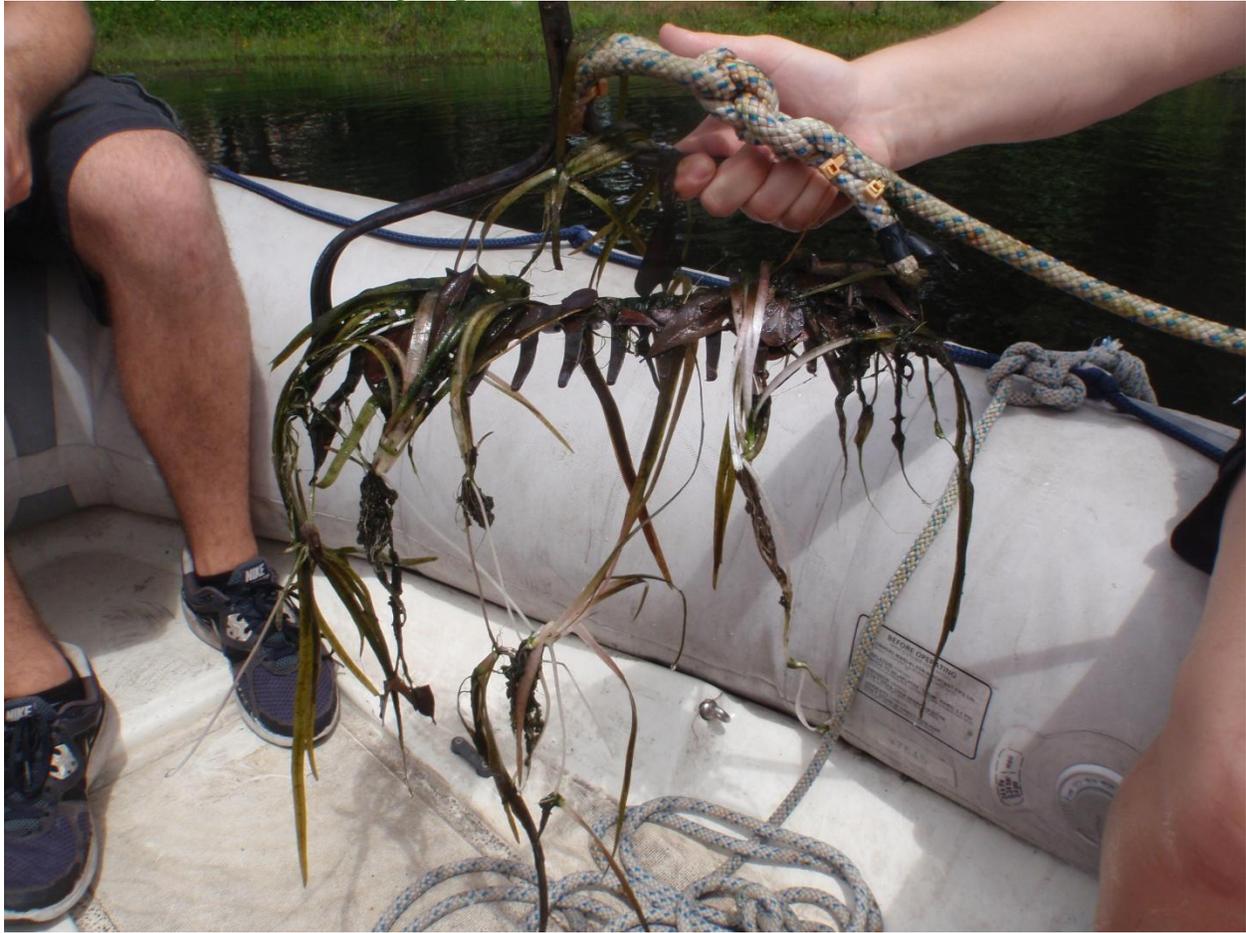
**Photo: Eelgrass found during inspection.**

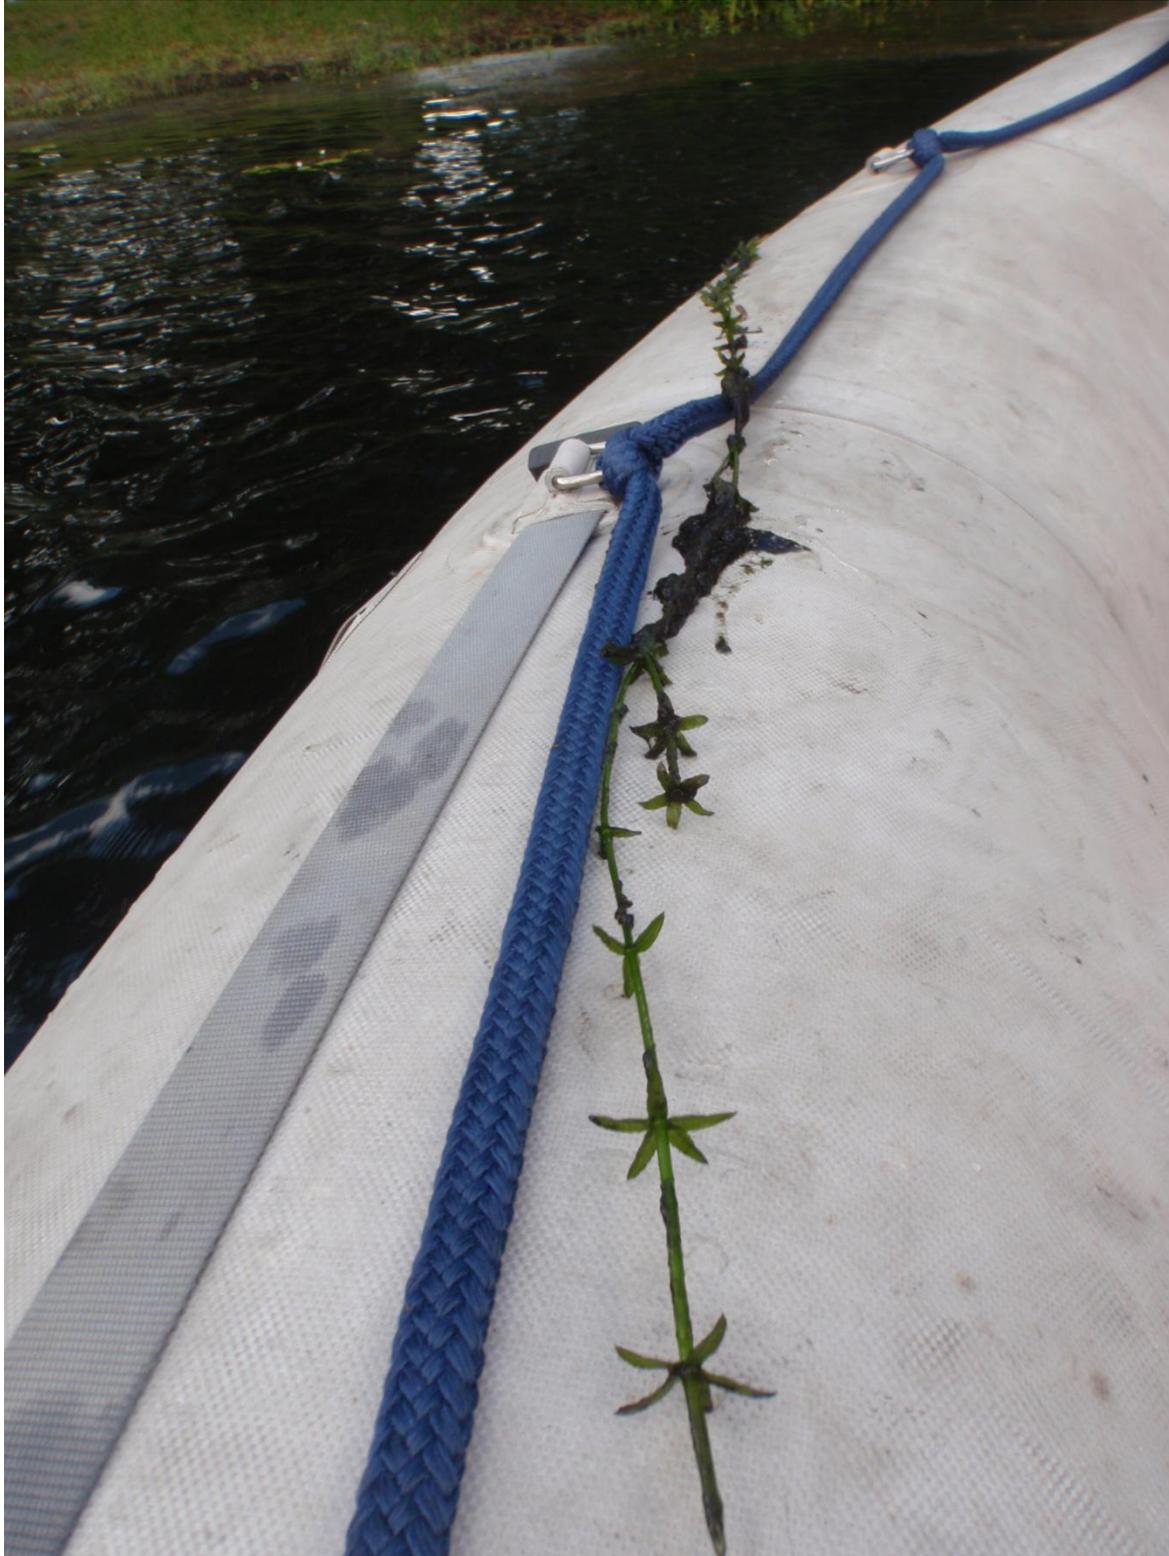
Hydrilla was the only invasive exotic species found and in less quantities than the previous inspection. It was sparsely intermixed with the native vegetation to a depth of 3 feet along the eastern shore and in the inflow canal along the west shoreline. It is suspected that with the increase in water elevation, the grass carp fish will be able to consume and reduce the population of hydrilla establishing in shallow water.

**Photo: Hydrilla found during inspection.**

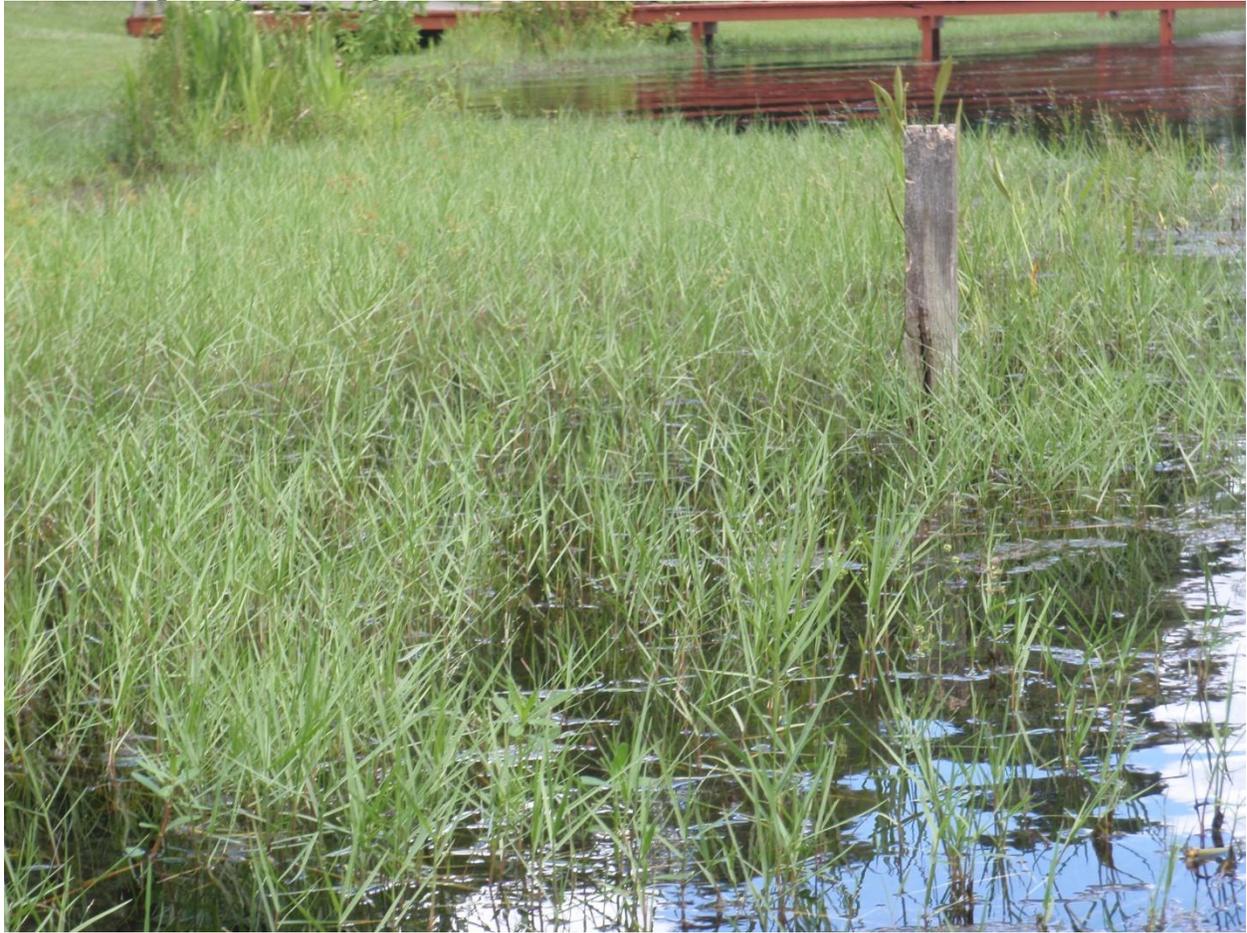
Barnyard and torpedo grass have been reduced in the southern portion of the lake. Please remember that as the water elevation rises or stays high, the herbicide contractor will be able to treat farther with each subsequent treatment. In other areas of the lake, torpedo grass has

expanded and will be targeted next month. Access corridors in the southern end of Mirror Lake were still open.

**Photo: Torpedo grass along the western shoreline.**

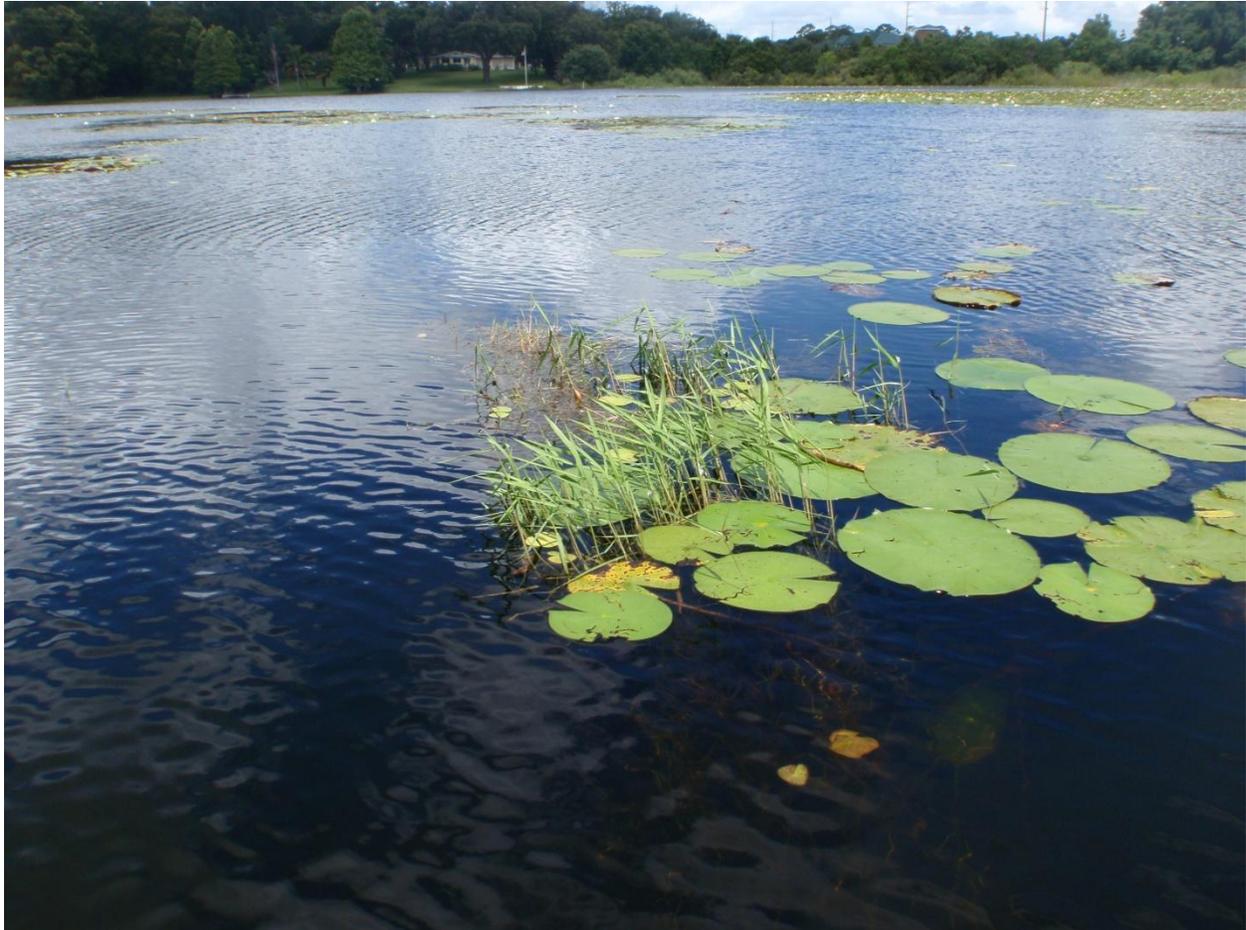
Native emergent vegetation found during the inspection included: canna lily, flat sedge, spike rush, pickerelweed, duck potato, and maidencane. Maidencane was observed expanding in several areas of the lake. Maidencane is a valuable common native emergent plant that provides food, protection, and nesting material for wildlife.

**Photo: Maidencane found during inspection.**

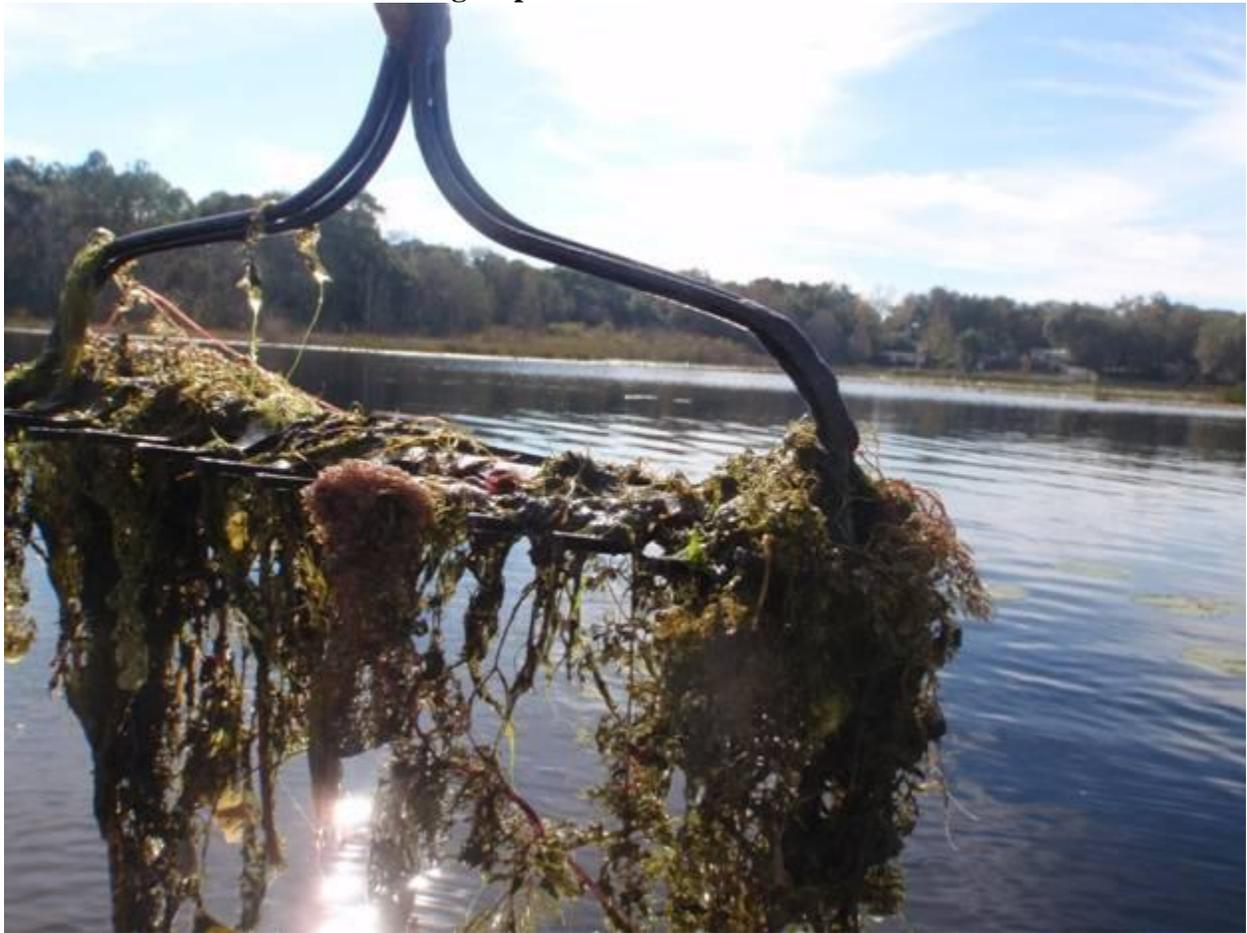
There was a large amount of submersed aquatic vegetation (SAV) found during this inspection. Native SAV included: lemon bacopa to a depth of 3 ft, coontail to a depth of 5 ft, southern naiad to a depth of 3 ft, stonewort to a depth of 2 ft, bladderwort to a depth of 6 ft, baby's tears to a depth of 2 ft, road grass to a depth of 3, musk grass to a depth of 3 ft, and eelgrass to a depth of 6 ft.

**Photo: Bladderwort found during inspection.**

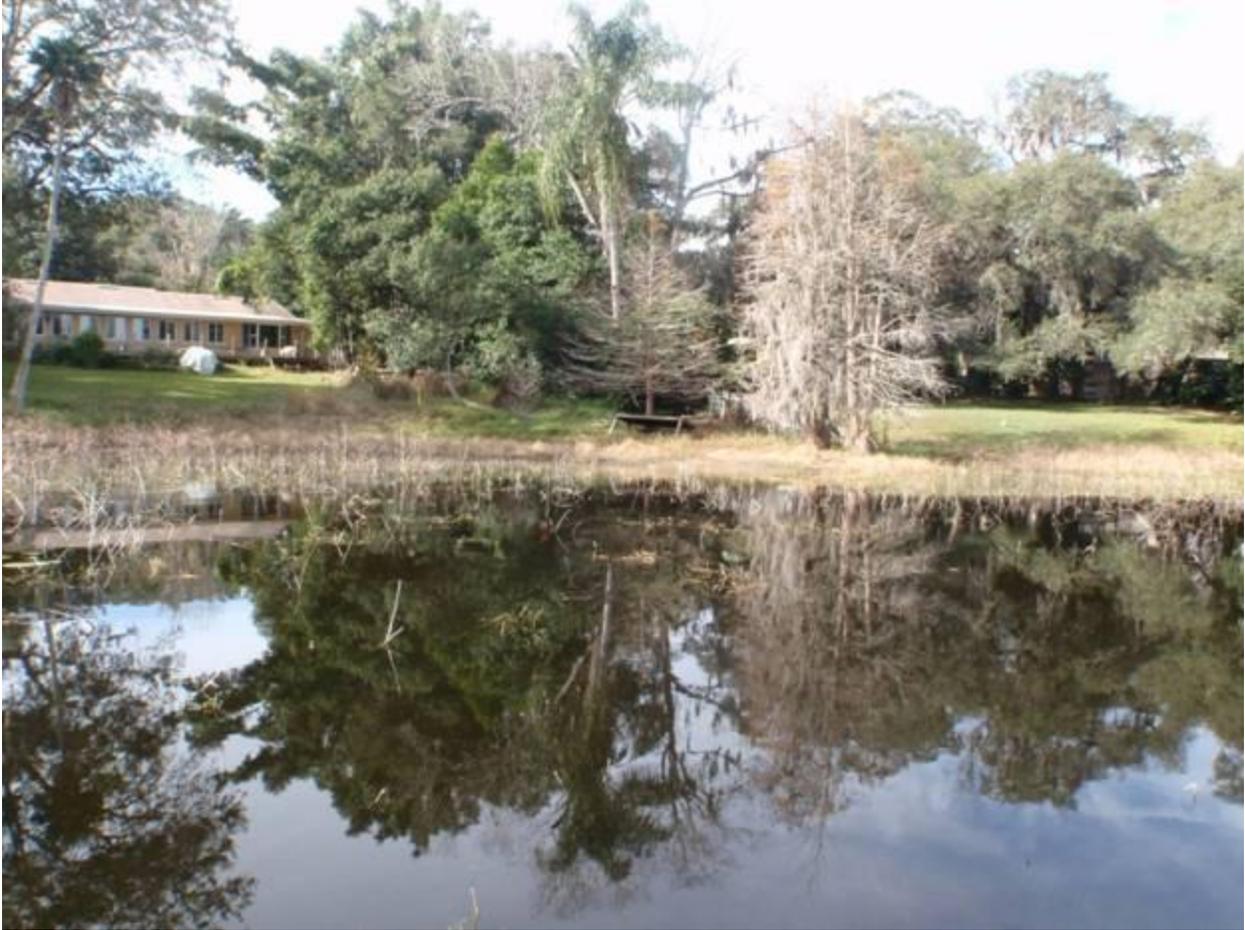
The access corridors in the southern end of Mirror Lake are now open. Treatment of the invasive species, torpedo grass, continues to be successful in other areas of the lake. Pickerelweed was also noted to be expanding in many areas around the lake.

**Photo: Area treated in the southern portion of the lake.**

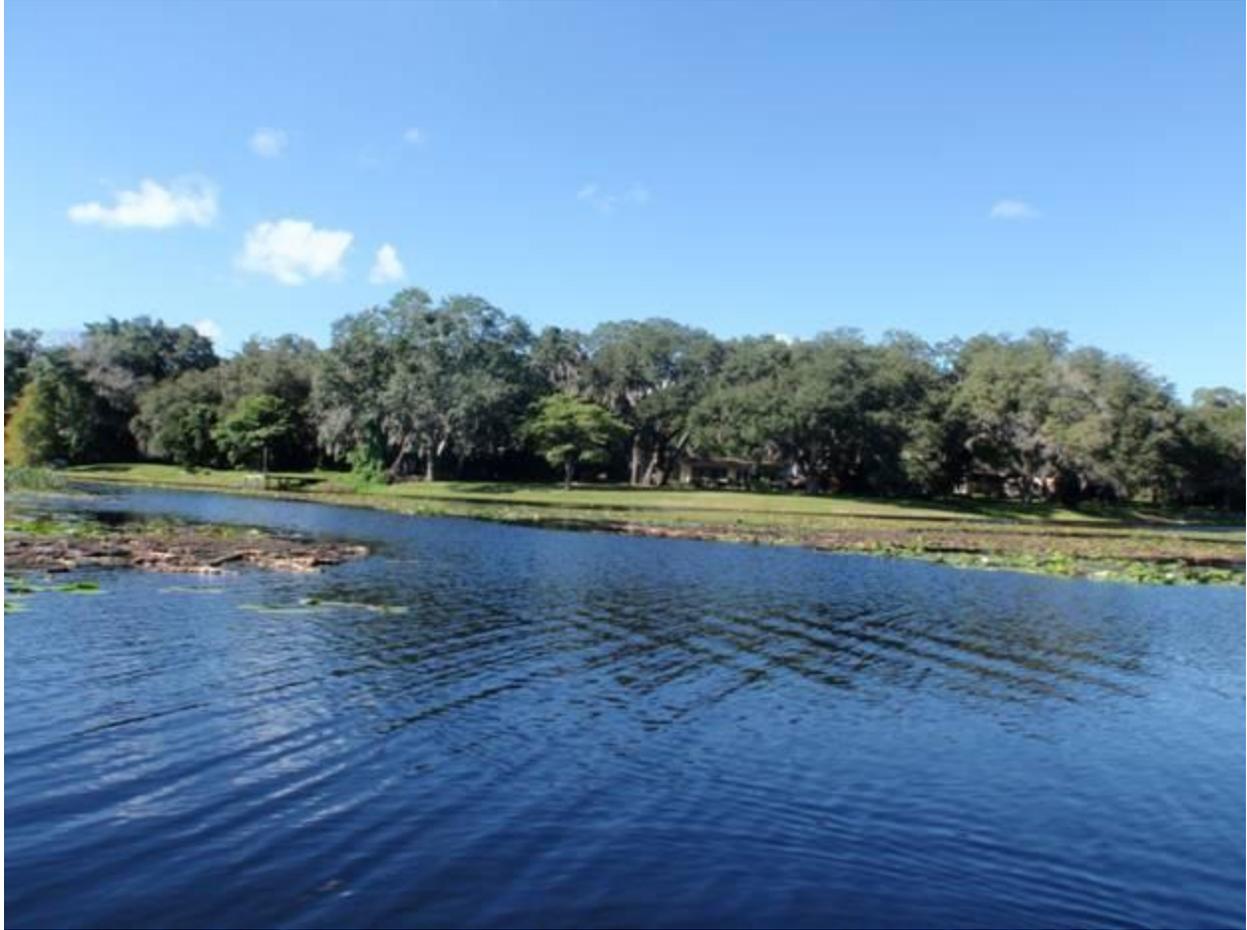
Water levels in Mirror Lake are returning to normal, providing access to most areas of the lake again. Seminole County herbicide contractors will continue to treat and open corridors as necessary to reestablish normal conditions.

**Photo: Open access corridor.**

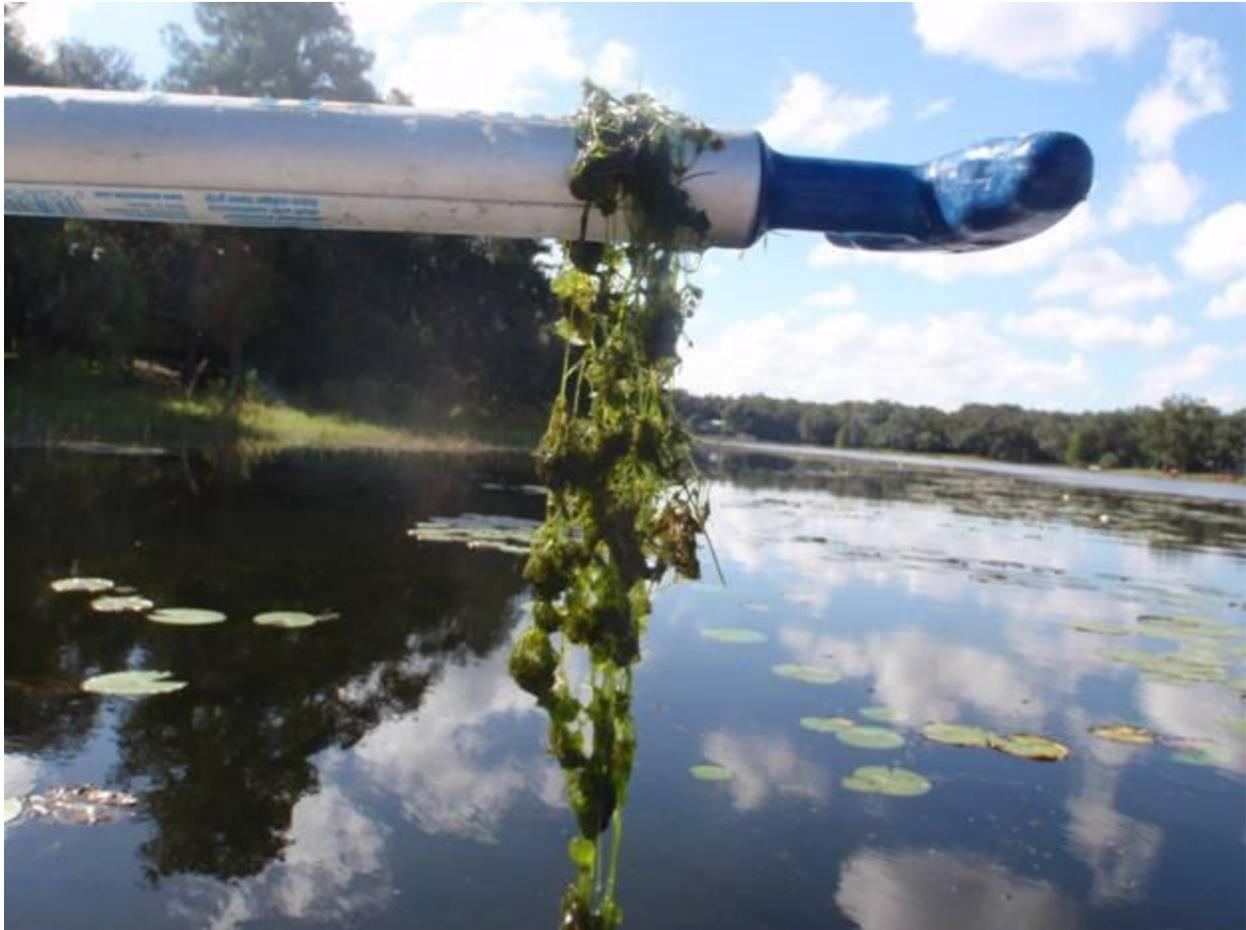
The native SAV found during this inspection included: lemon bacopa to a depth of 1 ft, coontail to a depth of 5 ft, southern naiad to a depth of 5 ft, stonewort to a depth of 2 ft, bladderwort to a depth of 5 ft, baby's tears to a depth of 1 ft, road grass to a depth of 4 feet, and eelgrass to a depth of 3 ft.

**Photo: Stonewort found during inspection.**

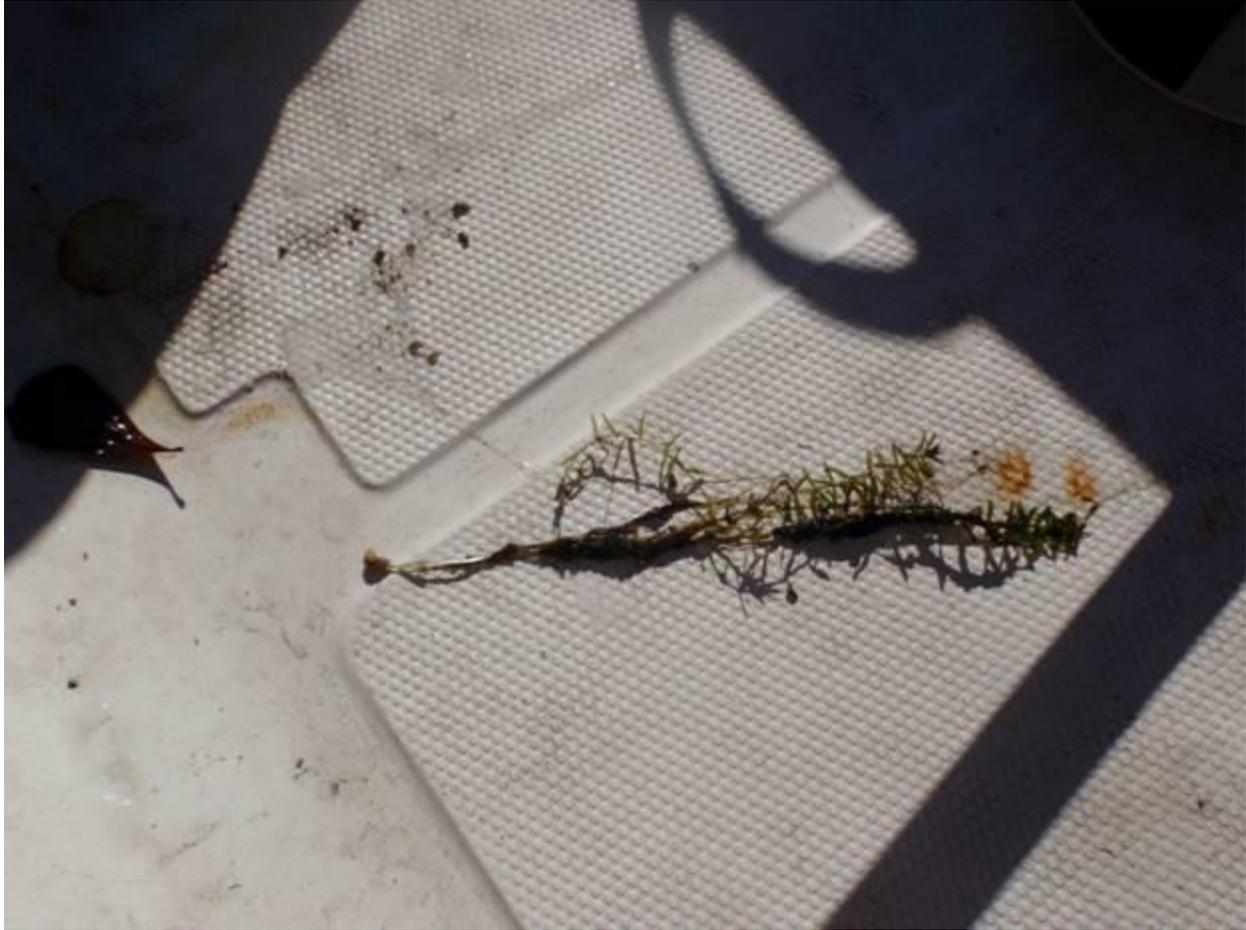
Hydrilla was found growing sparsely along the shoreline in shallow water, intermixed with native SAV. We will continue to monitor hydrilla growth within the lake to see if any further action will be necessary.

**Photo: Hydrilla found during inspection.**
